# DISTINGTON -BIG LOCAL

## DRAINAGE STRATEGY REPORT

Document Ref: DIS-AJP-ZZ-XX-RP-C-3000

## **PHASE 2: GROUND INVESTIGATION REPORT**

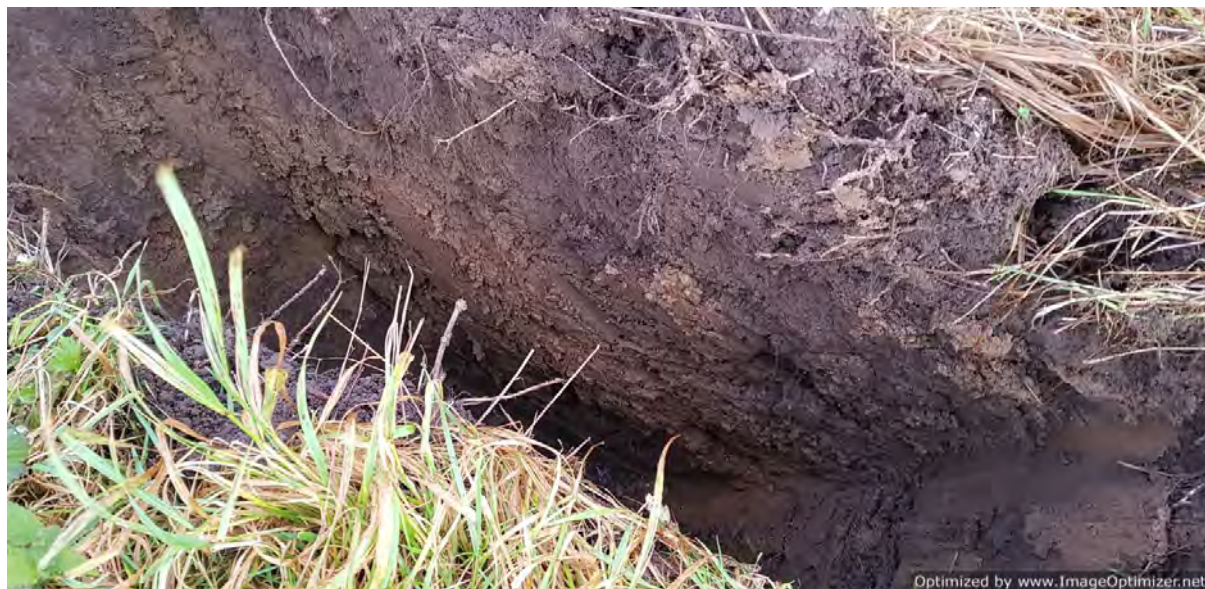
Soil Infiltration Test	
Pit Dimensions: 0.30 x 1.80m	
Duration (mins)	Water Level (m bgl)
0	0.40
20	0.41
80	0.39
120	0.38

During the test, the water level either remained static or rose within the pit, possibly due to the shallow groundwater ingress. The tests were terminated after a maximum duration of 240 minutes (4 hours). Based on the results of the tests, the ground conditions are not considered suitable for soak-away drainage.

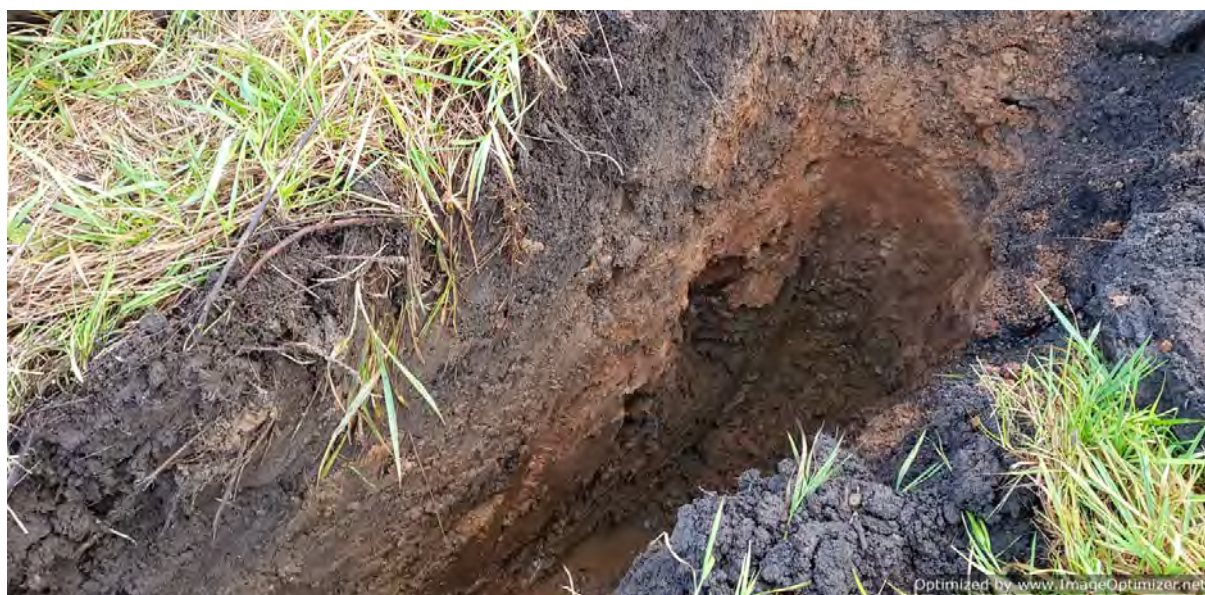
Soil Infiltration Test	
Pit Dimensions: 0.35 x 1.90m	
Duration (mins)	Water Level (m bgl)
0	0.70
60	0.56
120	0.54

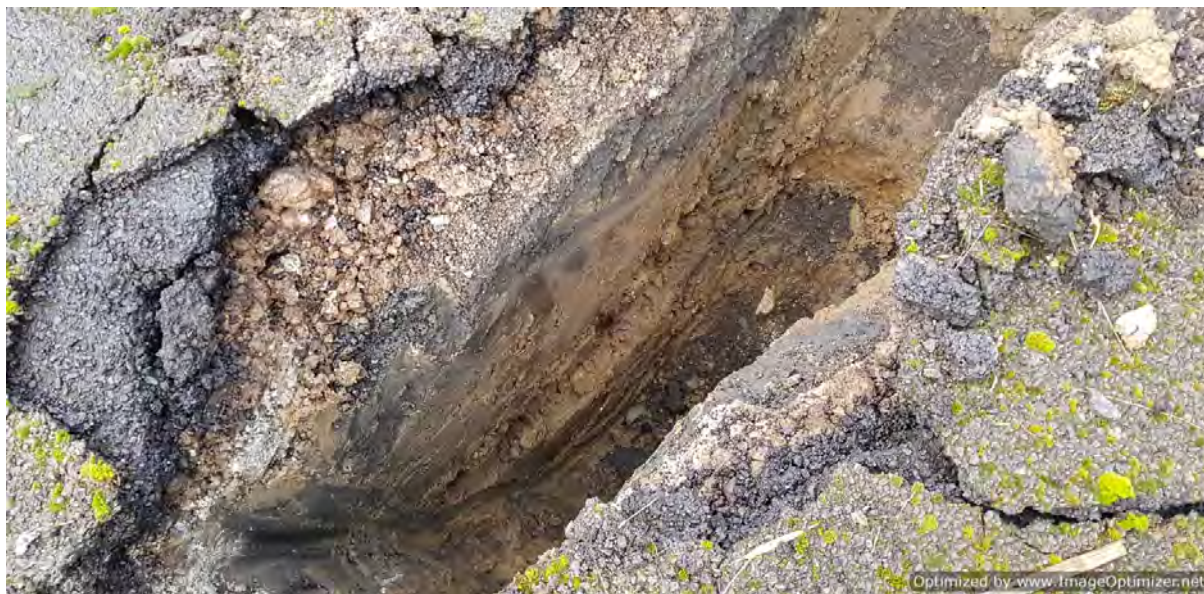
Soil Infiltration Test	
Pit Dimensions: 0.35 x 1.80m	
Duration (mins)	Water Level (m bgl)
0	0.45
40	0.45
75	0.45
120	0.45
240	0.45

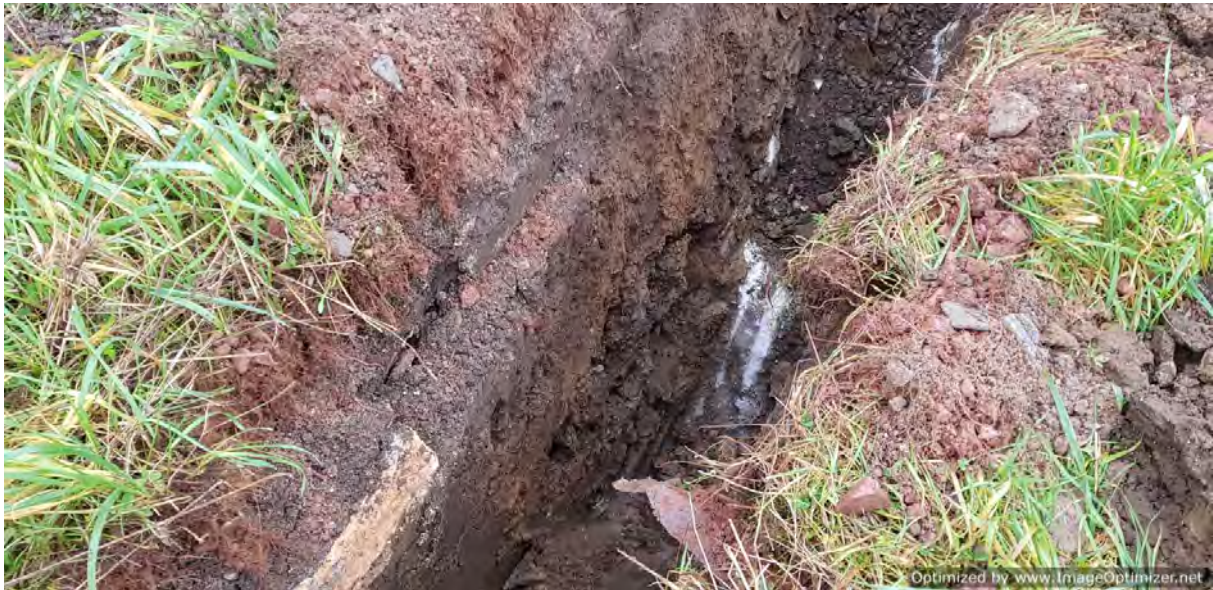
**GEO2019-4032: Land off Church Road, Distington, Cumbria – TP05**

Depth From (m)	Depth To (m)	Strata Description	Legend	Testing / Samples
0.00	0.22	MADE GROUND: Dark grey brown sandy gravelly LOAM with occasional mixed aggregate, brick, concrete and timber.

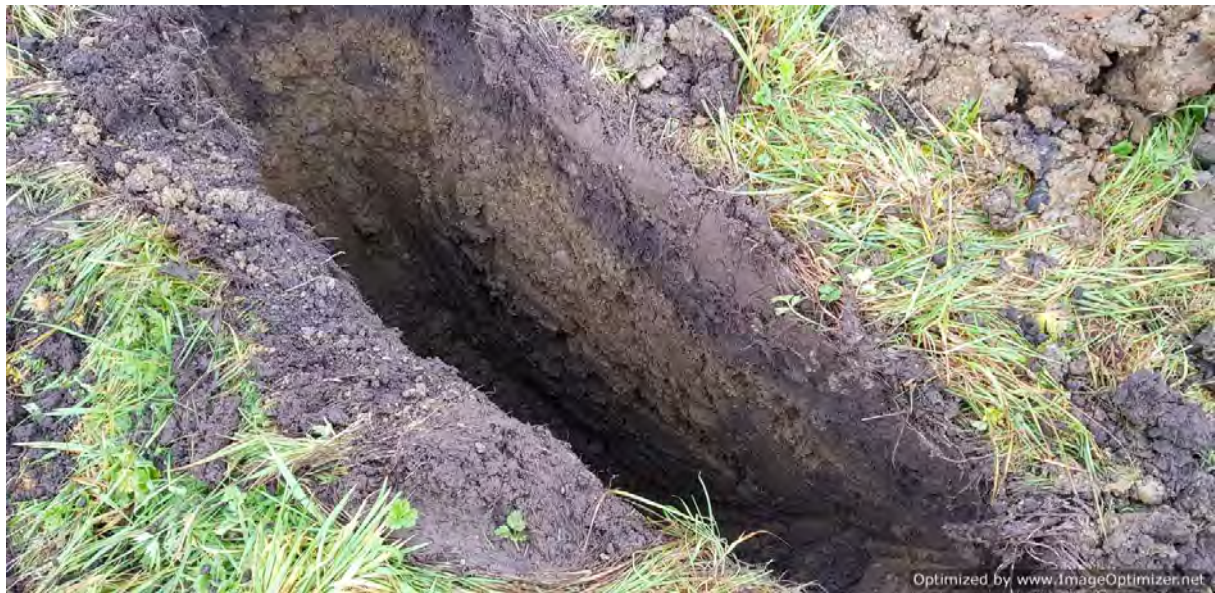
**GEO2019-4032: Land off Church Road, Distington, Cumbria – TP07**

Depth From (m)	Depth To (m)	Strata Description	Legend	Testing / Samples
0.00	0.26	TOPSOIL: Dark grey brown sandy gravelly LOAM with occasional glass.

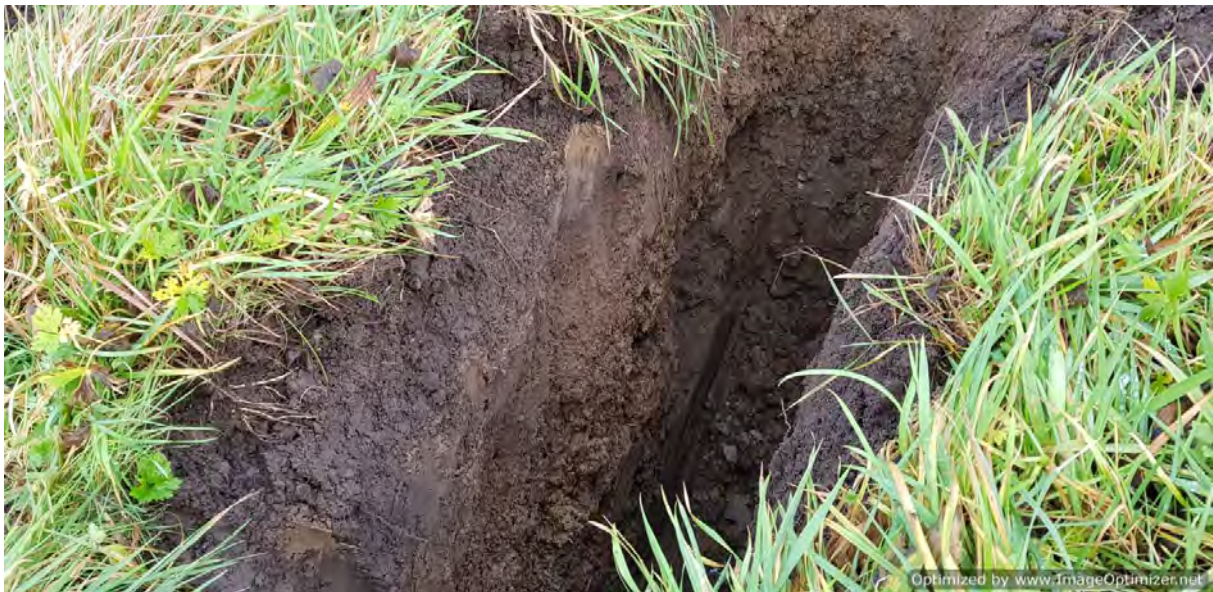
**GEO2019-4032: Land off Church Road, Distington, Cumbria – TP08**

Depth From (m)	Depth To (m)	Strata Description	Legend	Testing / Samples
0.00	0.30	MADE GROUND: Dark grey to black very sandy gravelly LOAM with occasional glass and gravel of clinker and asphalt.

End of trial hole at 1.50m. Slight groundwater ingress at c.0.30m bgl. Trial hole backfilled with arisings on completion.		
<b>Site:</b> Land off Church Road, Distington, Cumbria <b>Engineer:</b> J.Brock <b>Site Works Date:</b> 12/12/2019 <b>Plant:</b> Tracked 360 Excavator			<b>Log Notes:</b> HSV = Hand Shear Vane (kN/m <sup>2</sup> ) LP = Limited Penetration (HSV/CBR) B = Bulk Bag, J = Amber Glass Jar, T = Plastic Tub

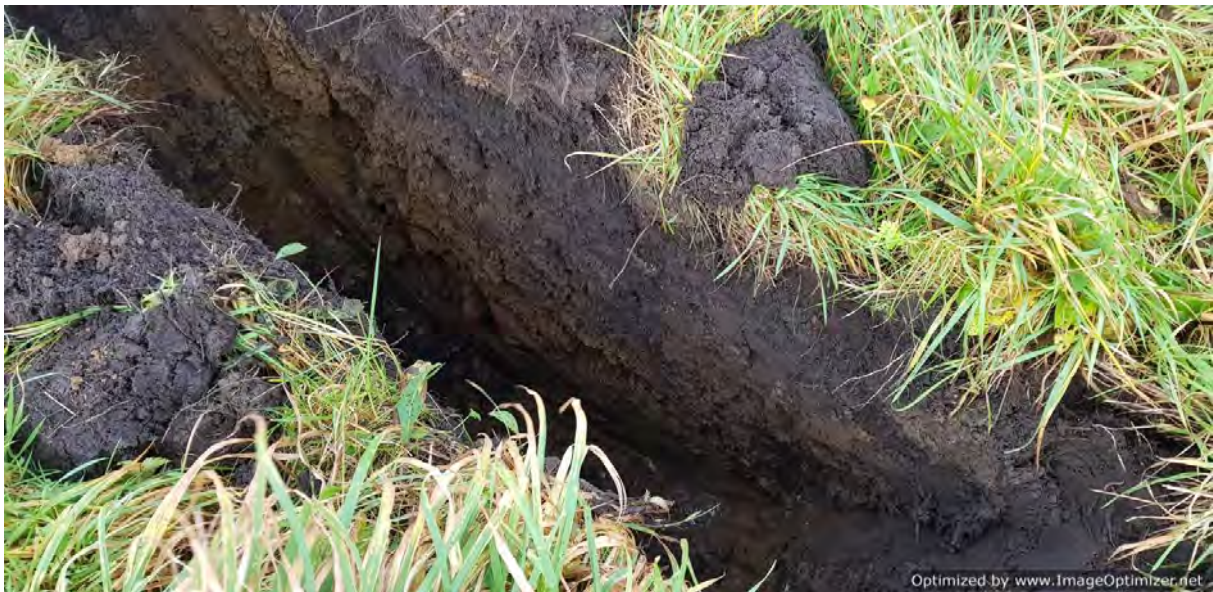
**GEO2019-4032: Land off Church Road, Distington, Cumbria – TP09**

Depth From (m)	Depth To (m)	Strata Description	Legend	Testing / Samples
0.00	0.08	MADE GROUND: Asphalt.		
0.08	0.12	MADE GROUND: Grey fine to coarse angular GRAVEL.		
0.12	0.18	MADE GROUND: Fused SLAG.		
0.18	0.40	MADE GROUND: Grey fine to coarse angular GRAVEL.		
0.40	0.68	RELICT TOPSOIL: Dark grey brown very clayey sandy gravelly LOAM.		0.5 - J
0.68	1.10	Firm brown silty, very sandy gravelly CLAY with pockets of medium to coarse sand.		
1.10	1.60	Stiff, locally firm to stiff dark brown very gravelly CLAY.		
		End of trial hole at 1.60m. Slight groundwater ingress at c.0.40m bgl. Trial hole backfilled with arisings on completion.
