**STATEMENT OF DISPLAY OF A SITE NOTICE IN ACCORDANCE WITH A.2(b) PART 31 OF SCHEDULE 2 OF THE GENERAL PERMITTED DEVELOPMENT ORDER 1995**

**Bats & Birds: Robertson memorials, Low Road, Whitehaven**

Robertson Memorials, Whitehaven, propose to demolish an existing garage structure which abuts the office at Low Road, Whitehaven. The proposals are currently going through planning (ref:TA/2023/296) and the requirement for bat and bird surveys have been highlighted prior to approvals.

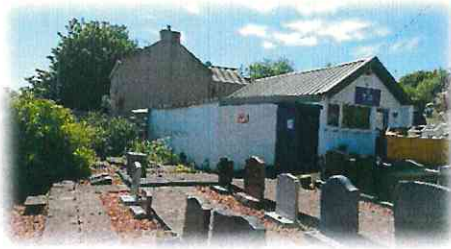
Plate 1: External view of Garage.

The garage is a single story 'lean-to' style building of brick and wooden support beam construction (plate 1). A steel lintel is present above the door and a length of boarded up 16 pane windows present on the eastern aspect. The roof consisted of corrugated roof panels on top of wooden lintels and external roof trim on both the northern and southern ends.

Upon close inspection no bat droppings could be found within the property. Externally all areas were tightly sealed with the exception of the eastern aspect above the guttering where the corrugated roofing provided gaps to the internal wooden lintel beam within. This feature, along with the garage's location within the surrounding environment afforded the building a low suitability for roosting bats.

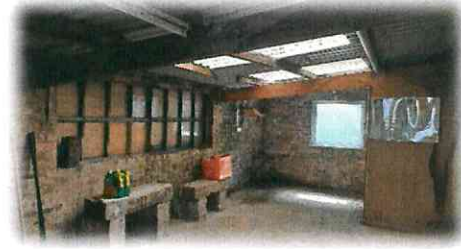
Plate 2: Internal Garage.

No bird nests or evidence of historic nesting was present.
