New House Farm  
Drigg  
Cumbria

AVISON YOUNG  
Ecological Constraints Study; 2023

VERSION 2  
Final

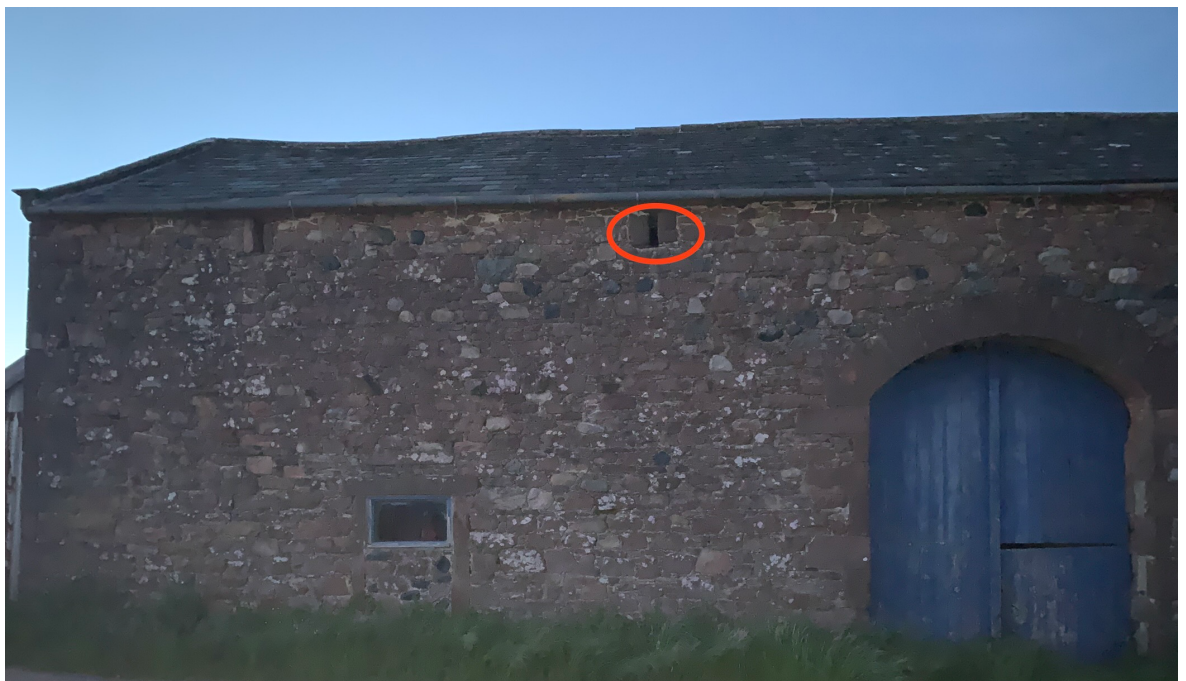
Photograph 1. RAP 1

A Common Pipistrelle re-entered its roost site within the [Stone Barn](#) at 04:21 via Roost Access Point (RAP) 1 ([Photograph 1](#)).

The confirmation of roosting bats within the Barn means that a licence from Natural England will be required to enable the proposed works to proceed lawfully. Given the identified roosts are of low conservation status, the site can be registered under the Bat Mitigation Class Licence (BMCL) scheme through a Registered Consultant (RC). Following submission of appropriate forms, the application takes up to ten working days to be assessed by Natural England.

No works to the Barn that may disturb roosting bats or prevent access to a potential bat roost should be completed until a licence is in place.

Works in the area of the roost (or potential roost sites if the specific location cannot be ascertained) will need to be supervised by an RC (or accredited agent). Prior to works commencing, the RC would provide a 'toolbox talk' to those contractors on site in which details of e.g. best working practices and what to do in the event of discovering a bat would be discussed.
