**Longlands Farmhouse and Cottage  
Cumbria**

AVISON YOUNG

**Update Ecological Constraints Study; 2023**

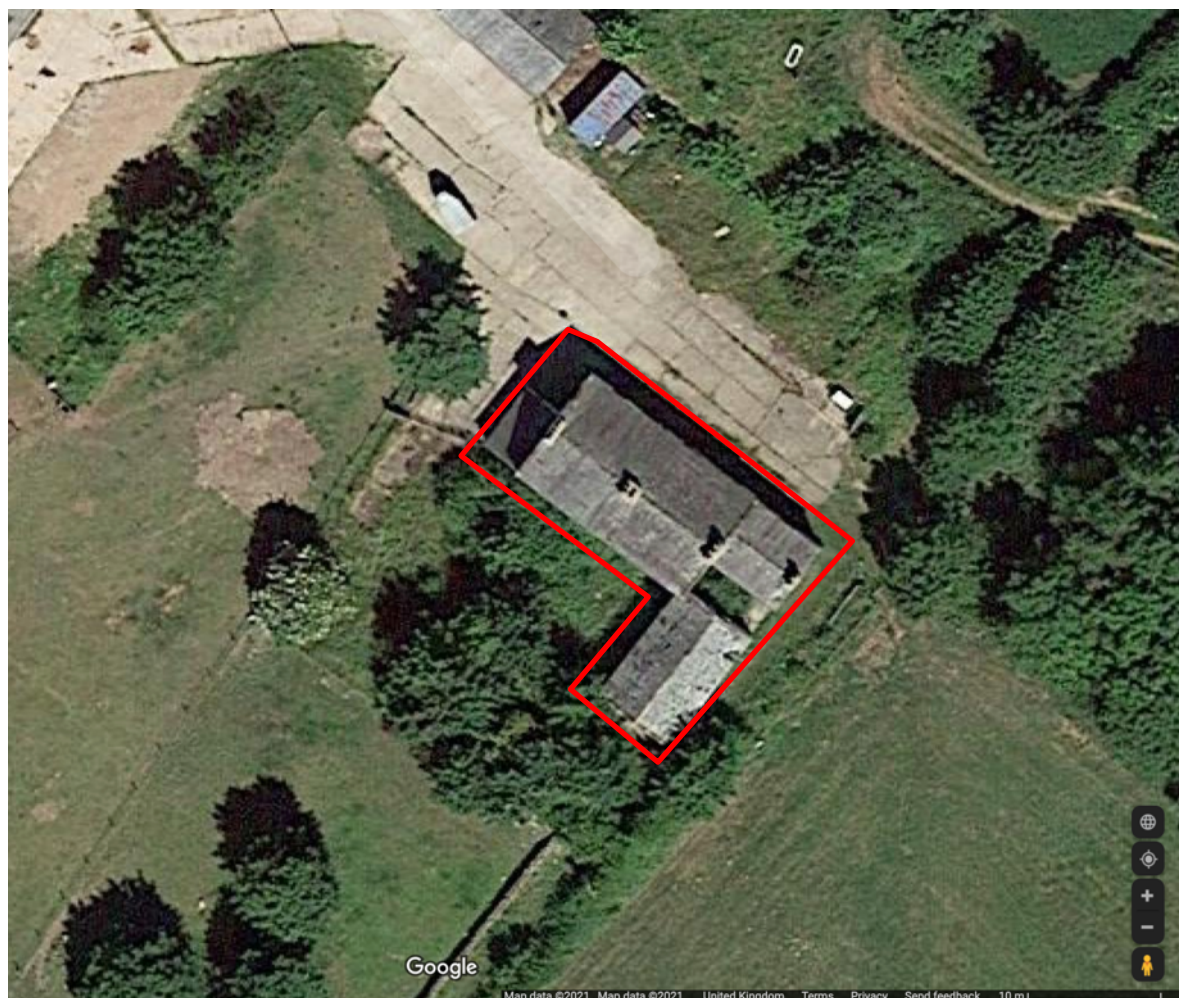
**Figure 2.** Site layout, buildings to be demolished in red

The site layout is shown on **Figure 2**.

It is proposed to demolish all buildings within the site (**Figure 2**).

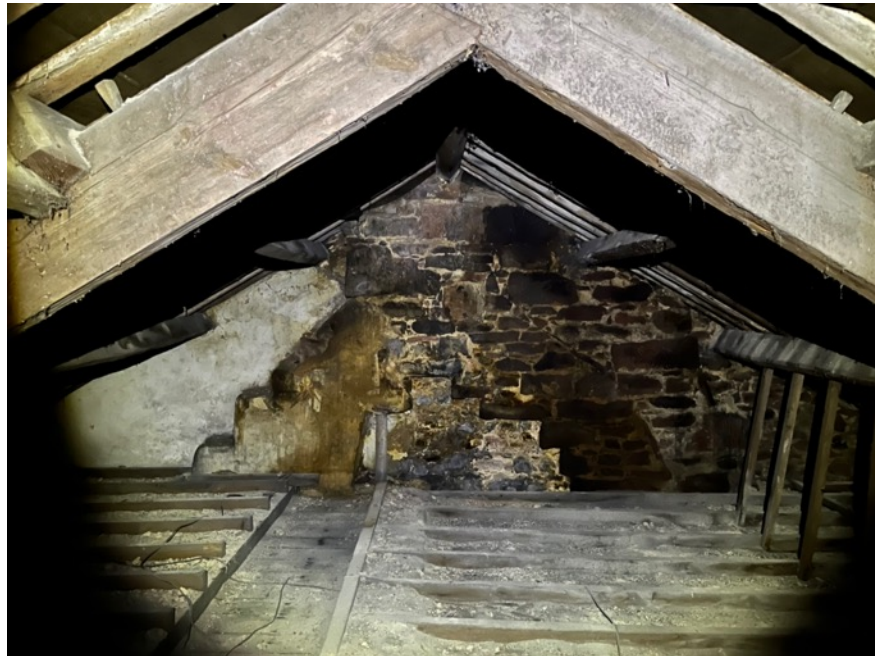
**Photograph 1.** Void above the house

Full access to the interior of the House and Cottage was achieved. The buildings were unoccupied. The roof of the house was lined with bitumen felt (**Photograph 1**) while the roof of the cottage was half unlined with the northern section lined with bitumen felt (**Photograph 2**).

Within the void above the house scattered pipistrelles-type droppings (50+, include some fresh) were present along with two Common Pipistrelles (**Photograph 3**) day-roosting. No other bats/evidence of other species was encountered.

No works to the building that may disturb roosting bats, or prevent access to a potential bat roost should be completed until a mitigation licence is in place.

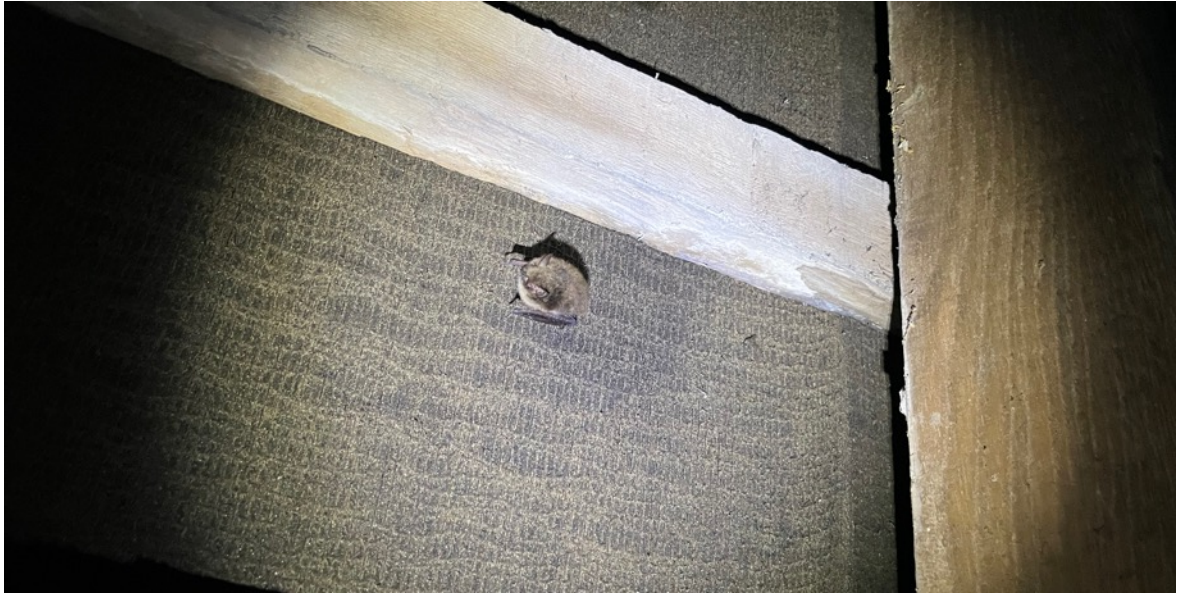
**Photograph 3.** Common Pipistrelle within void above House

The specific roost sites of the species detailed within **Table 2** during 2021 could not be determined. However, the Common Pipistrelle roosts were likely within the roof fabric and the Brown Long-eared Bats are likely to have roosted within the roof void near to the ridge. In 2023 the Common Pipistrelles roosted within the void (free hanging).

The confirmation of roosting bats within the site means that a licence from Natural England will be required to enable the proposed works to proceed lawfully. Given the identified roosts are of low conservation status, the site can be registered under the Bat Mitigation Class Licence (BMCL) scheme through a Registered Consultant (RC). Following submission of appropriate forms, the application takes up to ten working days to be assessed by Natural England.

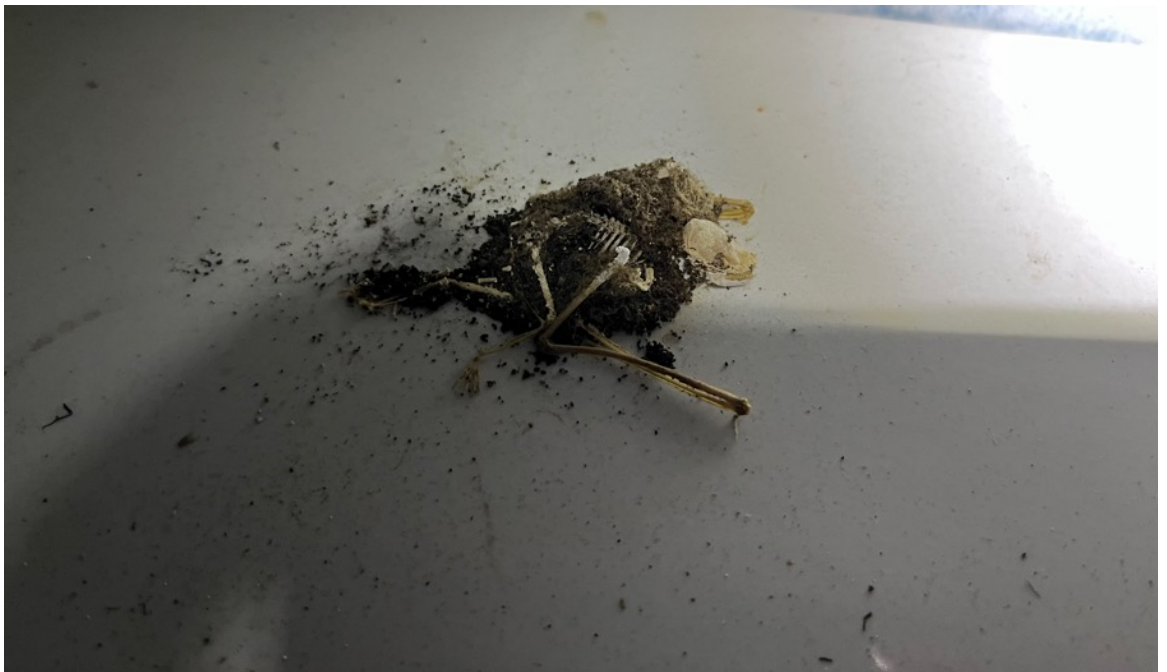
**Photograph 4.** Long-dead bat within Cottage

One long-dead bat (likely a pipistrelle species) was present within the bathroom of the Cottage (**Photograph 4**). No bats/evidence of bats was encountered within the Cottage.

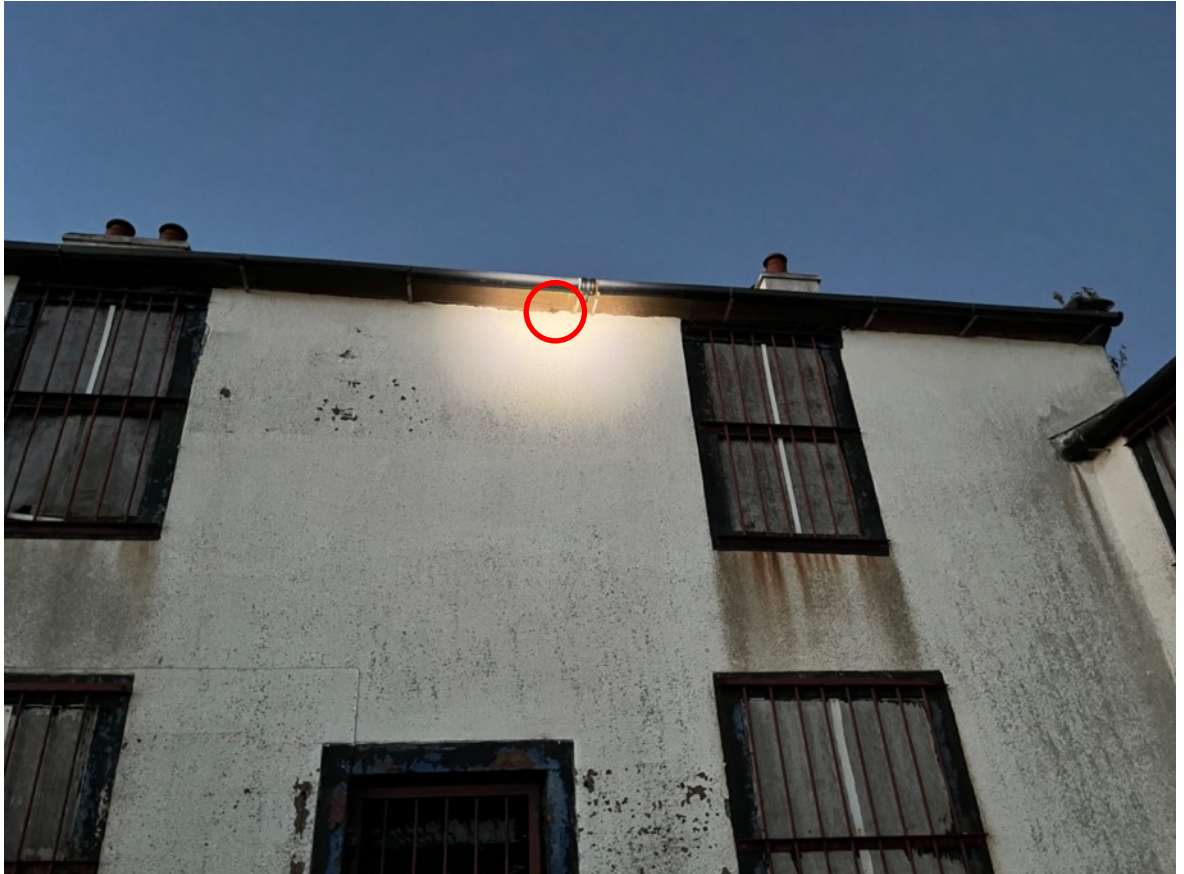
Photograph 5. RAP 5

Three Common Pipistrelles exited a day-roost via a gap at the eaves on the southern elevation of the House (Photograph 1) (Roost Access Point (RAP) 5).

The proposed works will result in the loss of all roosts.
