High Ling Bank, Cumbria

Ecological Constraints Study; 2023

AVISON YOUNG

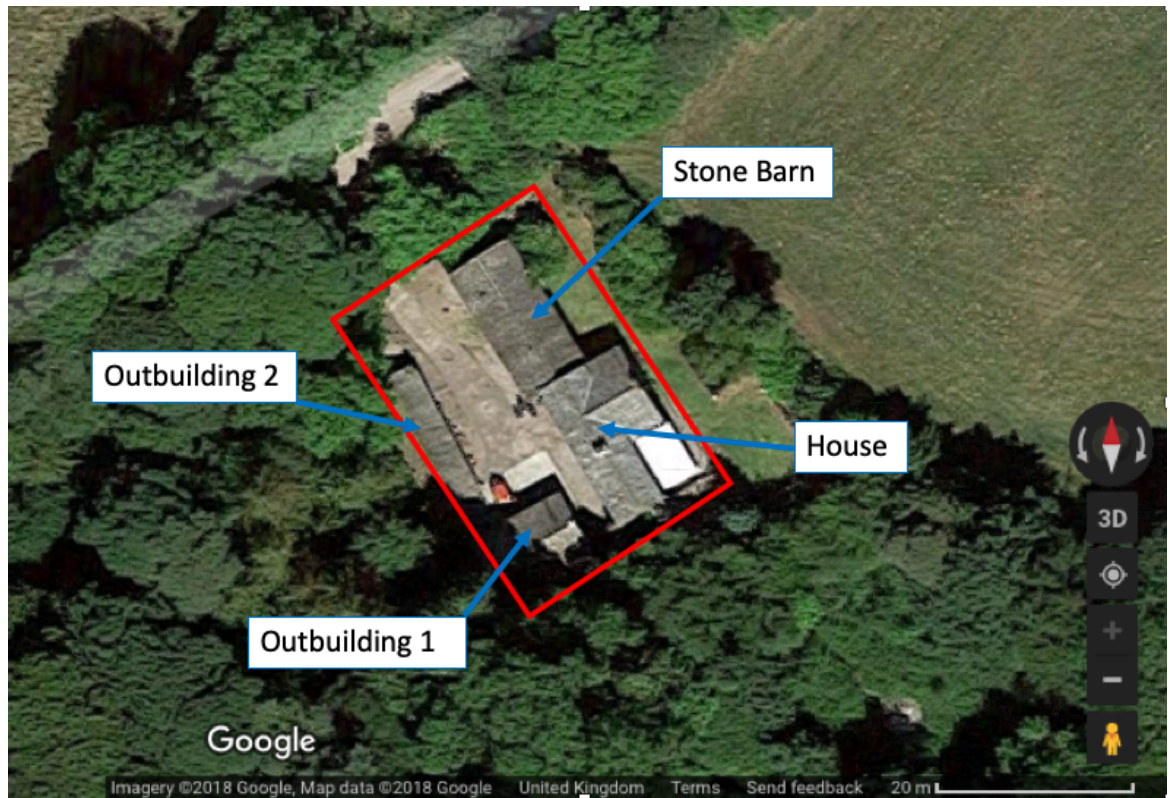
Figure 2. Site layout

The site layout is shown on Figure 2, four buildings were present within the site:

The buildings were accessed via a driveway to the north and enclosed a gravel/concrete yard area. Gardens/amenity grassland were present to the east, associated with the house. Further out, mixed woodland predominated to the south and west, with improved grassland fields present to the east and north (over a minor road).
