# Barn at Barwickstead, Beckermest, Cumbria

**Level 3 Historic Building Survey**  
**EH220/01**

## Level 3 Historic Building Survey for Green Swallow North Limited

<b>DATE ISSUED:</b>	November 2022
<b>PROJECT NUMBER:</b>	EH220
<b>SITE LOCATION:</b>	NGR: NY 01774 06815
<b>OASIS REFERENCE:</b>	edenheri1-510841

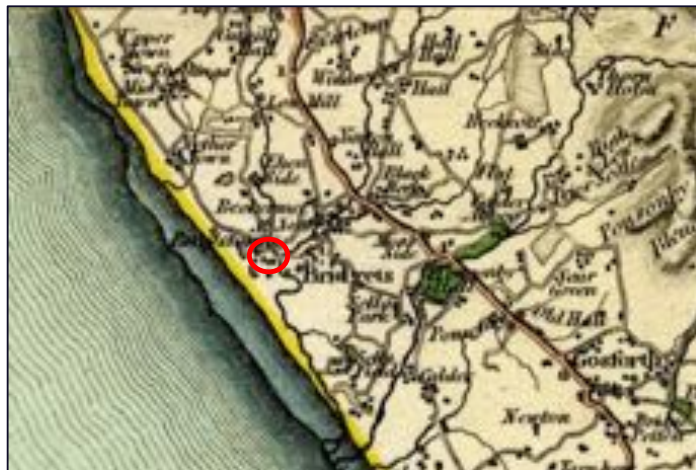
**Plate 2:** Extract from Greenwood's map of Cumberland 1834. A building is shown in the general location of Barwickstead, opposite the junction with Mill Lane
