### **Barwickstead barn and attached ancillary buildings (Grade II, NHLE Ref: 1472993)**

**Barwickstead Hennery-Piggery (Grade II, NHLE Ref: 1473208)**

## APPENDIX 2: Photographs

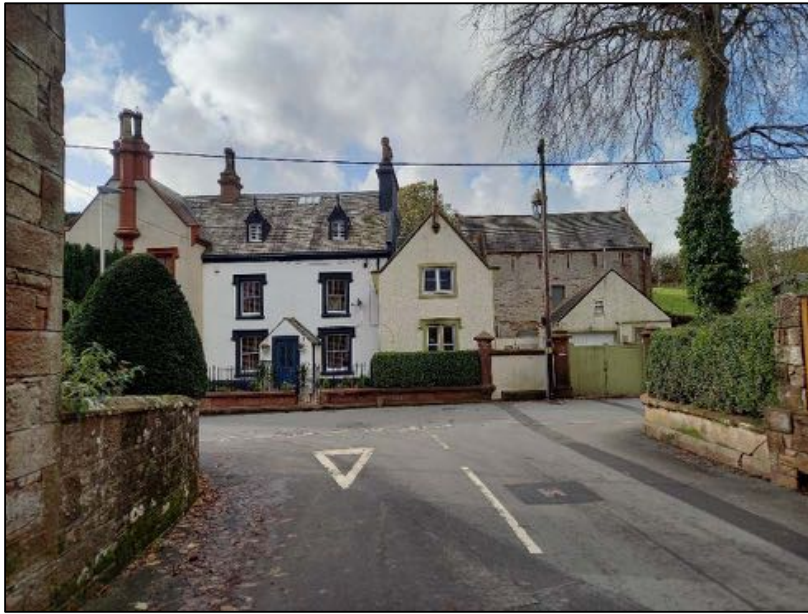
**Plate 3:** View looking west from Mill Lane showing the original house (now divided into three), with the barn located to its right-hand side, set back from the street frontage

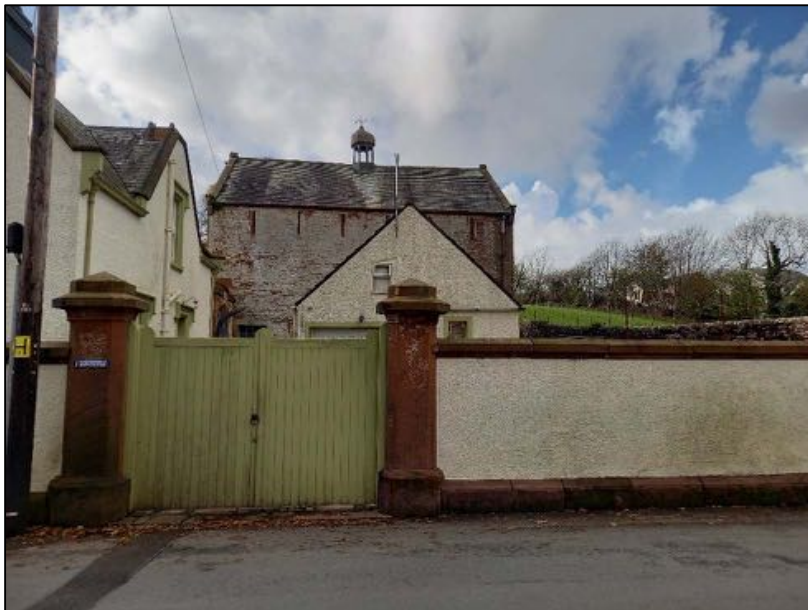
**Plate 4:** View looking west showing the east elevation of the barn, partly obscured by a modern garage and the boundary wall

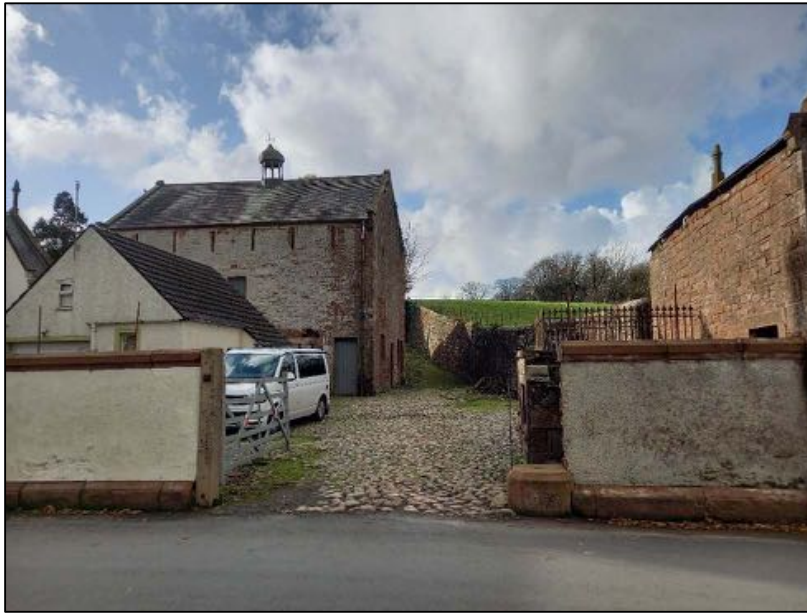
**Plate 5:** View looking west towards the barn from Morass Road, showing the cobbled yard, entrance gateway and Hennerly-Piggery to right of photograph

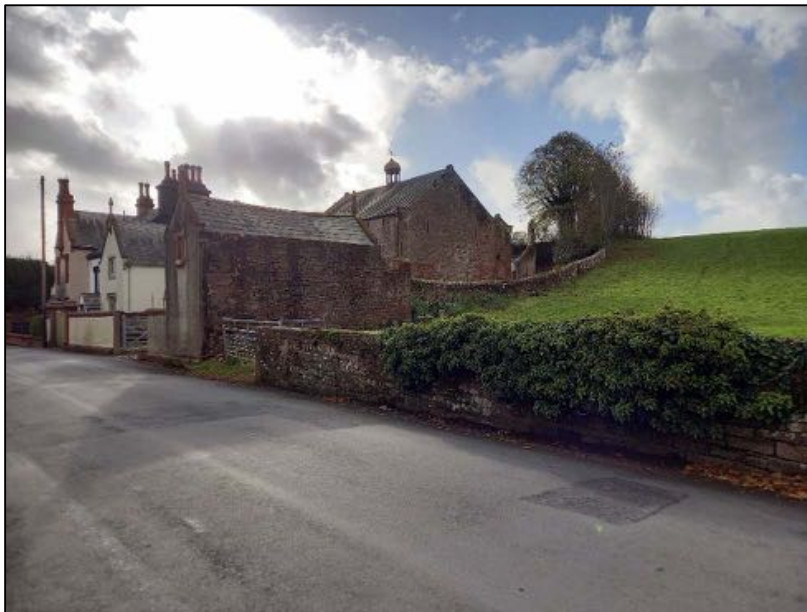
**Plate 6:** View looking south-west from Morass Road showing the house (left), the Hennerly-Piggery (central to the photograph) and the barn to right of photograph

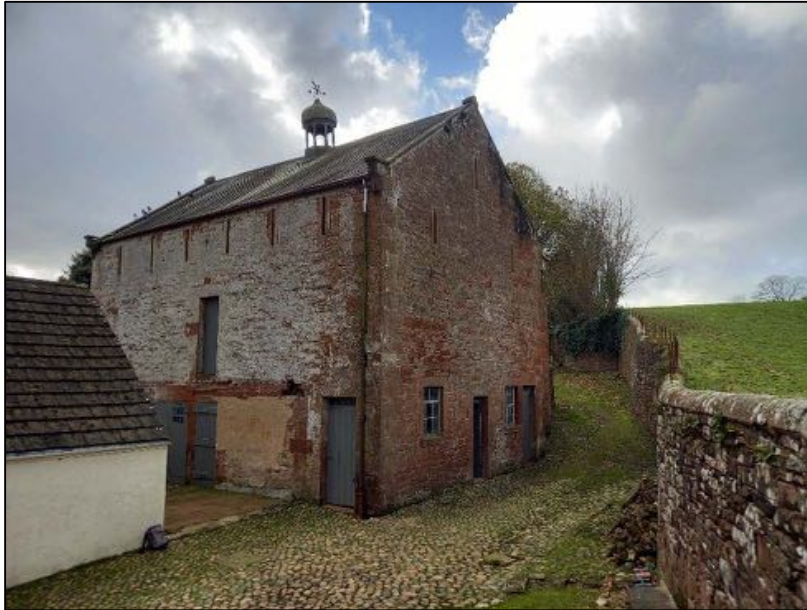
**Plate 7:** View from the steps of the Hennerly-Piggery looking south-west showing the barn with the cobbled yard and track along its north side and stone boundary walls separating the site from the field to the north

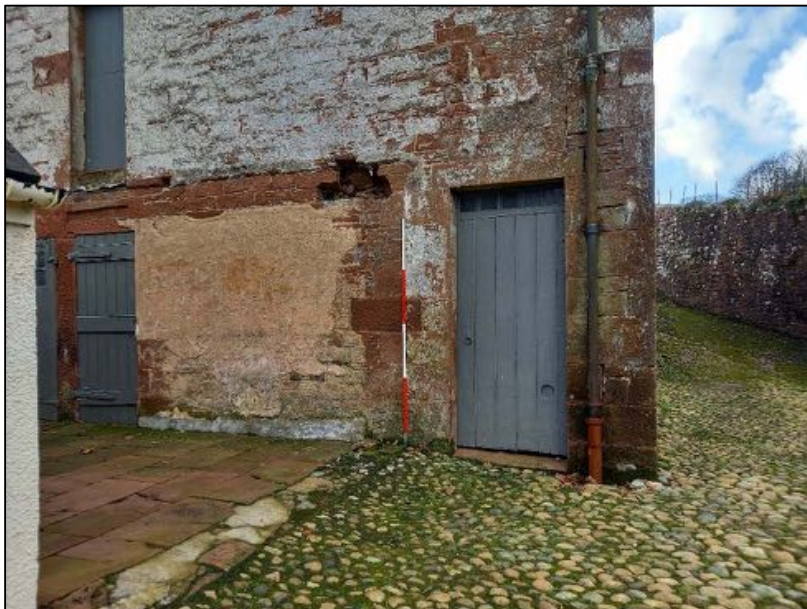
**Plate 8:** East elevation of the barn showing the northern doorway and scarring and stone floor of a former building (Scale = 2m)

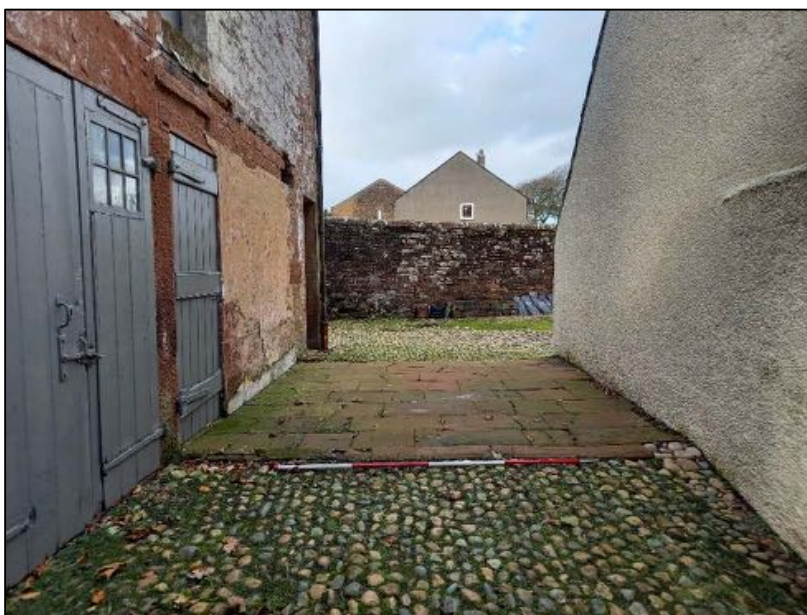
**Plate 9:** View looking north showing the location of a former building against the east elevation of the barn (left of photograph). The building to right of photograph is a modern garage (Scale = 2m)

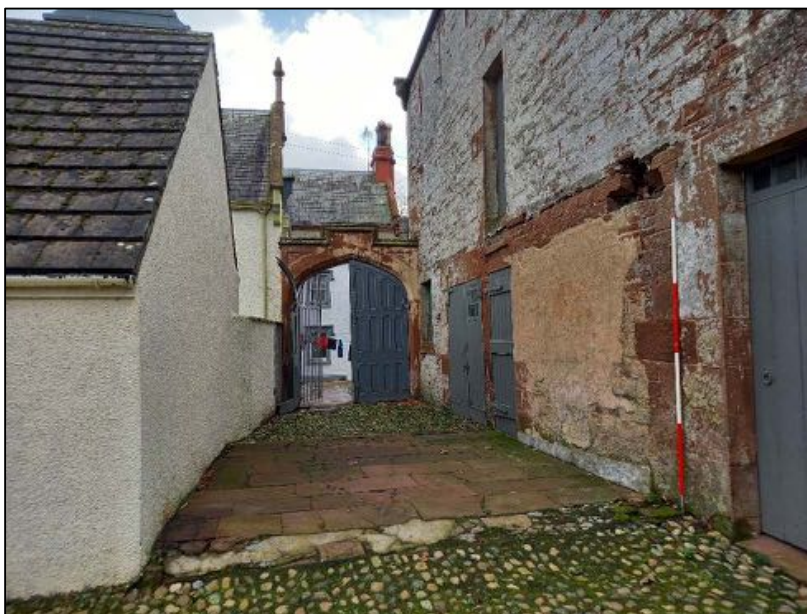
**Plate 10:** View looking south showing the location of a former building against the east elevation of the barn. The archway provides access to the rear of the house

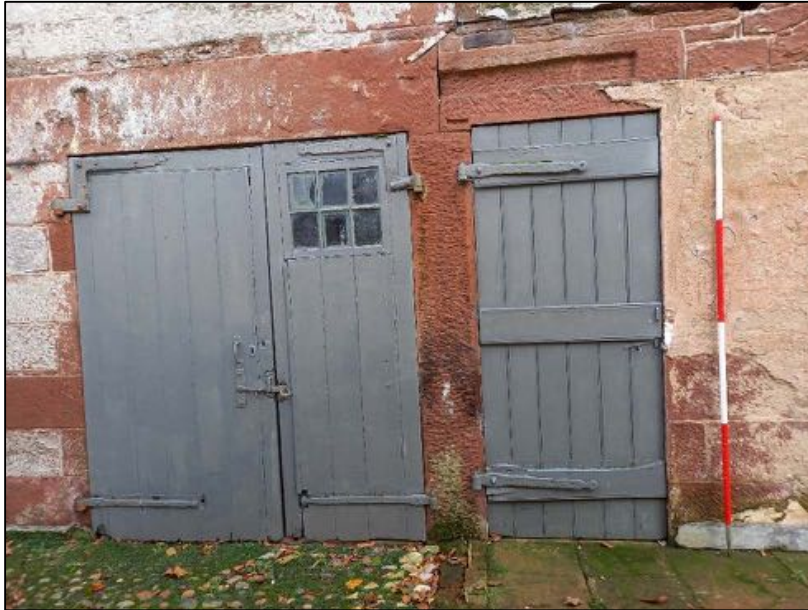
**Plate 11:** Doorways in the east elevation of the barn, ground floor (Scale = 2m)

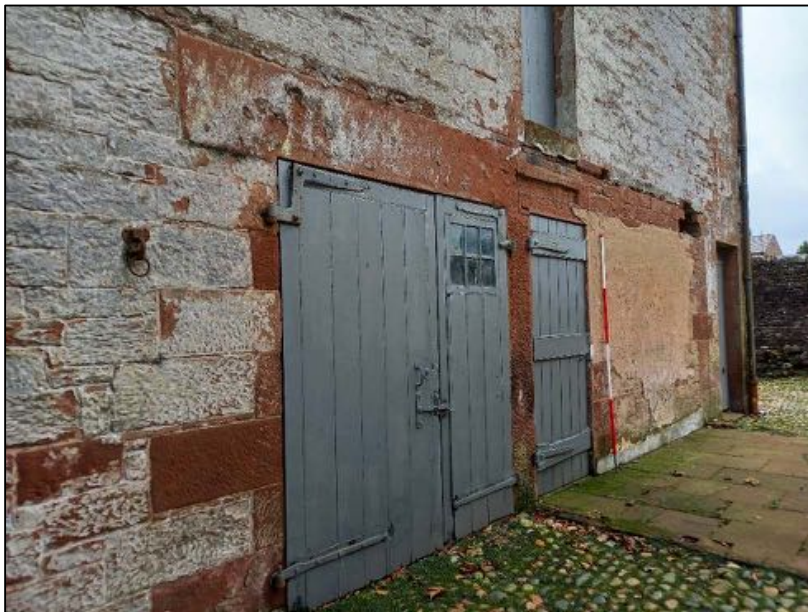
**Plate 12:** Central doorways in the east elevation of the barn, ground floor (Scale = 2m)

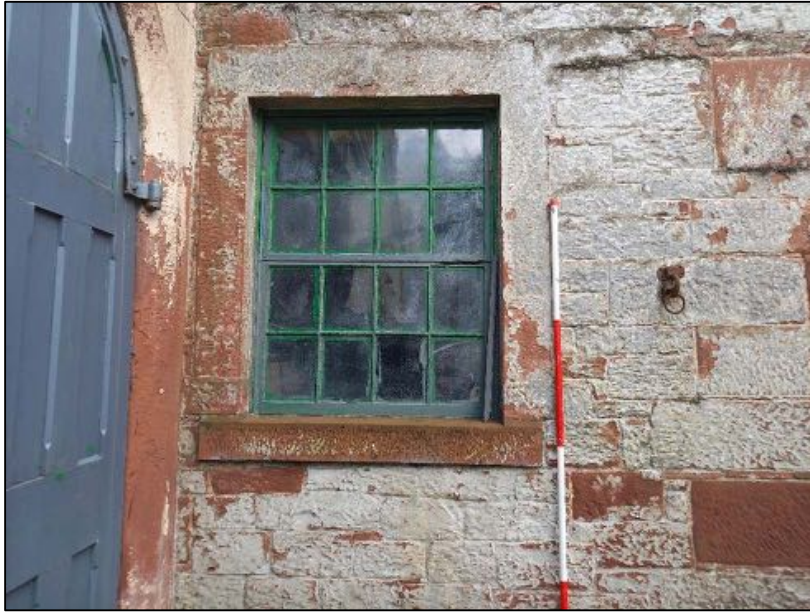
**Plate 13:** South end of the east elevation of the barn showing possible ground floor stable window

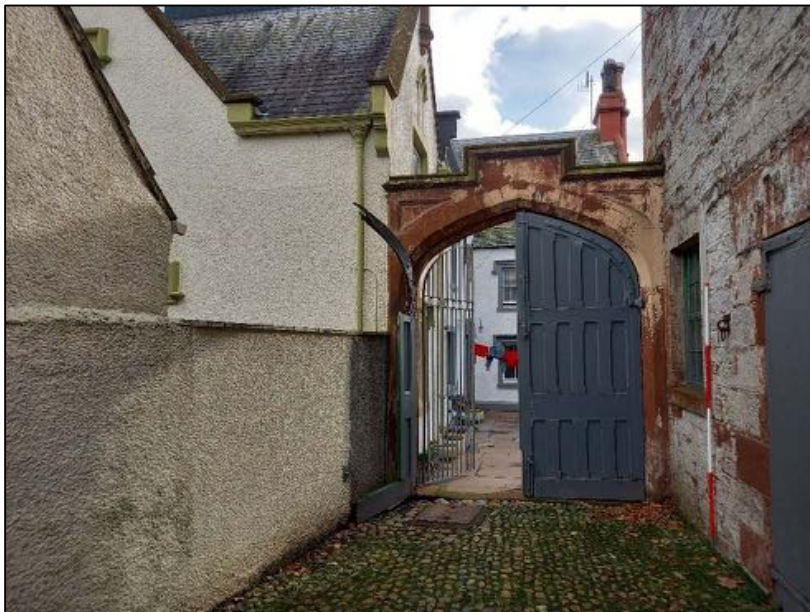
**Plate 14:** View looking south showing the archway between the house (left) and the barn (right)

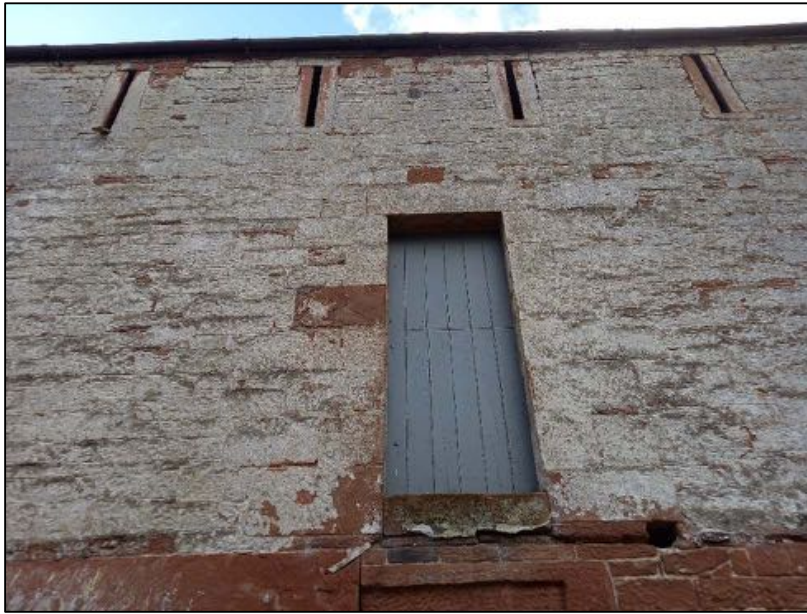
**Plate 15:** First floor winnowing or pitching door, east elevation of barn

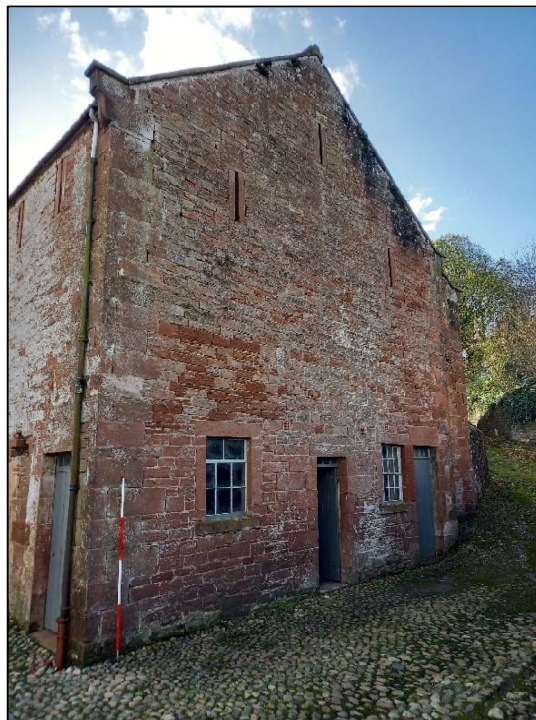
**Plate 16:** North elevation of the barn (Scale = 2m)
