# **Bat Survey**

## **‘Elf Hall’, Lady Hall, Millom**

**Report No. 0825/1**

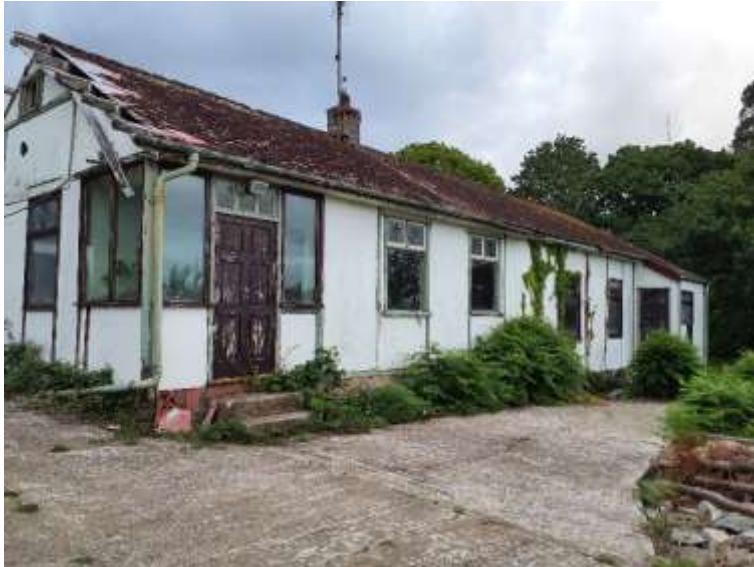
**Image 1.** Front (south) elevation of property.

Note the poor condition of the roof, especially at the western end.

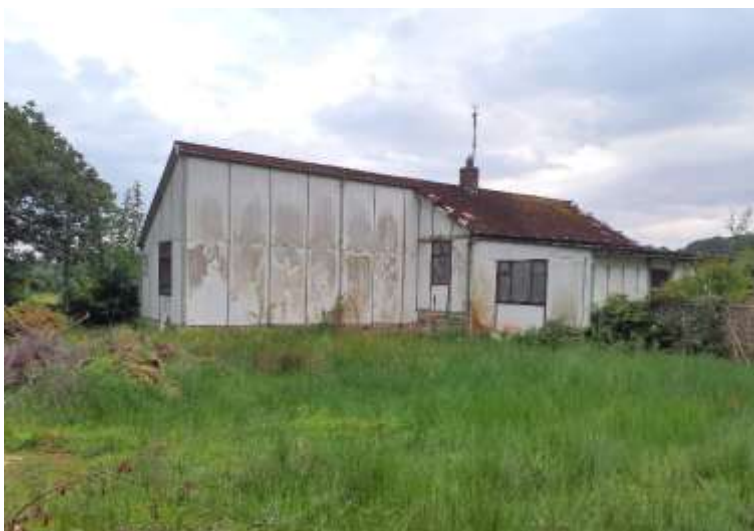
**Image 2.** Rear (north) elevation of the property.

One bat emerged from the western end of this elevation on survey 2.

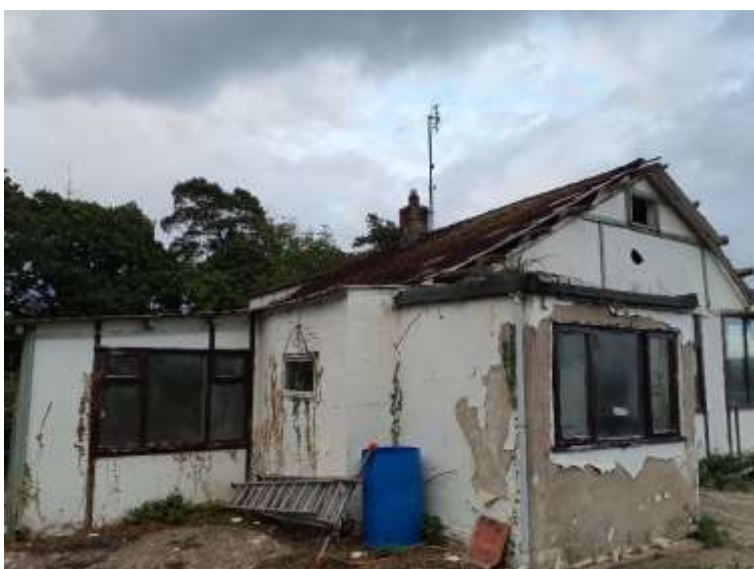
**Image 3.** North-west end of the property, showing the many gaps, and poor state of the roof.

Tawny owl emerged from the gable end on survey 1.

One bat emerged from this area on survey 2.

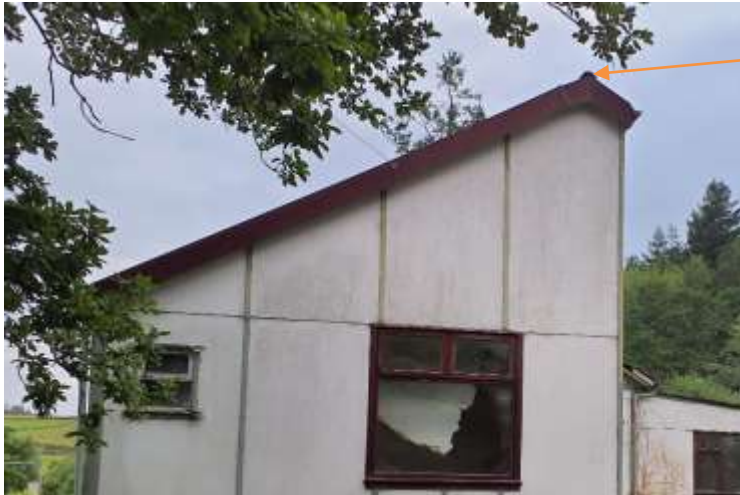
**Image 4.**  
Eastern gable of the property, showing ridge where 10 bats emerged on survey 1.

During the first dusk emergence survey ten bats were seen to emerge from the ridge on the eastern gable of the main building, and one from the northern eaves.

Ten bats (9 common pipistrelle and one soprano pipistrelle) emerged from the ridge roost during the first survey. This number is too low to be a maternity roost, and is most likely a group of males and non-breeding females. Unfortunately the damage to the roost site meant that the follow up survey could not corroborate or provide any additional detail to these findings.

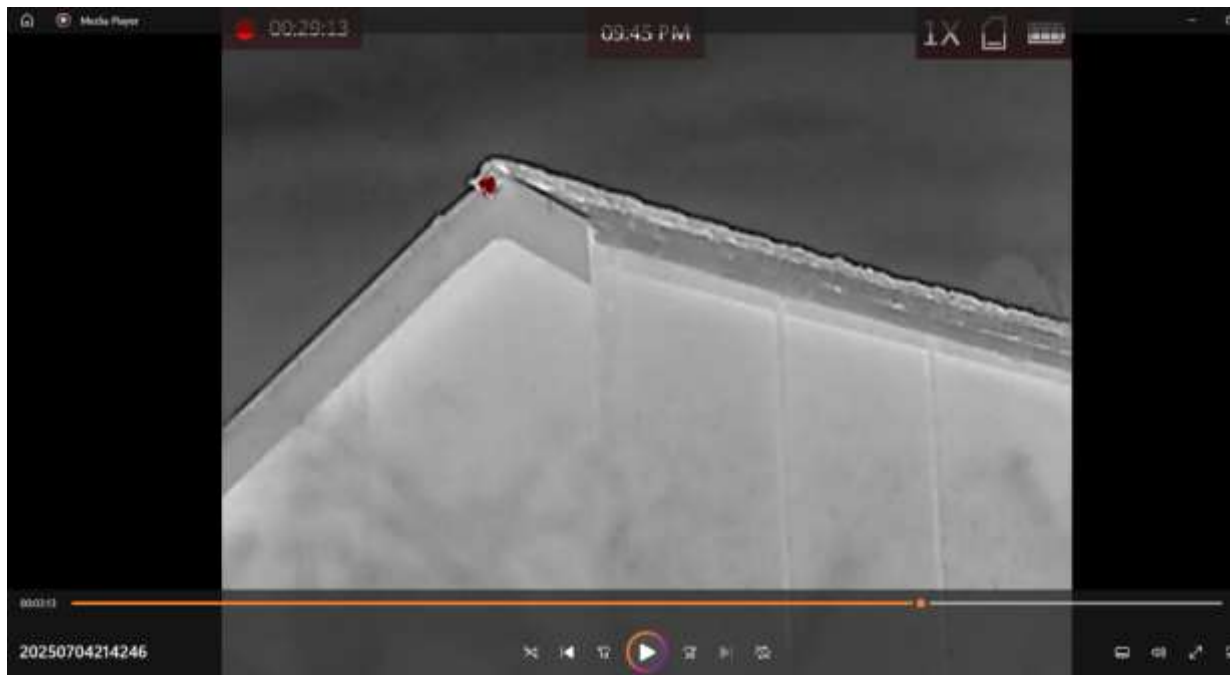
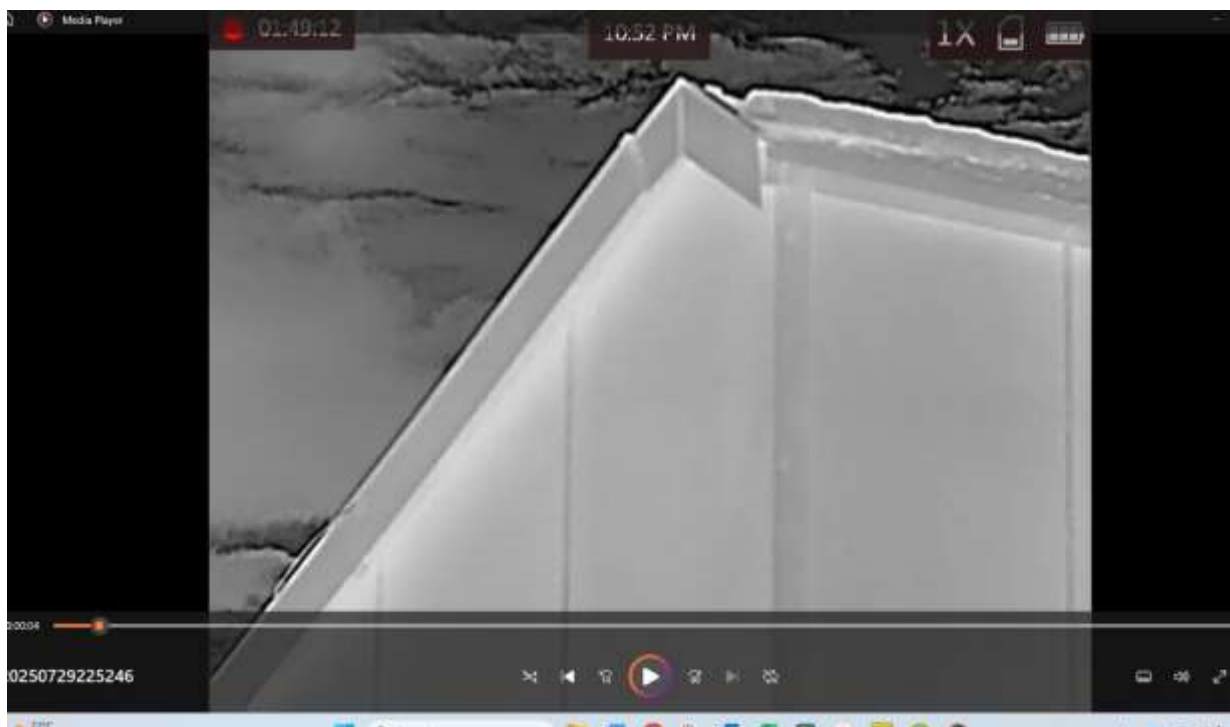
**Images 7&8.**

The ridge piece of the roof had been displaced between the first and second survey – effectively damaging the common pipistrelle roost.

Above - thermal imager view on survey 1, showing emerging pipistrelle.

Below – view form thermal imager on survey 2, showing displaced ridge.

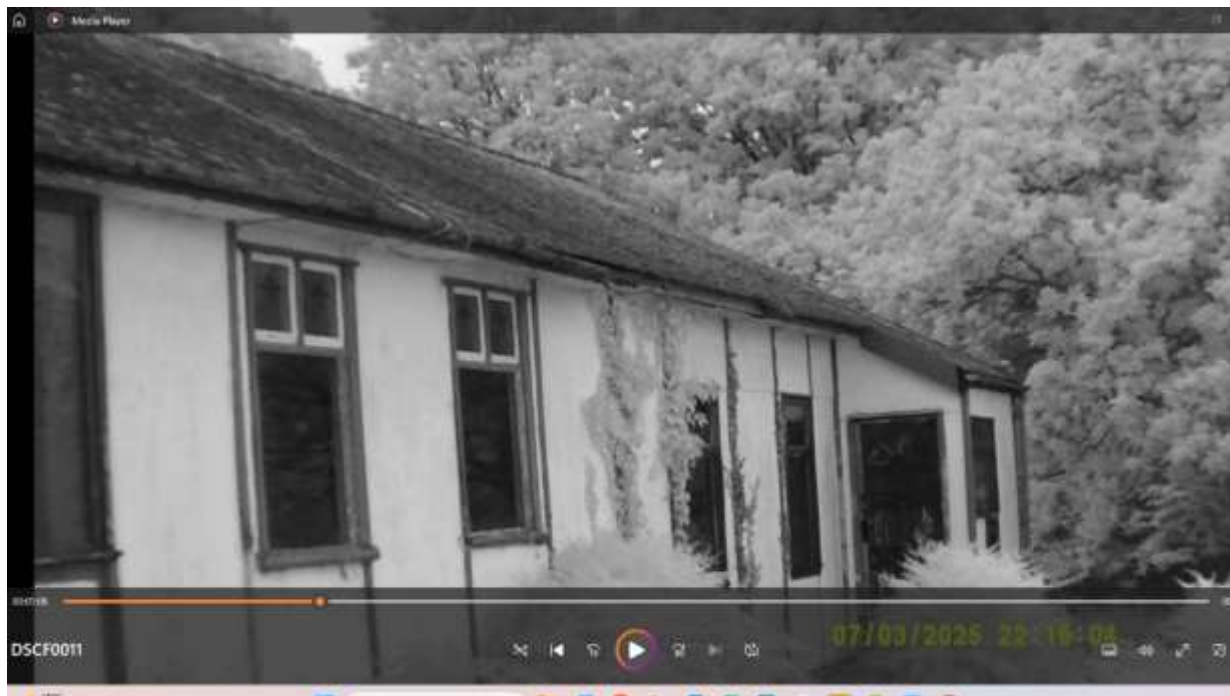
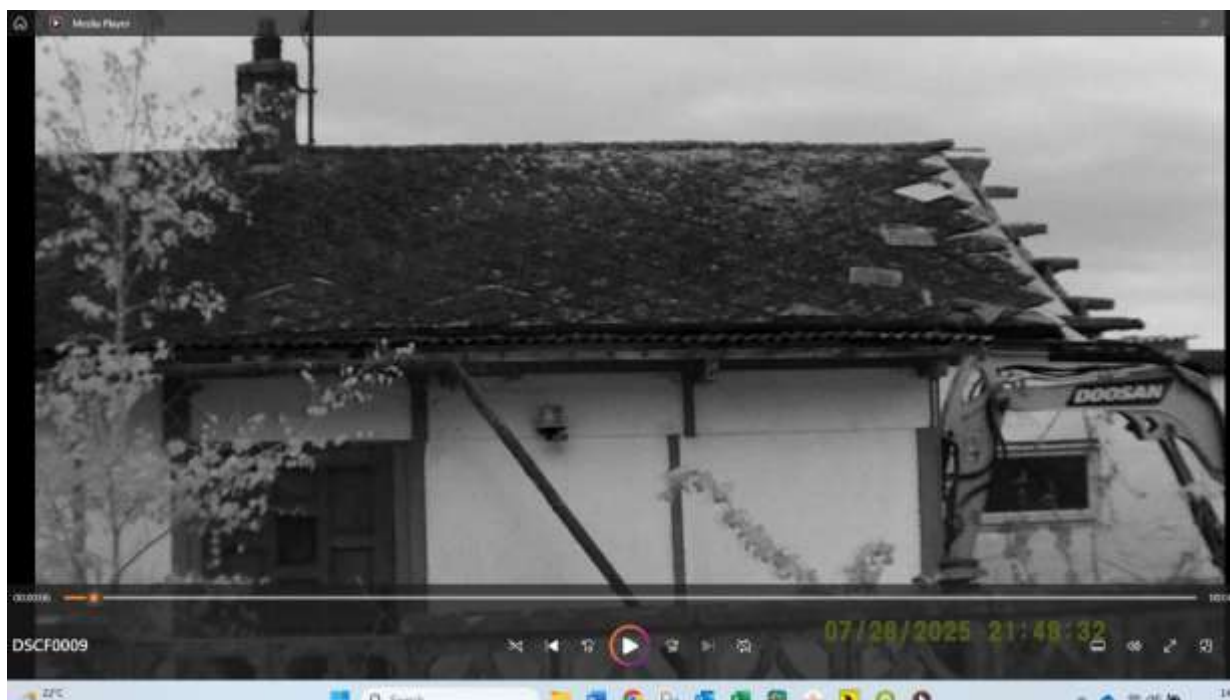
**Images 9 & 10.**

Above – view from infra-red camera on both surveys.

Below – view from infra-red camera on second survey, where 2 bats seen emerging.
