Phase 1

Environmental Assessment Report

Belvedere, Wath Brow, Cleator, Cumbria, CA23 3AE

Date: 30th November 2022

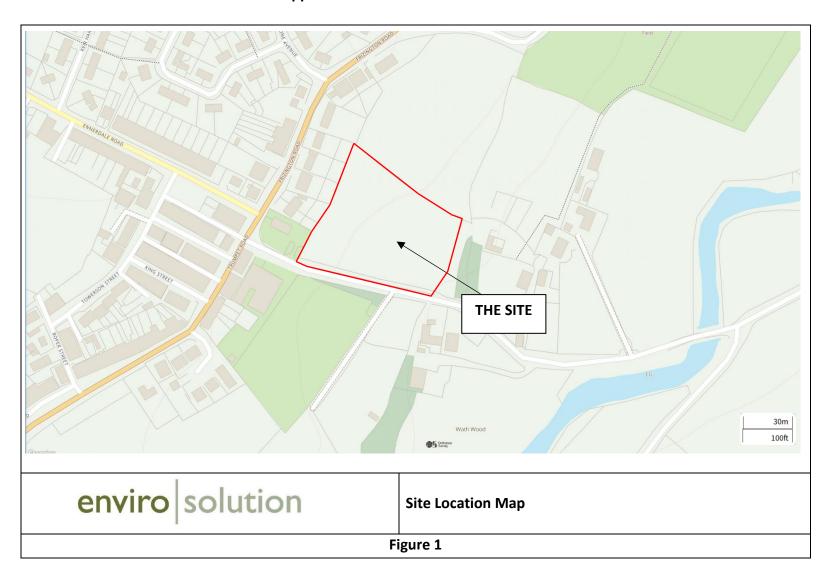
The site location is shown on Figure 1 in Appendix A.

The site is located at Belvedere, Wath Brow, Cleator, Cumbria, CA23 3AE. The British National Grid Reference for the approximate site centre is GR: 302869, 514574.

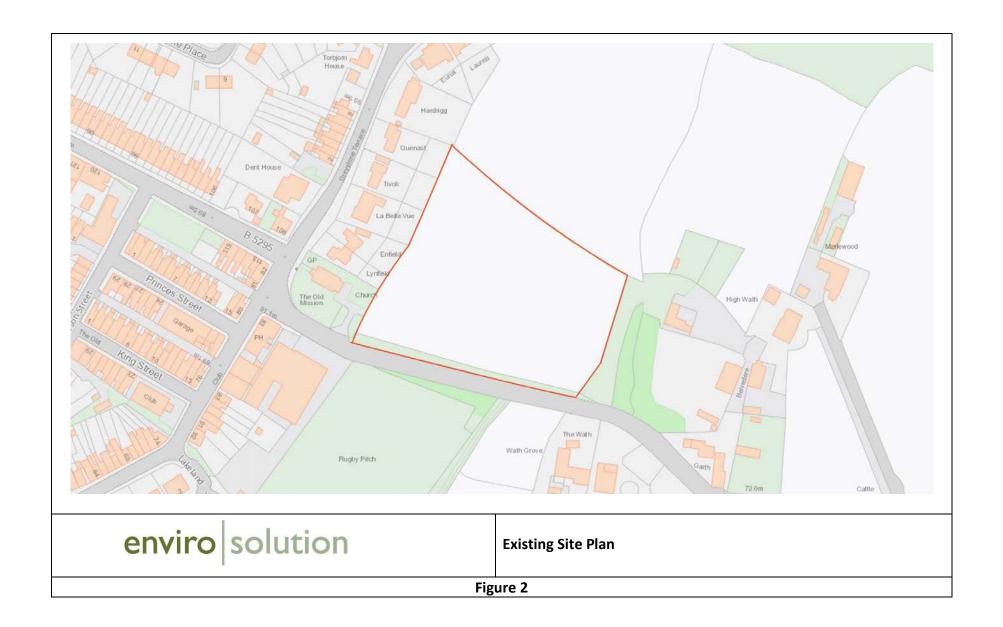
The site is an irregular shape and covers an approximate total area of 11,120 square metres.

The site is on an agricultural land, located off Frizington Road (A5086), on Cleator Moor Road. The site is currently an open field and can be accessed from a gated entrance off Frizington Road, along Cleator Moor Rd. The site is less than a 5-minute walk away from Frizington Bus Stop. The site is bounded by agricultural fields north and south as well as, bounded by residential properties east and west of the site.

The site slopes west to east from an elevation of 92m aOD to 84m aOD, and slopes north to south from an elevation of 94m aOD to 92m aOD.

The existing site plan is shown on **Figure 2** which is included in **Appendix A**. The site entrance photograph is included in **Appendix B**.

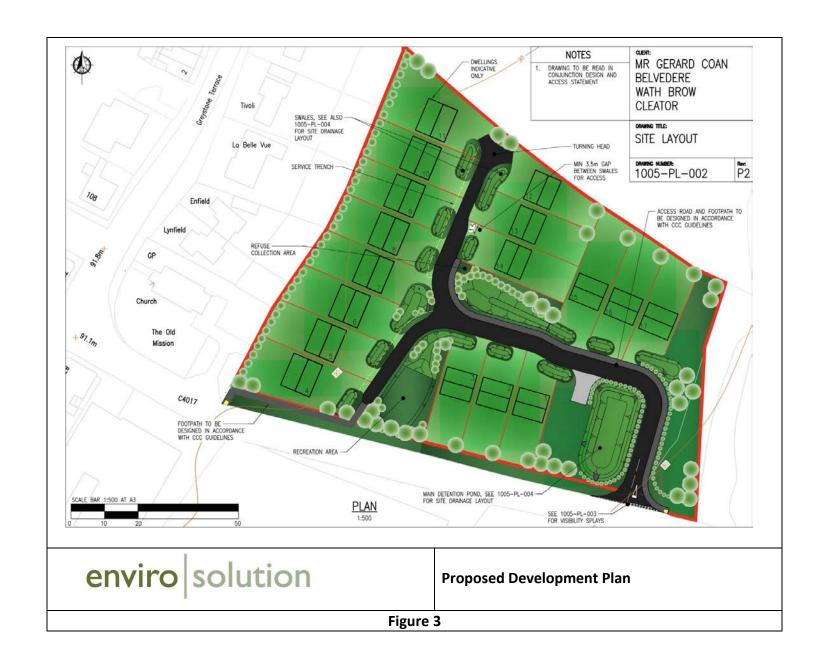
The formal development plan is to propose 15 dwellings, with an access road and footpath and a refuse collection area. The formal plans also included landscaped spaces, including a main detention pond.

The proposed development plan is shown on Figure 3 which is included in Appendix A.

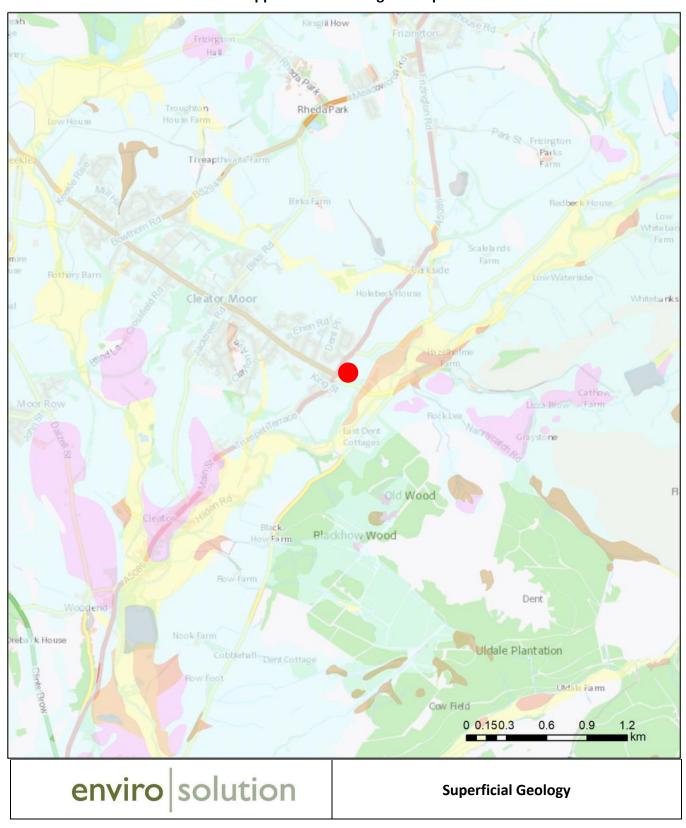
Superficial deposits 1:50,000 scale

Geological maps of the area indicate that the site is directly underlain by glacial diamicton deposits (Till), deposited during the Pleistocene Epoch. The deposits mainly consist of unsorted and unstratified drift deposited directly by and underneath a glacier without subsequent reworking by water from the glacier. It consists of a heterogenous mixture of clay, sand, gravel, and boulders varying widely in size and shape.

A copy of the geological maps is included in **Appendix D.** A copy of the BGS borehole records is included in **Appendix E**.

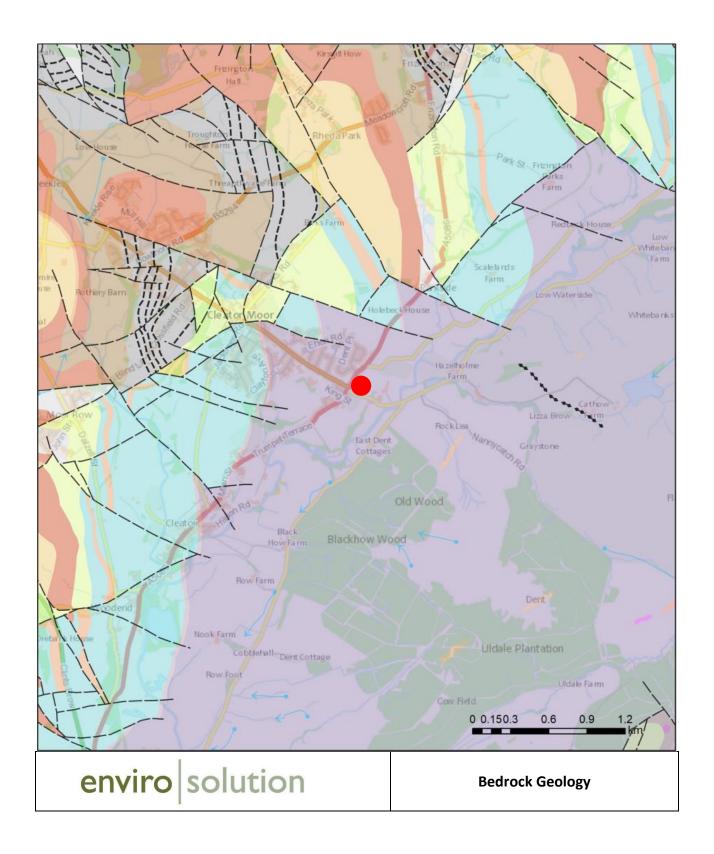
Bedrock geology 1:50,000 scale

The underlying bedrock is the Buttermere Formation, deposited during the Ordovician Period. The Buttermere Formation mainly consists of mudstone and sandstone, with olistostrome deposits comprise of disrupted, sheared and folded mudstone, siltstone and sandstone turbidite olistoliths.

The nearest geological fault is located approximately 300m northwest of the site.

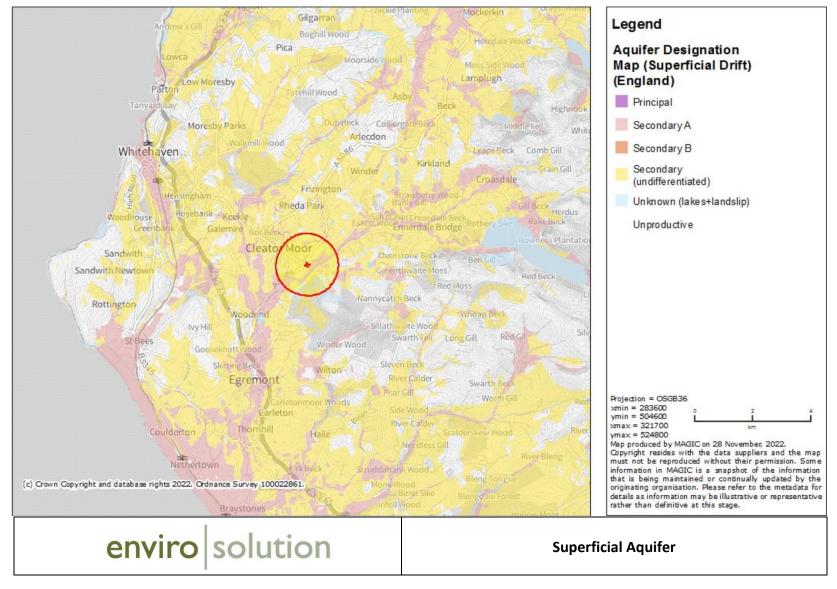
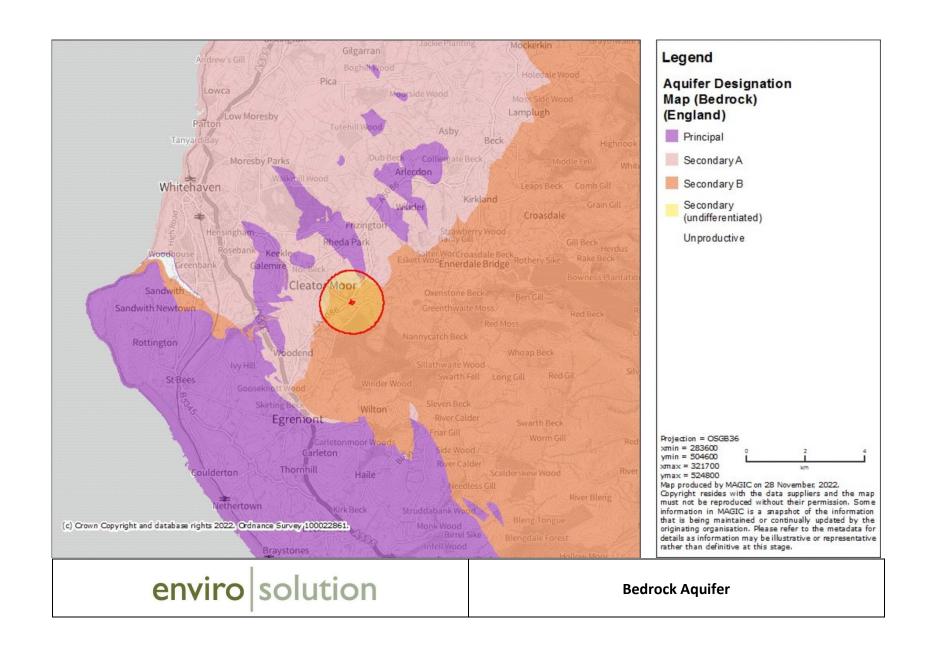
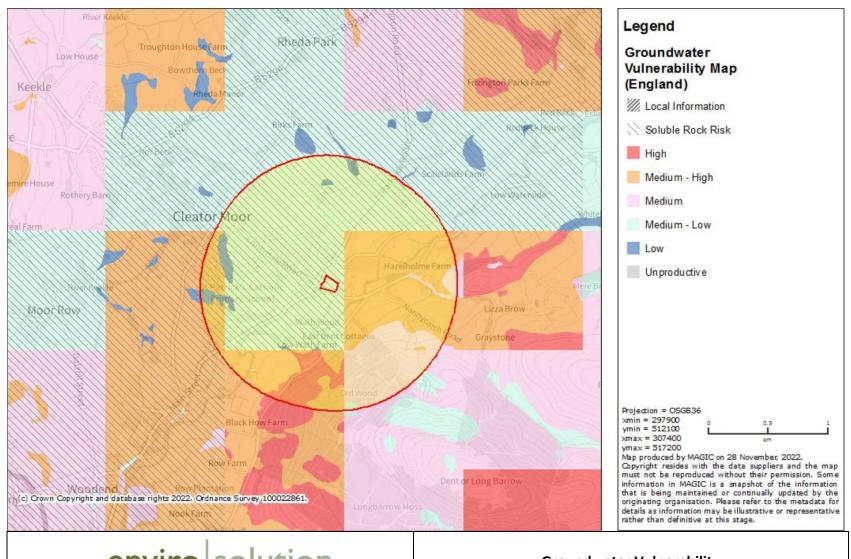
Appendix F – Hydrogeological Maps

The underlying superficial diamicton deposits (Till) is designated as a Secondary (undifferentiated) Aquifer, defined as; cases where it has not been possible to attribute either category A or B to a rock type. In most cases this means that the layer in question has previously been designated as both minor and non-aquifer in different locations due to the variable characteristics of the rock type.

The underlying Buttermere Formation is designated as Secondary B, defined as; predominantly lower permeability layers which may store and yield limited amounts of groundwater due to localised features such as fissures, thin permeable horizons and weathering. These are generally the water-bearing parts of the former non-aquifers.

The site is not located within a Source Protection Zone.

A copy of the hydrogeological maps is included in **Appendix F**.

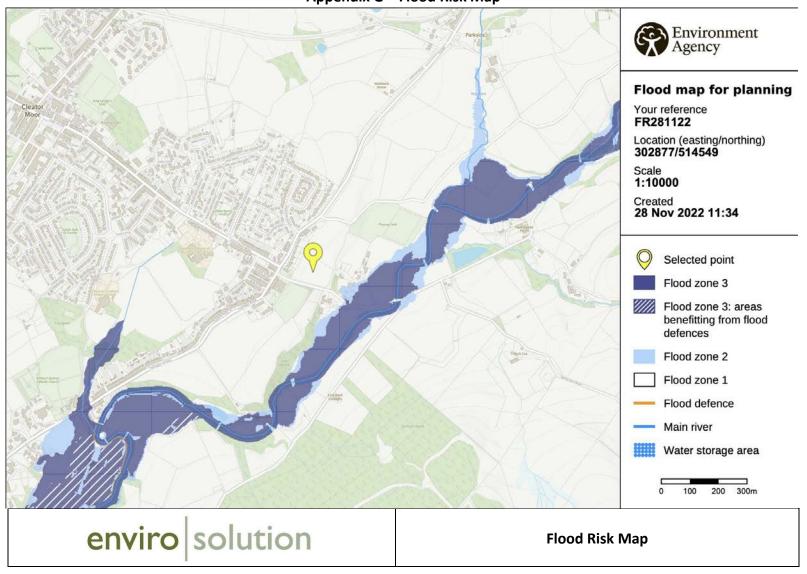
Appendix G - Flood Risk Map

The site lies within a Flood Zone 1 (low probability), land assessed as having less than a 1 in 1,000 annual probability of river flooding (0.01%) in any year (low risk). The completion of a detailed Flood Risk Assessment is not deemed necessary for this site.

A copy of the flood risk map is included in **Appendix G**.

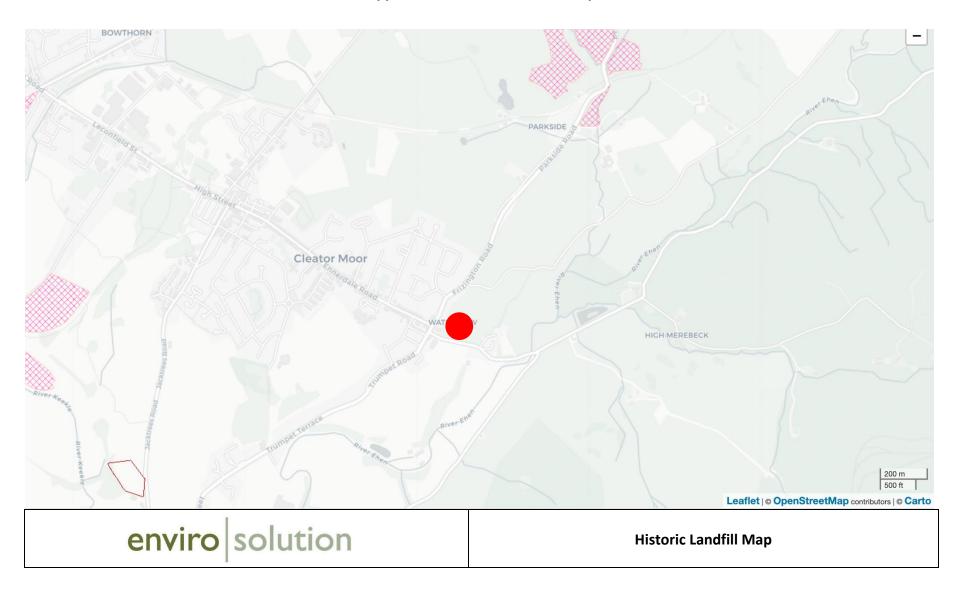
Appendix H – Historic Landfill Map

There are 2 records of historical landfill sites located within a 1km radius of the site.

Historic Landfill Site	Operation Dates	Waste Type	Distance from Site	
Parkside	Unknown	Unknown	870m NE	
Parkside North	1931-95	Inert	930m NE

A copy of the historic landfill map is included in **Appendix H**.

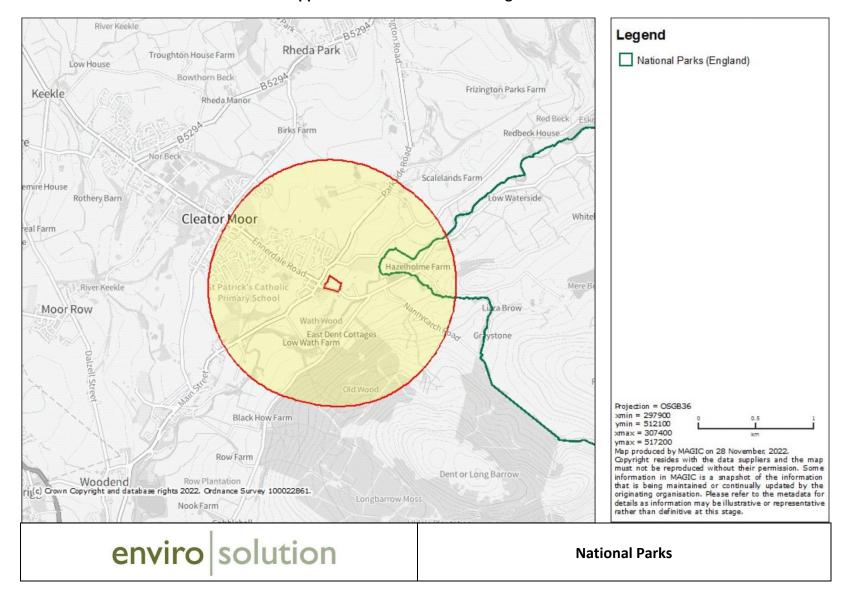
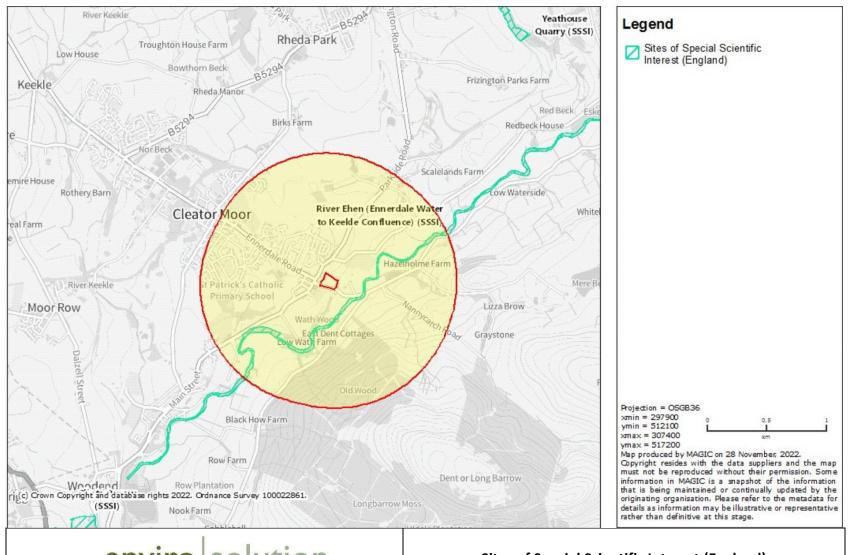
Appendix I – Environmental Designations

Features	Distance	Comments
National Parks	360m	The Wild Ennerdale National Park is located 360m northeast of the site.
Sites of Special Scientific Interest (England)	150m	The River Ehen (Ennerdale Water to Keekle Confluence) is a Site of Special Scientific Interest, located 150m southeast of the site.

Records of designated environmentally sensitive sites located within a 1km radius of the site are summarised in Table 4 and shown on plans included in **Appendix I**.
