FELLSIDE CHP PLANT

Demolition of WHRB's and GT's 2 / 3

FCHP-OMST-REP 002 Rev 0

Building Description to Support the Demolition of Units 2/3

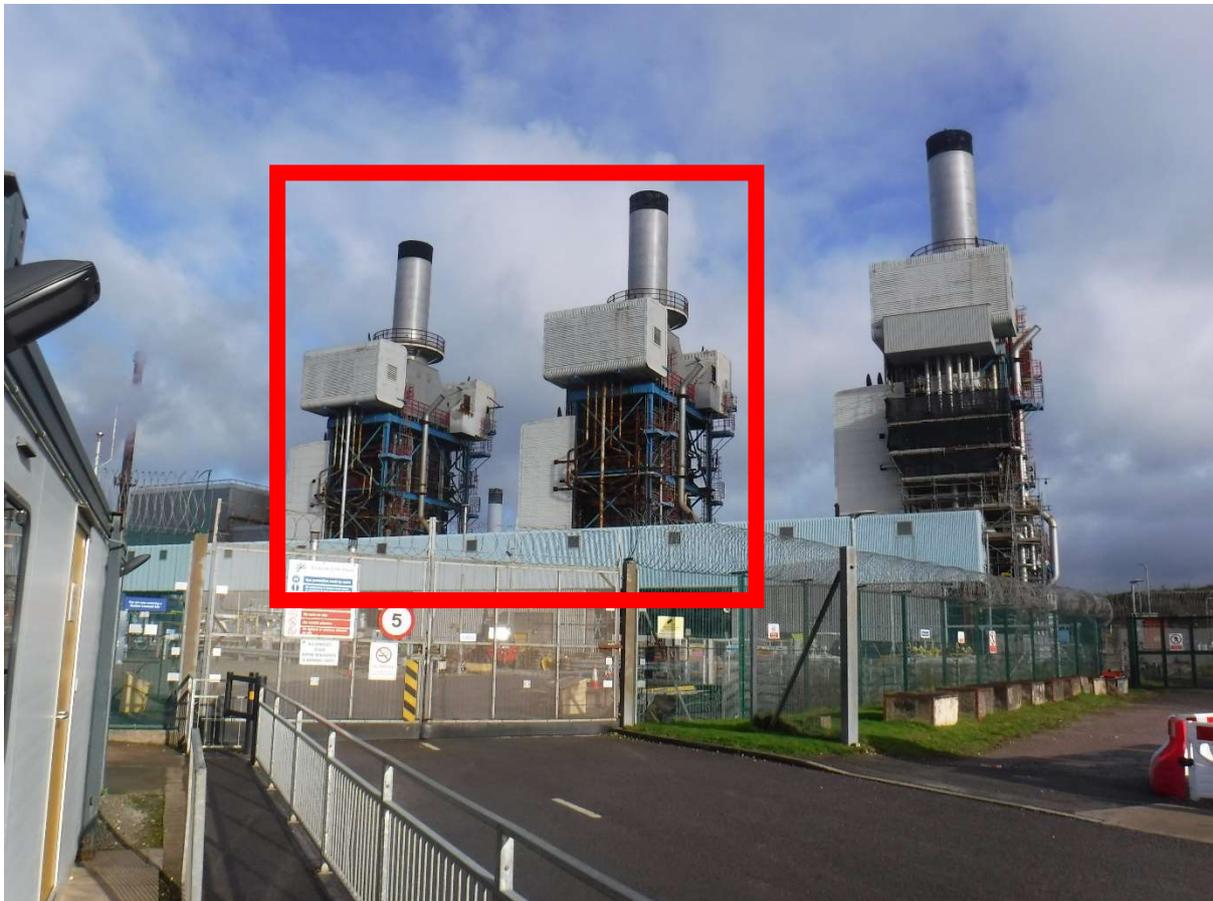
Picture 1 – The Upper Structures of the Waste Heat Recovery Boiler on Units 2 &3

The WHRB's are 42M in height and consist of multiple levels whilst the GT's are estimated to be approximately 10M in height located behind the WHRB's.

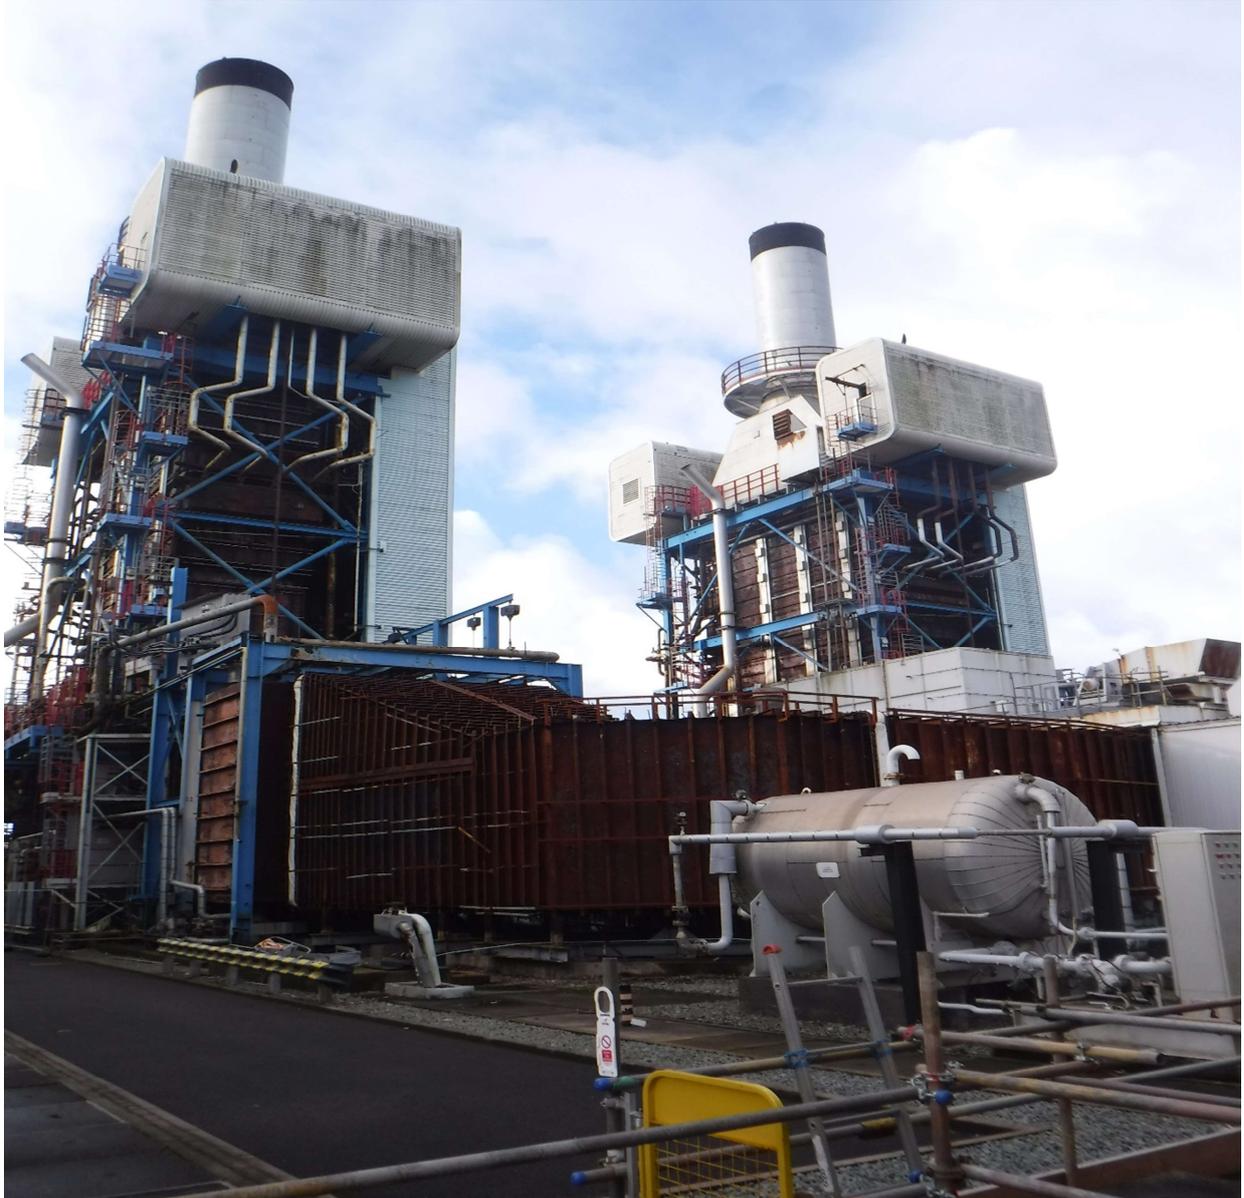
Picture 2 – The Gas Turbine housings of Unit 2, with the WHRBs of Units 2 & 3 behind.
