REMEDIATION STRATEGY

PROPOSED RESIDENTIAL DEVELOPMENT

LAND AT IVY MILL, MAIN STREET

Report Ref: 2021-4986

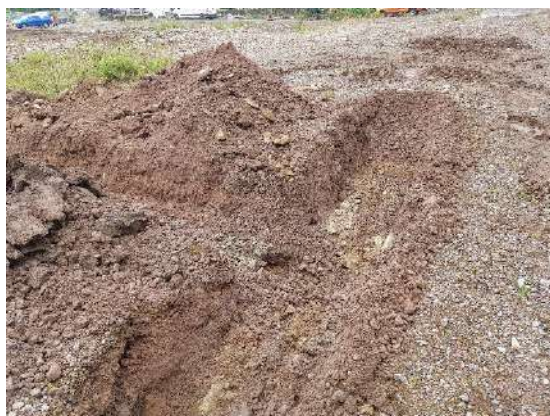
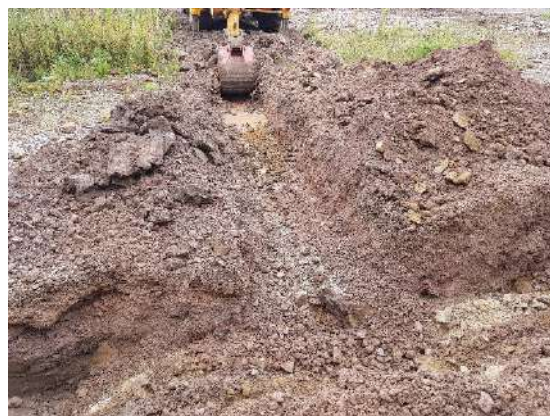
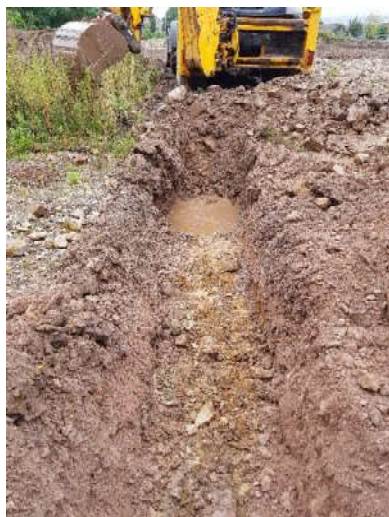
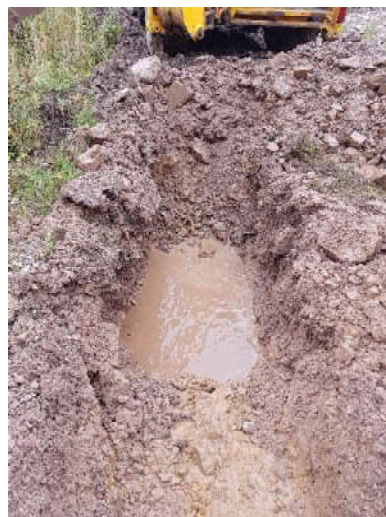
GEO2019-3886: Ivy Mill, Hensingham. TPD

0.60 W
		End of trial hole sides noted to be stable. The majority of the trial hole remained dry during and upon completion. Saturated gravels (demolition rubble) were noted at end of the trench. Dimensions: L (5.70m & 7.70m) x W (0.80m) x D (0.40m & 1.10m)

- The trial pit (TPD) was extended in length and direction with limited penetration into the sandstone albeit for the made ground (c.9m from the northern boundary) which fell away to c.1.10m bgl where no further excavation was possible. This area will need further works to fully determine the ground conditions at this location.
- Borehole BH04 was positioned to target the historical Above-ground Storage Tank (AST), although no longer present on site. At this location, limited made ground (c.0.30m) was evident with no visual and/or olfactory evidence of hydrocarbons noted.
- The additional trial pits (TP's 203 to 209) undertaken across this area identified rubble fill and clay with occasional demolition rubble to depths of c.0.10m and c.1.30m bgl. No evidence of hydrocarbons was noted.

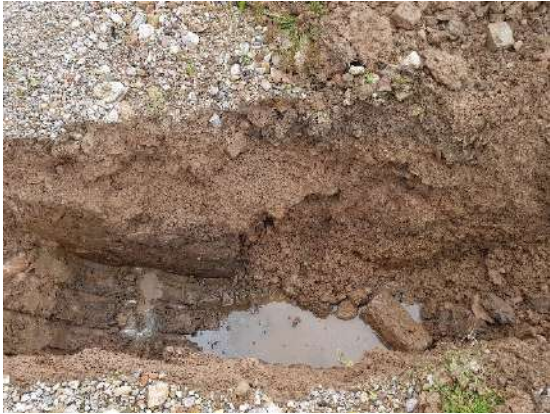
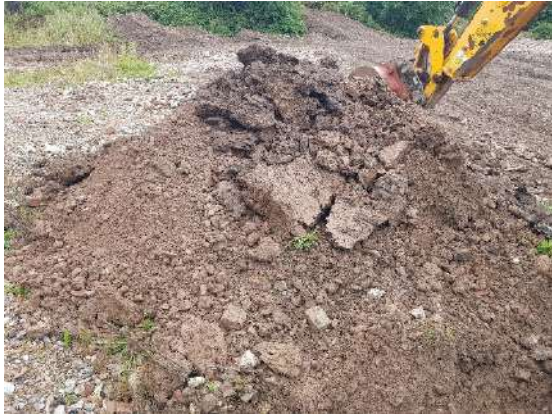
GEO2019-3886: Ivy Mill, Hensingham. TPF

1.50 B
		End of trial hole sides noted to be stable. A water ingress was noted at c.1.00m within the infilled former foundation run. Dimensions: L (4.20m) x W (0.65m) x D (1.50m)

- Not including the trial pits completed in the demolition stockpile (TP's F & G), the majority of this area was covered by demolition type rubble as well as slightly sandy slightly clay to depths of c.0.30m to c.1.25m bgl.
- On the stockpile, TP's F & G identified the crushed demolition rubble to depths of c.2.20m and c.2.40m bgl with possible concrete slabs noted at these depths, with no further excavation possible. On top of the "possible slab" encountered in TPF was a black gravel which exhibited olfactory evidence of hydrocarbons.
- Within TPD, made ground was recorded to a depth of c.0.40m bgl and then identified a relatively thin layer of clay before encountering sandstone. The made ground (gravel) between c.0.23m to c.0.40m bgl was noted to exhibit slight olfactory evidence of hydrocarbons.

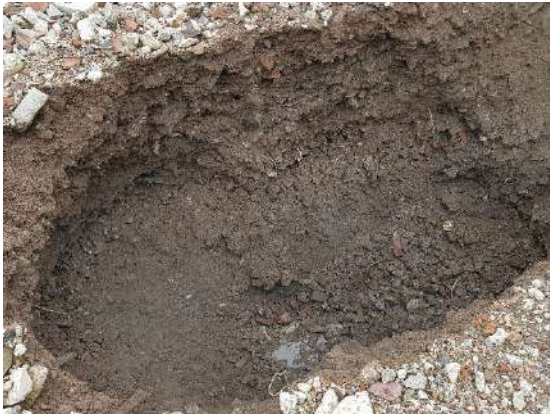
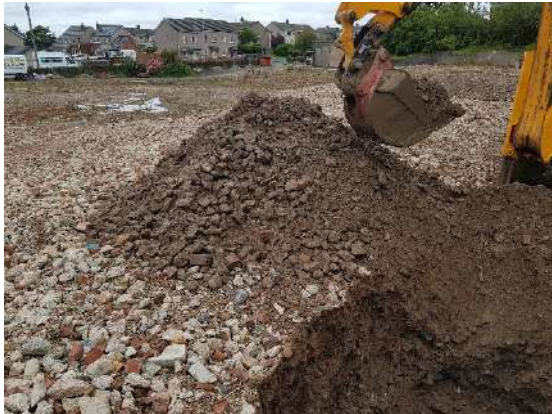
During and upon completion, trial hole sides noted to be unstable. A water ingress was noted at c.2.20m with a similar SWL upon completion. Dimensions: L (3.70m) x W (1.70m) x D (2.20m)

- On the stockpile, TP's F & G identified the crushed demolition rubble to depths of c.2.20m and c.2.40m bgl with possible concrete slabs noted at these depths, with no further excavation possible. On top of the "possible slab" encountered in TPF was a black gravel which exhibited olfactory evidence of hydrocarbons.
- Within TPD, made ground was recorded to a depth of c.0.40m bgl and then identified a relatively thin layer of clay before encountering sandstone. The made ground (gravel) between c.0.23m to c.0.40m bgl was noted to exhibit slight olfactory evidence of hydrocarbons.

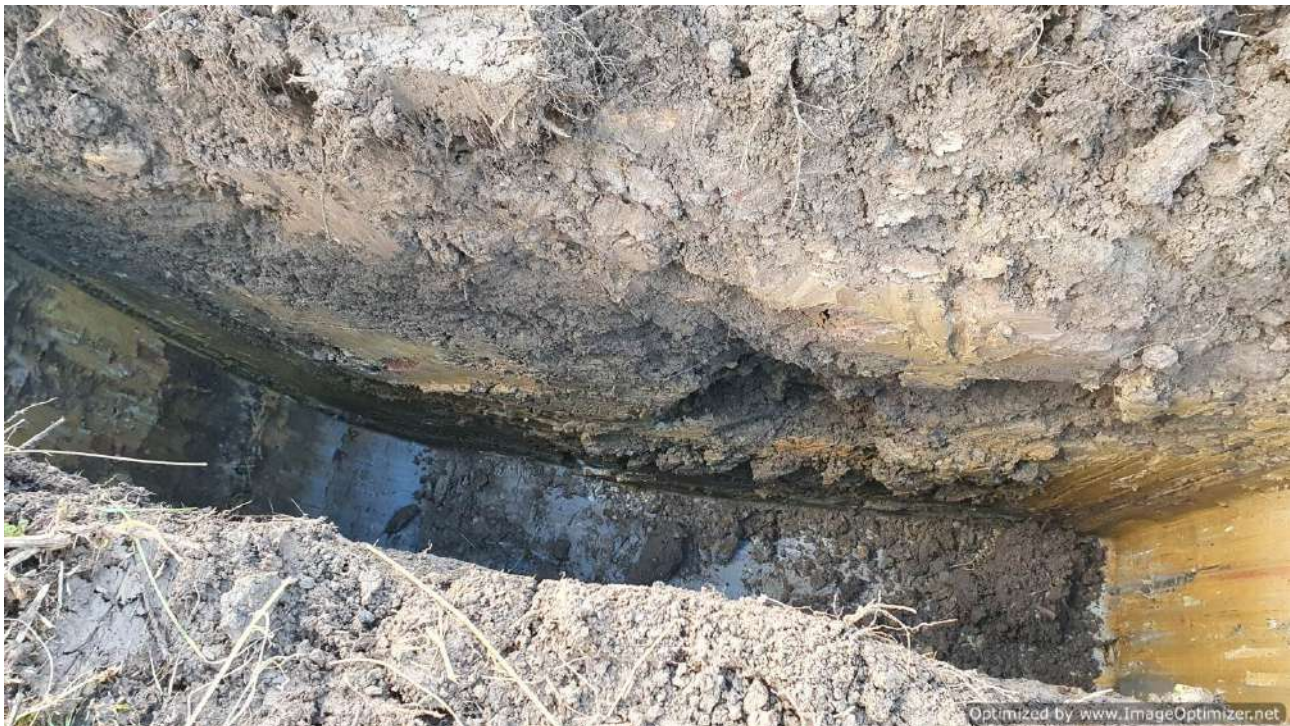
GEO2021-4625: Ivy Mill, Whitehaven, Cumbria – TP202

Depth From (m)	Depth To (m)	Strata Description	Legend	Testing / Samples
0.00	0.40	TOPSOIL: Dark brown sandy gravelly LOAM.

- The additional trial pits (TP's 201 to 202) undertaken across this area identified sandy gravelly soil to depths of c.0.40m and c.0.65m bgl. No anthropogenic debris or evidence of hydrocarbons was noted.

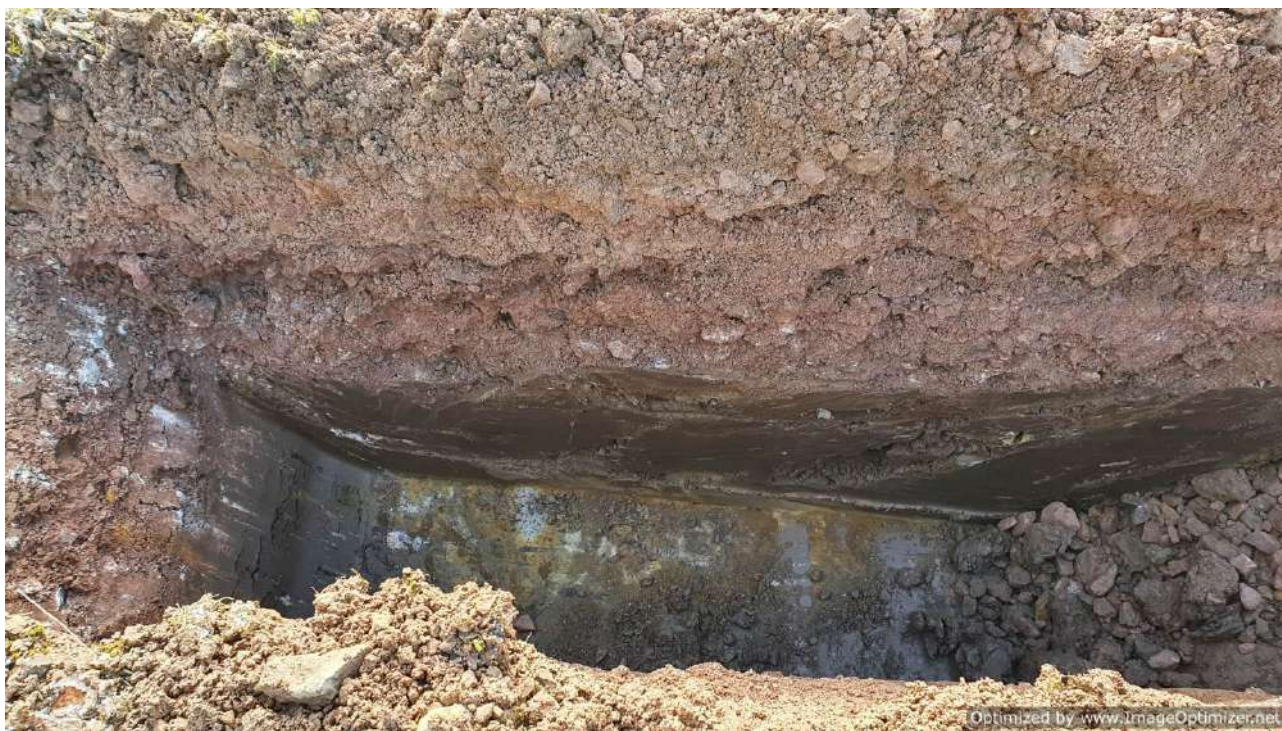
GEO2021-4625: Ivy Mill, Whitehaven, Cumbria – TP206

Depth From (m)	Depth To (m)	Strata Description	Legend	Testing / Samples
0.00	0.60	MADE GROUND: Dark grey brown sandy GRAVEL of aggregate and demolition rubble. Former foundation along western edge of pit.

0.90	-	POSSIBLE BEDROCK: Yellow and grey brown sandstone. Unable to excavate (possible large boulders?)		
		End of trial hole at 0.90m. Groundwater ingress from base of made ground. Trial hole backfilled with arisings on completion. No evidence of hydrocarbon contamination.		
Engineer: J. Brock Site Works Date: 08/02/2021 Plant: Tracked 360 Excavator			Log Notes: HSV = Hand Shear Vane (kN/m ²) LP = Limited Penetration (HSV/CBR) B = Bulk Bag, J = Amber Glass Jar, T = Plastic Tub

Although no relict foundations were identified during the initial phase of fieldworks, a possible slab was identified in TP's F & G below the demolition stockpile and therefore it may be the case that as well as the slab, former foundations may also be present on site with occasional relict foundations were also noted within TP's 206 and 207.

However, across the remainder of the site, water ingresses were recorded in TP's D – G, J and 206 to 207 at depths of between c.0.40m and c.2.20m bgl. The groundwater was noted within the demolition rubble, former foundation runs and the interface of the made ground and natural clay deposits.

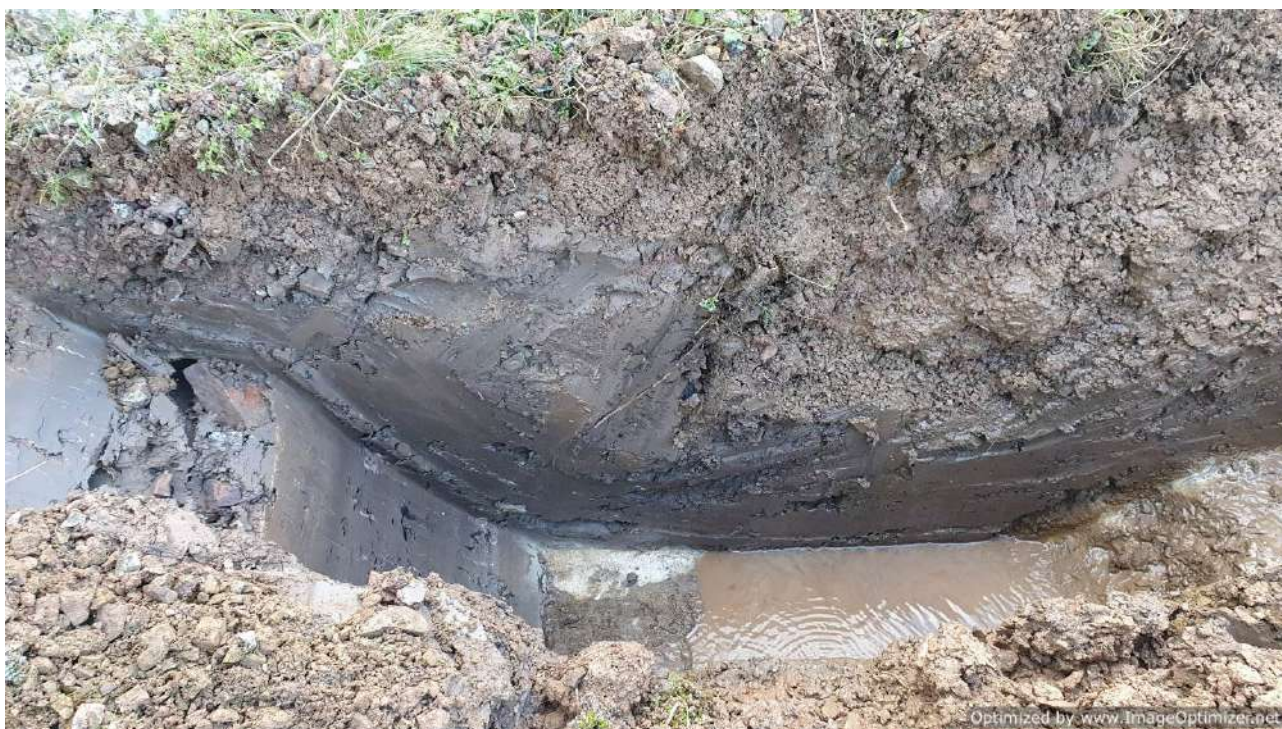
GEO2021-4625: Ivy Mill, Whitehaven, Cumbria – TP207

Depth From (m)	Depth To (m)	Strata Description	Legend	Testing / Samples
0.00	1.20	MADE GROUND: Dark grey brown sandy GRAVEL of aggregate and demolition rubble. Former foundation along southern edge of pit. Very unstable. 0.90 – Groundwater ingress from c.0.90m bgl.

1.60	-	POSSIBLE BEDROCK: Yellow and grey brown sandstone. Unable to excavate (possible large boulders?)		
		End of trial hole at 1.60m. Groundwater ingress from base of made ground. Trial hole backfilled with arisings on completion. No evidence of hydrocarbon contamination.		
Engineer: J. Brock Site Works Date: 08/02/2021 Plant: Tracked 360 Excavator			Log Notes: HSV = Hand Shear Vane (kN/m ²) LP = Limited Penetration (HSV/CBR) B = Bulk Bag, J = Amber Glass Jar, T = Plastic Tub

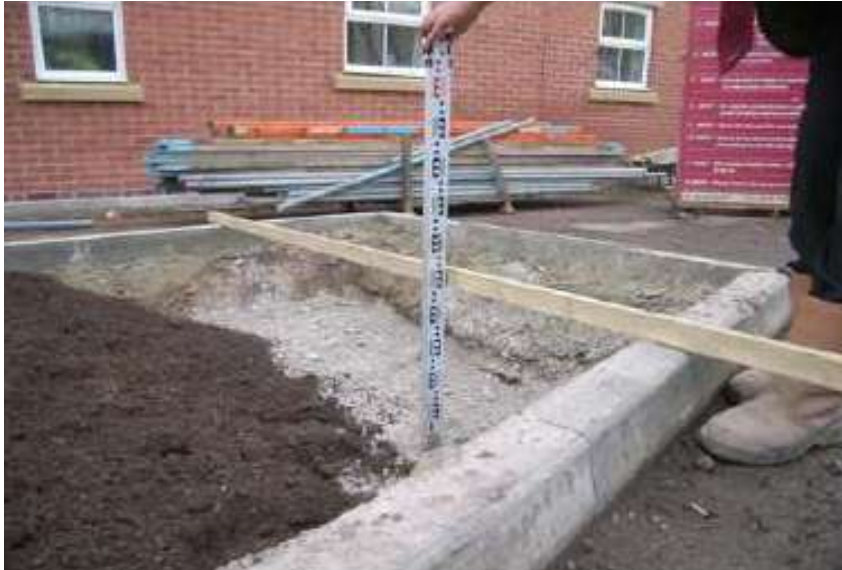
Photograph 1:
Depth check of inert
cover within area of
public open space.
Physical break layer
and topsoil visible.

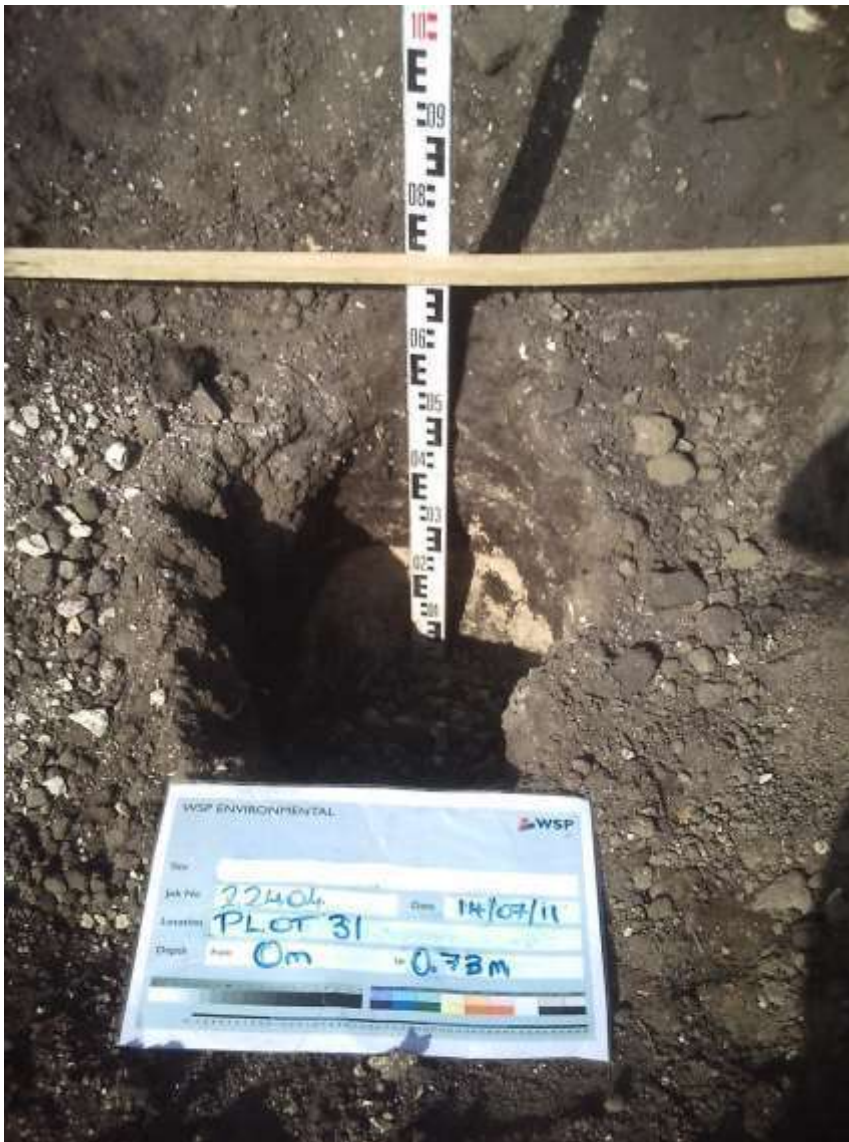
Photograph 2:
Depth check of inert
cover with Site &
Location Information
Board.

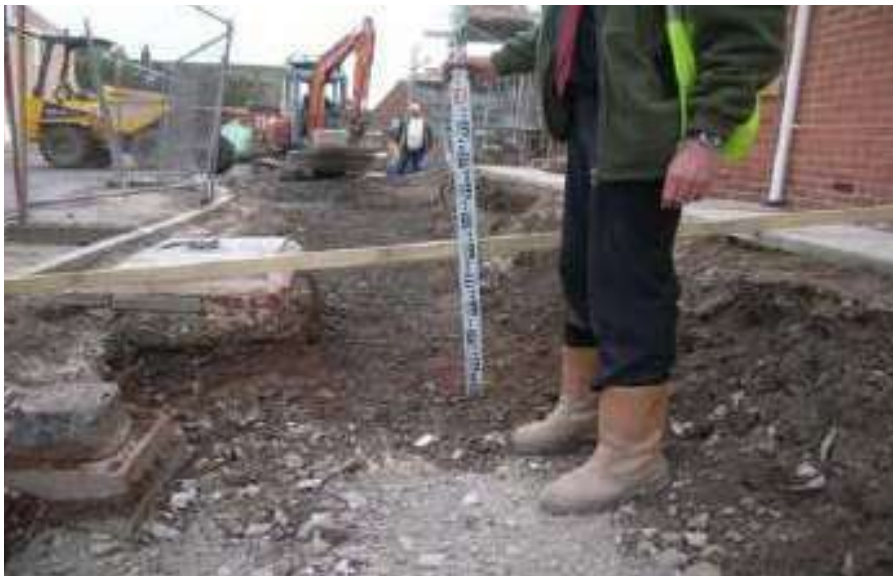
Photograph 3:
Depth check of inert cover within areas of front gardens.

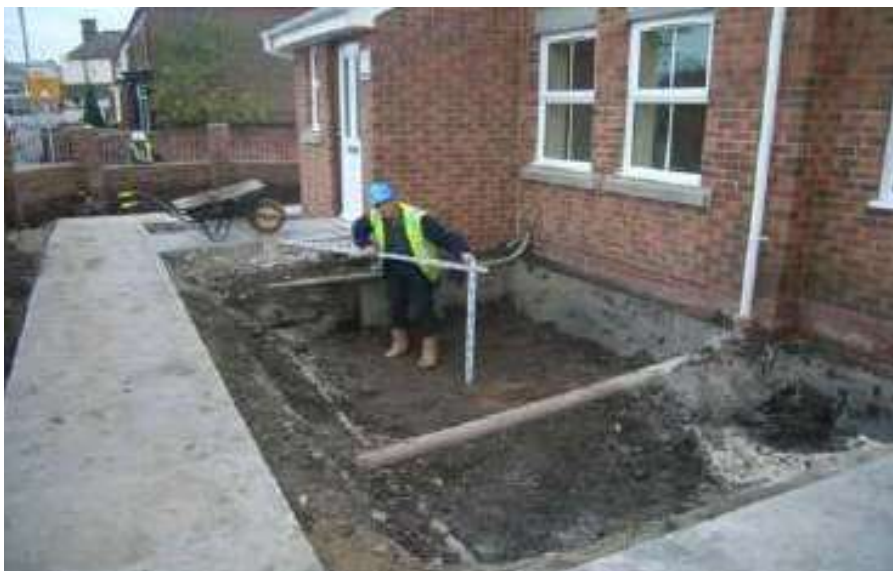
Photograph 4:
Depth check of inert cover within areas of front gardens.

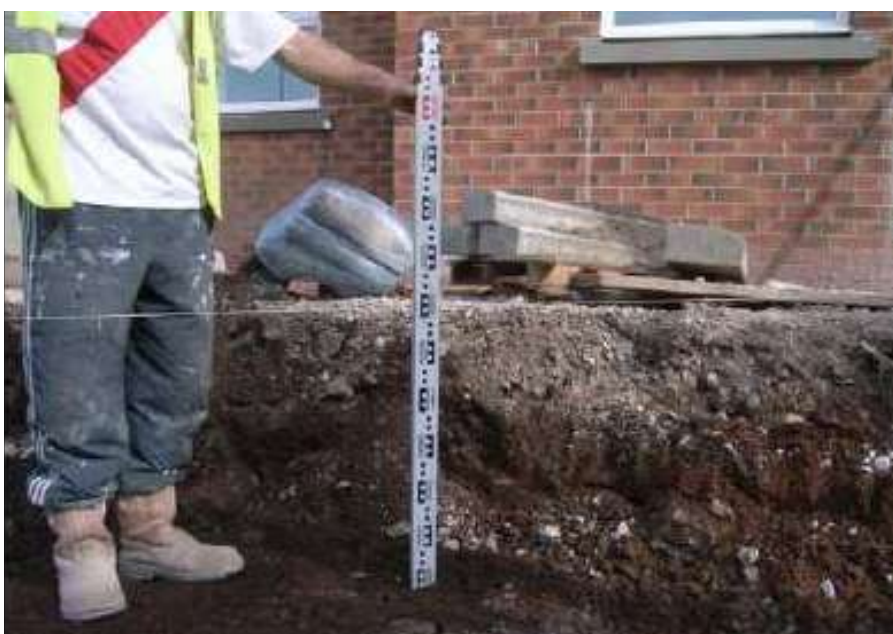
Photograph 5:
Depth check of inert cover within rear gardens. Taut string line spans across excavation.

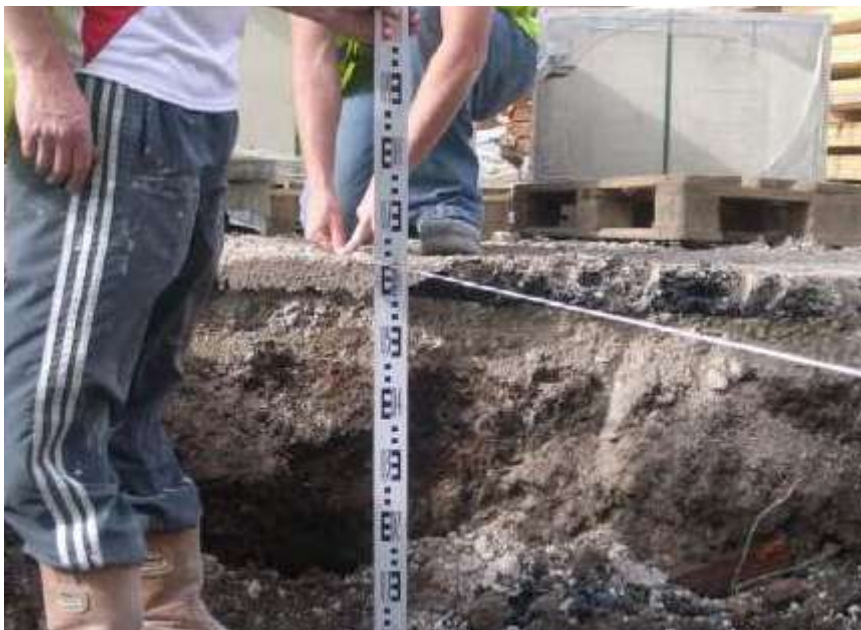
Photograph 6:
Depth check of inert cover within rear gardens. Taut string line spans across excavation.

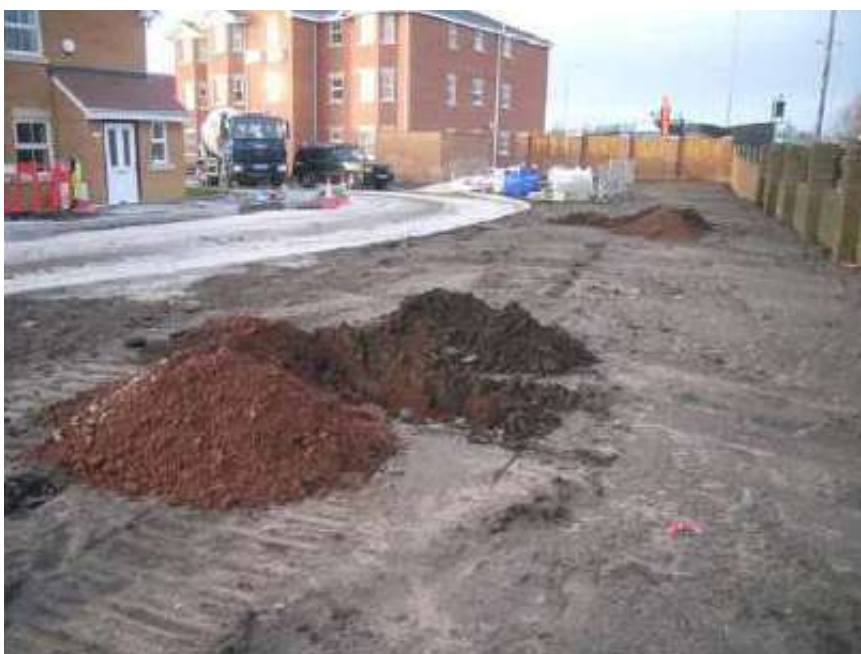
Photograph 7:
Shows the spatial location of the verification pit.

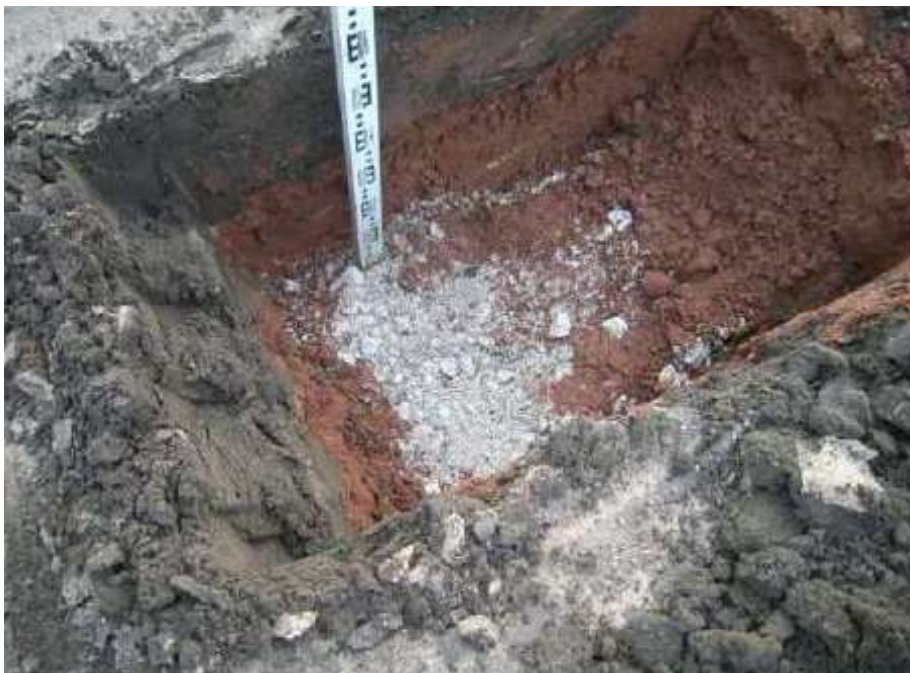
Photograph 8:
Excavation within public open space and verification pit showing the presence of a remediation break layer at the base, a crushed sandstone inert fill overlain by topsoil.

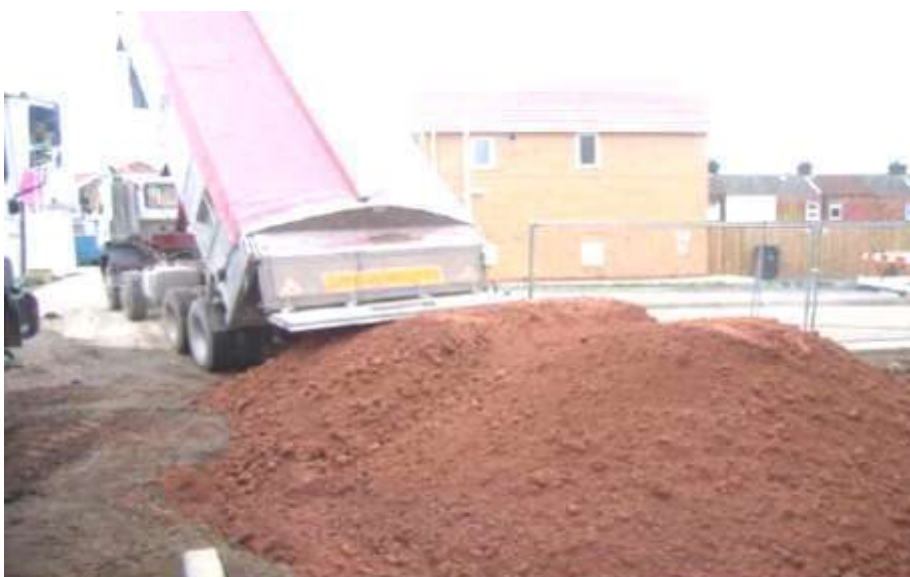
Photograph 9:
Inert crushed sandstone being delivered. The spatial area of the remediation can be observed from these photographs (old terrace housing).

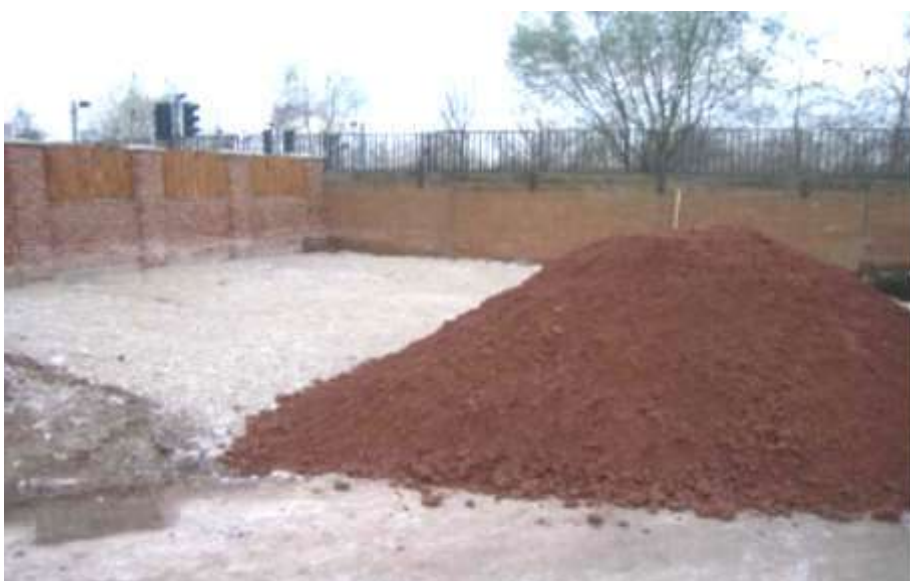
Photograph 10: Inert crushed sandstone being delivered with visible remediation break layer. The spatial area of the remediation can be observed from these photographs (traffic lights).

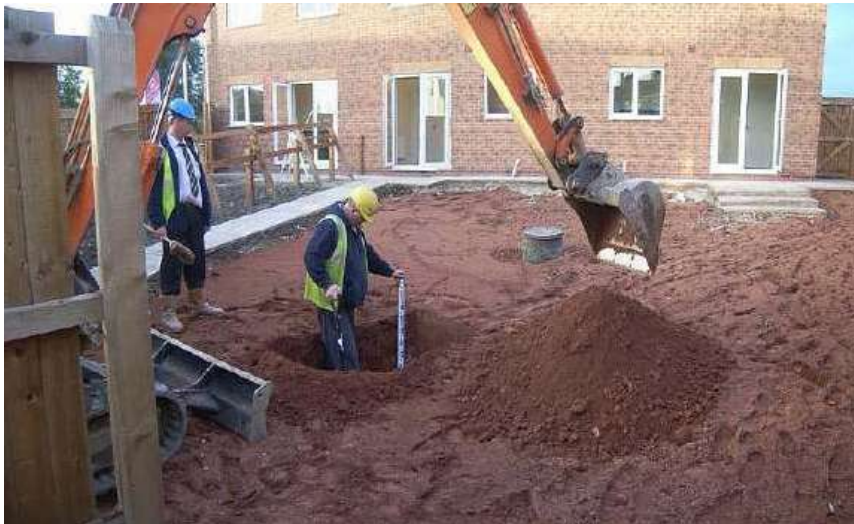
Photograph 11:
Shows the
remediation of the
rear garden, with a
significant depth
(1.0m) of inert cover.
This photograph has
been stitched to form
a panoramic
photograph and
hence there is slight
distortion

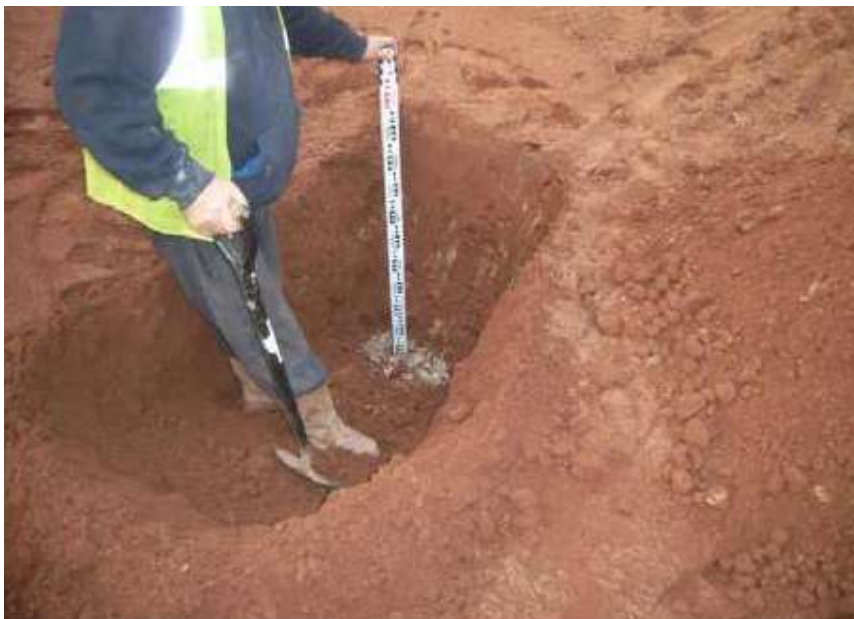
Photograph 12:
Shows the
remediation of the
rear garden, with a
significant depth
(1.0m) of inert cover.
Remediation break
layer visible at the
base of the
excavation.
