PHASE 2: GROUND INVESTIGATION REPORT

PROPOSED VEHICLE BODY WORKSHOP

MILLOM ROAD, MILLOM

Report Ref: 2023-5901

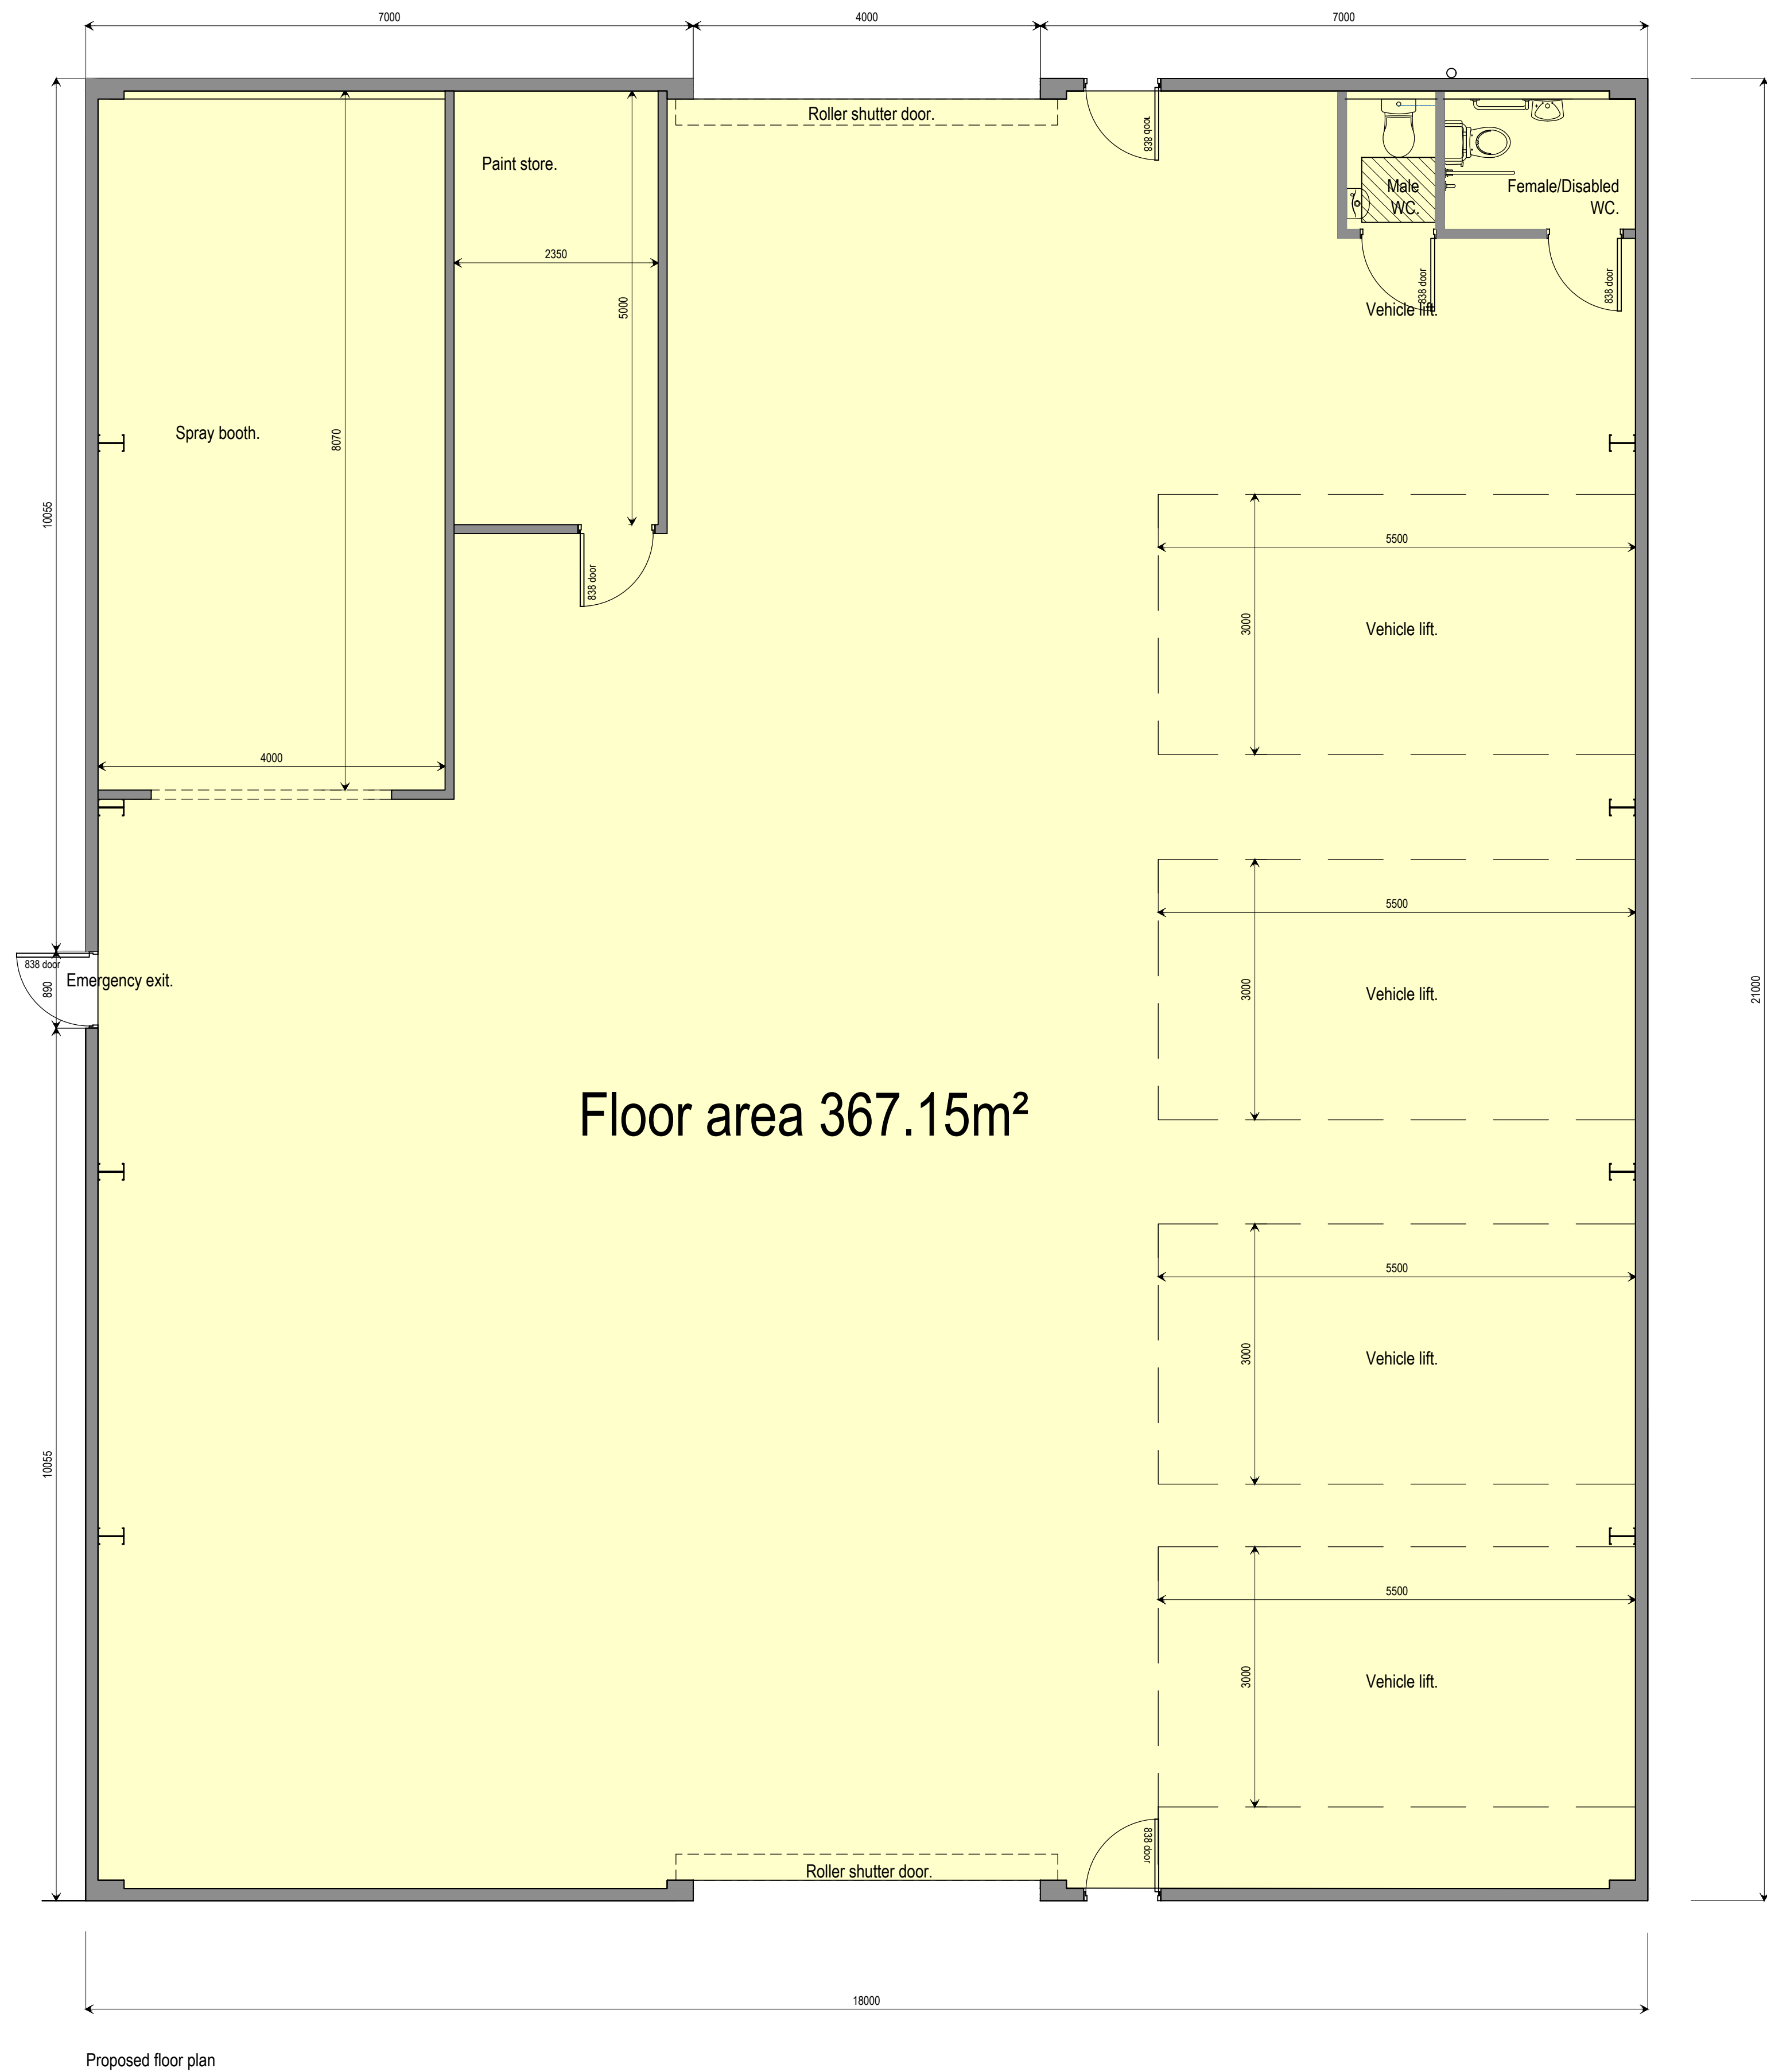
Proposed Vehicle body workshop at Millom
Road,Millom.Cumbria.LA18 4BW.
For Mr.J.Milligan.
General arrangement drawing.

It is understood that the Client will construct a vehicle body workshop. A plan of the proposed layout has been provided and a copy is included in Appendix I. The plan indicates a portal framed warehouse with car parking and other associated infrastructure. There are no plans to incorporate any soft landscaping.
