**SOIL REMEDIATION STRATEGY**

**PROPOSED RESIDENTIAL DEVELOPMENT**

**LAND AT SCURGILL**

**Report Type:** DRAFT RSv1 – For Design Team Review

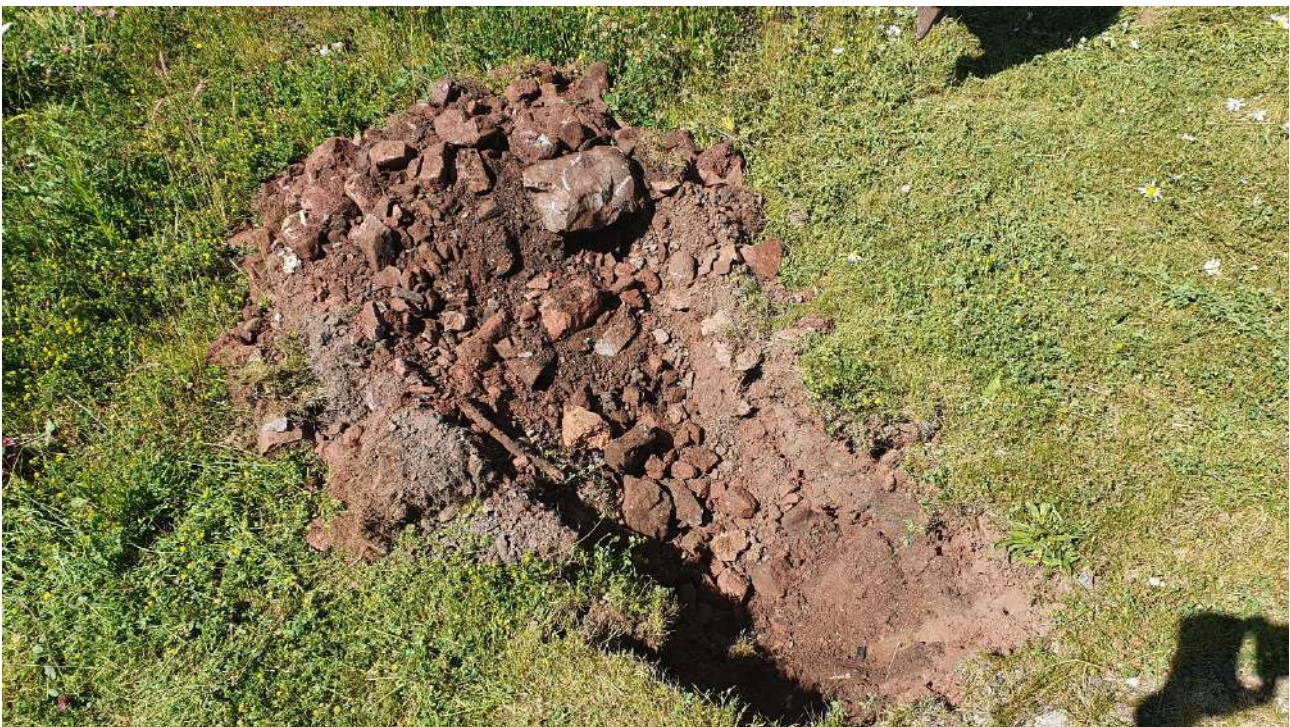
End of trial pit at 1.60m. Trial pit is dry on completion. Trial pit backfilled with arisings.		
<b>Engineer:</b> J.Brock <b>Site Works Date:</b> 18/06/2021 <b>Plant:</b> 3CX Backhoe Excavator			<b>Log Notes:</b> HSV = Hand Shear Vane (kN/m <sup>2</sup> ) LP = Limited Penetration (HSV/CBR) B = Bulk Bag, J = Amber Glass Jar, T = Plastic Tub

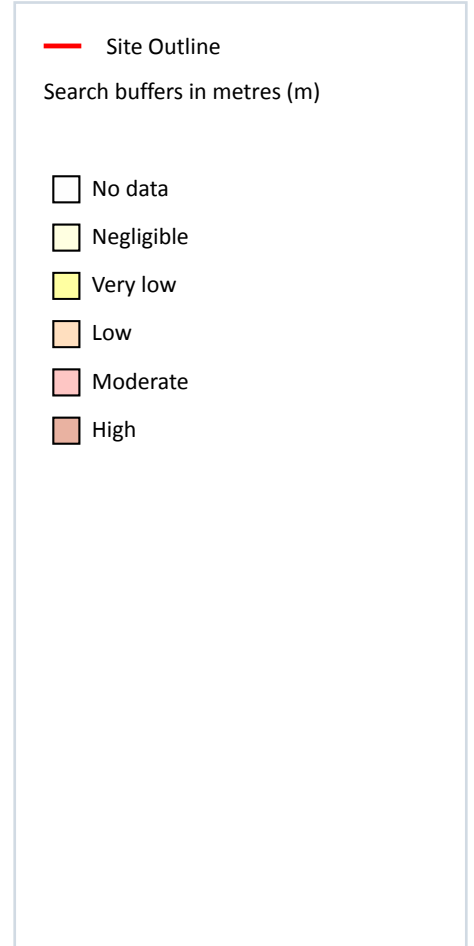
## Natural ground subsidence - Running sands

The potential hazard presented by rocks that can contain loosely-packed sandy layers that can become fluidised by water flowing through them. Such sands can 'run', removing support from overlying buildings and causing potential damage.

Location	Hazard rating	Details
On site	Very low	Running sand conditions are unlikely. No identified constraints on land use due to running conditions unless water table rises rapidly.

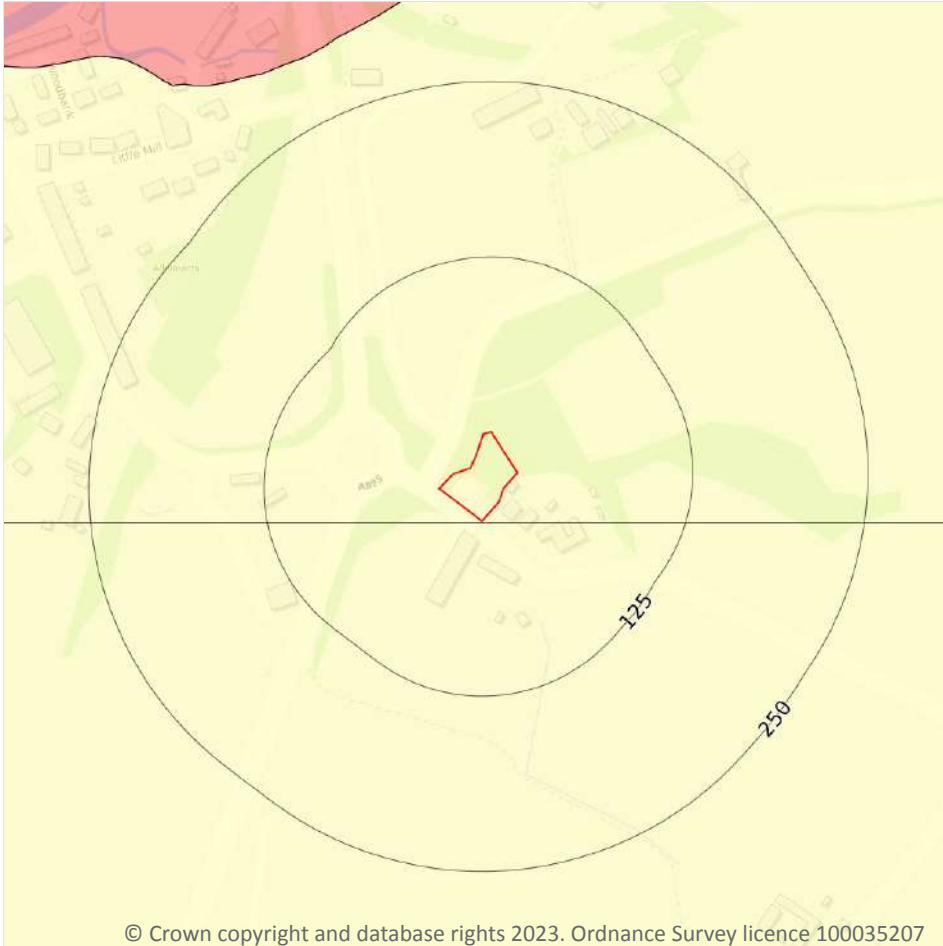
## Natural ground subsidence - Compressible deposits

The potential hazard presented by types of ground that may contain layers of very soft materials like clay or peat and may compress if loaded by overlying structures, or if the groundwater level changes, potentially resulting in depression of the ground and disturbance of foundations.

Location	Hazard rating	Details
<b>On site</b>	<b>Negligible</b>	<b>Compressible strata are not thought to occur.</b>
1m S	Negligible	Compressible strata are not thought to occur.

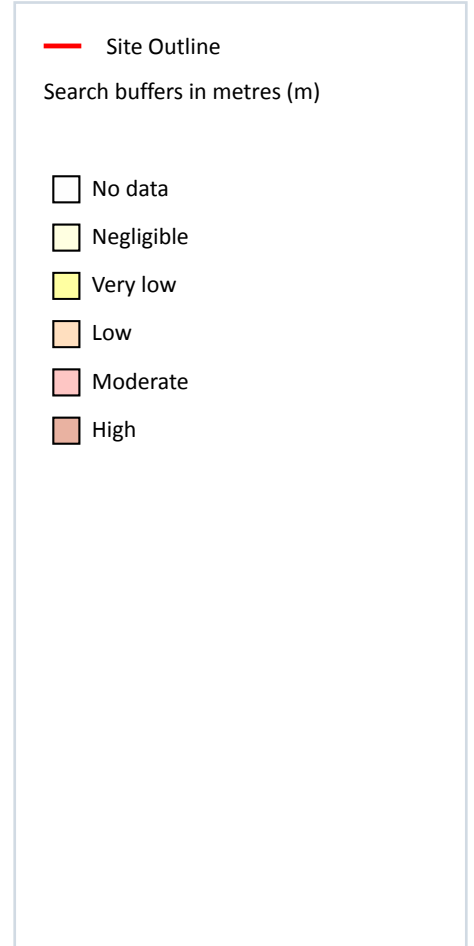
## Natural ground subsidence - Ground dissolution of soluble rocks

The potential hazard presented by ground dissolution, which occurs when water passing through soluble rocks produces underground cavities and cave systems. These cavities reduce support to the ground above and can cause localised collapse of the overlying rocks and deposits.

Location	Hazard rating	Details
On site	Negligible	Soluble rocks are either not thought to be present within the ground, or not prone to dissolution. Dissolution features are unlikely to be present.

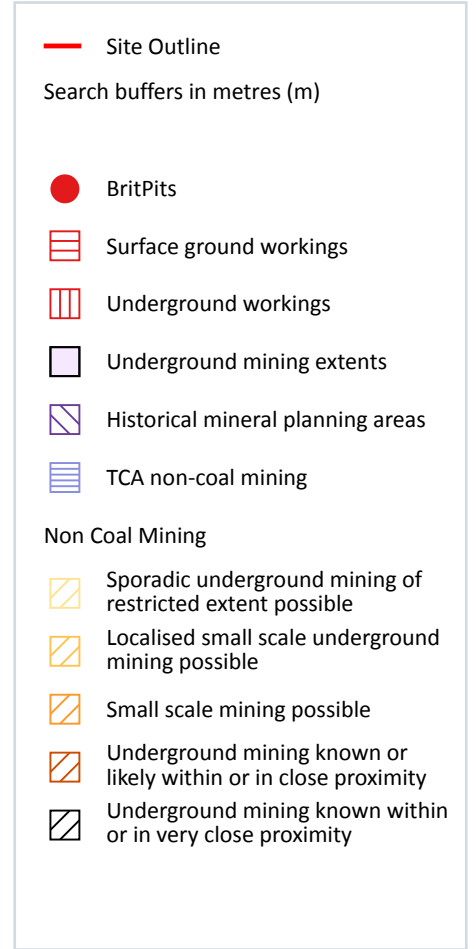
## 5 Mining and ground workings

ID	Location	Name	Commodity	Class	Likelihood
1	On site	Not available	Iron Ore (Non Vein)	E	<b>Underground mining is known or considered likely within or very close to the area. The location, extent and nature of mining should be considered in any site investigation. Potential for difficult ground conditions should be considered.</b>
2	1m S	Not available	Iron Ore (Non Vein)	E	Underground mining is known or considered likely within or very close to the area. The location, extent and nature of mining should be considered in any site investigation. Potential for difficult ground conditions should be considered.
7	317m NW	Not available	Iron Ore (Non Vein)	B	Underground mine workings may have occurred in the past or current mines may be working at significant depth to modern engineering standards. Potential for difficult ground conditions are unlikely and are at a level where they need not be considered.

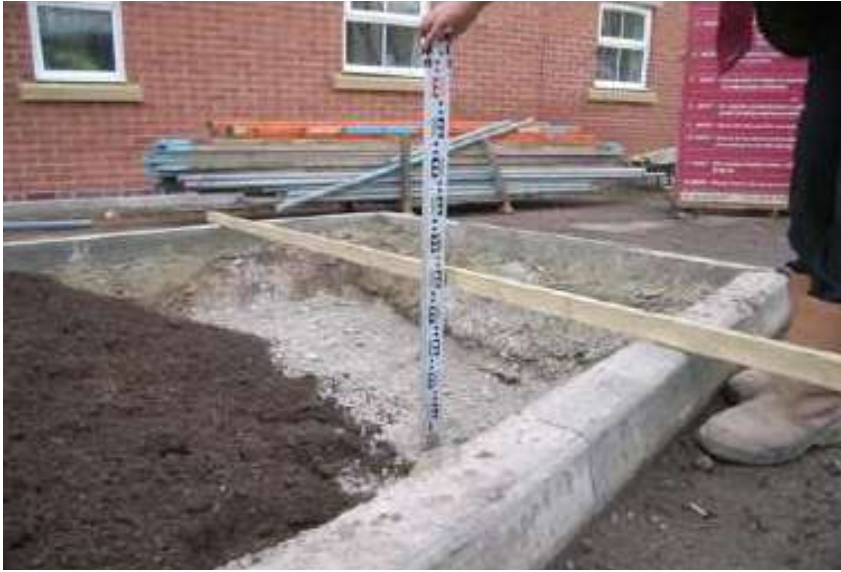
Photograph 1:  
Depth check of inert  
cover within area of  
public open space.  
Physical break layer  
and topsoil visible.

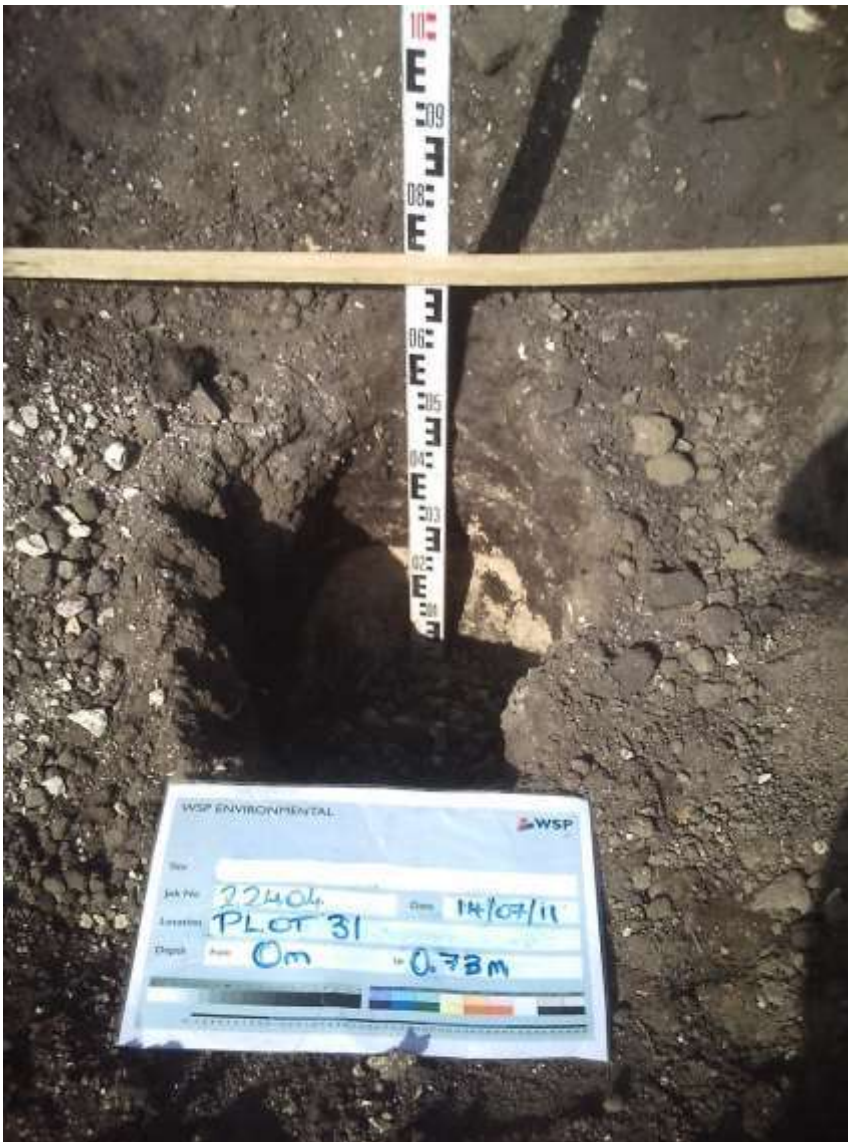
Photograph 2:  
Depth check of inert  
cover with Site &  
Location Information  
Board.

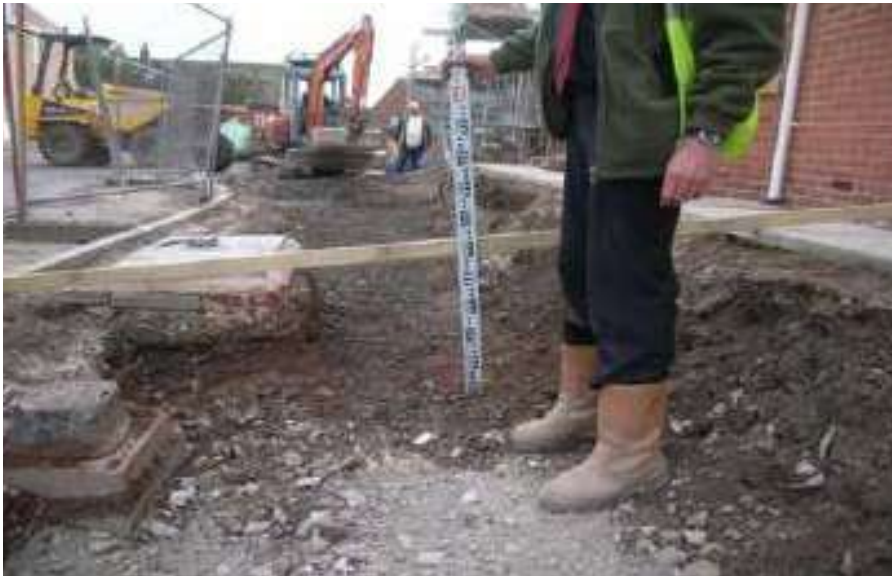
Photograph 3:  
Depth check of inert cover within areas of front gardens.

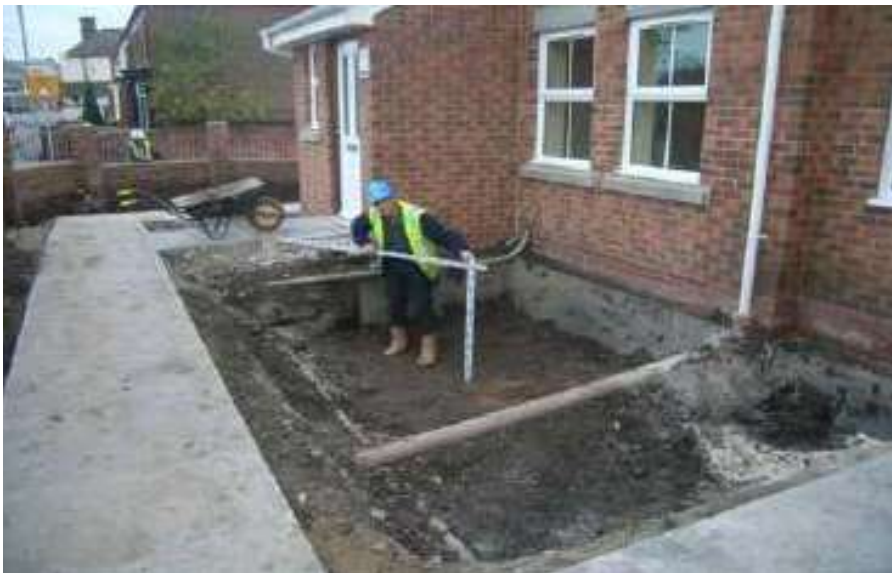
Photograph 4:  
Depth check of inert cover within areas of front gardens.

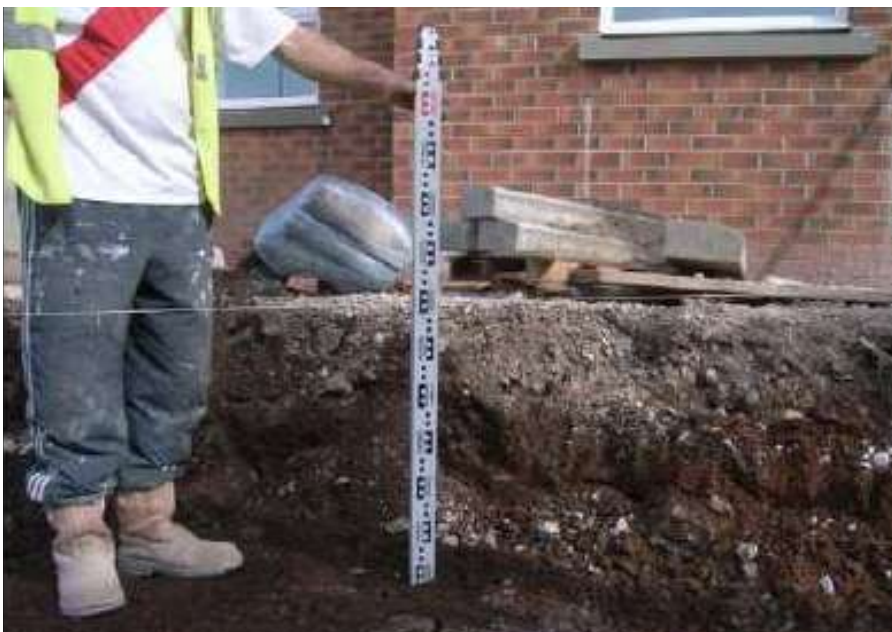
Photograph 5:  
Depth check of inert cover within rear gardens. Taut string line spans across excavation.

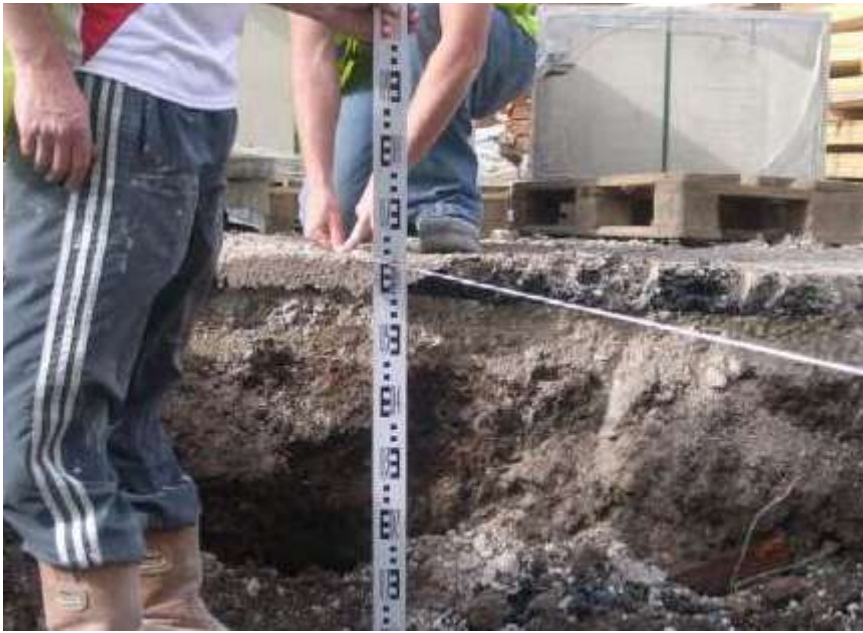
Photograph 6:  
Depth check of inert  
cover within rear  
gardens. Taut string  
line spans across  
excavation.

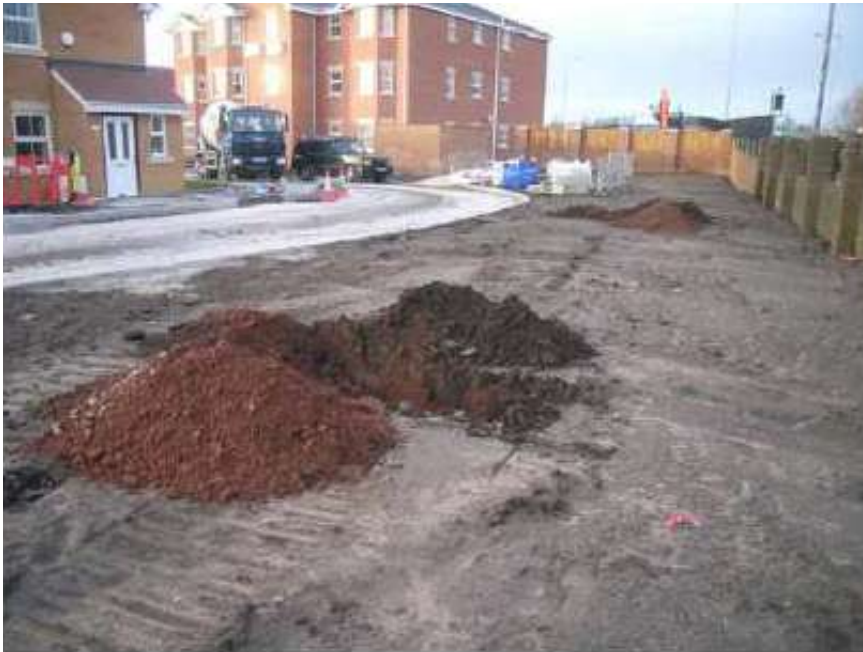
Photograph 7:  
Shows the spatial  
location of the  
verification pit.

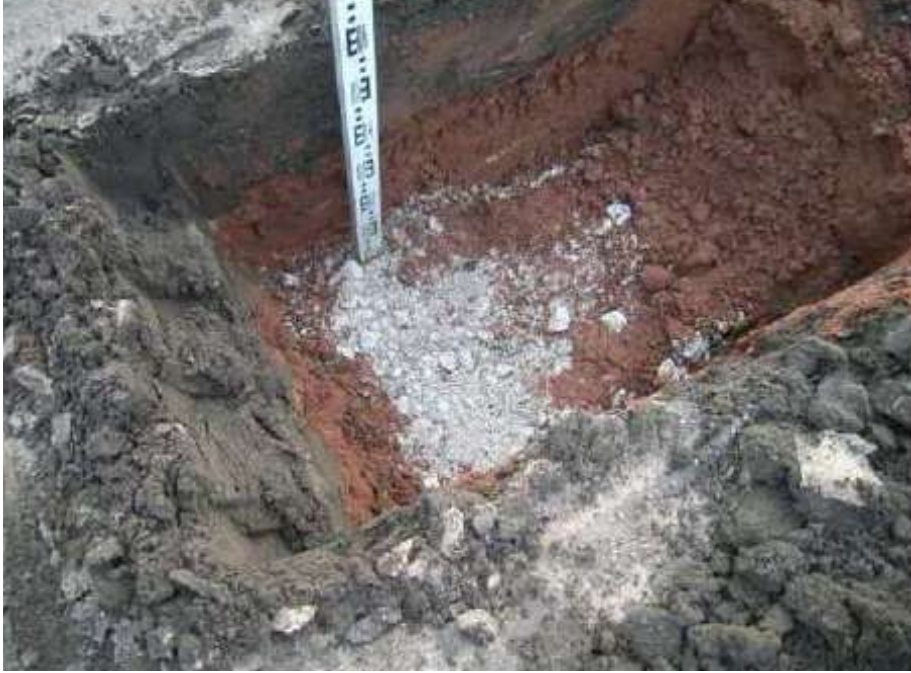
Photograph 8: Excavation within public open space and verification pit showing the presence of a remediation break layer at the base, a crushed sandstone inert fill overlain by topsoil.

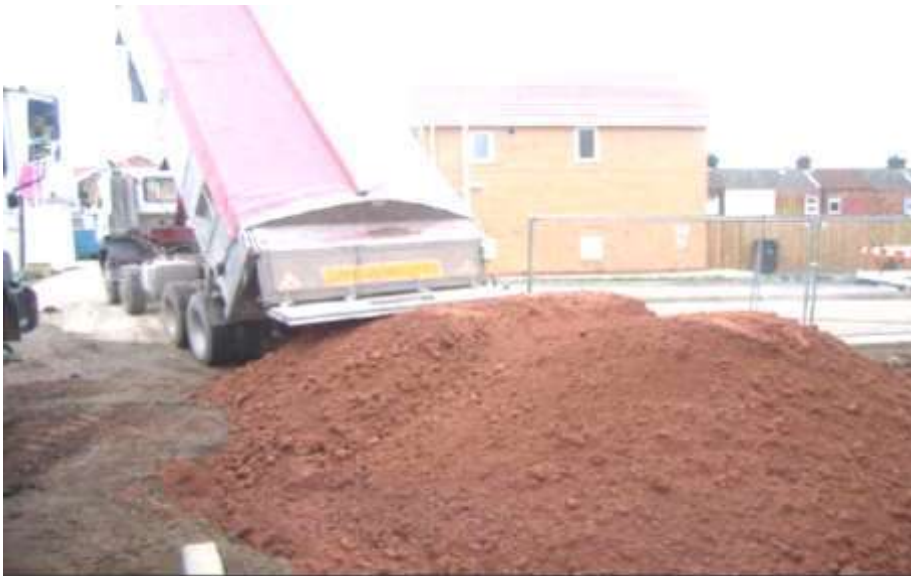
Photograph 9: Inert crushed sandstone being delivered. The spatial area of the remediation can be observed from these photographs (old terrace housing).

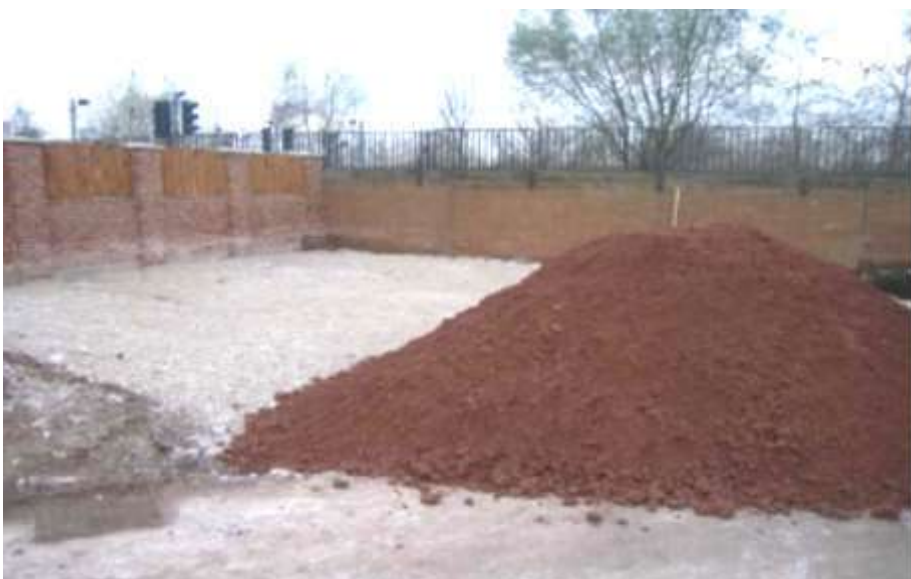
Photograph 10: Inert crushed sandstone being delivered with visible remediation break layer. The spatial area of the remediation can be observed from these photographs (traffic lights).

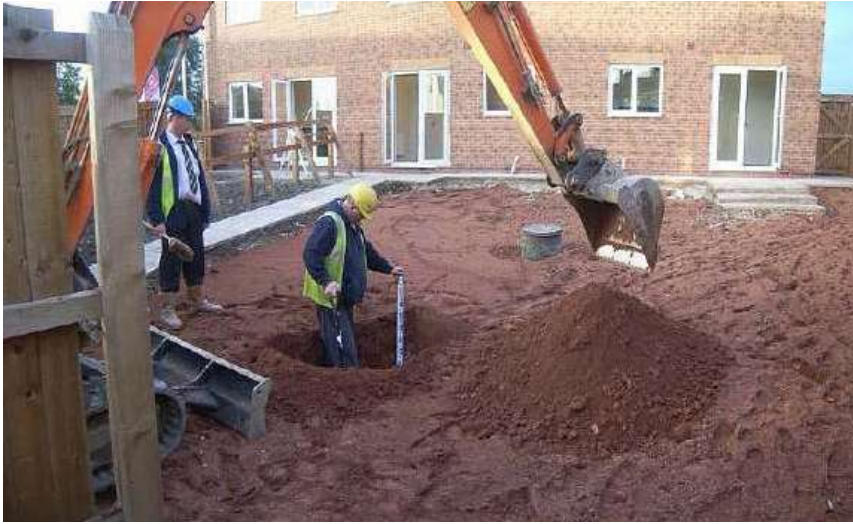
Photograph 11:  
Shows the remediation of the rear garden, with a significant depth (1.0m) of inert cover. This photograph has been stitched to form a panoramic photograph and hence there is slight distortion

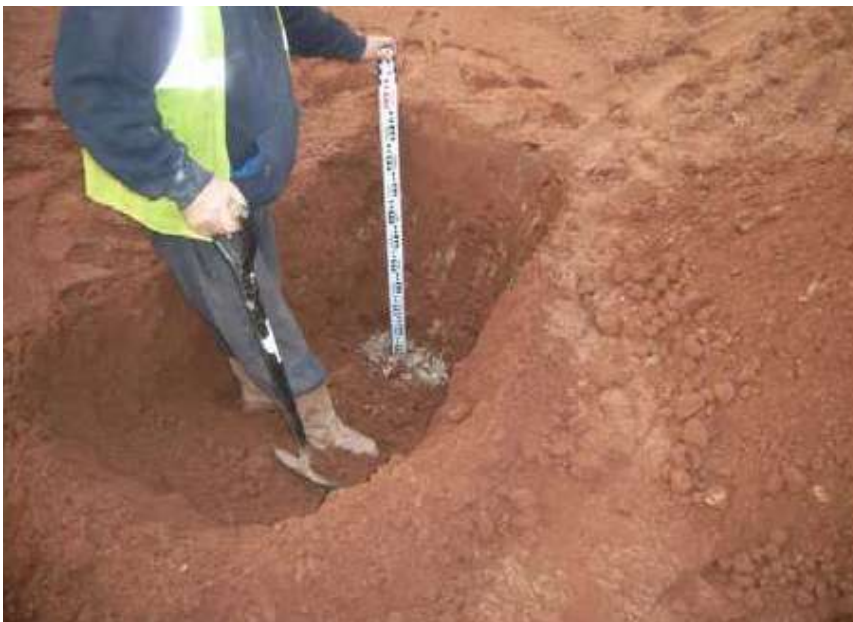
Photograph 12:  
Shows the remediation of the rear garden, with a significant depth (1.0m) of inert cover. Remediation break layer visible at the base of the excavation.
