**Project No:** GEO2024-6332

**Project Name:** Cleator Mills, Cumbria

**Project Title:** Supplementary Ground Investigation and Remediation Strategy

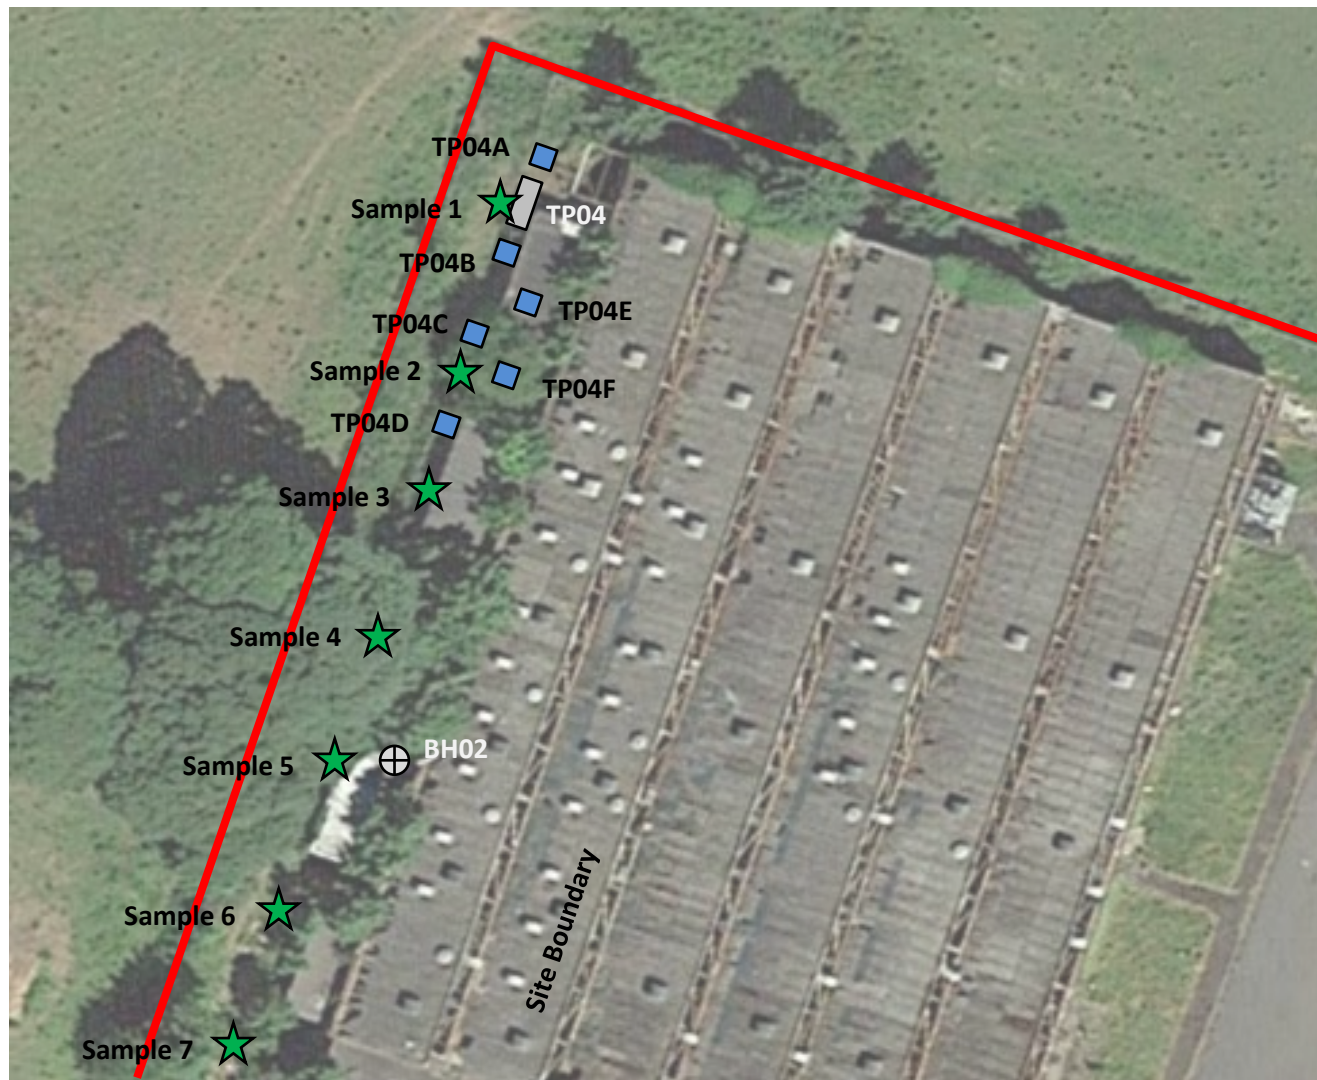
**GEO2024-6332: Land at Cleator Mills, Cumbria – Exploratory Hole Location Plan**

GEO attended the site on the 3<sup>rd</sup> and 24<sup>th</sup> May 2024 to further investigate land to the west of the former building where minor hydrocarbon contamination had previously been encountered in trial pit TP04 and asbestos contamination was previously recorded in borehole BH02. During the site works, this area comprised crushed demolition rubble.

- 5 No. trial pits (TP04A to TP04F) to depths of between c.0.30m and c.1.10m bgl.
- Surface sampling of the demolition rubble at 7 No. Locations (Sample 1 to Sample 7).

An exploratory hole location plan is attached. The trial pits were located within the vicinity of trial pit TP04 which had previously encountered minor hydrocarbon contamination (slight odour) in order to identify a possible source of the contamination and to allow the materials to be excavated and disposed of if present.

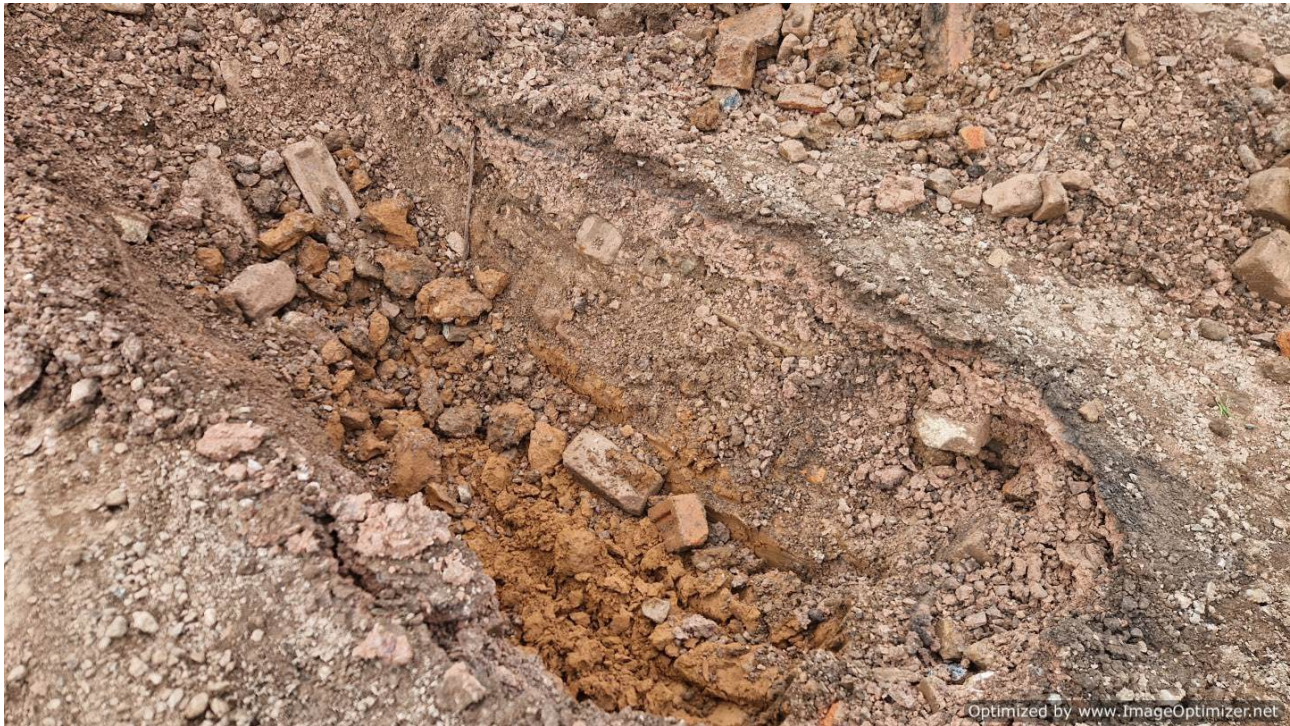
**GEO2024-6332: Land at Cleator Mills, Cumbria – TP04A**

Depth From (m)	Depth To (m)	Strata Description	Legend	Testing / Samples
0.00	0.24	MADE GROUND: Dark grey brown silty sandy angular GRAVEL of aggregate, brick and concrete.

0.20 - J
0.24	0.80	Firm to stiff red brown silty sandy CLAY.

Trial hole remained open and dry on completion. Trial hole backfilled with arisings on completion.		
<b>Engineer:</b> J.Brock <b>Site Works Date:</b> 08/05/2024 <b>Plant:</b> Tracked 360 Excavator			<b>Log Notes:</b> HSV = Hand Shear Vane (kN/m <sup>2</sup> ) LP = Limited Penetration (HSV/CBR) B = Bulk Bag, J = Amber Glass Jar, T = Plastic Tub

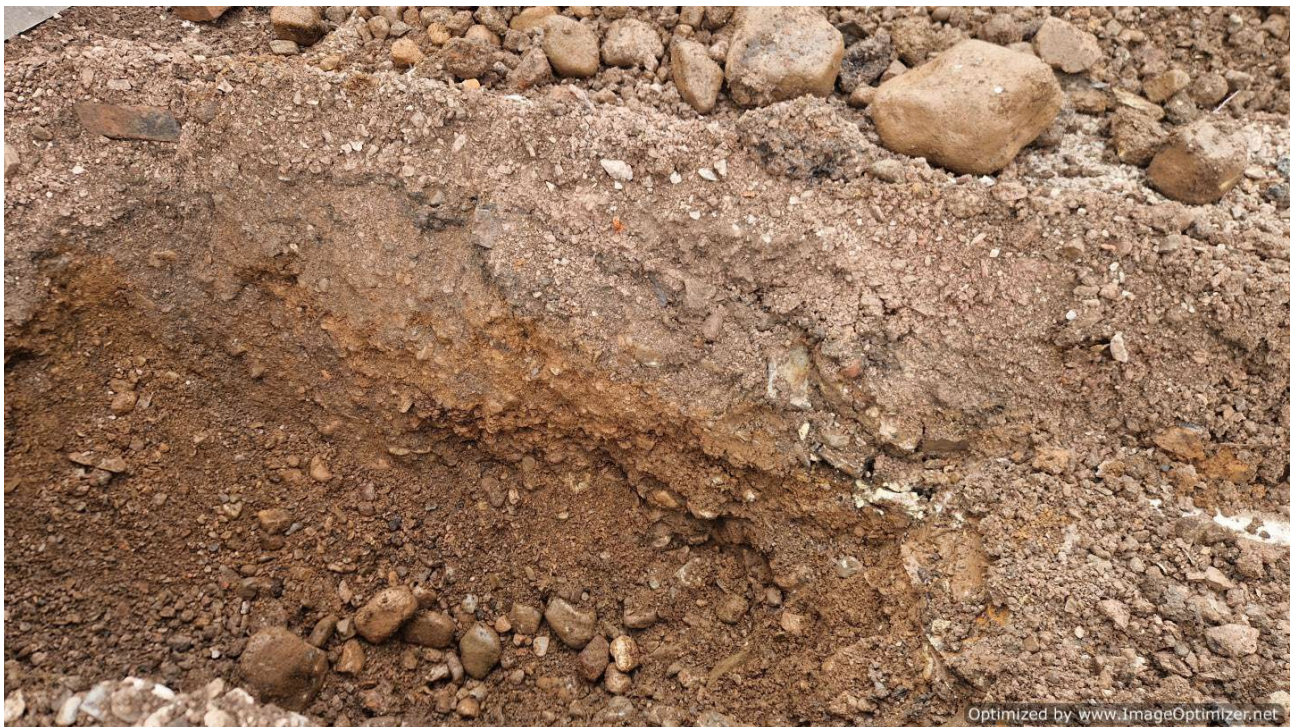
**GEO2024-6332: Land at Cleator Mills, Cumbria – TP04B**

Depth From (m)	Depth To (m)	Strata Description	Legend	Testing / Samples
0.00	0.44	MADE GROUND: Dark grey brown silty sandy angular GRAVEL of aggregate, brick and concrete.

0.44	1.10	Red brown sandy sub-rounded GRAVEL and COBBLES of mixed lithology.

0.50 - J
		Trial hole remained open and dry on completion. Trial hole backfilled with arisings on completion.

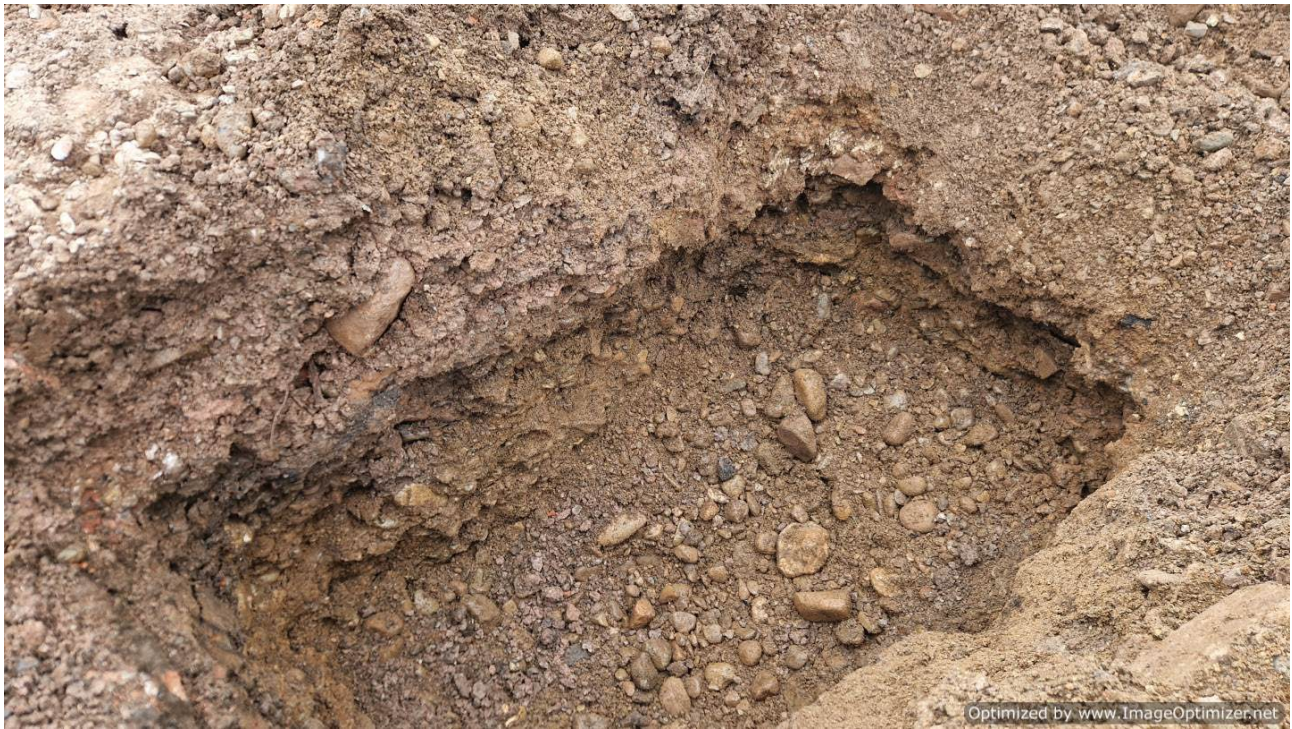
**GEO2024-6332: Land at Cleator Mills, Cumbria – TP04C**

Depth From (m)	Depth To (m)	Strata Description	Legend	Testing / Samples
0.00	0.62	MADE GROUND: Dark grey brown silty sandy angular GRAVEL of aggregate, brick and concrete. Many bricks.

0.40 - J
0.62	0.90	Red brown sandy sub-rounded GRAVEL and COBBLES of mixed lithology.

Trial hole remained open and dry on completion. Trial hole backfilled with arisings on completion.		
<b>Engineer:</b> J.Brock <b>Site Works Date:</b> 08/05/2024 <b>Plant:</b> Tracked 360 Excavator			<b>Log Notes:</b> HSV = Hand Shear Vane (kN/m <sup>2</sup> ) LP = Limited Penetration (HSV/CBR) B = Bulk Bag, J = Amber Glass Jar, T = Plastic Tub

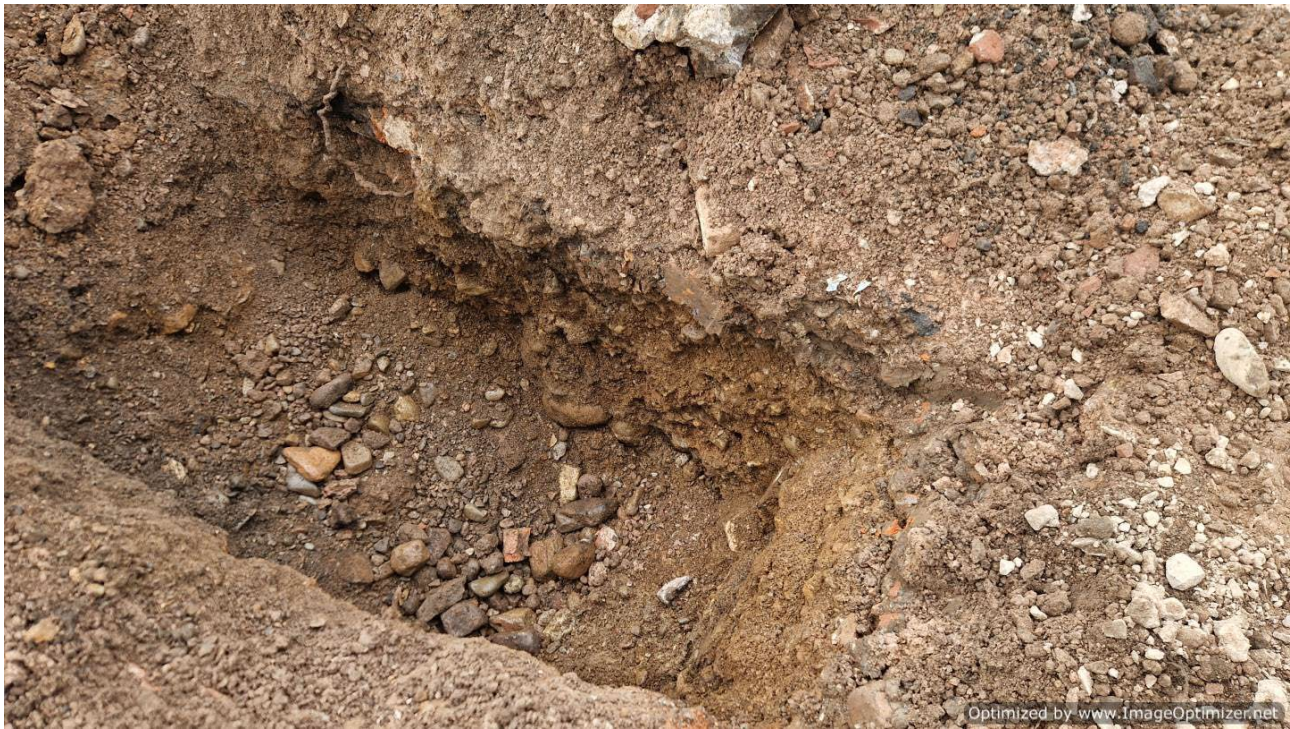
**GEO2024-6332: Land at Cleator Mills, Cumbria – TP04D**

Depth From (m)	Depth To (m)	Strata Description	Legend	Testing / Samples
0.00	0.44	MADE GROUND: Dark grey brown silty sandy angular GRAVEL of aggregate, brick and concrete. Occasional pockets of reworked gravelly clay.

0.44	0.90	Red brown sandy sub-rounded GRAVEL and COBBLES of mixed lithology.

0.50 - J
		Trial hole remained open and dry on completion. Trial hole backfilled with arisings on completion.

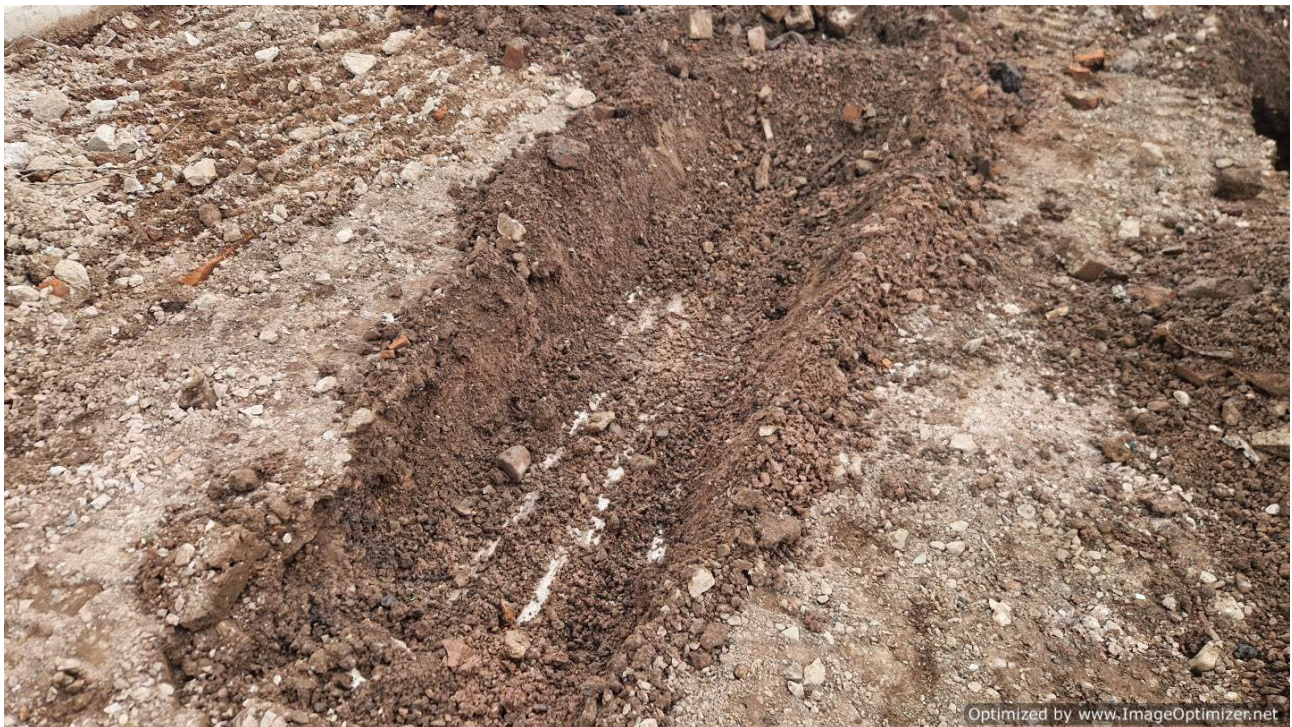
**GEO2024-6332: Land at Cleator Mills, Cumbria – TP04E**

Depth From (m)	Depth To (m)	Strata Description	Legend	Testing / Samples
0.00	0.30	MADE GROUND: Dark grey brown silty sandy angular GRAVEL of aggregate, brick and concrete.		
0.30		Concrete. Unable to penetrate. Trial pit terminated.		
		Trial hole remained open and dry on completion. Trial hole backfilled with arisings on completion.

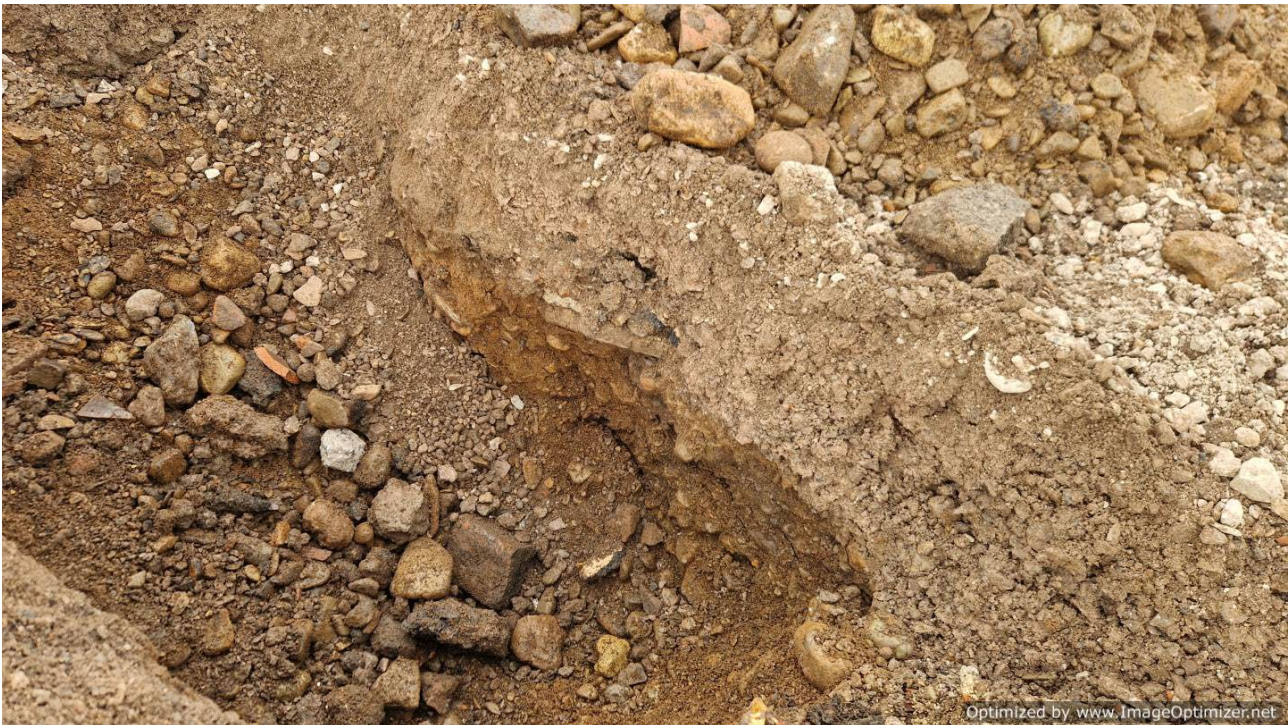
**GEO2024-6332: Land at Cleator Mills, Cumbria – TP04F**

Depth From (m)	Depth To (m)	Strata Description	Legend	Testing / Samples
0.00	0.39	MADE GROUND: Dark grey brown silty sandy angular GRAVEL of aggregate, brick and concrete.

0.39	0.70	Red brown sandy sub-rounded GRAVEL and COBBLES of mixed lithology.

Trial hole remained open and dry on completion. Trial hole backfilled with arisings on completion.		
<b>Engineer:</b> J.Brock <b>Site Works Date:</b> 08/05/2024 <b>Plant:</b> Tracked 360 Excavator			<b>Log Notes:</b> HSV = Hand Shear Vane (kN/m <sup>2</sup> ) LP = Limited Penetration (HSV/CBR) B = Bulk Bag, J = Amber Glass Jar, T = Plastic Tub
