## **PHASE 2: GROUND INVESTIGATION REPORT**

**PROPOSED COMMERCIAL DEVELOPMENT OF**

**LAND OFF MILLOM ROAD, MILLOM**

**Report Type:** DRAFT - Ground Investigation Report (GIR) v1

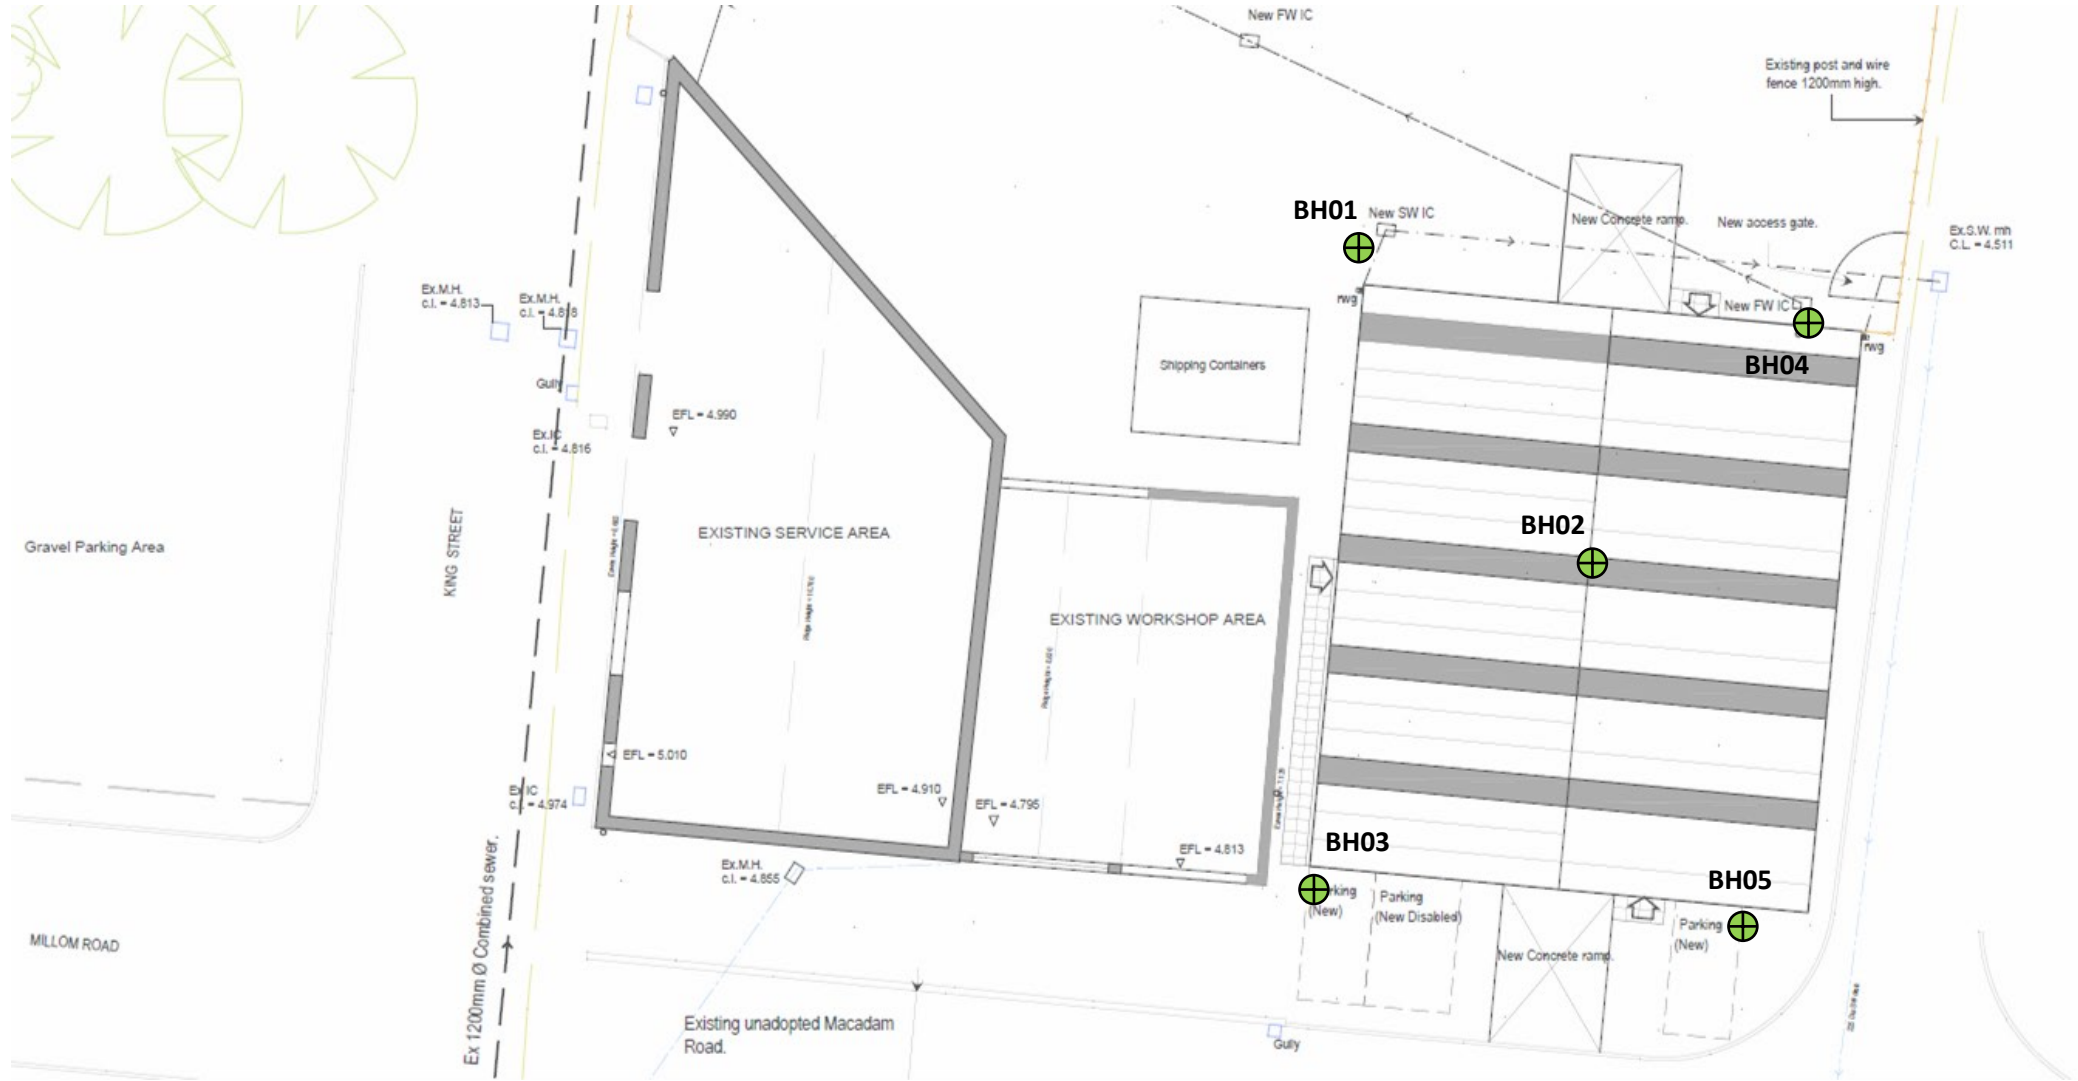
## GEO2022-5585: Millom Road, Millom – Exploratory Hole Location Plan

The exploratory holes were located within the footprint of the proposed building footprint as indicated on the exploratory hole location plan which is included in Appendix I.

- 5 No. Dynamic (Windowless) Sampling Boreholes (BH01 to BH05) to depths of between c.0.40m and c.3.45m bgl.
- Gas and groundwater monitoring (4 visits completed).
- In-situ geotechnical testing (Standard Penetration Tests (SPT)).
- Site supervision by a suitably qualified and experienced Geo-Environmental Engineer.
- Laboratory chemical screening of soil samples.

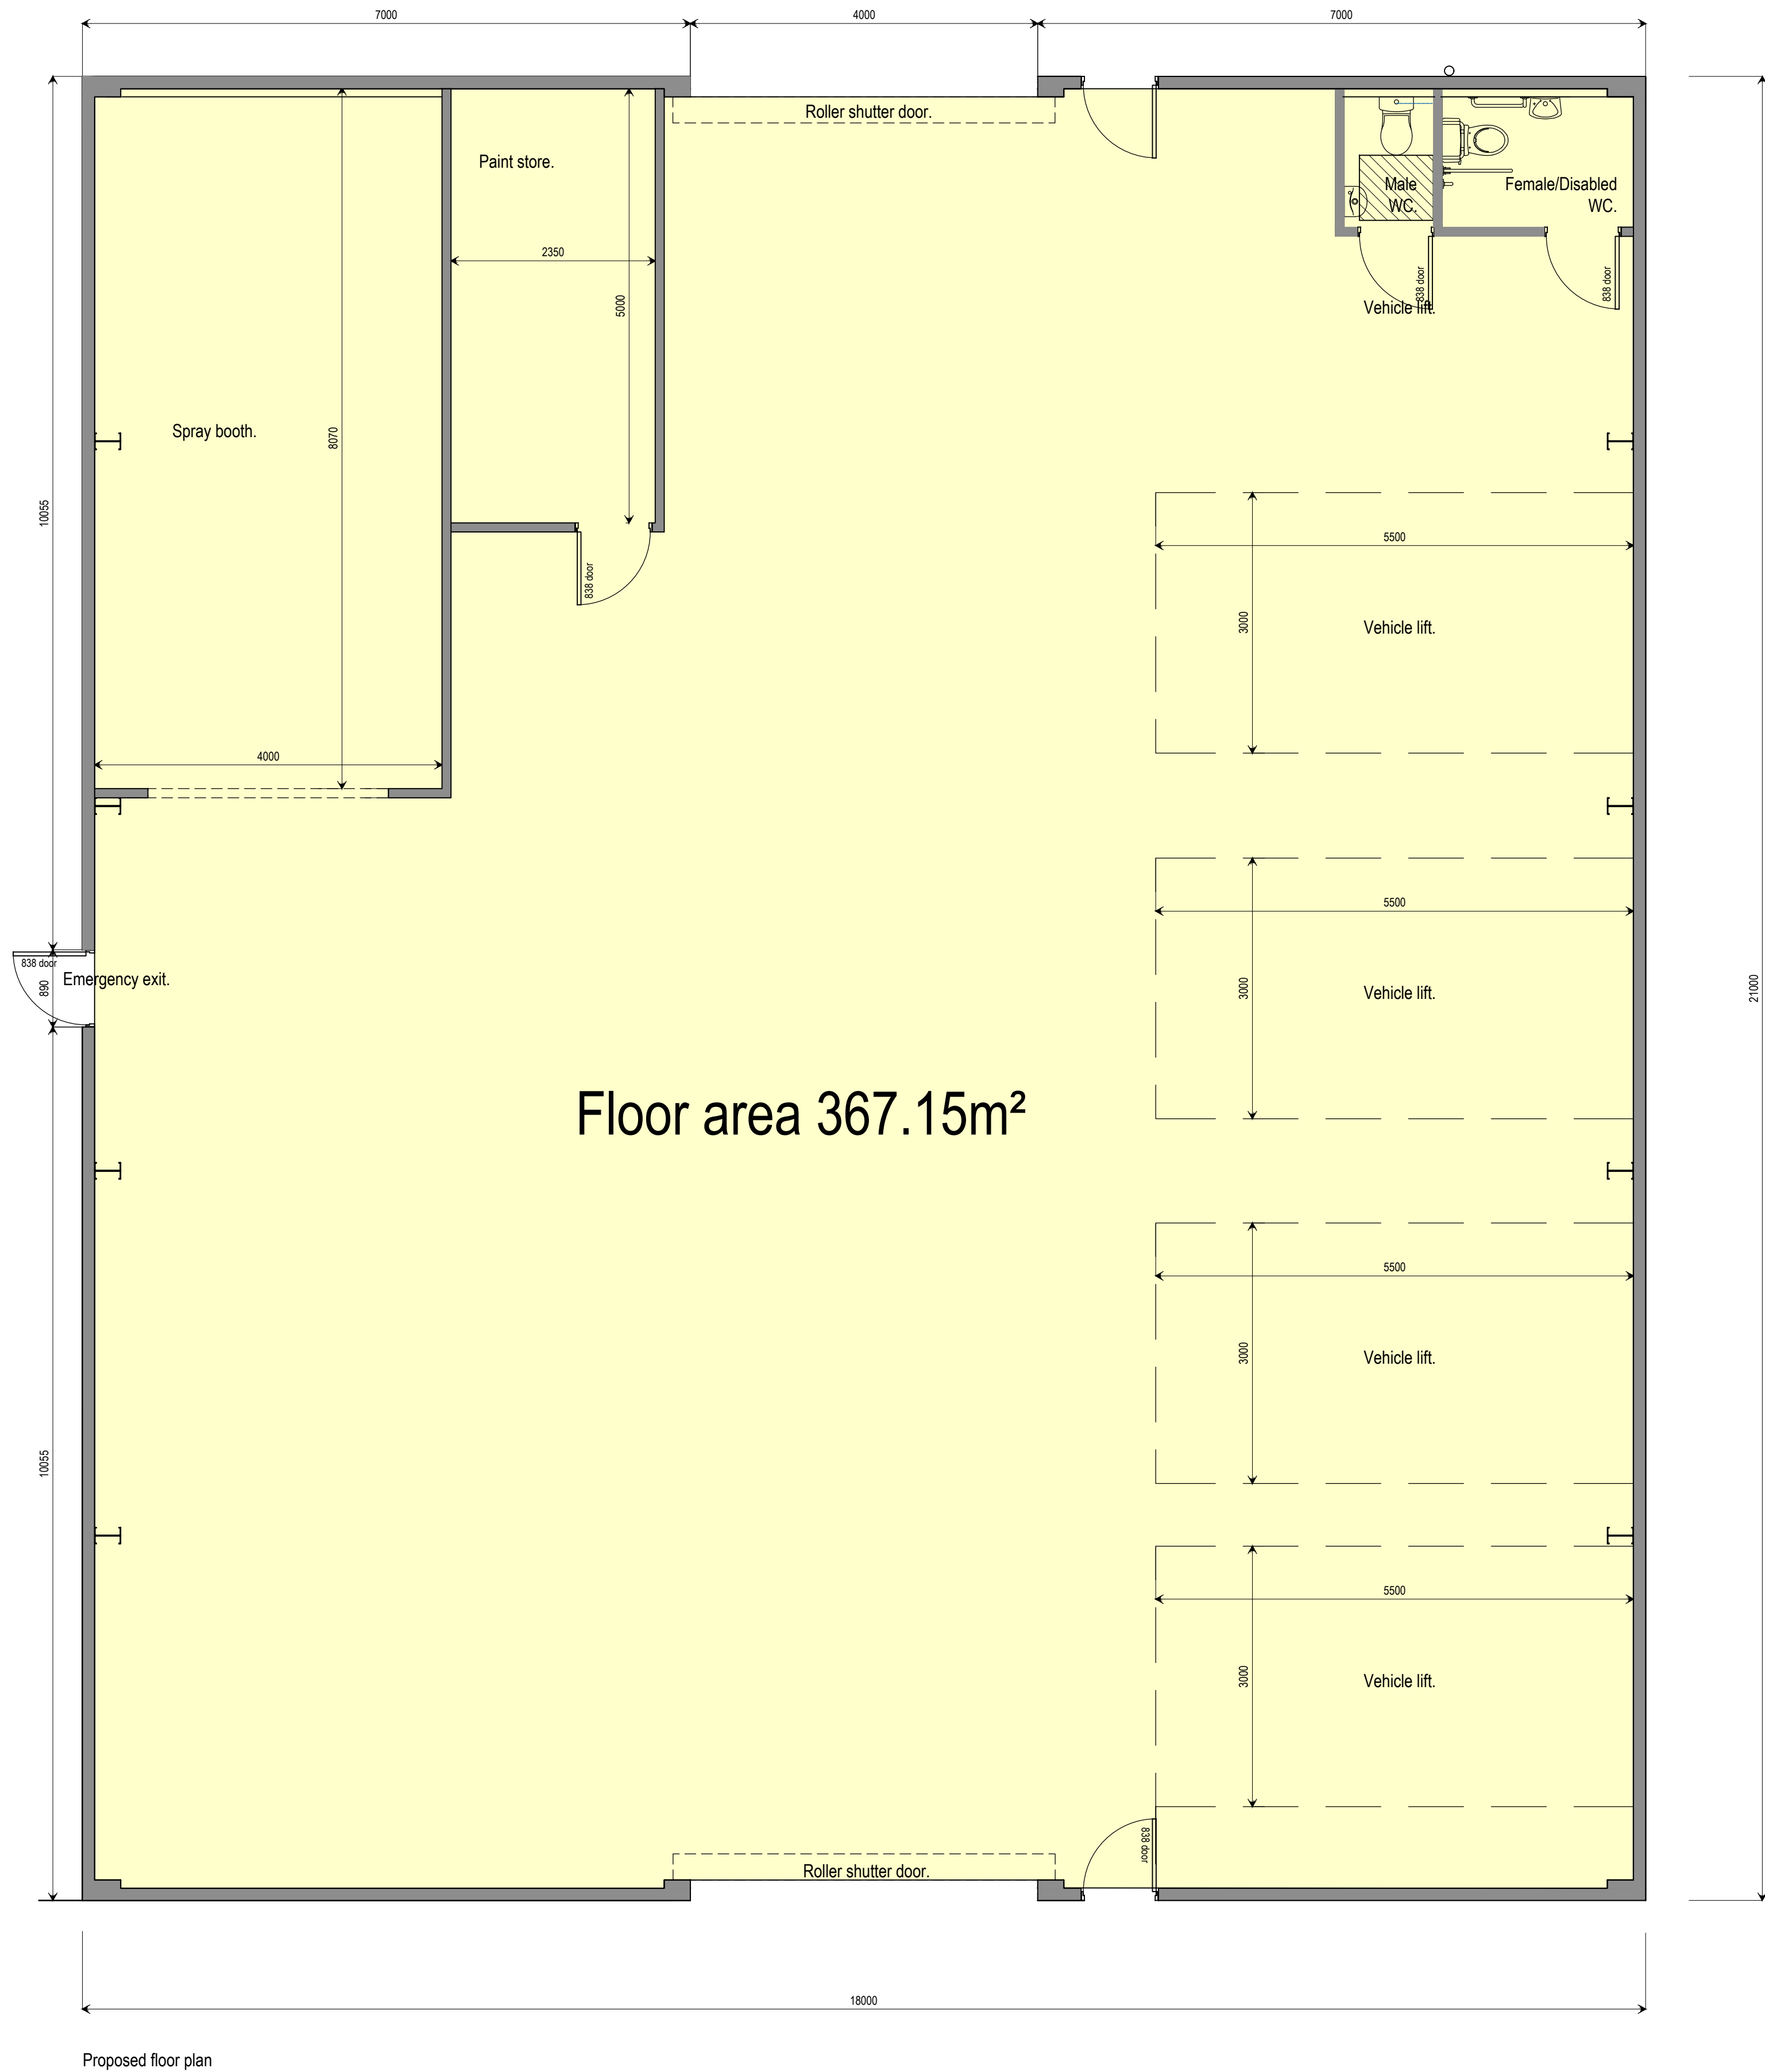
Proposed Vehicle body workshop at Millom  
Road,Millom.Cumbria.LA18 4BW.  
For Mr.J.Milligan.  
General arrangement drawing.

**Materials.**  
**Roof.** Profiled metal sheets colour Anthracite.RAL 7016  
**Walls.**Profiled metal sheets colour Solent Blue.RAL CLASSIC 240 40 40  
**Doors.**Coated steel colour Anthracite.RAL 7016  
**Fascias,gutters and downpipes.**Coated steel colour Anthracite.RAL 7016

Scales 1:50,1:1250 @A1  
June 2022.  
Dwg No.MIL\_JM.01(B).

It is understood that the Client construct a vehicle body workshop. A plan of the proposed layout has been provided and a copy is included in Appendix I. The plan indicates a portal framed warehouse with car parking and other associated infrastructure. There are no plans to incorporate any soft landscaping.
