PHASE II GROUND INVESTIGATION REPORT

**CLEATOR MOOR ACTIVITY CENTRE, CLEATOR MOOR, CUMBRIA, CA25 5AN
PREPARED FOR ALLIANCE LEISURE SERVICES LIMITED**

Project No.	GEOL22-8472	Client	Alliance Leisure Services Limited
Report Type	Phase II Ground Investigation Report		
Design Team	Cohesion Consult Limited, Furness Partnership Limited & Robert Limbrick Limited		
Project Type	Redevelopment of Cleator Moor Activity Centre comprising a new sports facility replacing the existing sports facility, along with a change in layout to on-site parking areas		
Site Address	Cleator Moor Activity Centre, Cleator Moor, Cumbria, CA25 5AN		
NGR	302150, 515090		
Date	10/03/2023		
Prepared by	Nathan Waterhouse		
Qualifications	BSc (Hons) MSc		
Position	Director		
Checked by	Richard Stripp		
Qualifications	BSc (Hons) MSc FGS MIEnvSc		
Position	Director		
Approved by	Terry M^cMenam		
Qualifications	BSc (Hons) CSci CEnv FGS MIEnvSc FCMI MIoD		
Position	Director

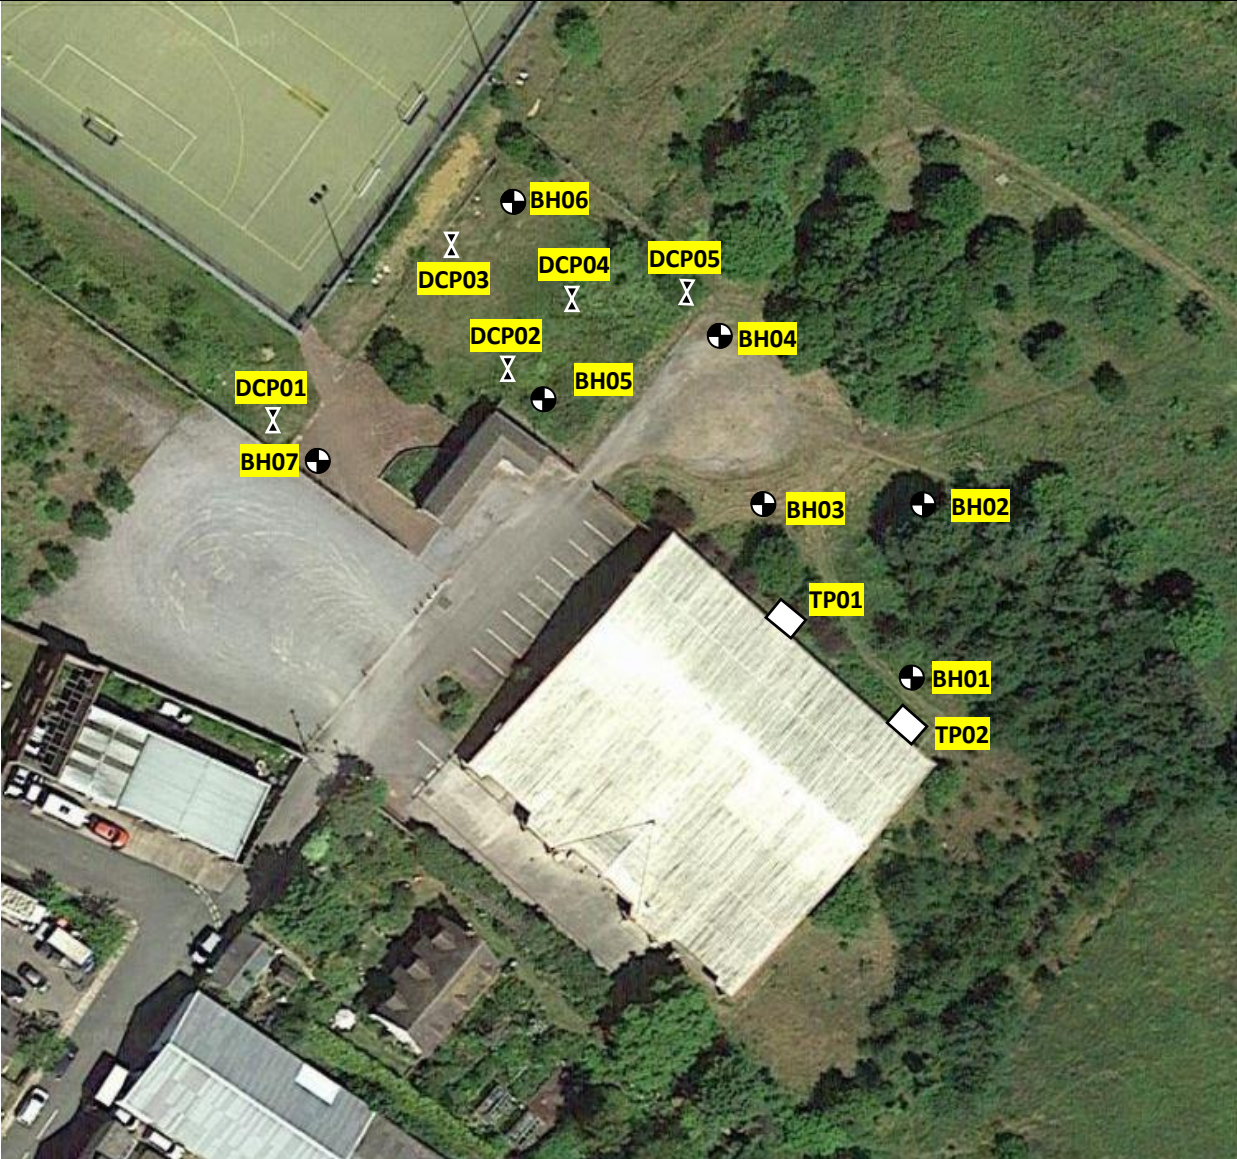
Key:

BH01 – Windowless Sampling Borehole

TP01 – Manually Excavated Foundation Trial Pit

The borehole, trial pit and DCP positions can be seen on the investigation location plan attached in Appendix II. Detailed descriptions of the strata encountered during the investigation works are presented on the borehole and trial pit record sheets attached in Appendix II.

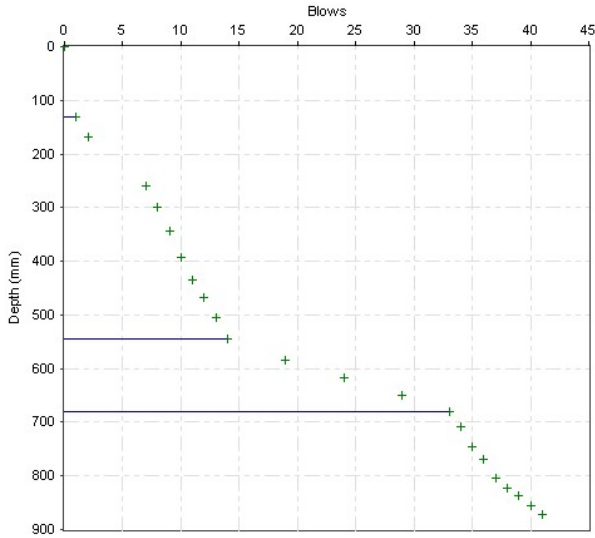
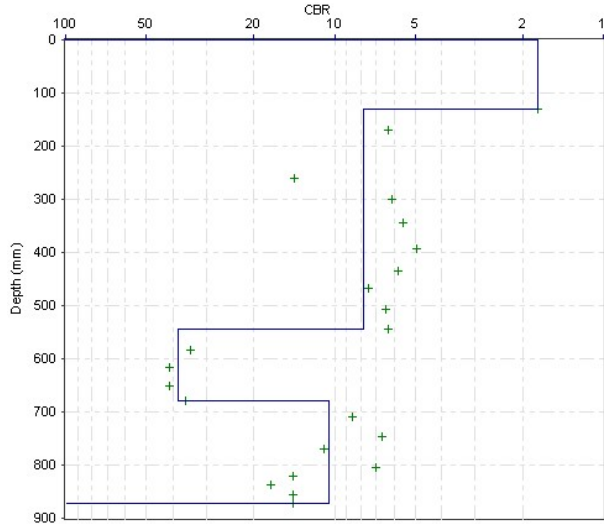
Layer Boundaries: Chainage 1.000

Layer Boundaries Chart

CBR Chart

The calculated results provided comprise penetration rates (mm / blow) & CBR values (%), and the DCP test results, including a graphical representation, can be seen within the DCP test reports attached in Appendix II.

The results have identified, where new hardstanding surfacing is to be constructed and where the initial ground deposits are used as an undisturbed subgrade (in their present condition) a typical equivalent CBR design value of 5% can be adopted for design purposes for the deposits present below 0.45m, although loose spots may be present due to the nature of the soil ground. The achievable CBR values for the area investigated should improve under compaction and therefore higher CBR values may be attainable.

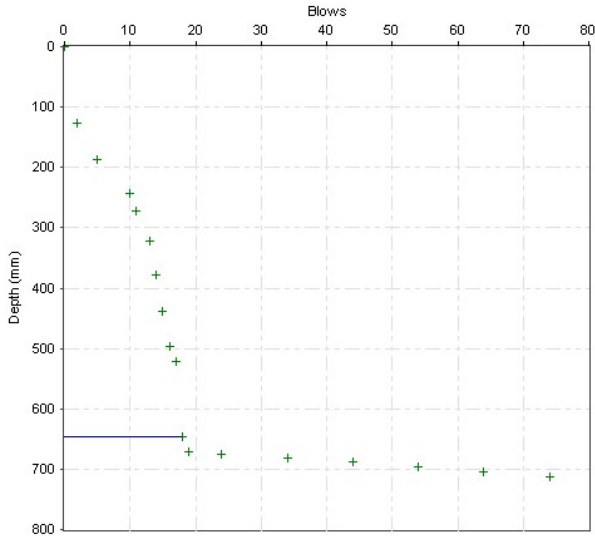
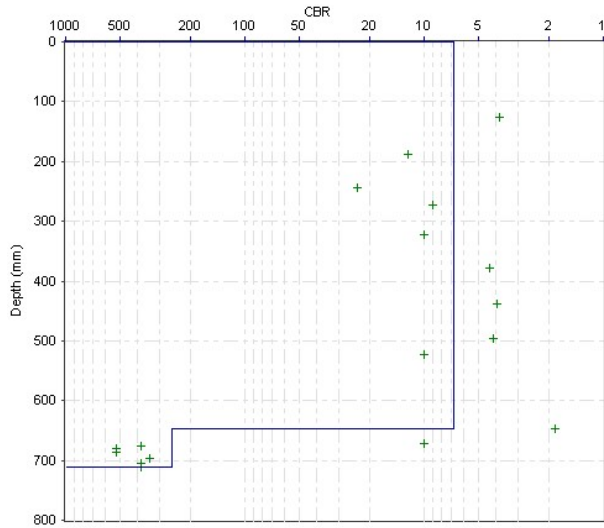
Layer Boundaries: Chainage 2.000

Layer Boundaries Chart

CBR Chart

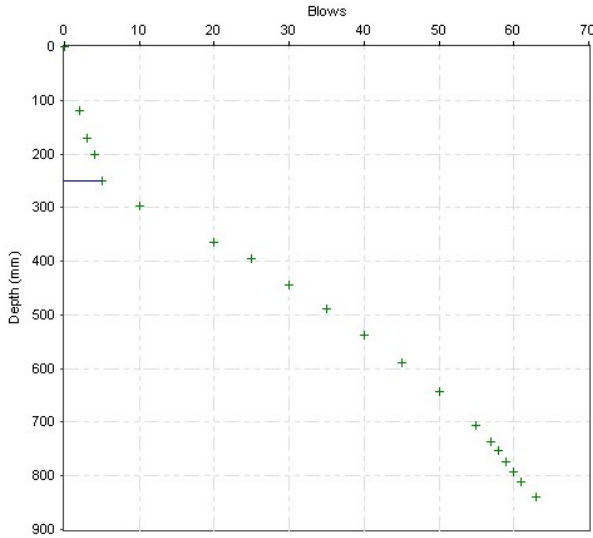
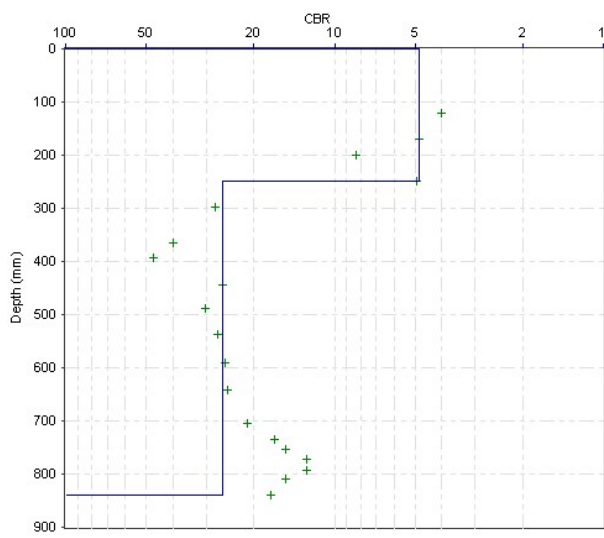
Layer Boundaries: Chainage 3.000

Layer Boundaries Chart

CBR Chart

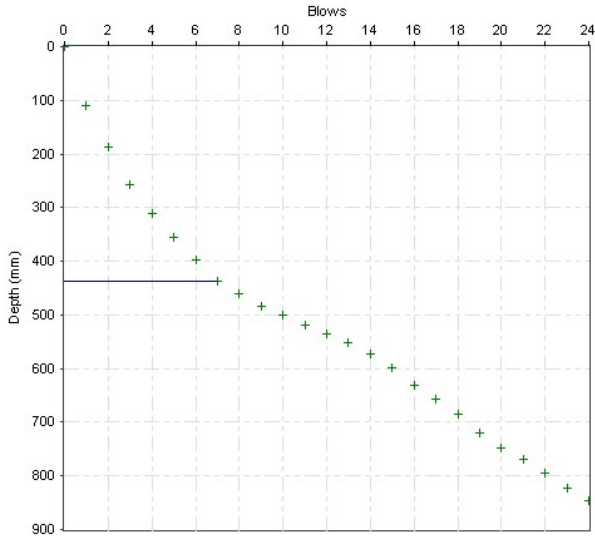
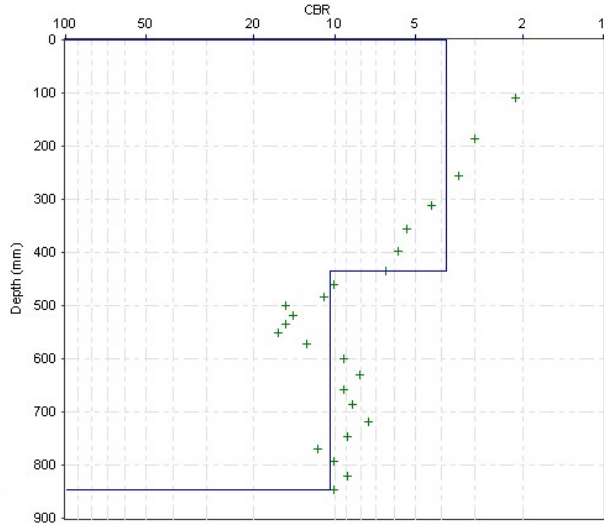
Layer Boundaries: Chainage 4.000

Layer Boundaries Chart

CBR Chart

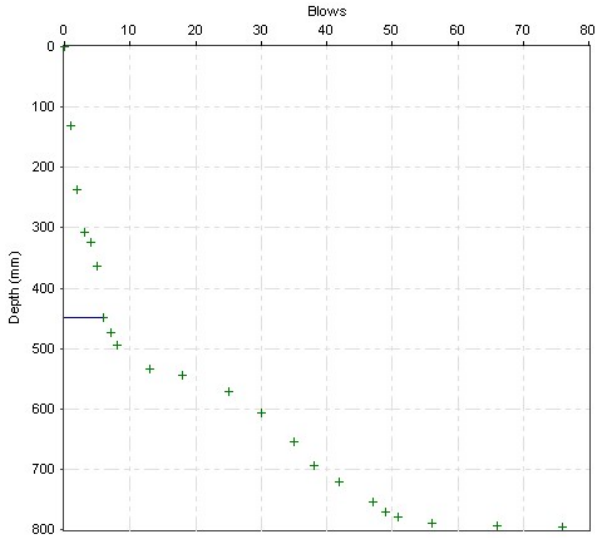
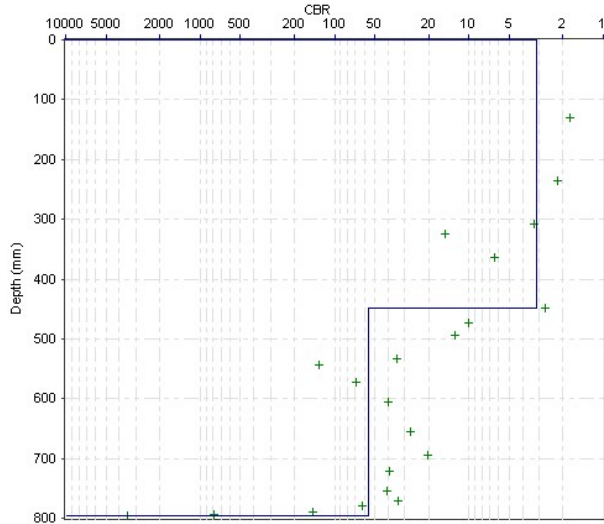
Layer Boundaries: Chainage 5.000

Layer Boundaries Chart

CBR Chart

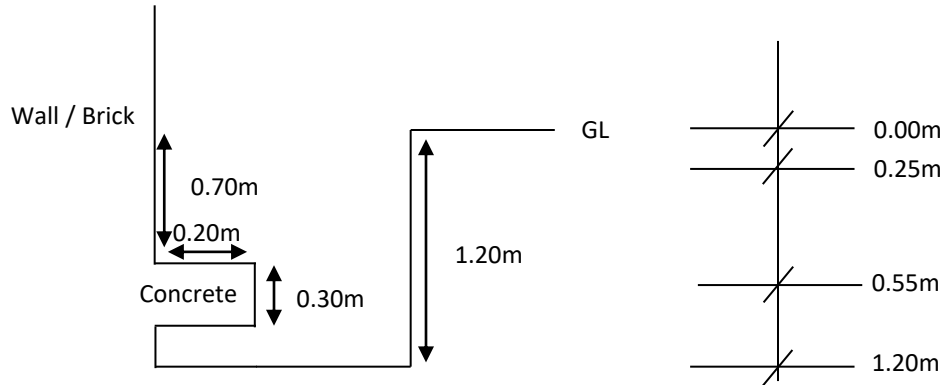
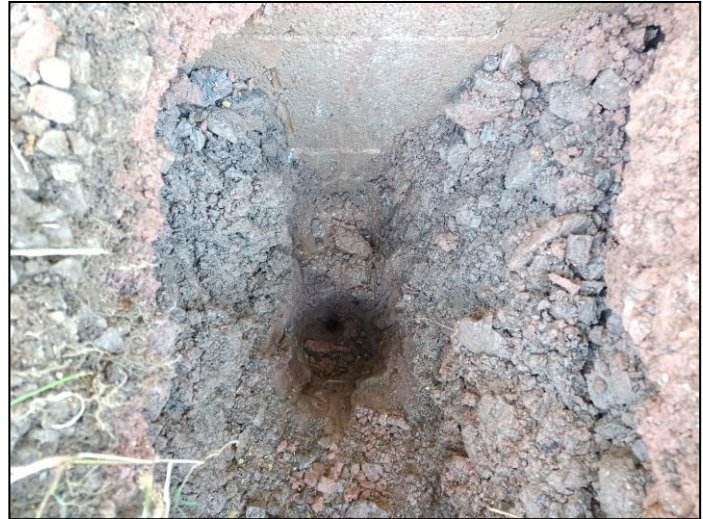
FOUNDATION DETAIL SHEET – TP01

Trial Pit Cross Section (TP01)

Trial Pit Strata (TP01)

Trial pit noted to be wet at 1.10m.

Trial pit stable.

Trial pit location	Foundation details
TP01	The existing building wall extended to a depth of 0.70m below current ground levels, where a concrete footing was encountered. The concrete was noted to project out from the existing building wall by 0.20m and was noted to be 0.30m in thickness and based within the natural stiff clay deposits
TP02	The existing building wall extended to a depth of 0.80m below current ground levels, where a concrete footing was encountered. The concrete footing was noted to project out from the existing building wall 1.60m and was noted to be 0.30m in thickness and based within the natural stiff clay deposits

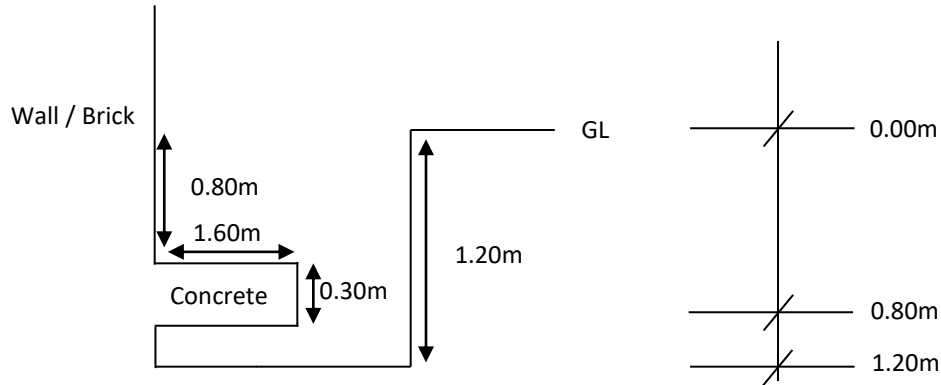
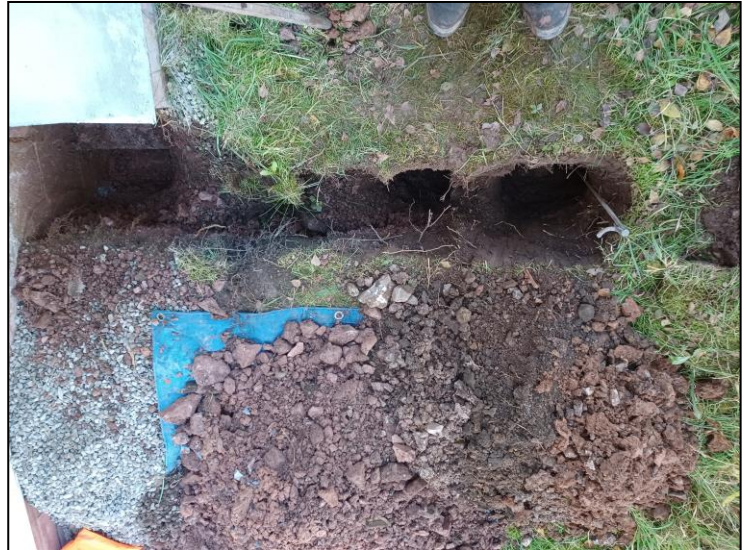
**Trial Pit Cross
Section (TP02)**

Trial Pit Strata (TP02)

Trial pit terminated at a depth of 1.20m.

Trial pit noted to be dry and stable.
