BAT SURVEY AT

Hakodadi, Arlecdon, CA26 3UW

Author	Amy Cooke	Date	24/01/2025
Checked by	Andrew Gardner	Date	24/01/2025
Report Version	1		
Field data entered	<input type="checkbox"/>		
Report Reference	9589

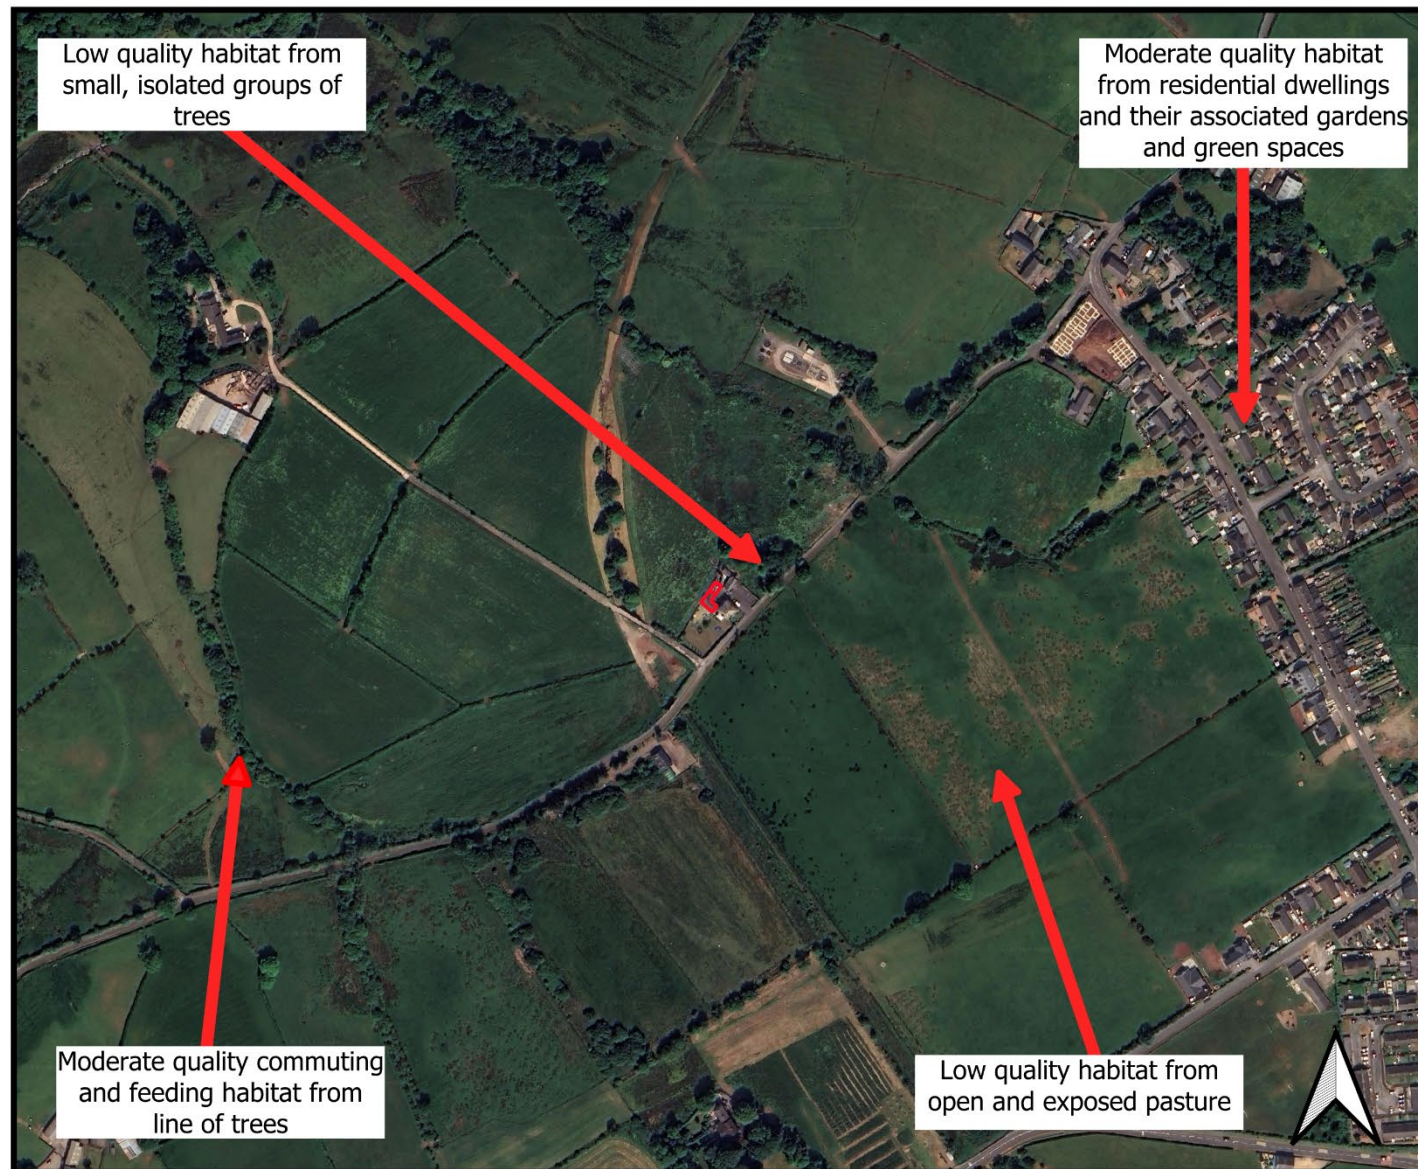
Figure 5
Habitat Adjacent
Site

The habitat at and adjacent to the site was assessed from satellite imagery this was then ground truthed, Figure 5.

The habitat on and adjacent to the site identified from satellite images was ground truthed. Details of the habitats found on and adjacent to the site are detailed in Figure 5.

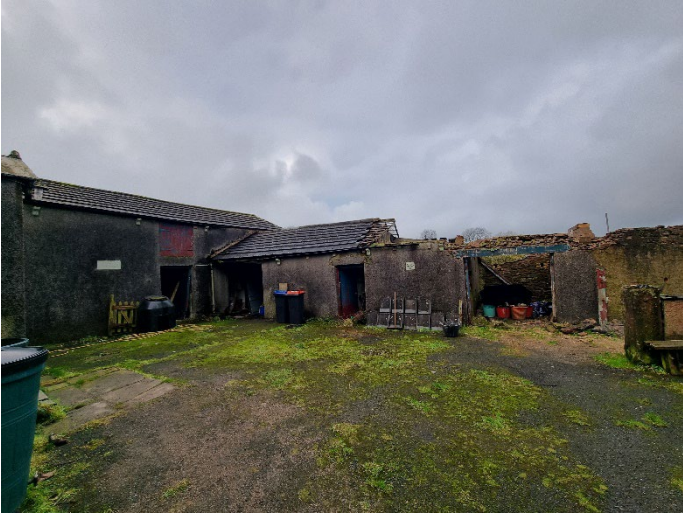
<p>The buildings are attached and situated in an exposed location.</p>

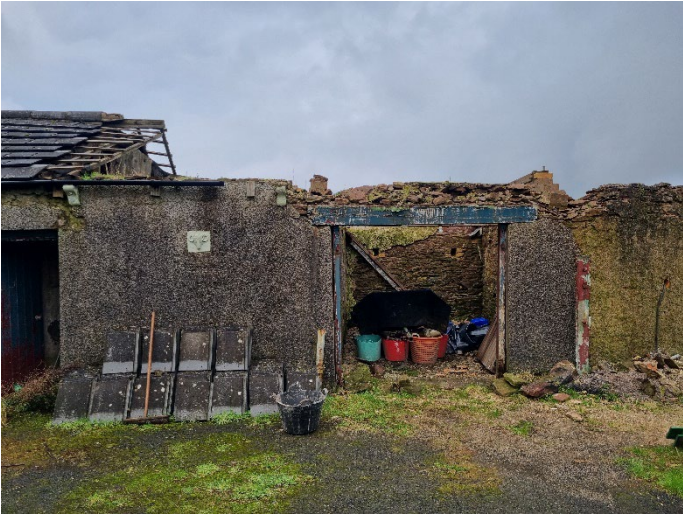
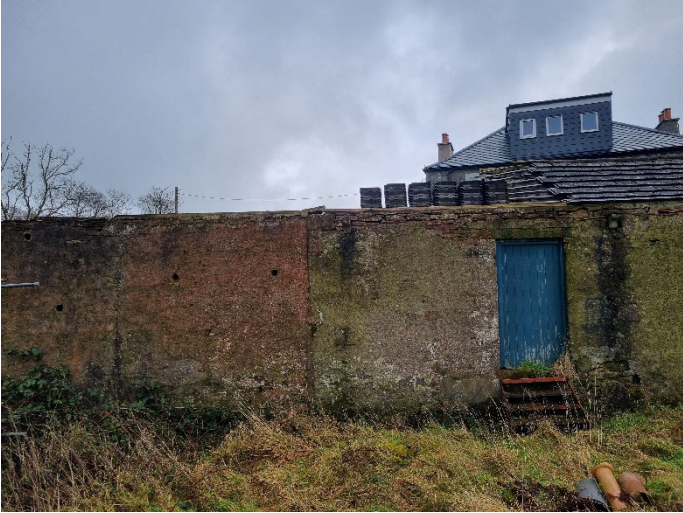
<p>Building 1</p> <p>The roof is missing.</p> <p>The rendering over the external walls is in moderate condition, with some areas missing and exposing the stone underneath.</p>

The walls of the building are made from natural stone and are rendered. The rendering to the South-east elevation is in good condition with no gaps or cracks. To the North-west, the render is missing to the top of the wall, exposing the stone underneath. There are gaps between the exposed stones where the rendering is missing. However, these are very open and exposed, and no indications of use by bats could be found, such as droppings externally below the gaps.

There are no soffits or eaves boards, and the roof is completely missing.

To summarise the building is small in size and the external walls are in moderate condition with some gaps and cracks, but exposed due to the missing roof. The roof is missing, and the internal

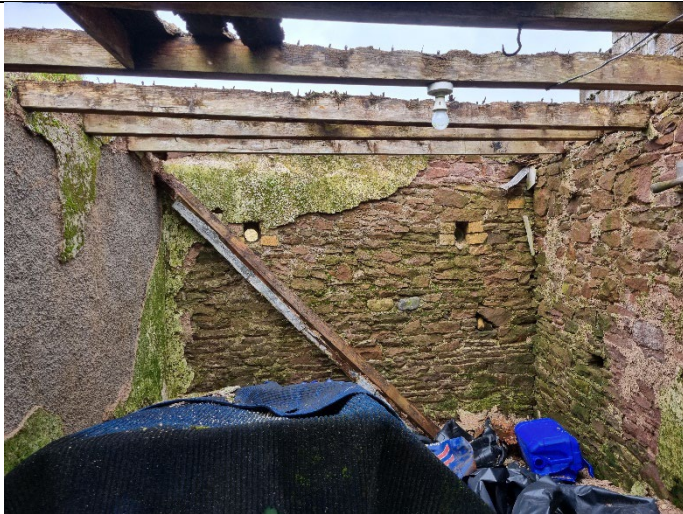
The internal walls of building 1 are partially rendered. No indications of use by bats could be found.

The internal walls of the barn are available to roosting by bats as the roof is completely missing, exposing the internal structure. The render is largely missing over the internal walls, and there are some gaps between the exposed stones and the bottom of the broken render. No indications of use by bats could be found, such as droppings on the walls.

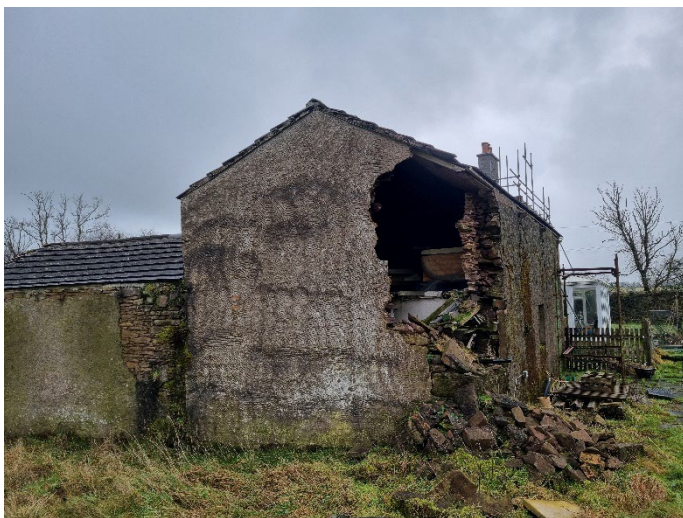
Building 2

There is a large gap in the corner of building 2 where the wall has collapsed.

The roof is in generally good condition with no raised slates.

The rendering is in generally good condition, but is missing in some areas.

The walls of the building are rendered and in generally moderate condition; however, a large area of the Western corner of the building has collapsed, providing direct access inside.

The roof of the building is made from concrete tiles and is lined. There were no raised slates on any of the roof pitches, and it was noted that the South-western roof pitch had two Velux windows installed; these contribute towards the brightness of the internal space, making it unfavourable to bats. The roof is partially covered in moss, suggesting the tiles are damp and undisturbed.

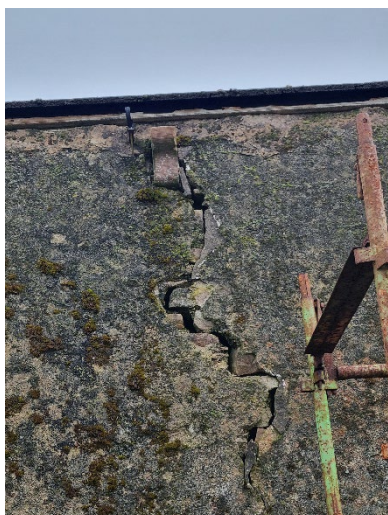
The deep structural cracks were assessed, and showed no indications of use by bats.

As well as this, there are several deep structural cracks in the stonework to the South-west of the building, one of which may offer opportunity for roosting by bats. These were assessed from the ground using binoculars and a 1,000,000-candle power torch. Indications of use of the cracks, such as droppings on the external walls below, were searched for, but none could be found.

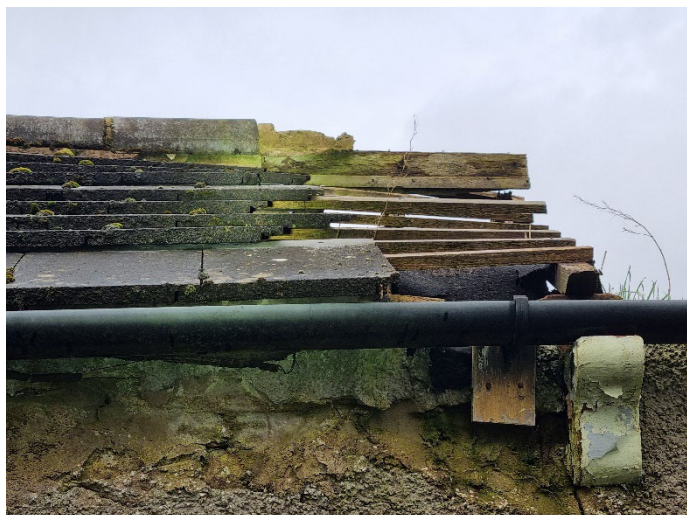
A gap under the ridge-tile where the roof of attached building 1 has collapsed. This was judged to be too open and exposed to be favourable to bats.

The ridgelines appeared well-sealed, except at the North-east gable end where the building connects to building 1, and the roof is partially collapsed. Here, there is a gap under the end ridgeline tile, which was judged to be too open and exposed to be favourable to roosting bats, and when assessed from the ground with binoculars and a 1,000,000-candle power torch, no indications of use by bats could be found.

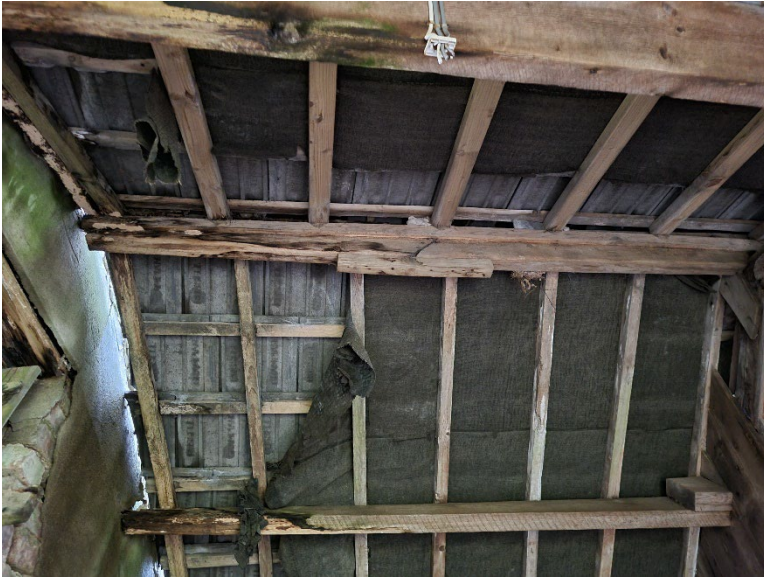
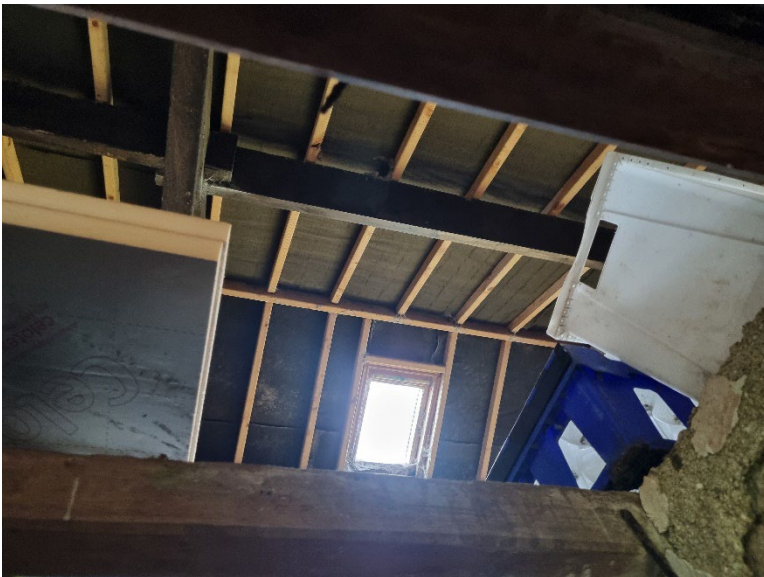
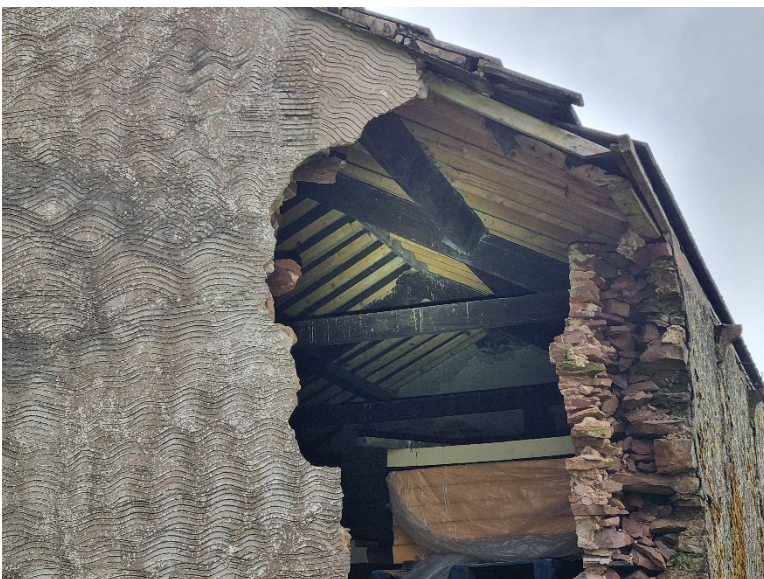
The internal lining is in generally good condition, but is missing in some areas. Despite this, no indications of use on the internal building by bats could be found.

The internal walls of the barn are available to roosting bats as there are no doors or windows, and there is a large corner of the building missing which provides direct access into the internal space. However, despite this, no indications of use of the building by bats could be found. It is judged that because of the large gaps providing direct access into the building, the internal space is too draughty and cold to be favourable to roosting bats.

The timber beams in the roof were found to be in excellent condition with no rot, splits or gaps suitable for roosting or hibernating bats. The underside of the roof is exposed due to the gaps in the walls, and as such is cold and draughty, making it unfavourable to roosting bats. The collapsed corner of the building, and the presence of the Velux roof lights make the internal space light and bright, and further unfavourable to roosting bats. The lining is in generally good condition, and in one area of the building looks new. No indications of use by bats could be found.
