# Bat Survey

## 'Hawkrigg', Holmrook

8<sup>th</sup> June 2023

Report No. 0623/6

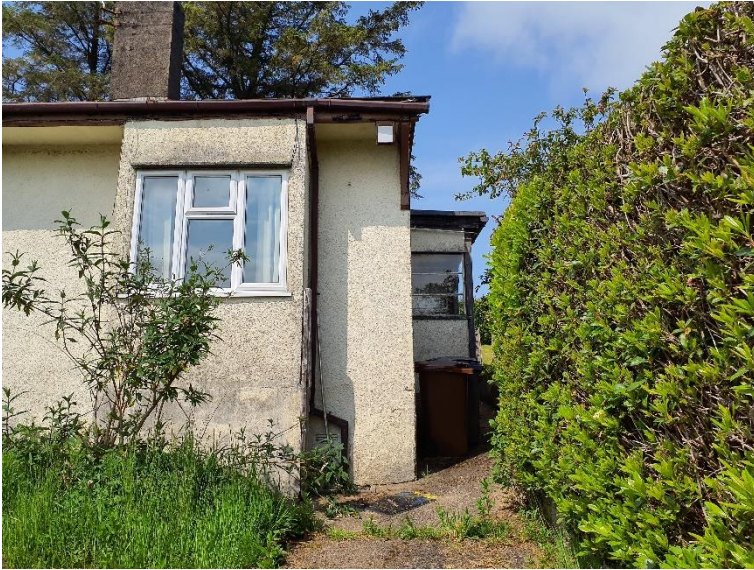
**Image 1.** Front (East) and side (north) elevation of property.

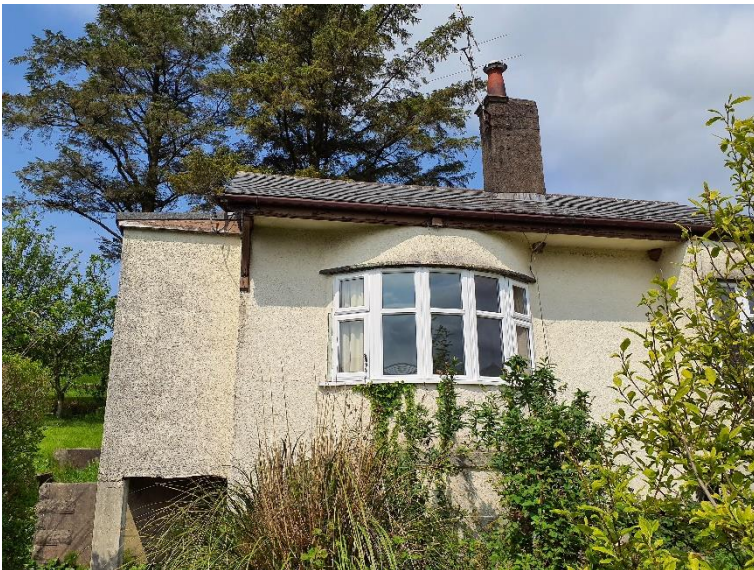
**Image 2.** Front elevation showing the well sealed wall tops and composite slate roof.

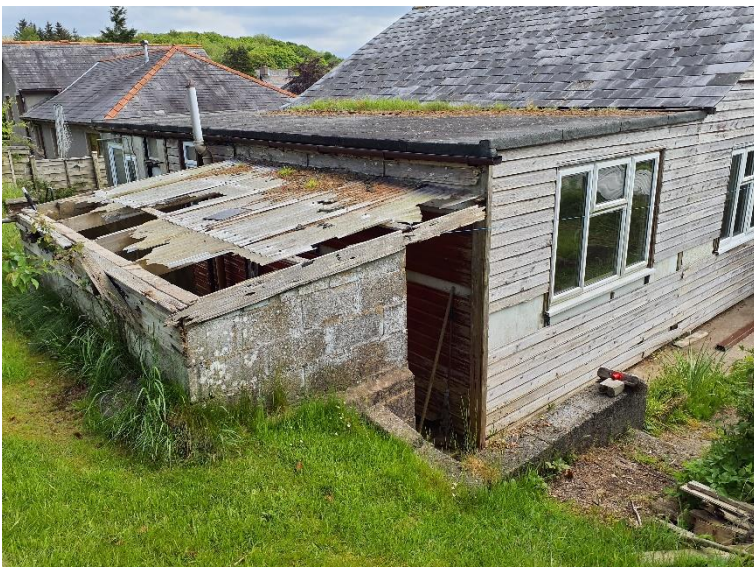
There is a block-built lean-to at the rear of the house (west elevation). The roof is covered by corrugated plastic sheets, but these are partially degraded and the area is not weatherproof.

**Image 3.** Rear flat roof area and partially collapsed roof of lean-to.

No gaps in slates or wood panelling.

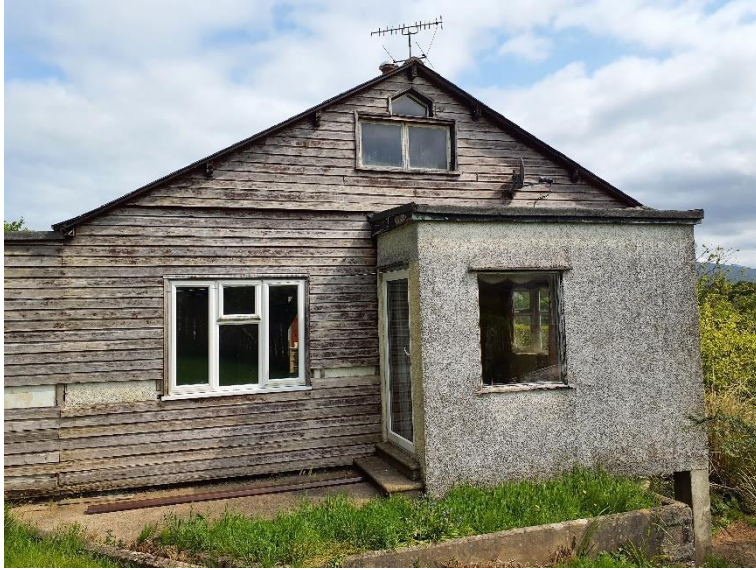
Windows and doors are mostly made of PVC and frames are well sealed. The external walls are very well sealed, with no gaps at the wall tops. One small gap was noted in the south-west corner where the wood had rotted (and it was being collected by bees for use in nest construction).

**Image 4.**  
South elevation with wood panelling and small flat roof porch.

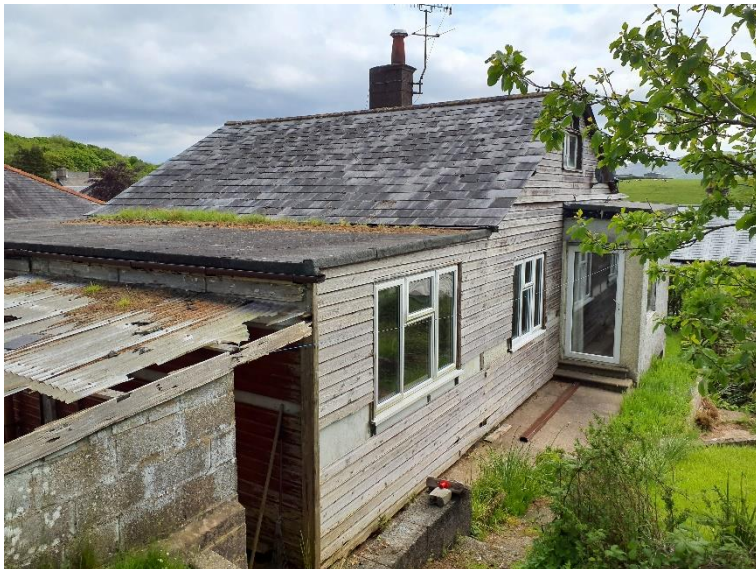
There are no gaps between slates or ridge slates, they are very tightly aligned.

**Image 5.**  
Showing the flat roof and western pitch of the main roof.  
No gaps between slates- all very tight fitted.

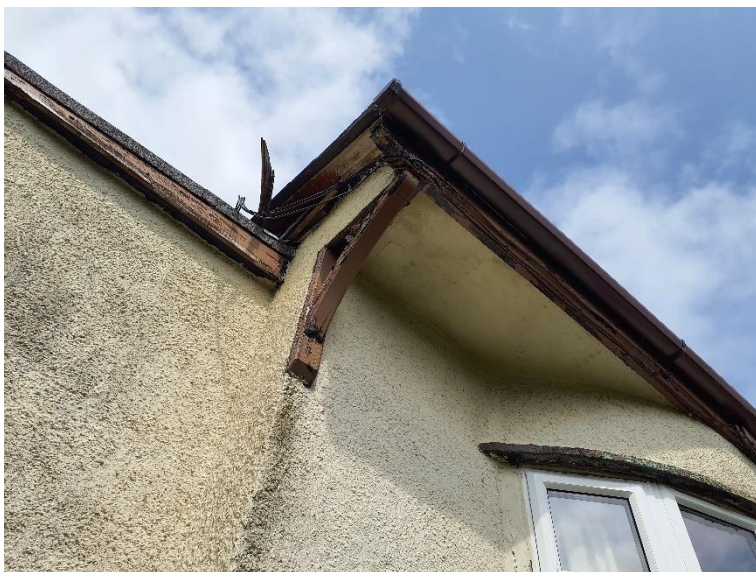
**Image 6.**  
No gaps at the wall tops.

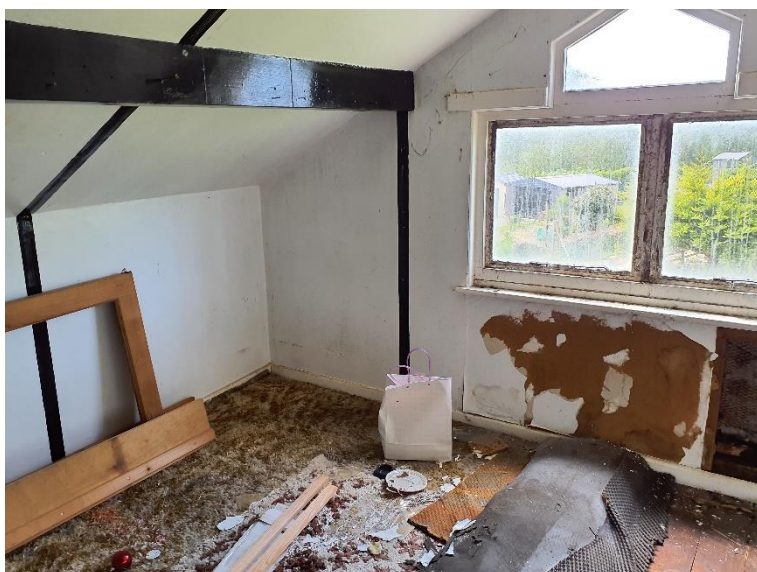
The roof is pitched and covered by composite slates, with a flat roofed area to the rear (covered by roofing felt). Underneath the slates is wood panelling, which has been boarded over on the southern elevation where the half of the loft void has been opened up into the living space (vaulted ceiling). The remaining roof void is well sealed, with no potential access routes identified.

**Image 7.**  
Interior, looking south, showing boarded underside to the roof.

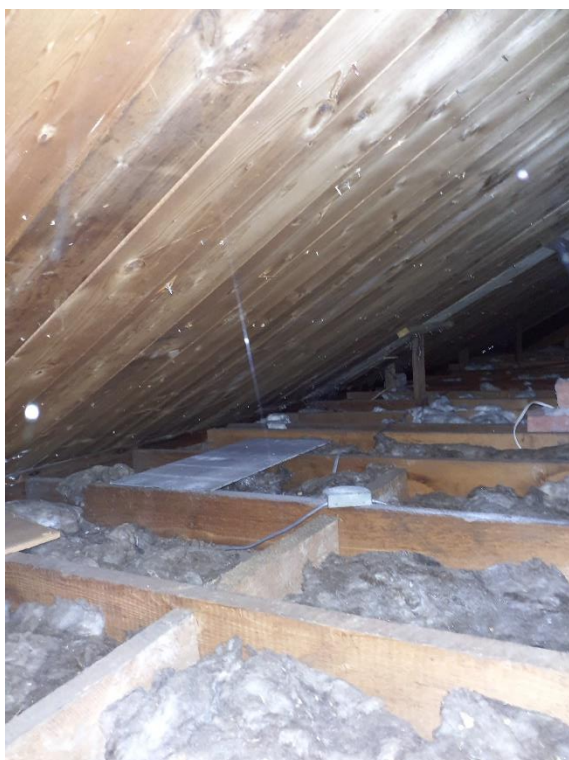
**Image 8.**  
Interior of the roof space on the northern half of the dwelling.

No daylight or gaps seen in the wood panelling under the slates.
