**Hensingham House, Whitehaven,
Phase 3 Development**

Phase 1 Desk Study

Thomas Milburn (Property) Limited

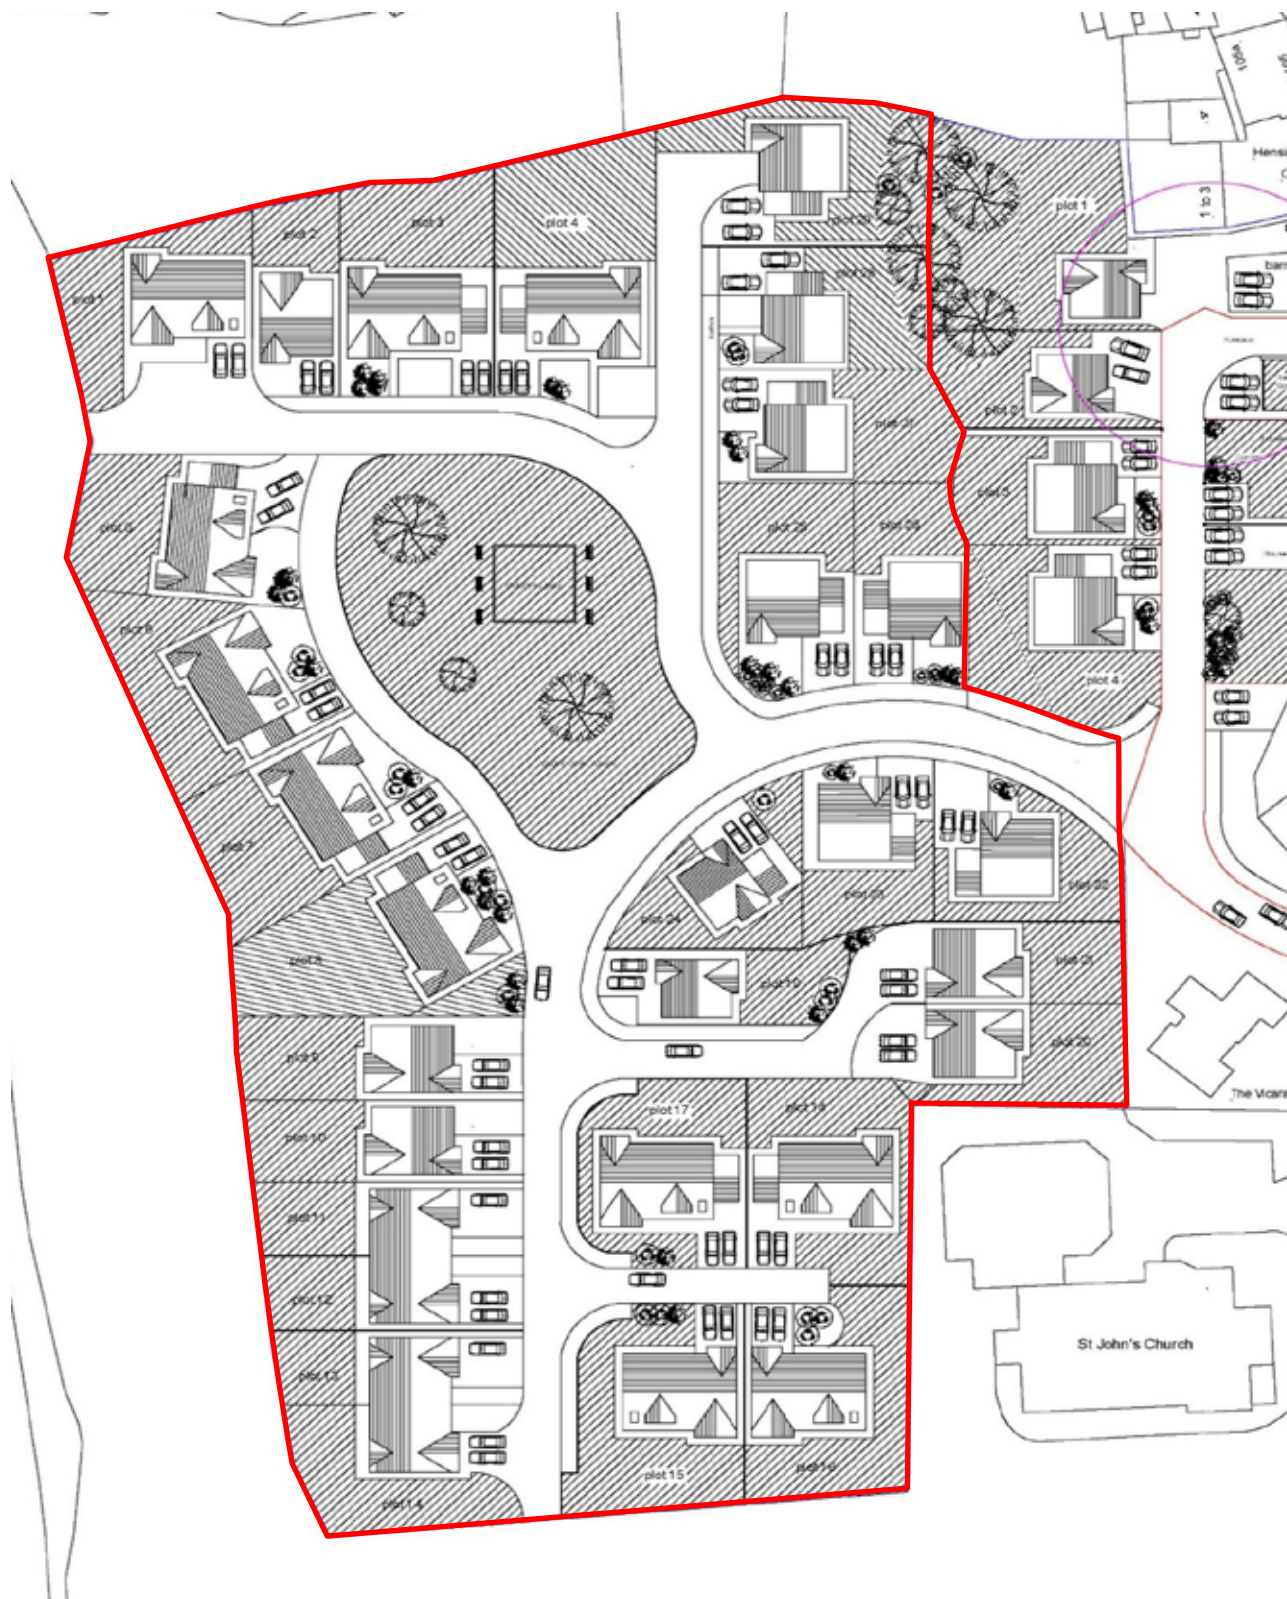
- 3.1.1 The current development plan provided by the Architect for all three phases of development is included in Appendix A. An extract from this plan is given in Figure 3 to illustrate the

proposals for Phase 3, which shows 29 dwellings with associated hardstandings and garden areas, access roads and an area of public open space with children's play area.

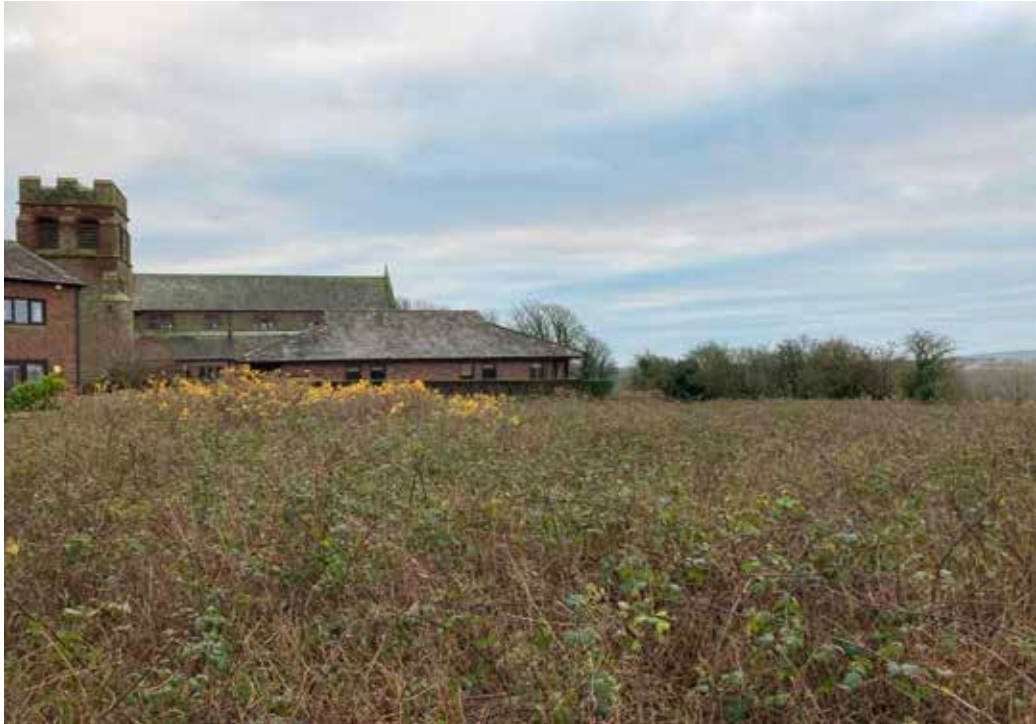
Photo 1: View looking south towards St John's Church along eastern boundary of site.

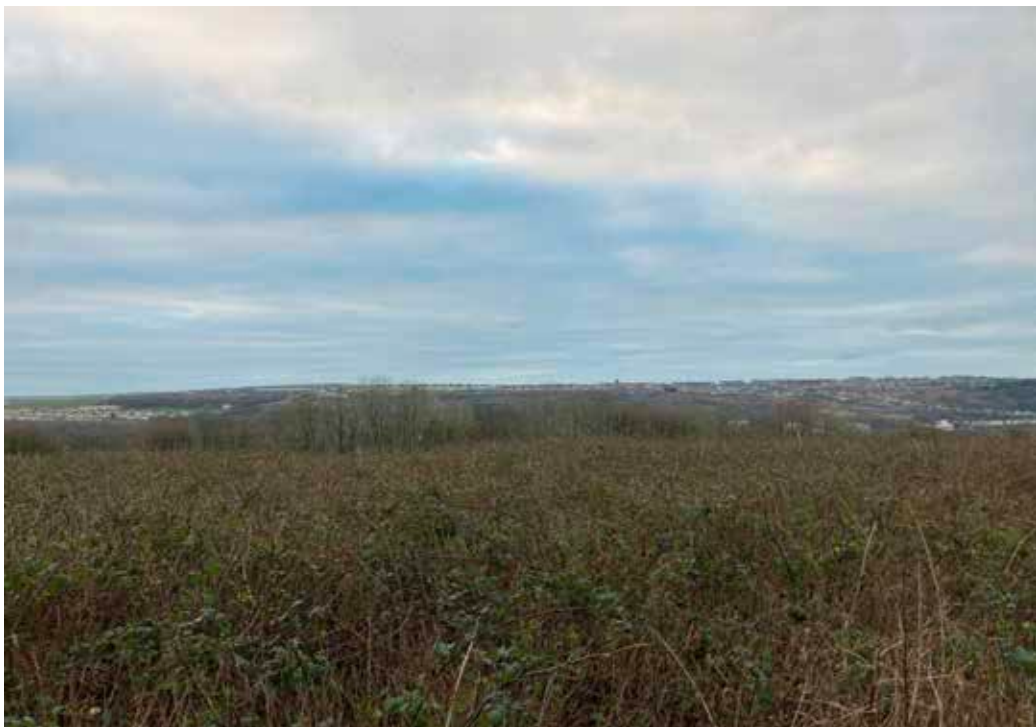
Photo 2: View looking westwards across site. Trees in middle distance border the bypass just beyond western site boundary.

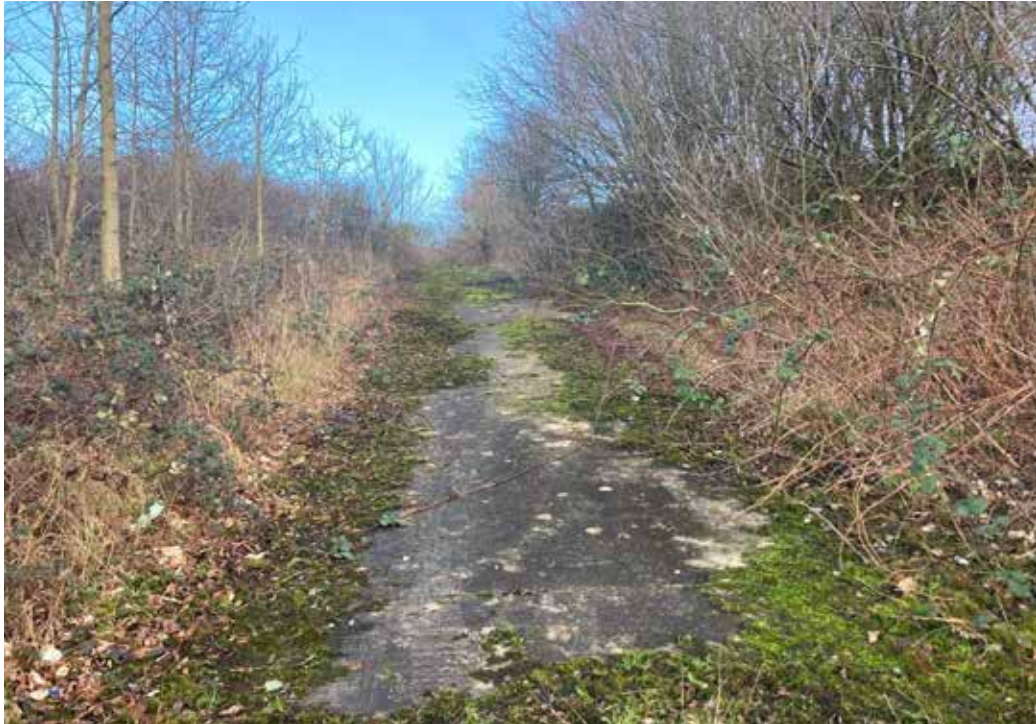
Photo 3: View looking up concrete access track from bypass towards north-west corner of site.

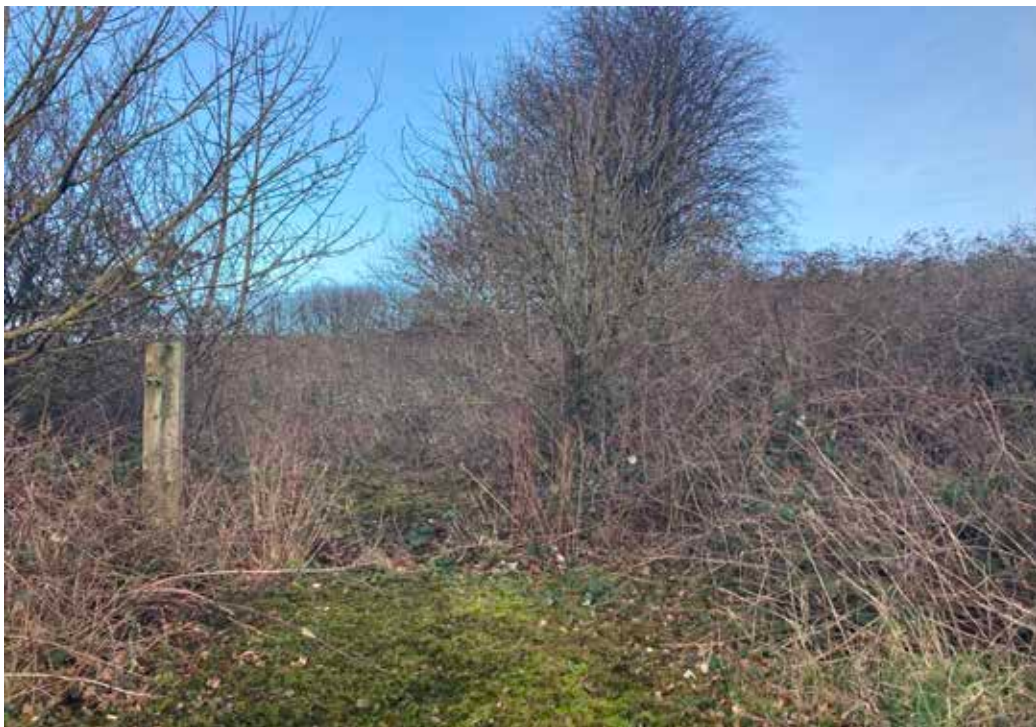
- 2.2.4 Access to the site is limited to a concrete track from the A595 which leads to the north-west corner of the site. A dense thicket of brambles prevented access into the field from the access track and from the Phase 2 development area on the east side of the site. Illustrative photographs are included in Figures 4 and 5.

Photo 4: Thicket of brambles preventing access onto site from track at north-west corner.

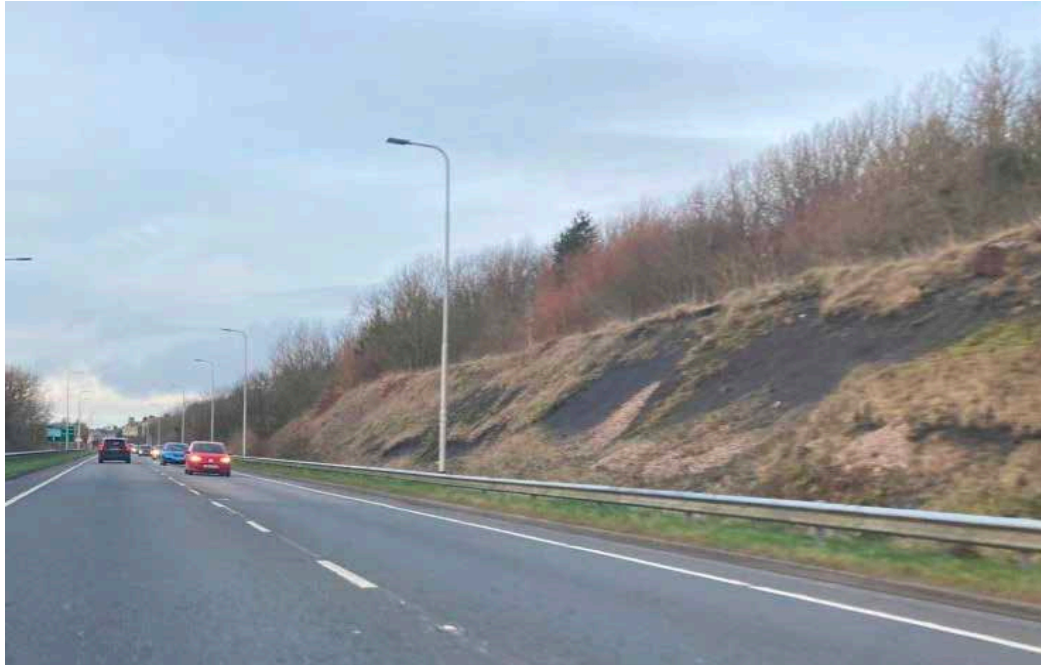
- 2.2.5 Historical maps (see section 5.1) show that the western site boundary was formed with the construction of the Hensingham Bypass in the 1980s. The site boundary is about 45 m from the centreline of the bypass, which is a single carriageway road. Between the site boundary and the road there is a wooded slope, approximately 25 m wide, and a steep cutting slope adjacent to the highway (see photograph, Figure 6). The cutting is estimated to be some 5 m high and cut in to rocks of the Hensingham Formation at an angle of 45°.

Photo 5: Cutting slope on Hensingham Bypass to west of site.
