# HERITAGE STATEMENT

**Former Whittles Store  
6-8 Duke Street  
Whitehaven**

**Energy Coast West Cumbria (Properties) Ltd**

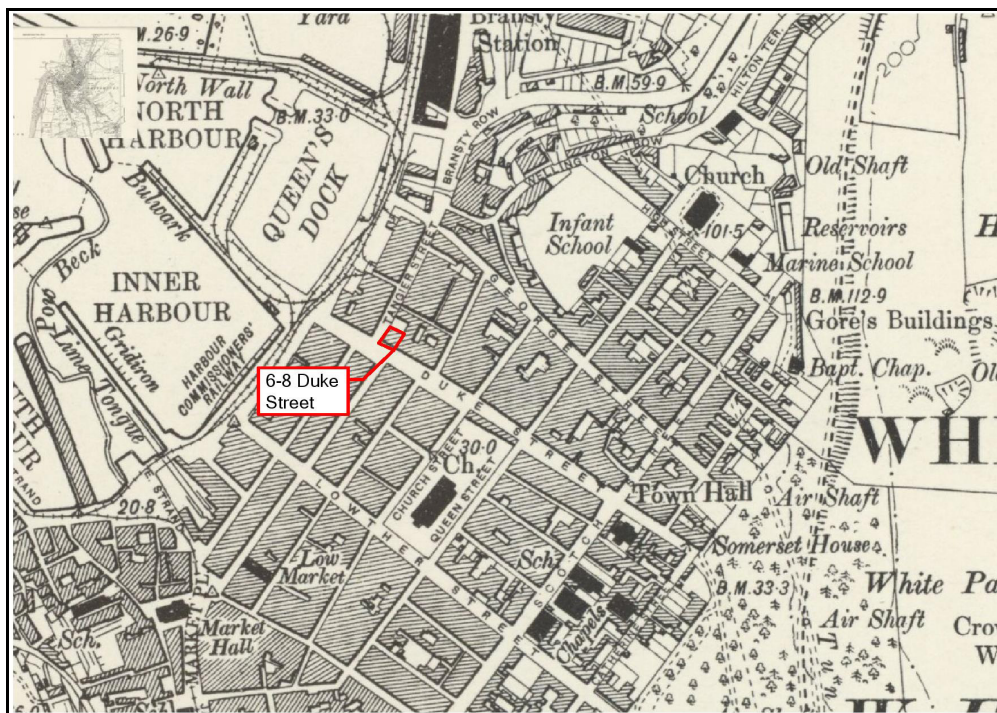
1. Extract from Ordnance Survey Map of 1900

By the date of the Ordnance Survey Map in 1900 (Plate 1), the site was fully developed as seen today. In 1889 number 6 Duke Street is recorded as Davis's Chusan Tea Warehouse, as evidenced in Plate 2. Immediately after that date the property appears to have undergone a significant change in character when the Italianate-style stucco modifications were carried out to the Duke Street and Tangier Street elevations (see plate 3).

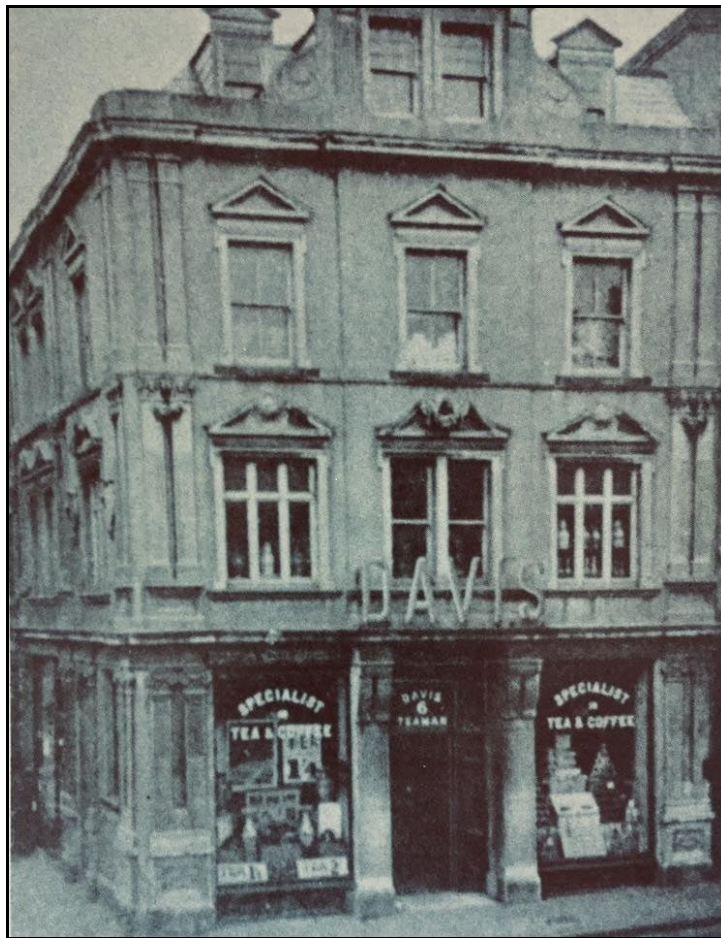
3. J Davis Tea and Coffee Shop from late 1889

This simple presentation from the late Georgian/early Victorian period was significantly altered in 1889 when the parapets were removed and the fenestration re-arranged to three bays at first and second floor levels; symmetry was achieved with three door and glazed openings at ground floor level. The Italianate stucco ornamentation was incorporated at this time with a hierarchy of split scrolled pediments and simple pediments at higher level, string courses and cornice immediately above shop level. The ornate dormer on the front elevation was added at this time. A distinct hierarchy in the treatment of window openings was introduced with mullion and transom windows at first floor level and 2-over-2 sash windows with horns above. Several of the mullion and transom windows remain.

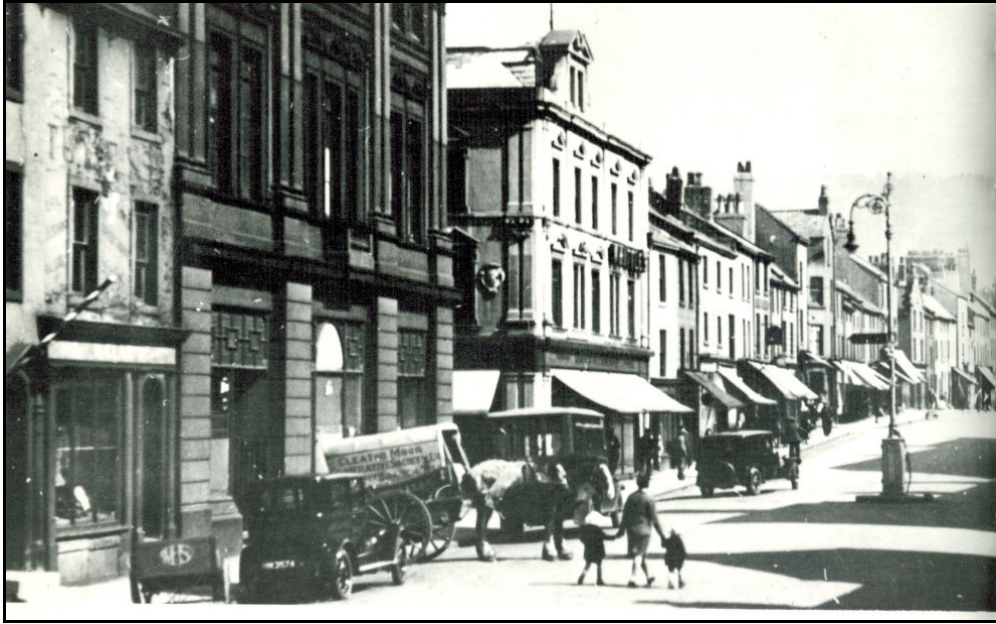
4. By 1920 the building is in the ownership of John Whittle & Son and has been extended onto the adjoining site to the right, probably around 1909

This first phase was followed with a further phase of alteration around 1909 when the adjoining building was demolished and extended into. Photographic evidence from 1920 (Plate 4) shows the later phase of development with signage to the front elevation entitled "Whittles", indicating that there was a change of ownership from J Davis before that date.

The next phase of development around 1909 appears to have instigated significant structural alteration to the building when the floorplan was extended into the adjoining building. Some elements of the fenestration were repeated with simple pediments but internally it appears that many cross-walls were removed at this time and the steel frame structure now evident was inserted. The incorporation of the gated lift and adjoining stair are in typical 1920's style and align with this phase of alteration.

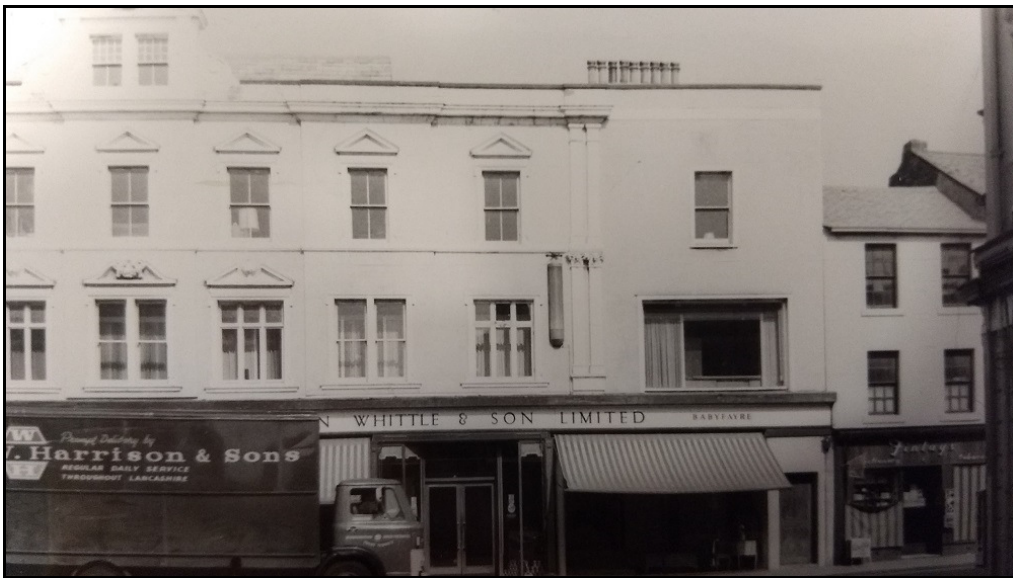
5. Around the 1960's the property was extended further to the right and presented in part the simplified appearance of the period

A third phase of development appears to have occurred in the early 1960s when 8 Duke Street was assimilated into the floor plan, creating additional floor space and the fire escape stair now evident along the right-hand party wall (see Plate 5).

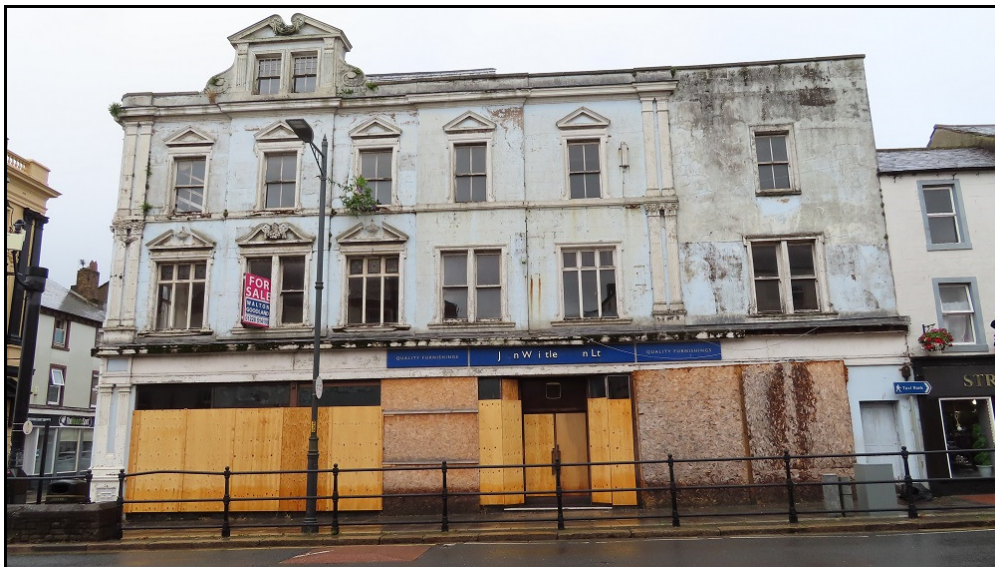
6. The elevation onto Duke Street showing the three phases of development from 1889 to mid 1960's

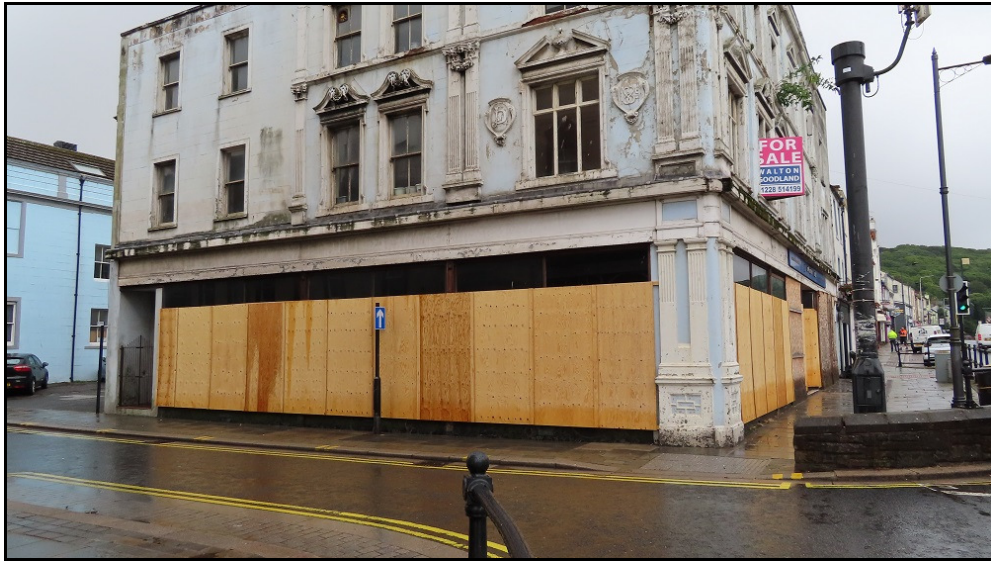
7. The Tangiers Street elevation dating from 1889 to 1909

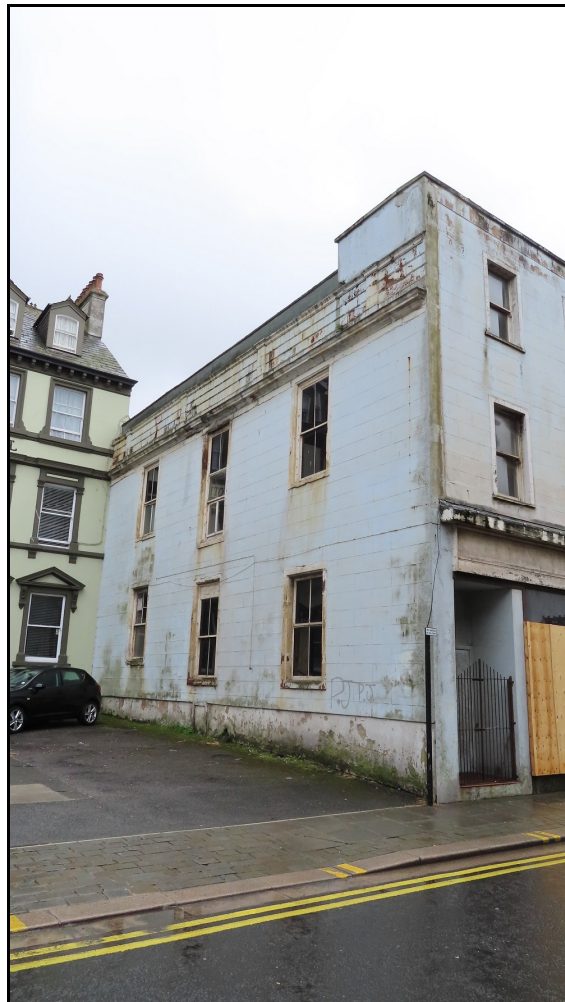
8. The view of the rear of the building from Tangiers Street with the Waverley Hotel adjoining

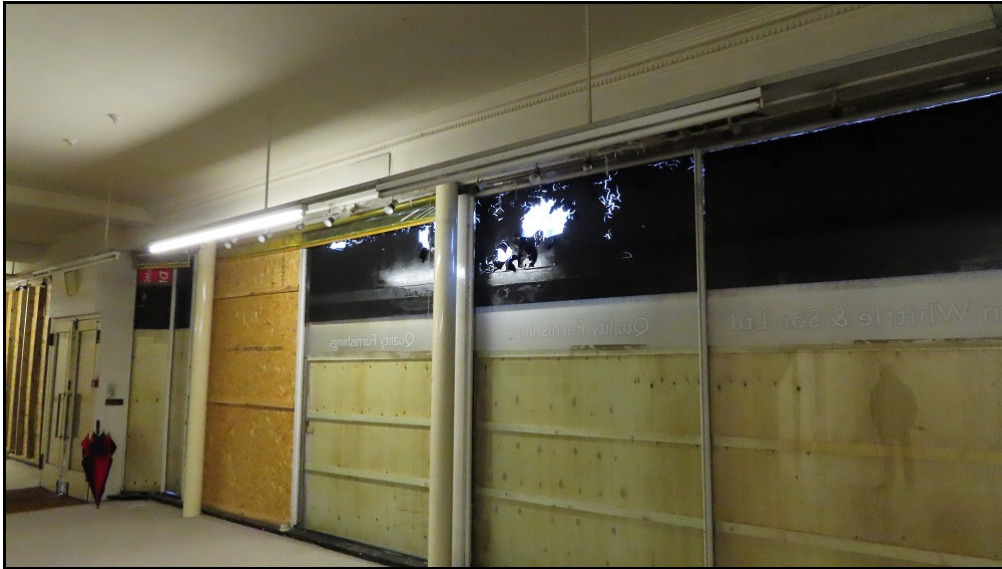
9. The steel columns that support the shop frontage date from the early 1900's and will be retained

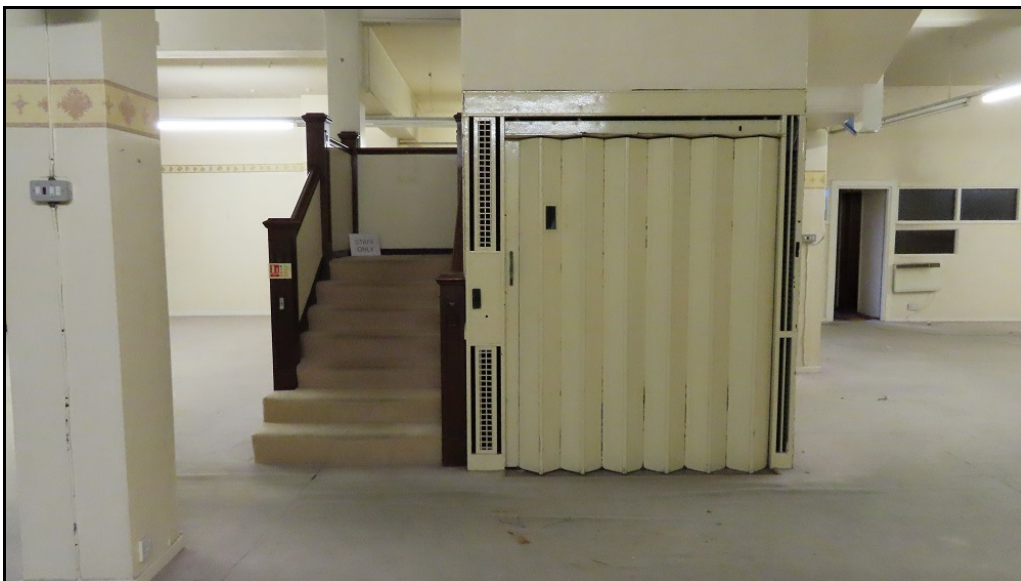
10. The gated lift and adjoining stair date from the early 1900's and will be retained

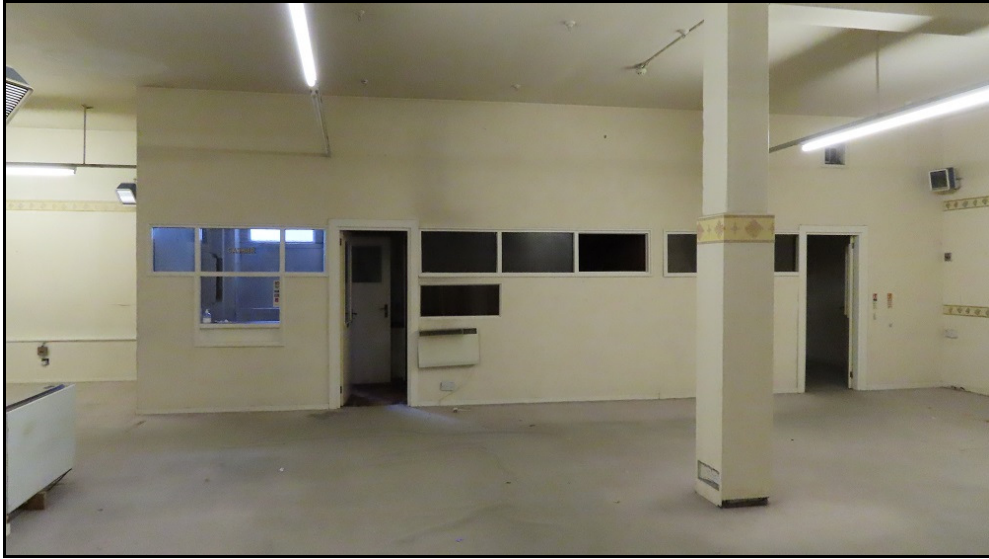
11. The internal partitions within the building hold no historic merit and will be removed

- Internally, none of the internal partitions and fabric proposed for removal hold any historic merit and date principally from the mid to late 20<sup>th</sup> century; as all the remaining features that attract significance will be retained, it can be concluded that **the proposed internal works will not harm the heritage significance of the property.**

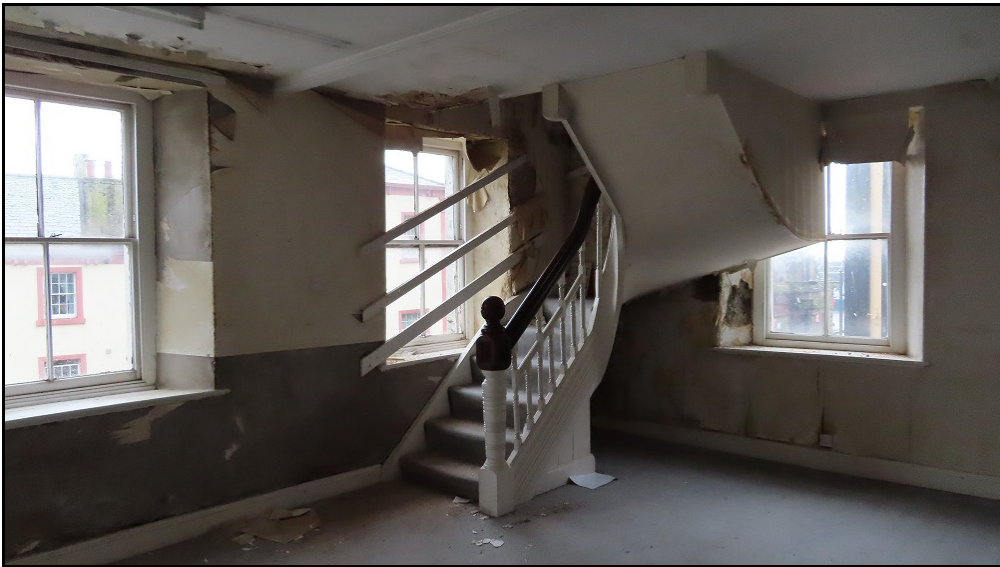
12. The surviving mid-Victorian staircase between first and second floors will be retained

As evident currently, the only remaining internal features from the earliest phase of building are an ornate plaster cornice at the front left at ground floor level and the second-floor staircase in the front left corner. By the late 1930s, when J Whittle and Son were recorded in ownership, most of the internal historic fabric appears to have been lost. However, the gated lift and adjoining stair echo the styles of the early 20<sup>th</sup> century, and thereby 'signpost' a key phase in the development of the property. The pictorial record below highlights those features that contribute to the interpretation of the building phases and can therefore be attributed with some heritage significance (see Plates 6 to 12).

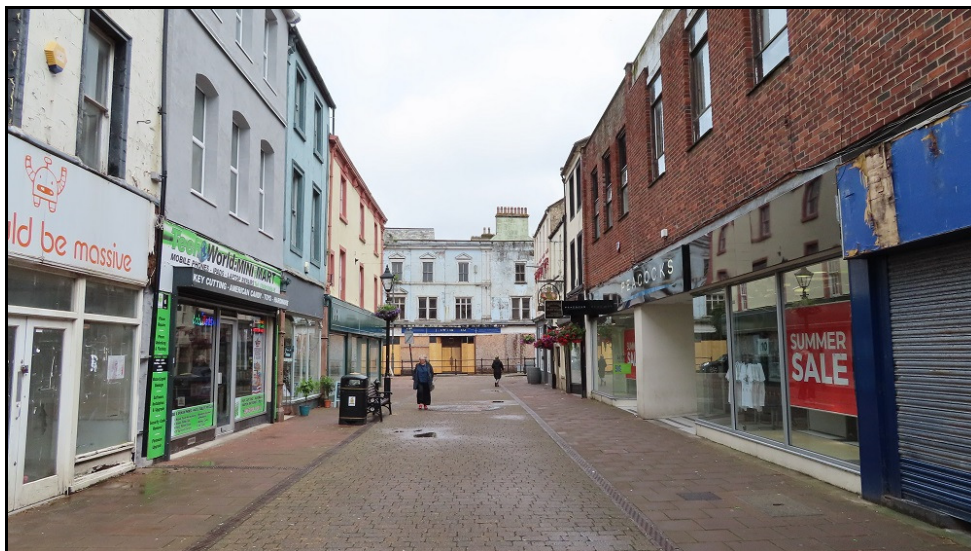
13. Whittles occupies a prominent position when viewed from King Street

The Character Appraisal identifies that 6-8 Duke Street represents one of a group of Grade II Listed Buildings around the junction of Duke Street, King Street and Tangier Street, all of which make a significant contribution to the appreciation of the Conservation Area. Indeed, the building can be appreciated from all four points of the compass as shown in the photographs below. Historic England have emphasised the group value of the property and its neighbours in the listing document, ref: NGR:NX937518318.

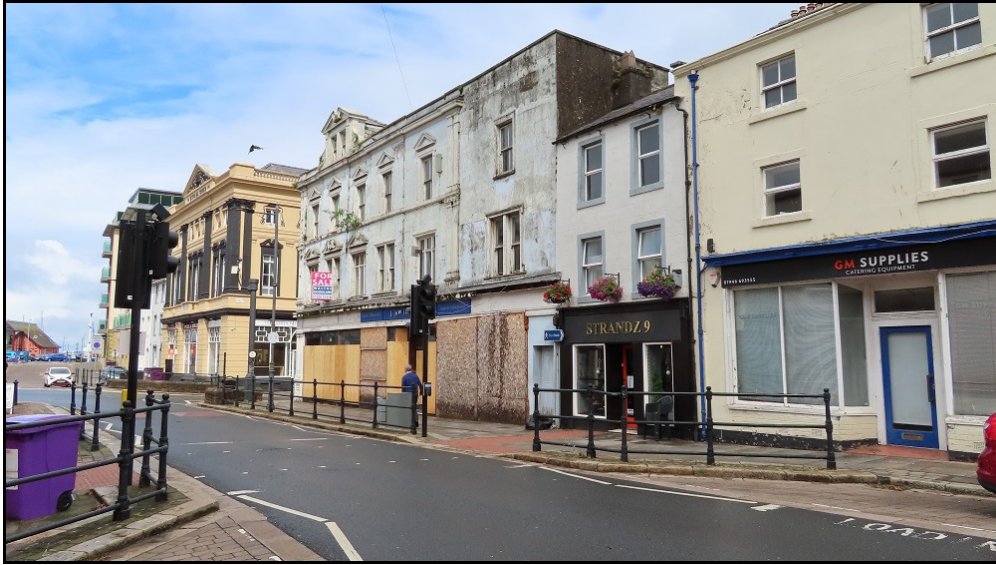
14. The view along Duke Street is recognised as one of the principal views of the Conservation Area; Whittles plays a major role in its appreciation

The Character Appraisal identifies that Duke Street provides an important vista from south east to north west, passing directly in front of the subject premises and linking the appreciation of the Conservation Area with the harbour and its historic features.

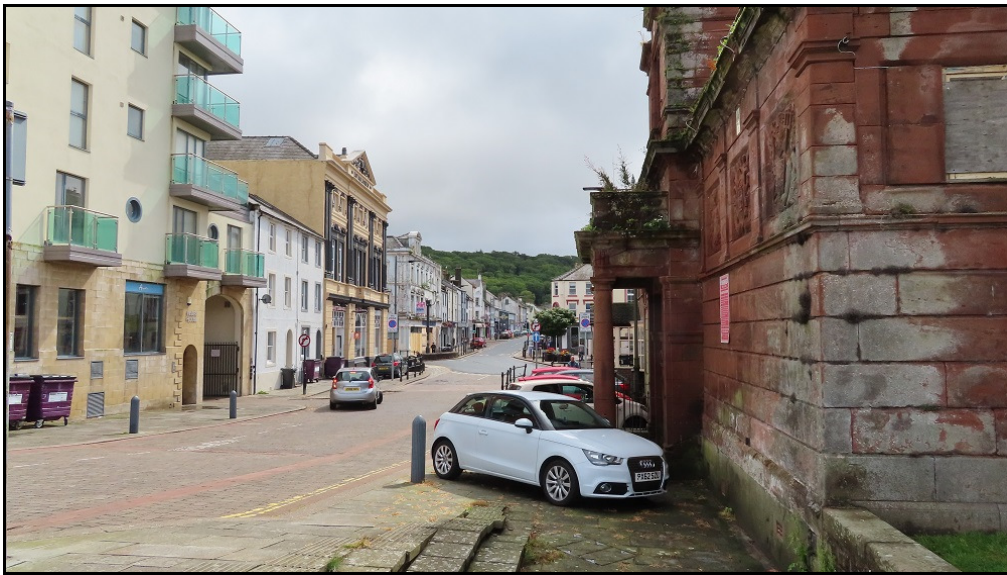
15. 6-8 Duke Street plays an integral part in the appreciation of Duke Street when viewed from near the Bath House building

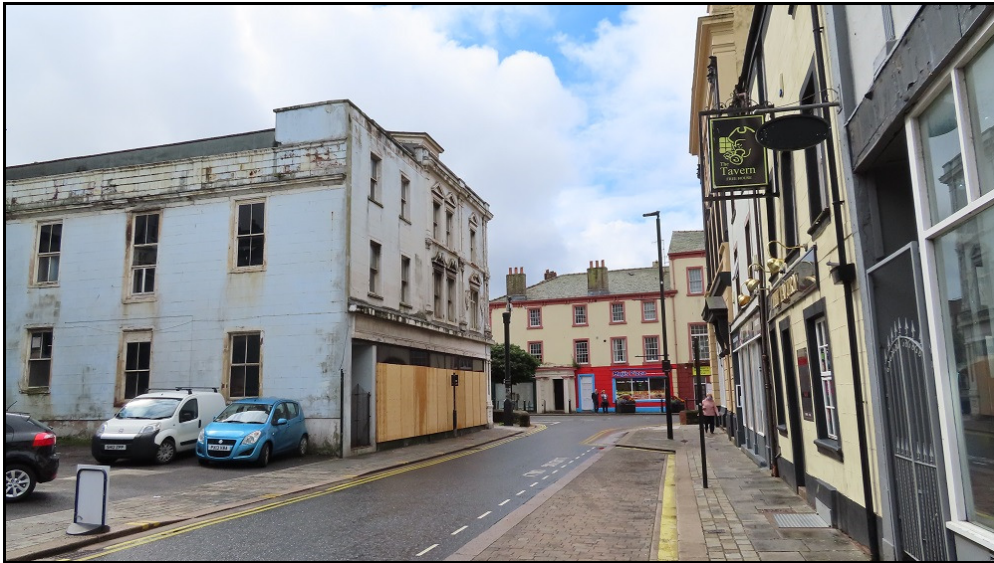
16. The approach through the Conservation Area towards the historic docks along Tangiers Street is dominated by the contribution made by Whittles
