BAT, BARN OWL & NESTING BIRD SURVEY AT

High House, Sandwith, Whitehaven

Author	Andrew Gardner	Date	28/2/2022
Checked by	Andrew Gardner	Date	28/2/2022
Report Version	1		
Field data entered	<input type="checkbox"/>		
Report Reference	7783

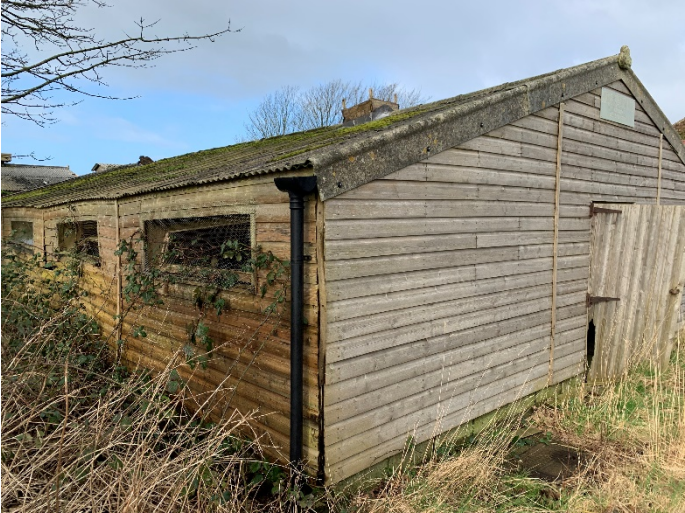
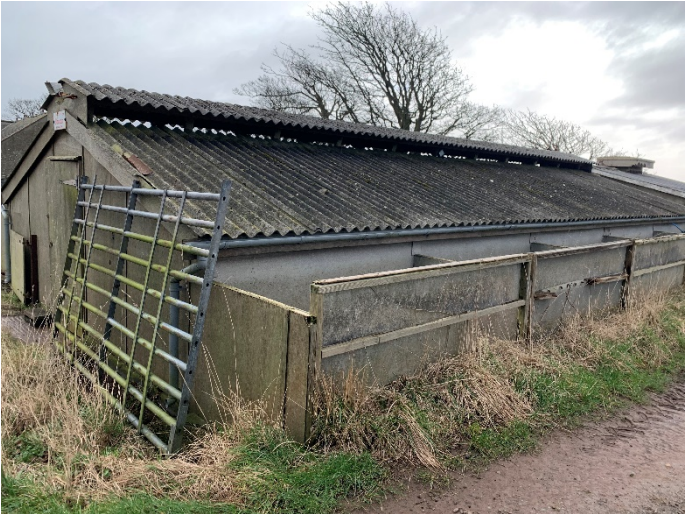
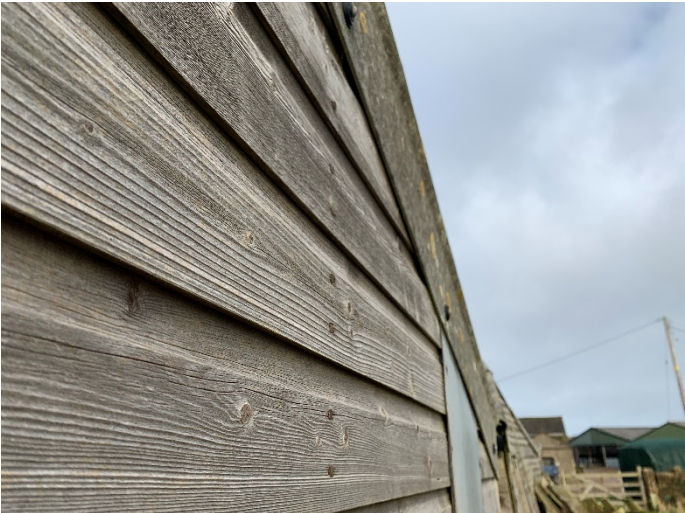
The walls of the buildings are made from insulated timber boards either plywood or tongue and groove. Some of the walls are degrading, the timber becoming disjointed. The nature of construction however does not provide wall cavities into which bats can take access.

<p>Building 1- The simple timber clad walls lack cavities suitable for use by bats</p>

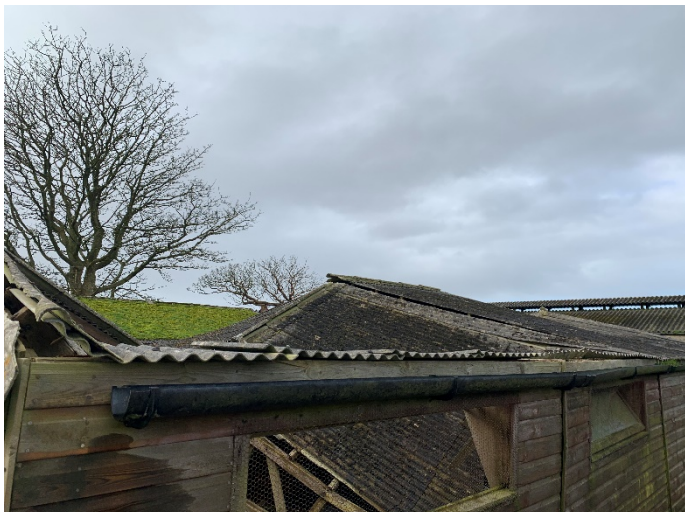
Building 1- Small gaps under roof coverings where the roofs have collapsed do not provide suitable roost sites

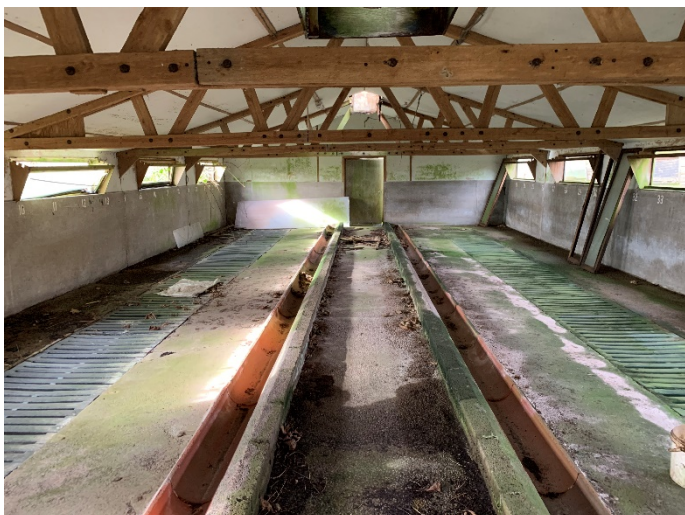
Building 1- Internal rooms are open and light

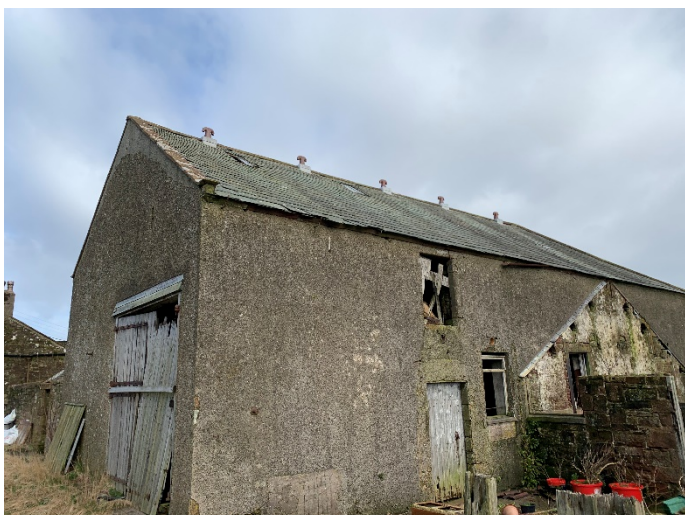
The walls of the building are made from natural red sandstone which has been rendered and are in good condition. There are no structural gaps or cracks, the render is in good condition.

Building 2- Well sealed walls and eaves

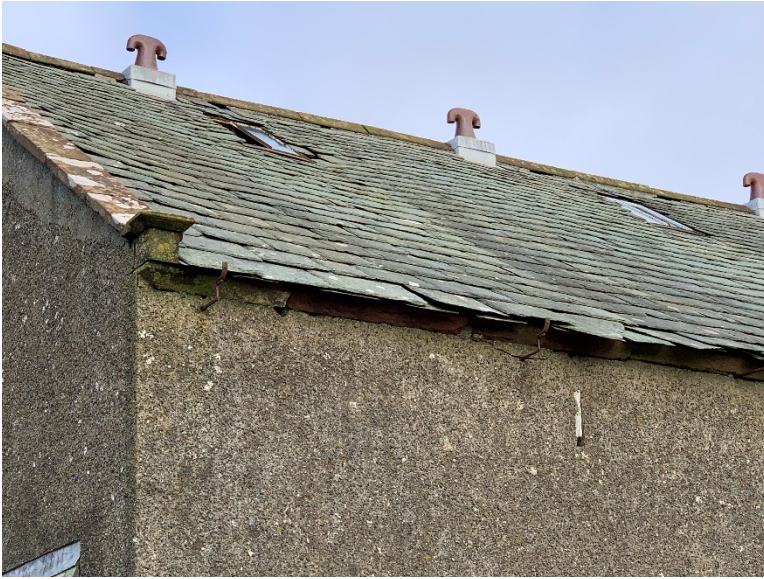
The roof of the building is made from stone slate and is unlined. There were occasional raised slates on both roof pitches, as well as ridgeline gaps where the mortar was missing. The full extent of the gaps could be seen from the ground with close focus binoculars and a 1,000,000 candle power torch. No indications of use by bats could be found. As the roof is unlined any use of the roof would also result in droppings being deposited internally. Missing slates allow water and light to penetrate the internal space.

Occasional slips slate allow light and rain into the interior

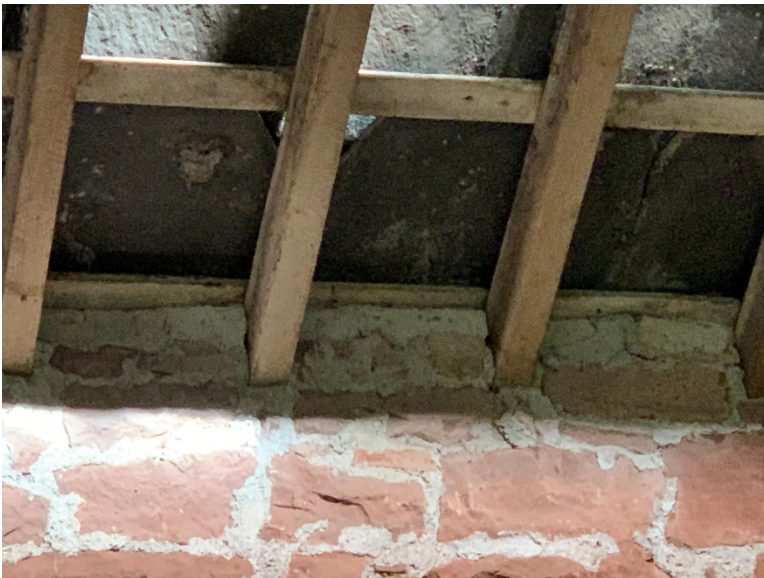
Internal wall tops are fully sealed

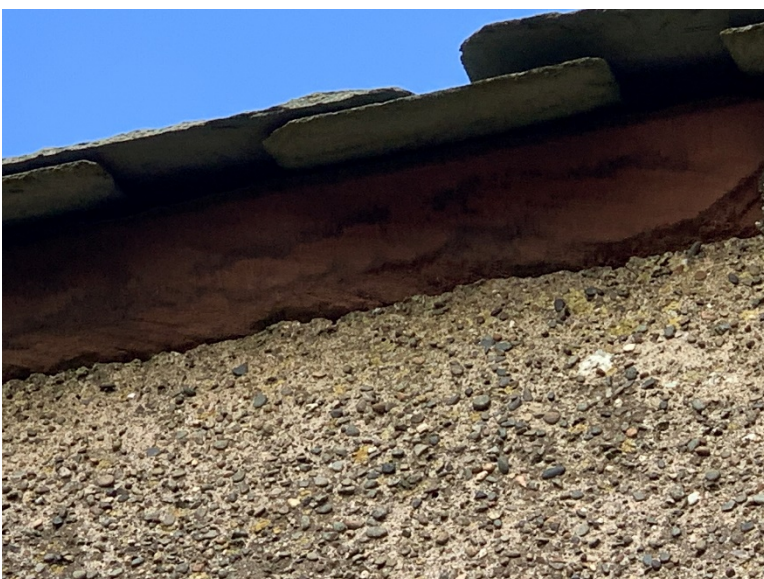
There are no soffit or eaves boards, small gaps do however extend over the eaves onto the wall tops in a small number of areas. There were no indications of roosting by bats in these areas and they could be fully inspected. The wall tops appear open and exposed. Missing rainwater goods mean the wall tops are likely to be damp.

External wall tops are sealed other than very small occasional gaps which could be inspected

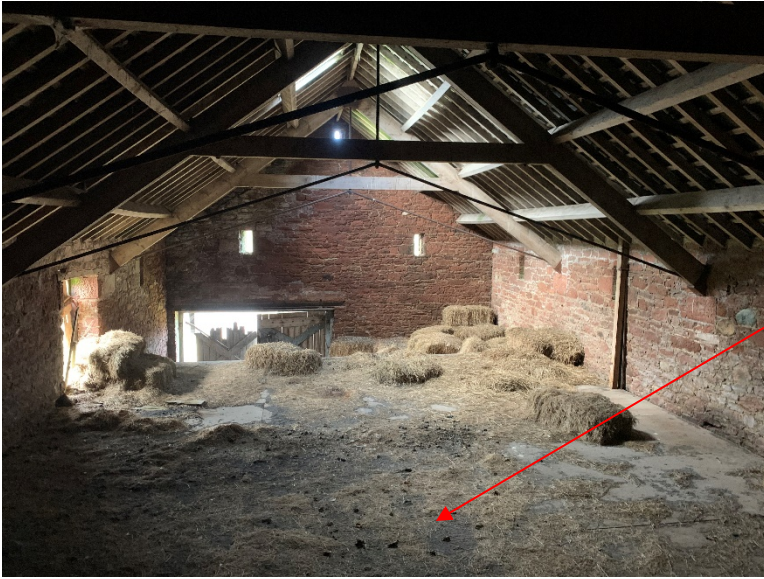
Internal void is open and light

Small number of barn owl pellets on the floor

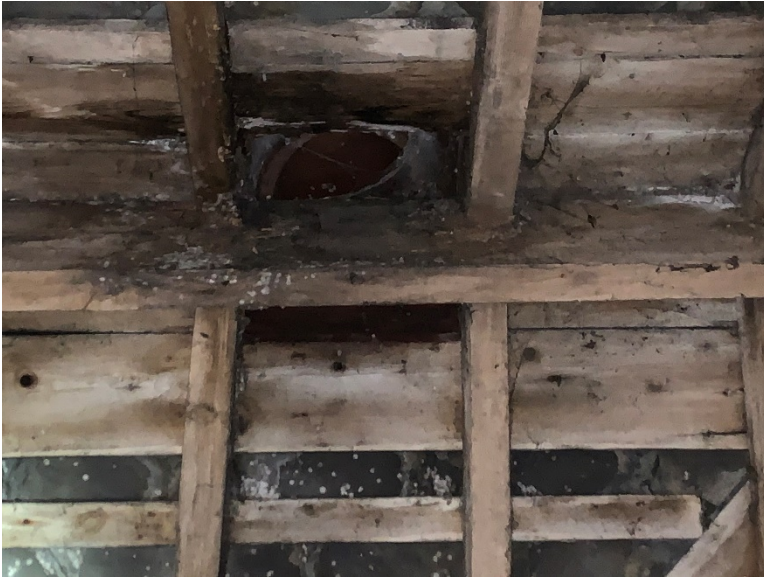
The timber beams in the roof were found to be in excellent condition with no rot, splits or gaps suitable for roosting or hibernating bats. There was a good covering of cobwebs under the roof. The internal space is open and light.

Cobwebs were noted along the ridge line internally
