Protected Species Survey: **Bats and Barn Owls**

Mr. J. Gate
Home Farm
Gilgarran
Workington
CA14 4RF

Barns at Home Farm
As above.

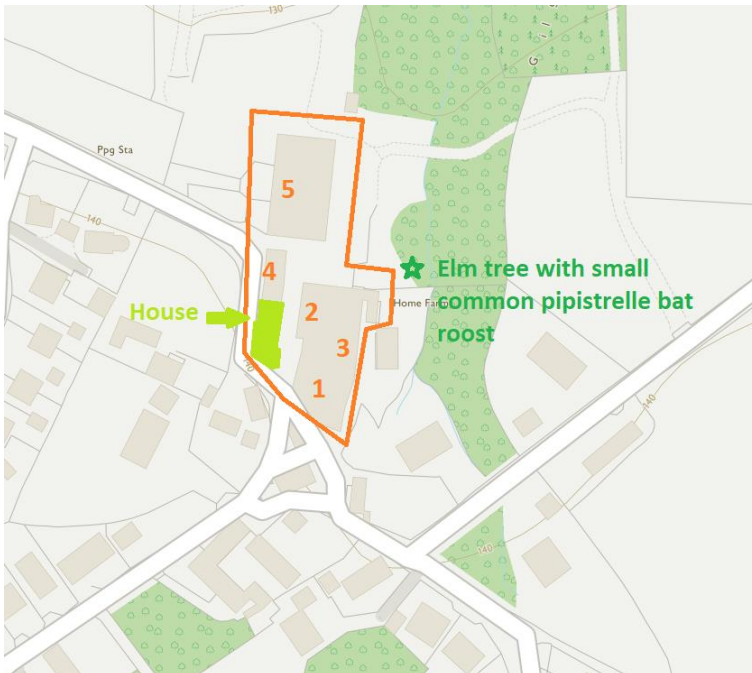
A1) Views of Site: **Plan of site**

Second dawn survey: Three common pipistrelle bats were identified and observed entering in to a dead elm tree via an old woodpecker hole. The tree is on the edge of the woodland facing the site (marked on plan above).

A small roost of common pipistrelle bats (*Pipistrellus pipistrellus*) was identified in an elm tree as marked on the plan in section A1.

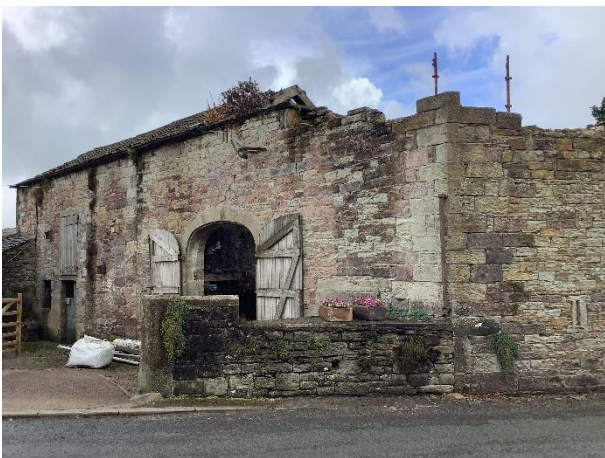
Front of site 1

Site 1 is an old sandstone-built barn which is well pointed inside and out with a concrete floor. It has a tiled roof which has totally collapsed in at the southern end and in need of repair at the northern end. There is a loft area at the northern end. This barn has a single storey row of old byres running off the northern aspect (Site 2).

Although site 1 site appeared to contain some suitable bat habitat, there was no evidence of use by bats. The hollow walls were damp due to the state of disrepair of the roof and this is likely to negate their potential for use as a roost site.

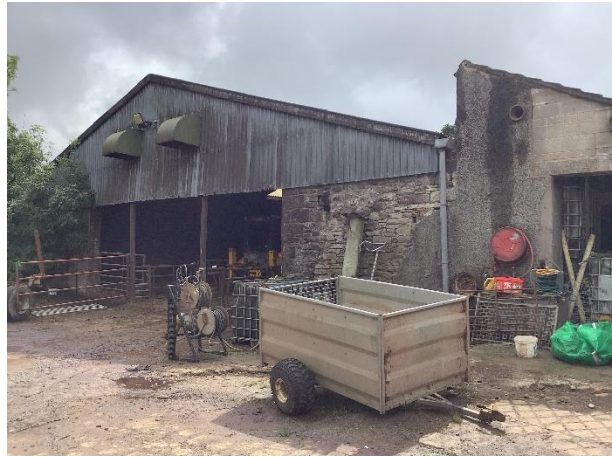
Site 3 is a large cattle shed which has low, stone- and block-built walls. It has a steel frame and a concrete sheeting roof and a concrete floor.

Sites 2, 3, 4 and 5 had no potential for bat habitat due to lack of access points and construction methods.

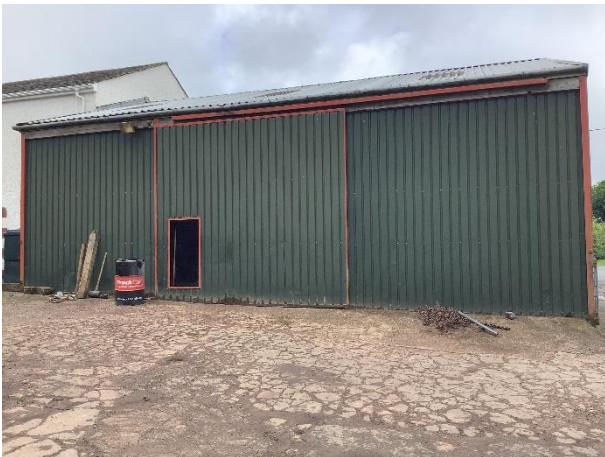
Site 4 adjoins the farmhouse and is a steel-framed workshop with metal profile sheeting roof and walls and a concrete floor.

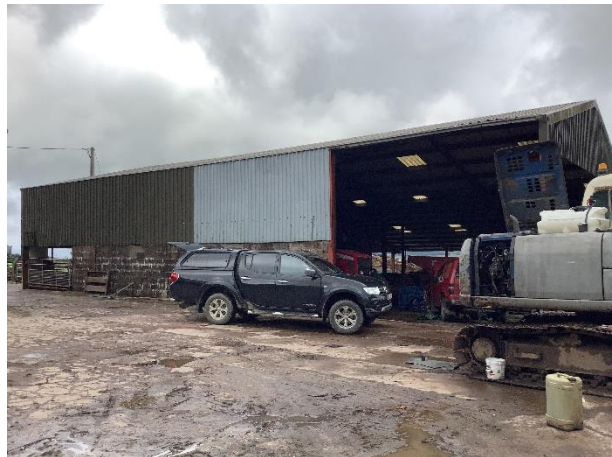
Site 5 is situated in the north of the yard. It is a large, steel-framed shed with metal profile sheeting.

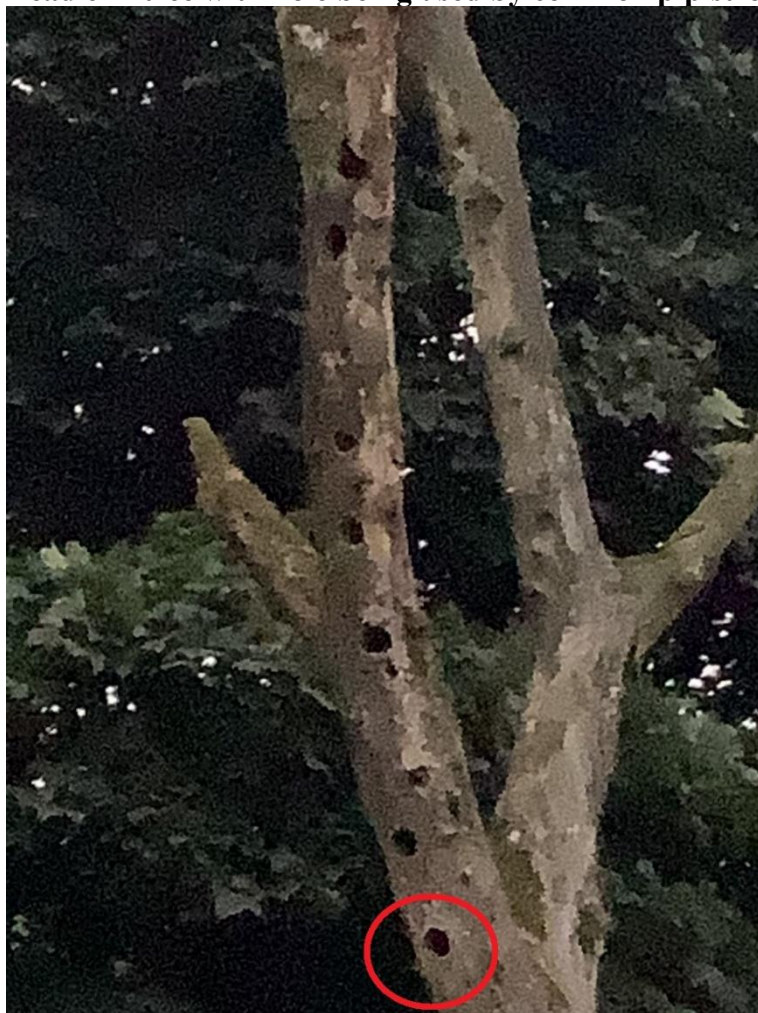
Dead elm tree with hole being used by common pipistrelles marked with red circle.

It is the surveyor's opinion that bats are not using the buildings. A bat roost was identified in a dead elm tree in the woodland to the east of the sites. If work is undertaken, this tree should not be removed without a European Protected Species License.

The dead elm tree should not need to be removed for the proposed works.
