Our ref: CCL102 – BQ&H

30TH September 2020

Re: Initial Inspection of Buildings Q & H, West Cumberland Infirmary

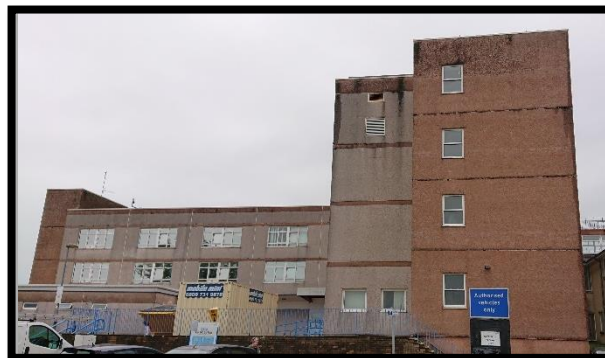
Plate 1: Building H

The two buildings in question are currently in use by the hospital and are both of very different construction. From initial views, building H is of brick and render construction, with a flat roof, accessible roof top plant room and lower level extension. For full assessment to be carried out internal access will be required along with access to the roof.

Prior to planned works commencing a full internal and external inspection should be carried out on buildings Q and H. Details of all potential roosting space should be recorded, and suitable survey locations marked. It is likely that following the results of the building assessments, activity surveys will be required to confirm if bats are roosting within either building.

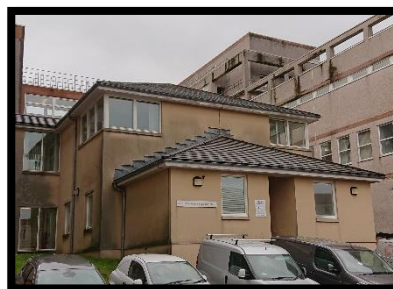
Plate 2: Building Q

Building Q is a structure of two levels with what appears to be two separate roof spaces. This building recorded a tiled roof with a concrete ridge. Full internal access, including access to both attic spaces will be required to provide a full assessment.
