Phase 2: Site Investigation

ISH Building, Leconfield Industrial Estate

Morgan Sindall

PHASE 2 SITE INVESTIGATION REPORT

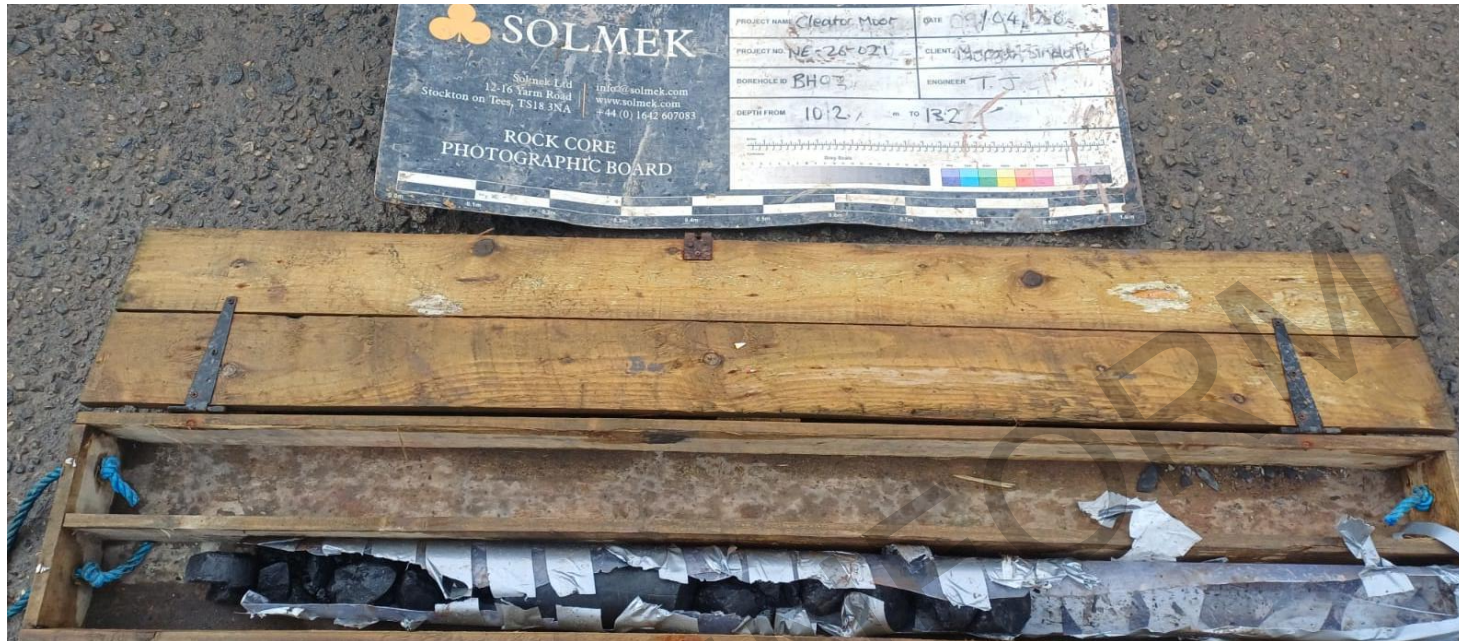
Figure 19: BH03 10.20-13.20m

Sandstone was noted within BH03 (13.20-13.80m & 14.70-15.30m), noted as medium strong.

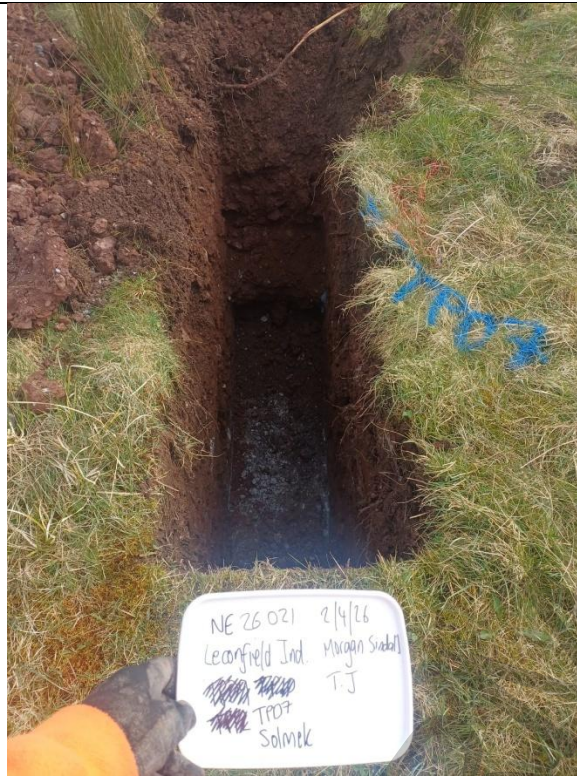
Figure 7: TP07

The fused slag deposits generally posed an obstruction to the excavator, with TPs 07-11 all terminating shallower than target depths, within slag materials. In addition, buried concrete was noted within TP12 (0.70-1.20m) resulting in termination at 1.20mbgl.

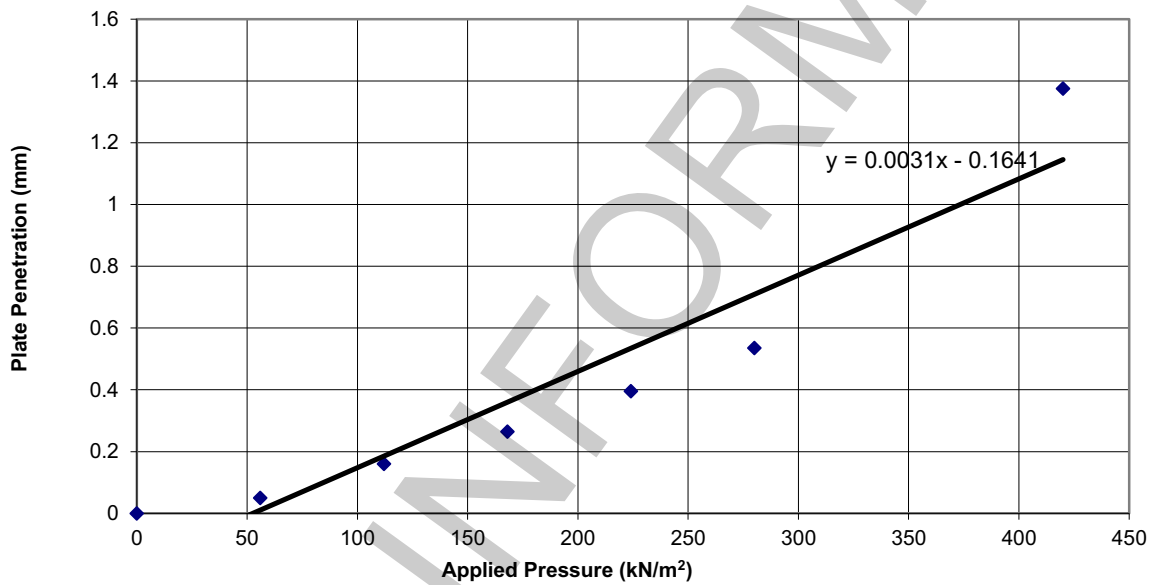
PLATE BEARING TEST		Date:	08.04.2026
Project Number:	NE-26-021	Test No:	PBT08
Project Name:	Cleator Moor, ISH Building	Test Level:	0.40m
Test Method: BS 1377 : Part 9 : 1990 (Incremental Method)		Weather:	Cold/sunny
Plate Diameter:	0.305 m	Load Applied:	420 kPa
Kentledge Type:	JCB 3CX	Remarks:	MADE GROUND. Sandy, gravelly Slag.

Pressure (kN/m ²)	Plate Penetration (mm)
Initial	0	0
Stage 1	56	0.05
Stage 2	112	0.16
Stage 3	168	0.27
Stage 4	224	0.40
Stage 5	280	0.54
Stage 6	420	1.38
Stage 7		
Stage 8

Conversion Factor	0.45	Produced by:
Stress Applied @ 1.25mm	661.90 kN/m ²	
Total Plate Deflection	1.38 mm	Checked by:
Plate Diameter	305 mm	
k305	529517	SOLMEK
k762	237089	
CBR	126 %
