The Punch Bowl Inn,
The Green,
Millom,
LA18 5HJ

Foul Water Inspection.

Initial inspection.

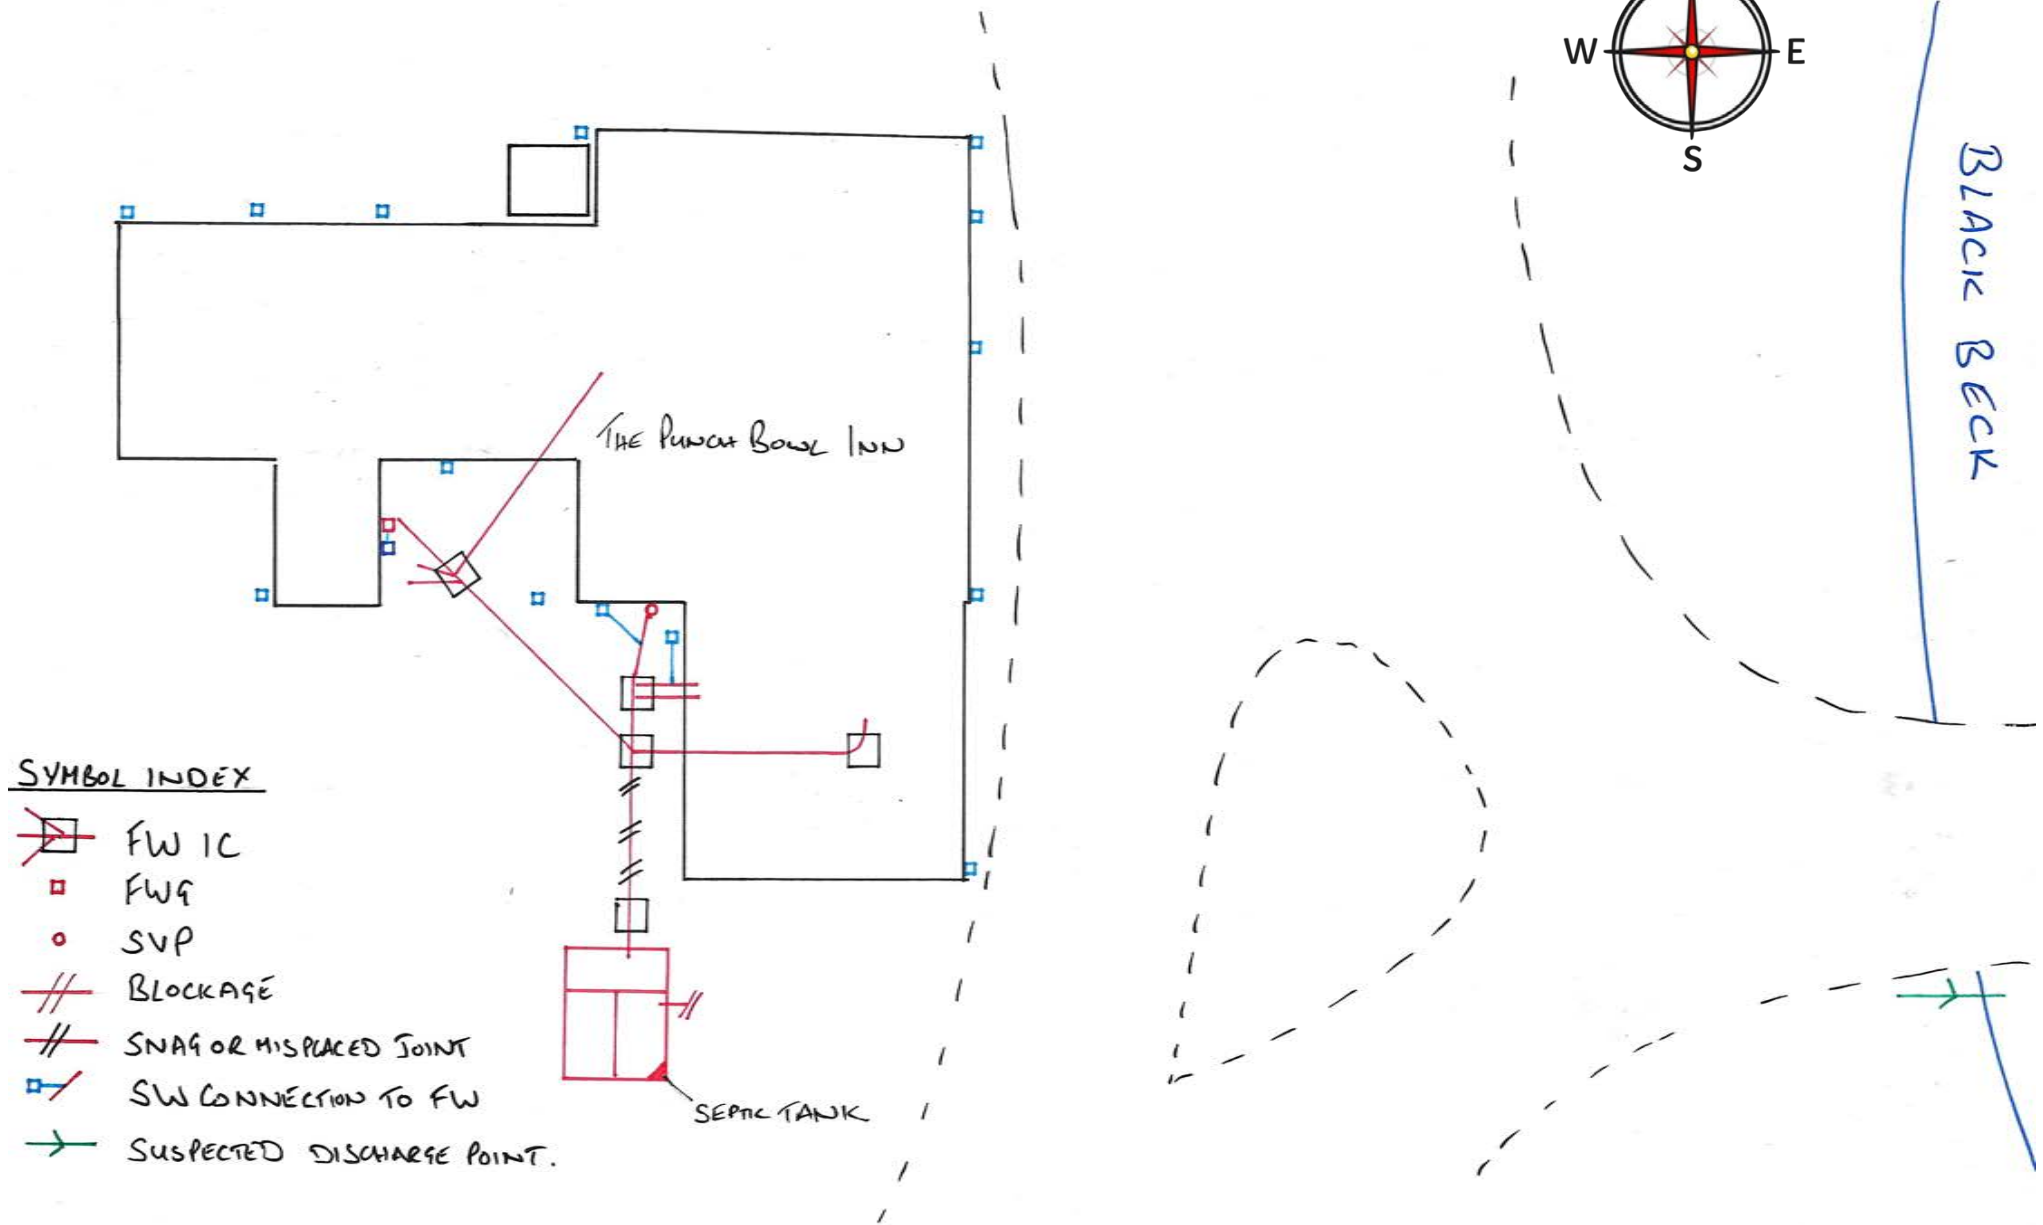
Fig 1. Existing Layout.

1. The existing septic tank is positioned in the beer garden field to South of the property. Layout sketch attached, Fig 1.
2. The tank is a Brick built, triple chamber septic tank, as shown in Fig 2, 3 and 4. It has a liquid capacity of approx. 1,700lt.

7. The drains around the property are generally in good condition, there are snags on the last runs between the penultimate chamber and the tank, as shown on Fig 1.

8. The FW drains on the property were all tested and all discharge to the tank.
9. The Rain Water Pipes (RWP) which take the SW were all tested and 3 of these do discharge to the FW system. These are indicated on Fig 1.

1. The Septic tank should be replaced with a WWTP suitable to meet the current and future requirements. Currently a minimum 20PE system would be suitable.
2. The outfall connection must be repaired. This will require further CCTV work to establish the blockage point from the outlet pipe at the water course.
3. The SW connections must be removed for the FW drains

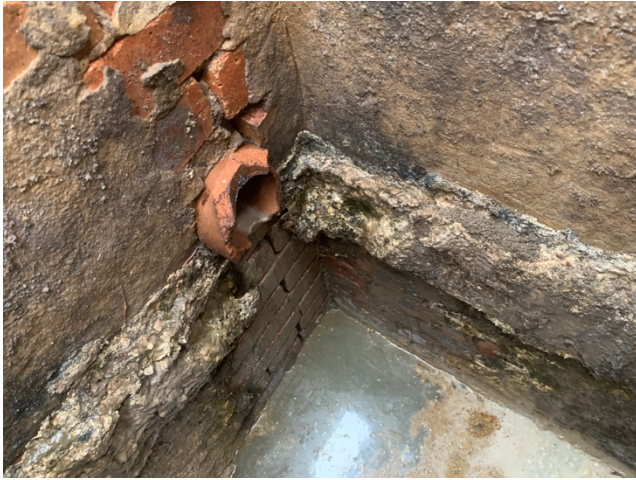
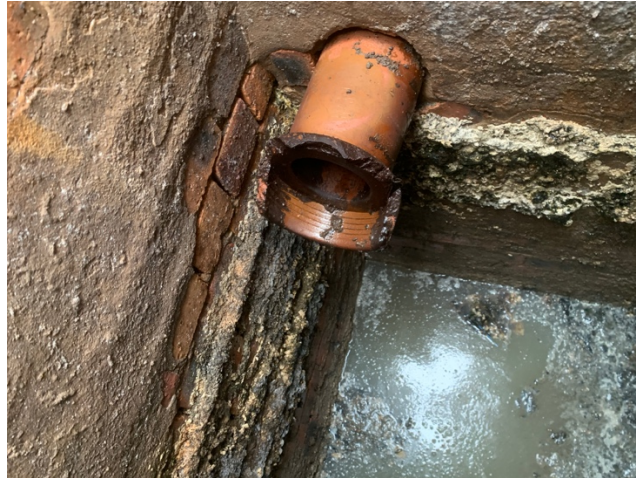
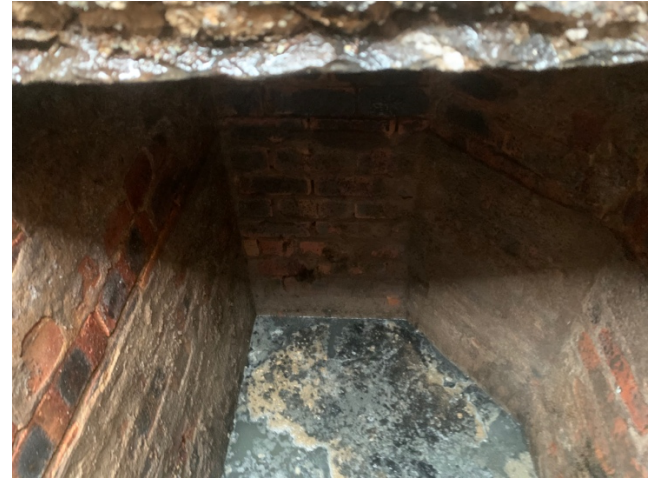
Fig 2, 3 and 4. Brick built, triple chamber septic tank.

3. The dip pipes are missing as shown in Fig 2, 3 and 5.
4. The tank is leaking in and out. The level of contents on the day were well below the outlet drain. Fig 5.

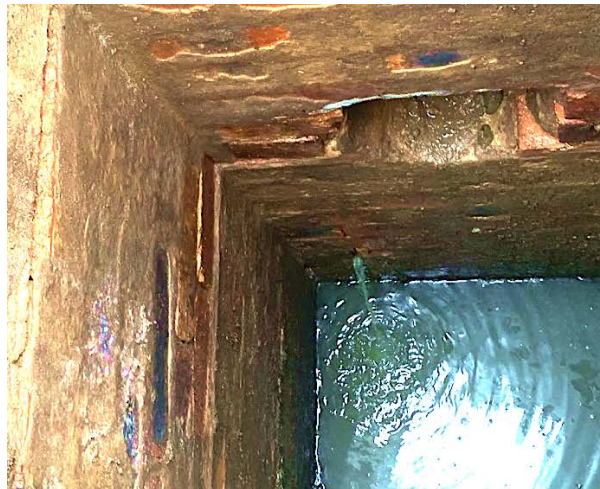
Fig 6. Leak from the outer wall.

5. When water was introduced to the first chamber, a leak from the outer wall allowed the fluid to enter the 3rd chamber, as per Fig 6.
6. The venue currently serves around 50 covers and with double sittings and no residential loading, this equates to 3,000 lt per day or a 20 Person Equivalent (PE)*.

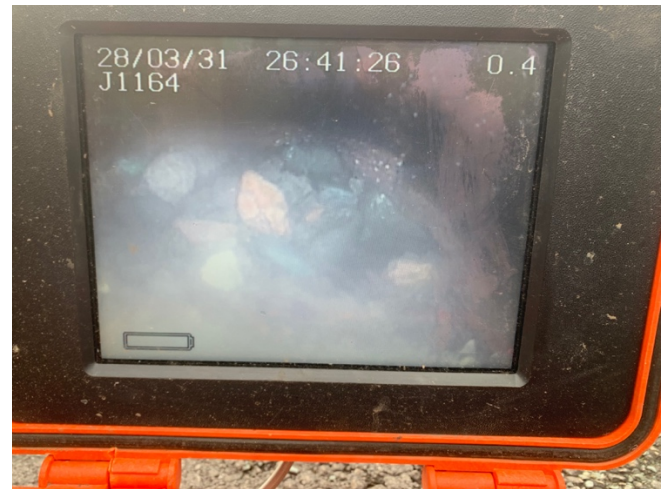
Fig 7. Outlet pipe blocked

10. The discharge is not situated within a Source Protection Zone I (SPz).
11. The tank outfall is currently collapsed and blocked immediately after the tank. Fig 7. However, it is locally believed to discharge to the water course across the road; Black beck.
