**Our Ref. No.: JCA25BAT022**  
**Date: 7th November 2025**  
**Your Ref. No.: N/A**

**Preliminary Roost Assessment for Bats / Nesting Birds - Garage &  
Ground floor sections / kitchen at Prospect House, Holmrook, CA19  
1UG**

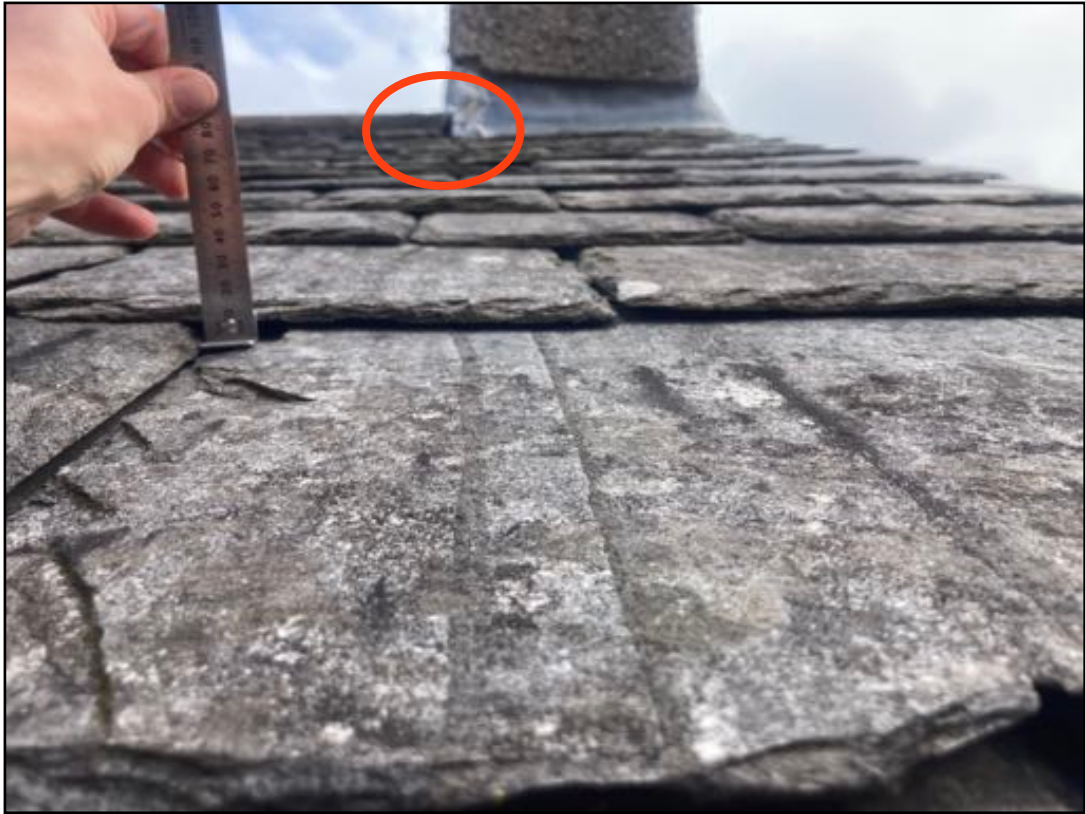
The walls were either rendered or exposed stonework - which had no gaps at all. There were no gaps in the ridges at all and the slate roof was tightly clad, with gaps assessed and measured - most gaps appeared less than 10mm - and where gaps were present the same under the slates was smaller further up - with no continuous gaps / no apparent access for bats to roost under the slates. The flashings where the kitchen tied into the main house were tight with no gaps. The reader at the gable end chimney was tight with no gaps - the flashing around this chimney was also tight but there was a small gap in the overlap at the western pitch.

**There was one gap in the chimney flashing that may give some level of potential for bats to access but may not provide a suitable crevice and was considered sub-optimal. Even considering the gap (which will be retained though the works anyway) then overall the kitchen & garage both offer 'nil/ negligible' bat roost opportunity. See Table 3 and Photos; Figs 4 - 7 below.**

**Figure 4:** Showing minimal / unlikely gaps for bats throughout the kitchen roof - there was a single gap in the flashing at the western pitch - as shown above - that could possibly provide a sub-optimal spaces for a single pipistrelle bat.

- Where possible gaps will not be left open over night to avoid the possibility of bats opportunistically roosting in gaps which will later be blocked.
- Any flashings or roof cladding should be removed by hand, with care, checking all areas as it is stripped.
- If bats are discovered or suspected at any time prior to or during works, all work in that area must pause and advice from the acting consultant be sought.

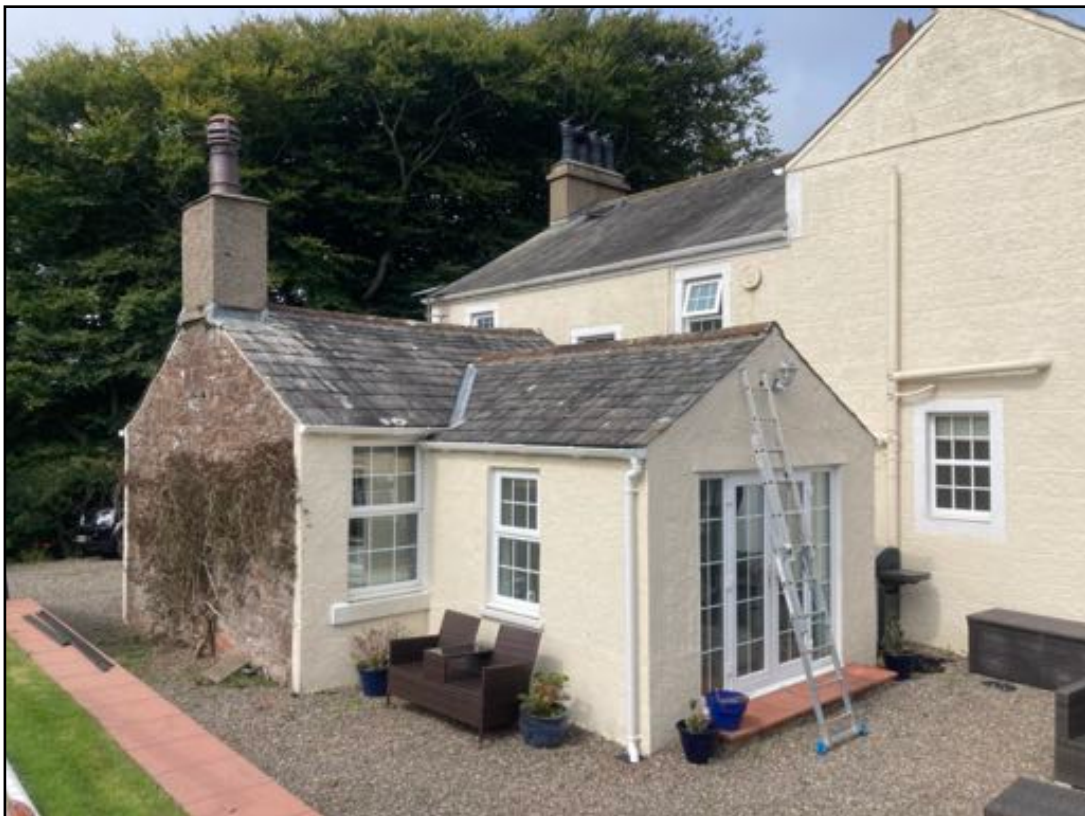
**Figure 5:** Showing the kitchen sections from the southwest - slate clad roof and ridges - very tightly set, despite a through search from ladder height, there was no typically suitable access for bats present.

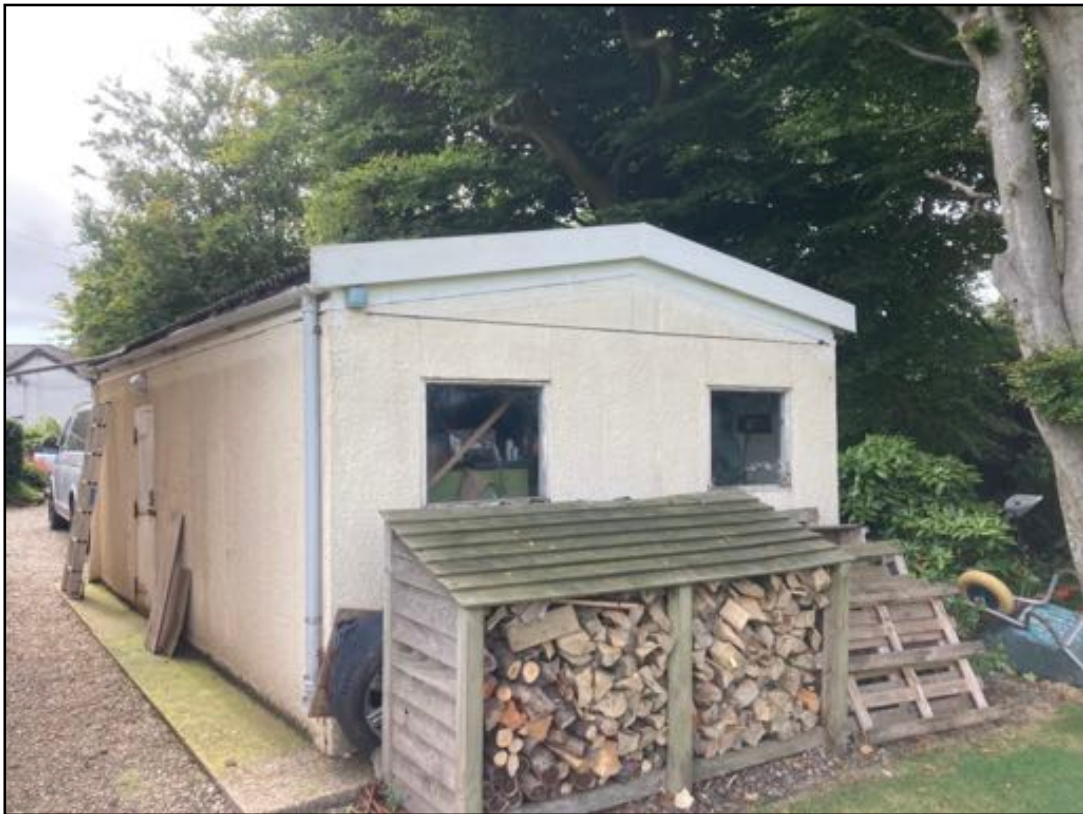
There were a couple of large gaps at the southern corners which could provide access for nesting birds but not bats.

**Figure 6:** Garage from the north - there were no gaps in the walls and no bat roost potential. The building was generally inaccessible to birds also - there may be some potential for access in gaps above the doors / at the sides at the southern end.

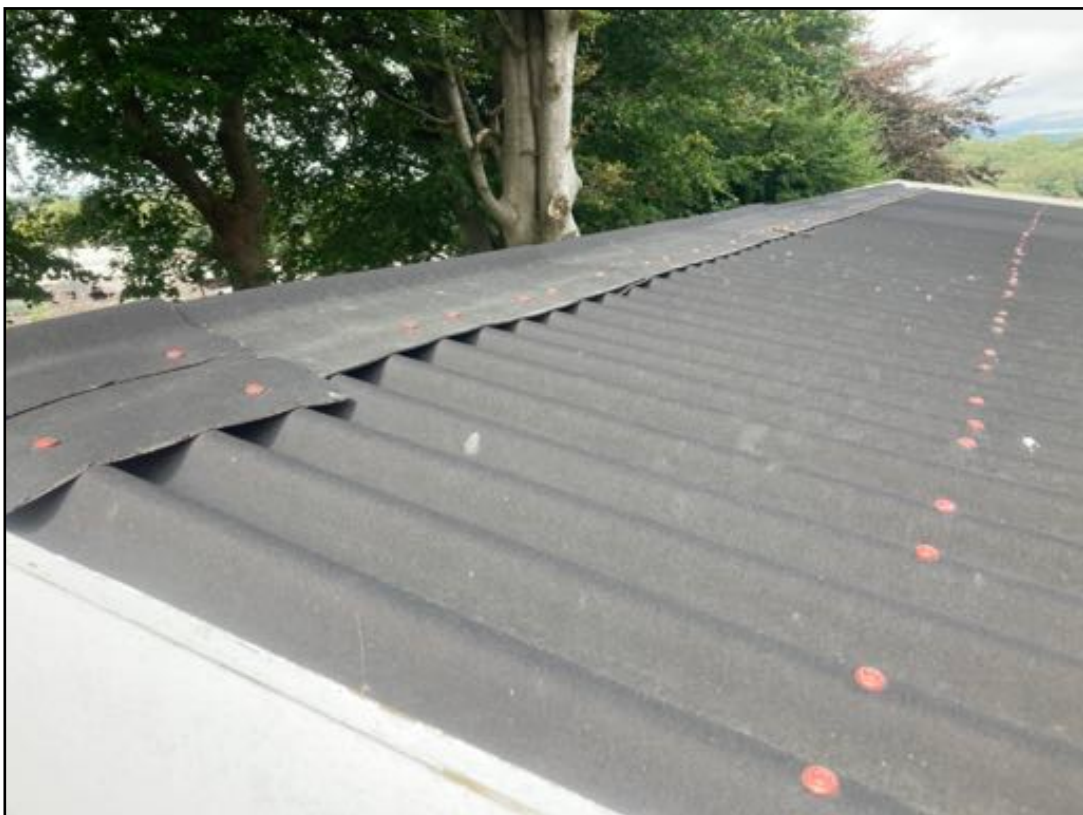
The garage was also thoroughly accessed and searched. It is a purpose-built construction with a bitumen profile sheet roof on top of a PVC sheet cladding, internally there are ply-boards present - the roof has no void and no crevices present that would provide any suitable roosting place for bats at all. The walls comprise of concrete panels with timber boarding along the wall tops and panelled sections at the gable ends - timber boarding can provide suitable gaps for bats sometimes, however there are no gaps / overlapping sections to these areas and no potential for bats.

**Figure 7:** Garage roof - the building is purpose built and the roof has no suitable access for bats and wall tops also do not present gaps or access to suitable voids / crevices. Once the garage here is removed then the trees shown here at the west of the house would be an ideal location to erect bats boxes / bird boxes and enhance the site for bats / birds - if desired.
