**PHASE I AND PHASE II  
GEO-ENVIRONMENTAL SITE INVESTIGATION**

**Jefferson Park  
Whitehaven  
Cumbria  
CA28 9HE**

**E3P Report: 10365-r1  
Issued: January 2014**

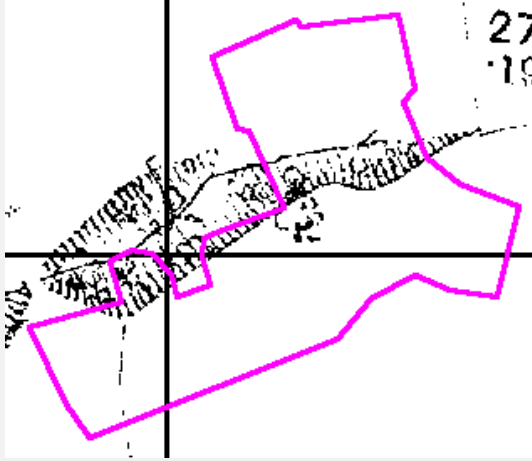
| Map Edition | Historical Land Use | Historical Map Excerpt |
|---|--|--|
| <p><b>1879</b><br/>1:2,500</p> | <p>The southern sector of the site is recorded as a <b>Brick Field</b>. An excavation is recorded through eastern sector running along the northern profile of the western sector. The northwest quadrant of the site is unspecified open land (possibly agricultural or brick field).</p> | |

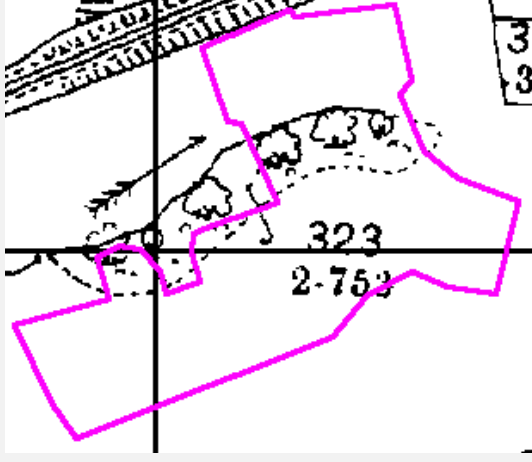
| Map Edition | Historical Land Use | Historical Map Excerpt |
|---|--|--|
| <p><b>1899</b><br/>1:2,500</p> | <p>No significant changes have occurred.</p> | |

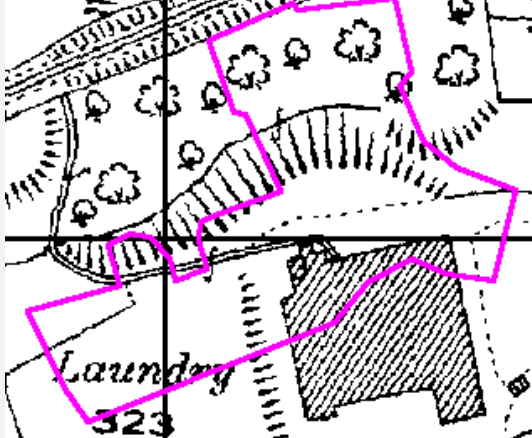
| Map Edition | Historical Land Use | Historical Map Excerpt |
|---|--|--|
| <p><b>1925/38</b><br/>1:2,500</p> | <p>A <b>Laundry</b> is now recorded extending into the southern sector of the site. The area of excavation is still recorded.</p> | |

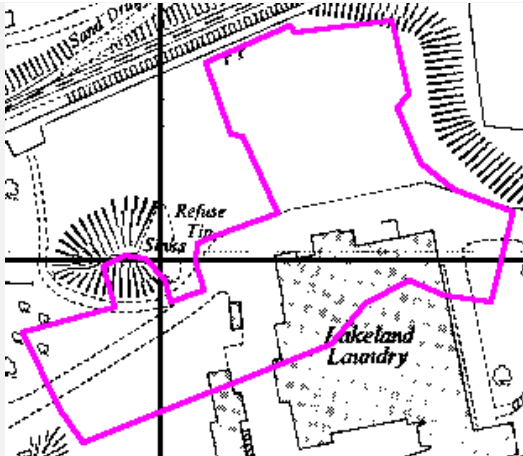
| Map Edition | Historical Land Use | Historical Map Excerpt |
|---|---|--|
| <p>1962<br/>1:2,500</p> | <p>A <b>Refuse Tip</b> is recorded extending into the northwest sector of the site. The previously identified excavation through the centre of the site is no longer recorded.</p> | <p>This map excerpt shows a site with a 'Refuse Tip' in the northwest sector and 'Lakeland Laundry' in the southeast. A pink outline highlights the site boundary. Other features include 'Sand Drags' and 'Roses'.</p> |

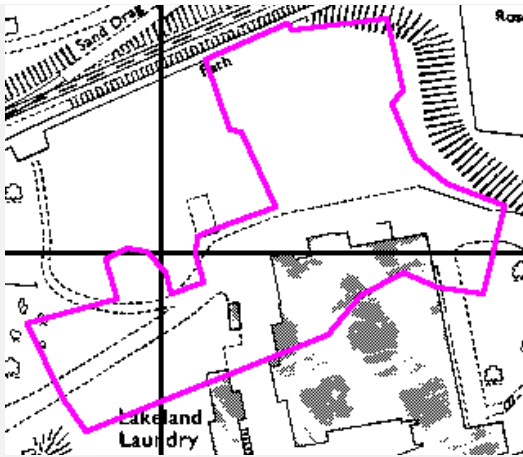
| Map Edition | Historical Land Use | Historical Map Excerpt |
|---|---|--|
| <p>1975/94<br/>1:2,500</p> | <p>The <b>Refuse Tip</b> is no longer recorded. No other significant changes.</p> | <p>This map excerpt shows the site with 'Lakeland Laundry' in the southeast. The 'Refuse Tip' is no longer recorded. A pink outline highlights the site boundary. Other features include 'Sand Drags' and 'Roses'.</p> |

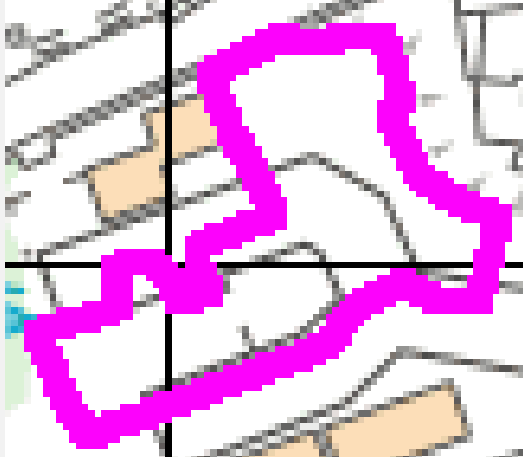
| Map Edition | Historical Land Use | Historical Map Excerpt |
|---|---|--|
| <p>2014</p> | <p>The <b>Laundry</b> has been demolished and the site has an access road through the eastern sector constructed as part of the wider residential development, in proximity to the subject site which is now recorded in its present day configuration.</p> | <p>This map excerpt shows the site with an access road through the eastern sector. The 'Lakeland Laundry' has been demolished. A pink outline highlights the site boundary.</p> |
