**John Paul Jones, Whitehaven**

**784-B064930**

## **Update Ecological Appraisal and Bat Roost Assessment Report**

**BEC**

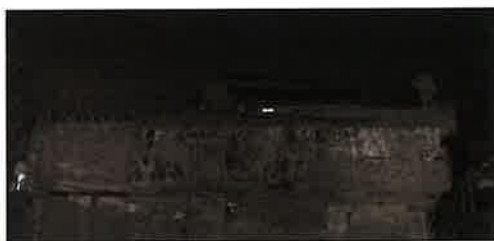
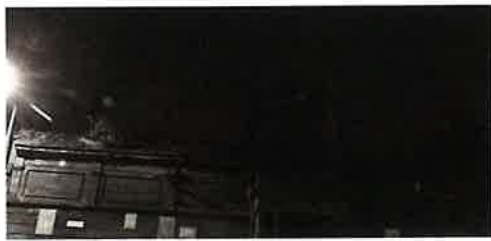
| Date of survey | Sunset | Start (S) | Finish (F) | Temperature (in °C) S/F | Rain S/F (mm/hr) | Wind speed <sup>1</sup> S/F | Cloud cover <sup>2</sup> % S/F |
|--|--|---|---|--|---|---|---|
| <b>IR cameras used (darkest point)</b> | B2.1<br> | | | B2.3<br> | | | |

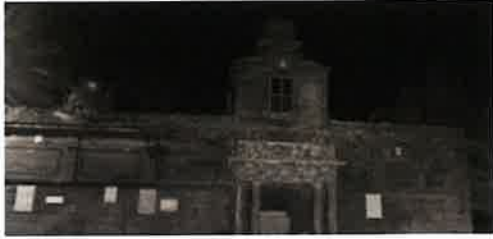
| Date of survey | Sunset | Start (S) | Finish (F) | Temperature (in °C) S/F | Rain S/F (mm/hr) | Wind speed <sup>1</sup> S/F | Cloud cover <sup>2</sup> % S/F |
|---|--|---|---|--|---|---|---|
| IR cameras used (darkest point) | B2.1: | | | B2.3: | | | |

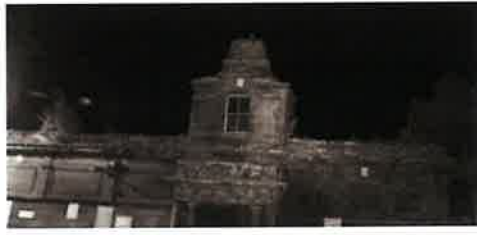
| Date of survey | Sunset | Start (S) | Finish (F) | Temperature (in °C) S/F | Rain S/F (mm/hr) | Wind speed <sup>1</sup> S/F | Cloud cover <sup>2</sup> % S/F |
|---|--|---|---|--|---|---|---|
| IR cameras used (darkest point) | B2.1: | | | B2.3: | | | |

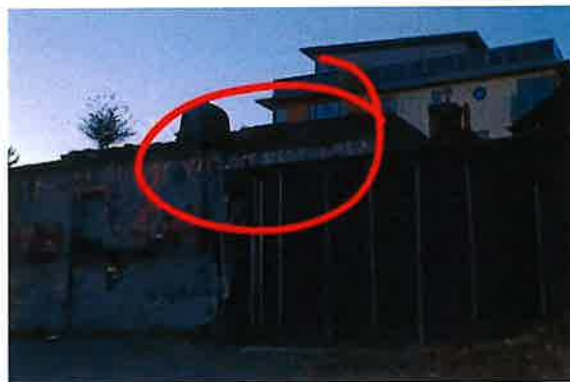
**Photograph 1: Location of roosting point on B2**

During the first survey visit, a single common pipistrelle was recorded emerging from a hole below roof on B2, observed from survey position B1.1 at 22:12 (64 minutes after sunset) - see Figure 4. The access point is shown in Photograph 1.

| Ecological Receptor | Assessment | Mitigation required | Opportunity for enhancement |
|---|--|---|--|
| Bats | <p>Two buildings were present within the site. B1 is proposed for demolition and B2 for partial demolition and partial retention.</p> <p>B1 was graded as moderate suitability for summer roosting bats, however no roosting bats were identified on the nocturnal surveys.</p> <p>B1 is considered suitable for hibernating bats as the building was unoccupied and unheated and had an accessible cellar through the loft void (internal areas open missing doors allowing bats access to the entire structure). The building was in a poor state of repair and considered unsafe for a full hibernation inspection. Furthermore, the building was considered suitable for hibernating pipistrelle</p> | <p>A precautionary working methodology will be required for the site before works can continue, which will stipulate required actions, such as direct supervision of suitable features being removed.</p> <p>All demolition contractors are to have a toolbox talk delivered by a licensed bat ecologist prior to demolition works commencing, regarding the potential presence of bats; and working methods to be used. The licensed bat ecologist will supervise works and inspect the potential hibernation features as they become accessible during demolition.</p> <p>Lighting schemes must be developed in accordance with the Institute of Lighting</p> | <p>The inclusion of at least two general purpose roosting bat boxes and one hibernation bat sited on retained trees or sections of B1 are required as compensation.</p> <p>The boxes should be sited 3-4m high and should be high enough to avoid direct illumination, placed out of the way of strong winds and positioned south-east to south-west where they can get sun for part of the day. Once installed, any disturbance including maintenance of a bat box must be completed under supervision of a licensed bat ecologist.</p> |
