Drainage Strategy

Proposed Housing Development, Land at Scalegill Road, Moor Row

Washington Homes Ltd

Ref: K40461.DS/001

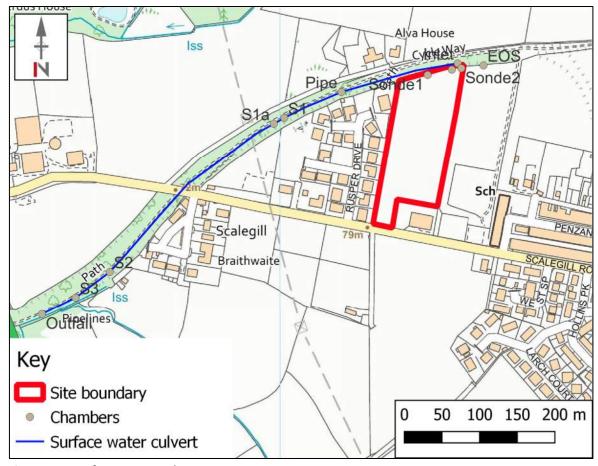
There are no identified surface water drainage features within the site boundary however the cycle path on the sites northern boundary contains drainage which was presumably associated with the former railway. This drainage is located at a level below that of the lowest point on the site and would naturally receive site runoff due to topography. An overview of the surface water drainage is provided in Figure 2.2. Further detail is provided in closer proximity to the site in Figure 2.3.

Figure 2.2 Surface water culvert

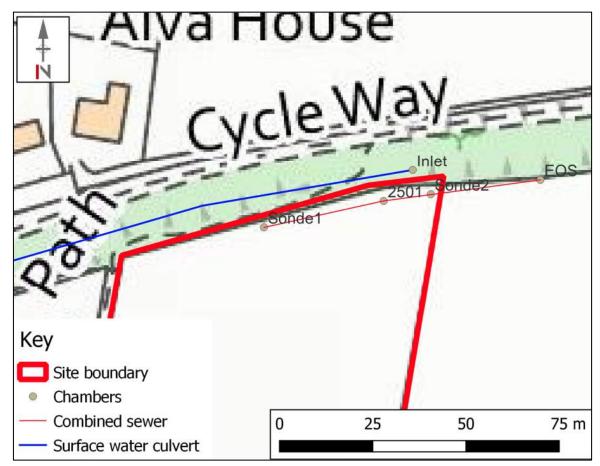
Figure 2.3 Drainage survey adjacent to site

The results of the drainage survey are included in Appendix B.

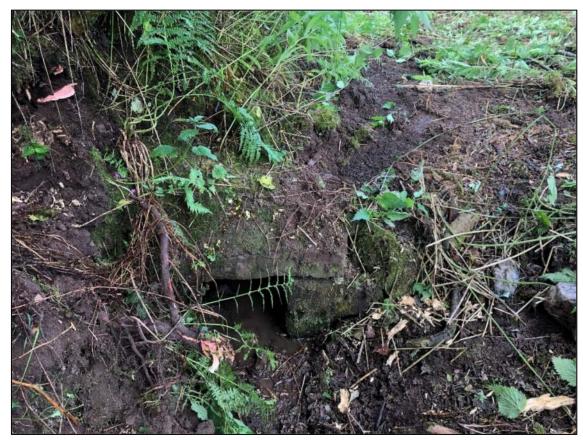
The cycle path drainage has been investigated and found to comprise a ditch at its upstream extent (Figure 2.4) before changing to a stone culvert adjacent to the site boundary. Beyond the site the stone culvert changes to a 400mm diameter pipe, becoming 300mm diameter prior to outfall to an open ditch. The drainage survey was undertaken on 7th July 2023 during dry conditions and the system was surveyed as far as possible without damaging the watercourse. The stone culvert is difficult to survey, and the camera made limited progress. It was possible to investigate the culvert 16.5m downstream of the upstream headwall and culvert depth at this location was 0.7m deep to crown. Further excavations on the line of the stone section were not possible due to vegetation, increasing depth and digger access constraints.

Figure 2.4 Culvert inlet and ditch

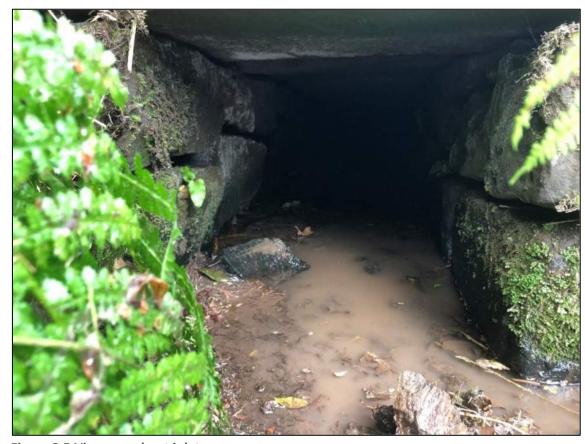
Figure 2.5 View up culvert inlet

The stone culvert contained water at its inlet however was dry beyond. The culvert changed construction to a 400mm diameter clay pipe at a point approximately 160m downstream of the culvert inlet. The stone culvert appears to be in generally good condition.

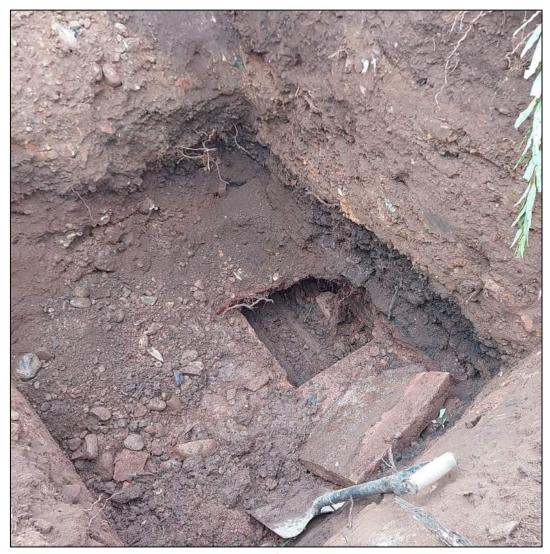
Figure 2.6 Excavation on Culvert at Extent of Camera Survey

Access to the pipe was achievable at 5 locations and this section of the drain is generally located at a depth of 500 - 600mm. Small, shallow stone built chambers are present and three of these were located to allow camera access. It is probable that other buried chambers also exist. At manhole S2 pipe diameter reduces from 400mm to 300mm and the outfall was flowing freely.

The piped section of watercourse is in good condition and would be a suitable connection point for the disposal of surface water.

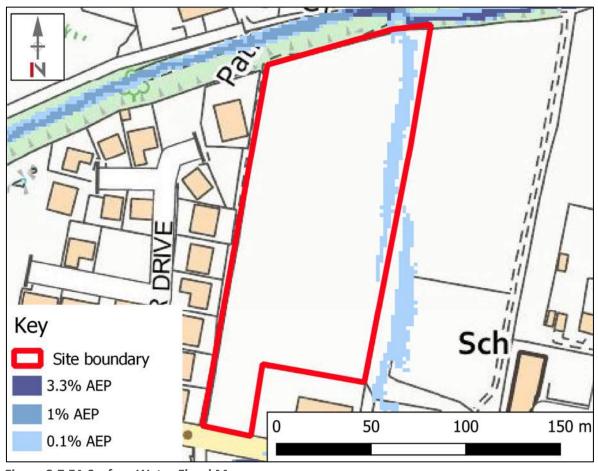
For the site a low probability 0.1% AEP flow route is predicted along the site's east boundary. This however does not appear correct following a walkover survey.

Figure 2.7 EA Surface Water Flood Map

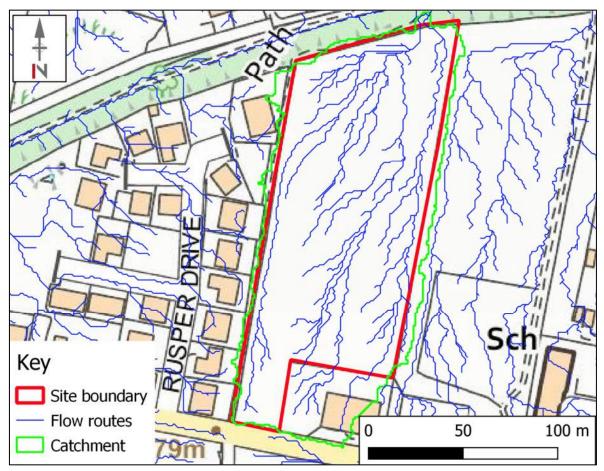
Further investigation has been undertaken using LiDAR data dated 2021 and catchment analysis to define the contributing area to the watercourse. Results provided in Figure 2.8 show the catchment covers little more than the site boundary and disproves the EA surface water flood map product. An area to the south associated with the working man's club is predominantly hardstanding and roof area which is positively drained and would not contribute flow.

Figure 2.8 Catchment Boundary

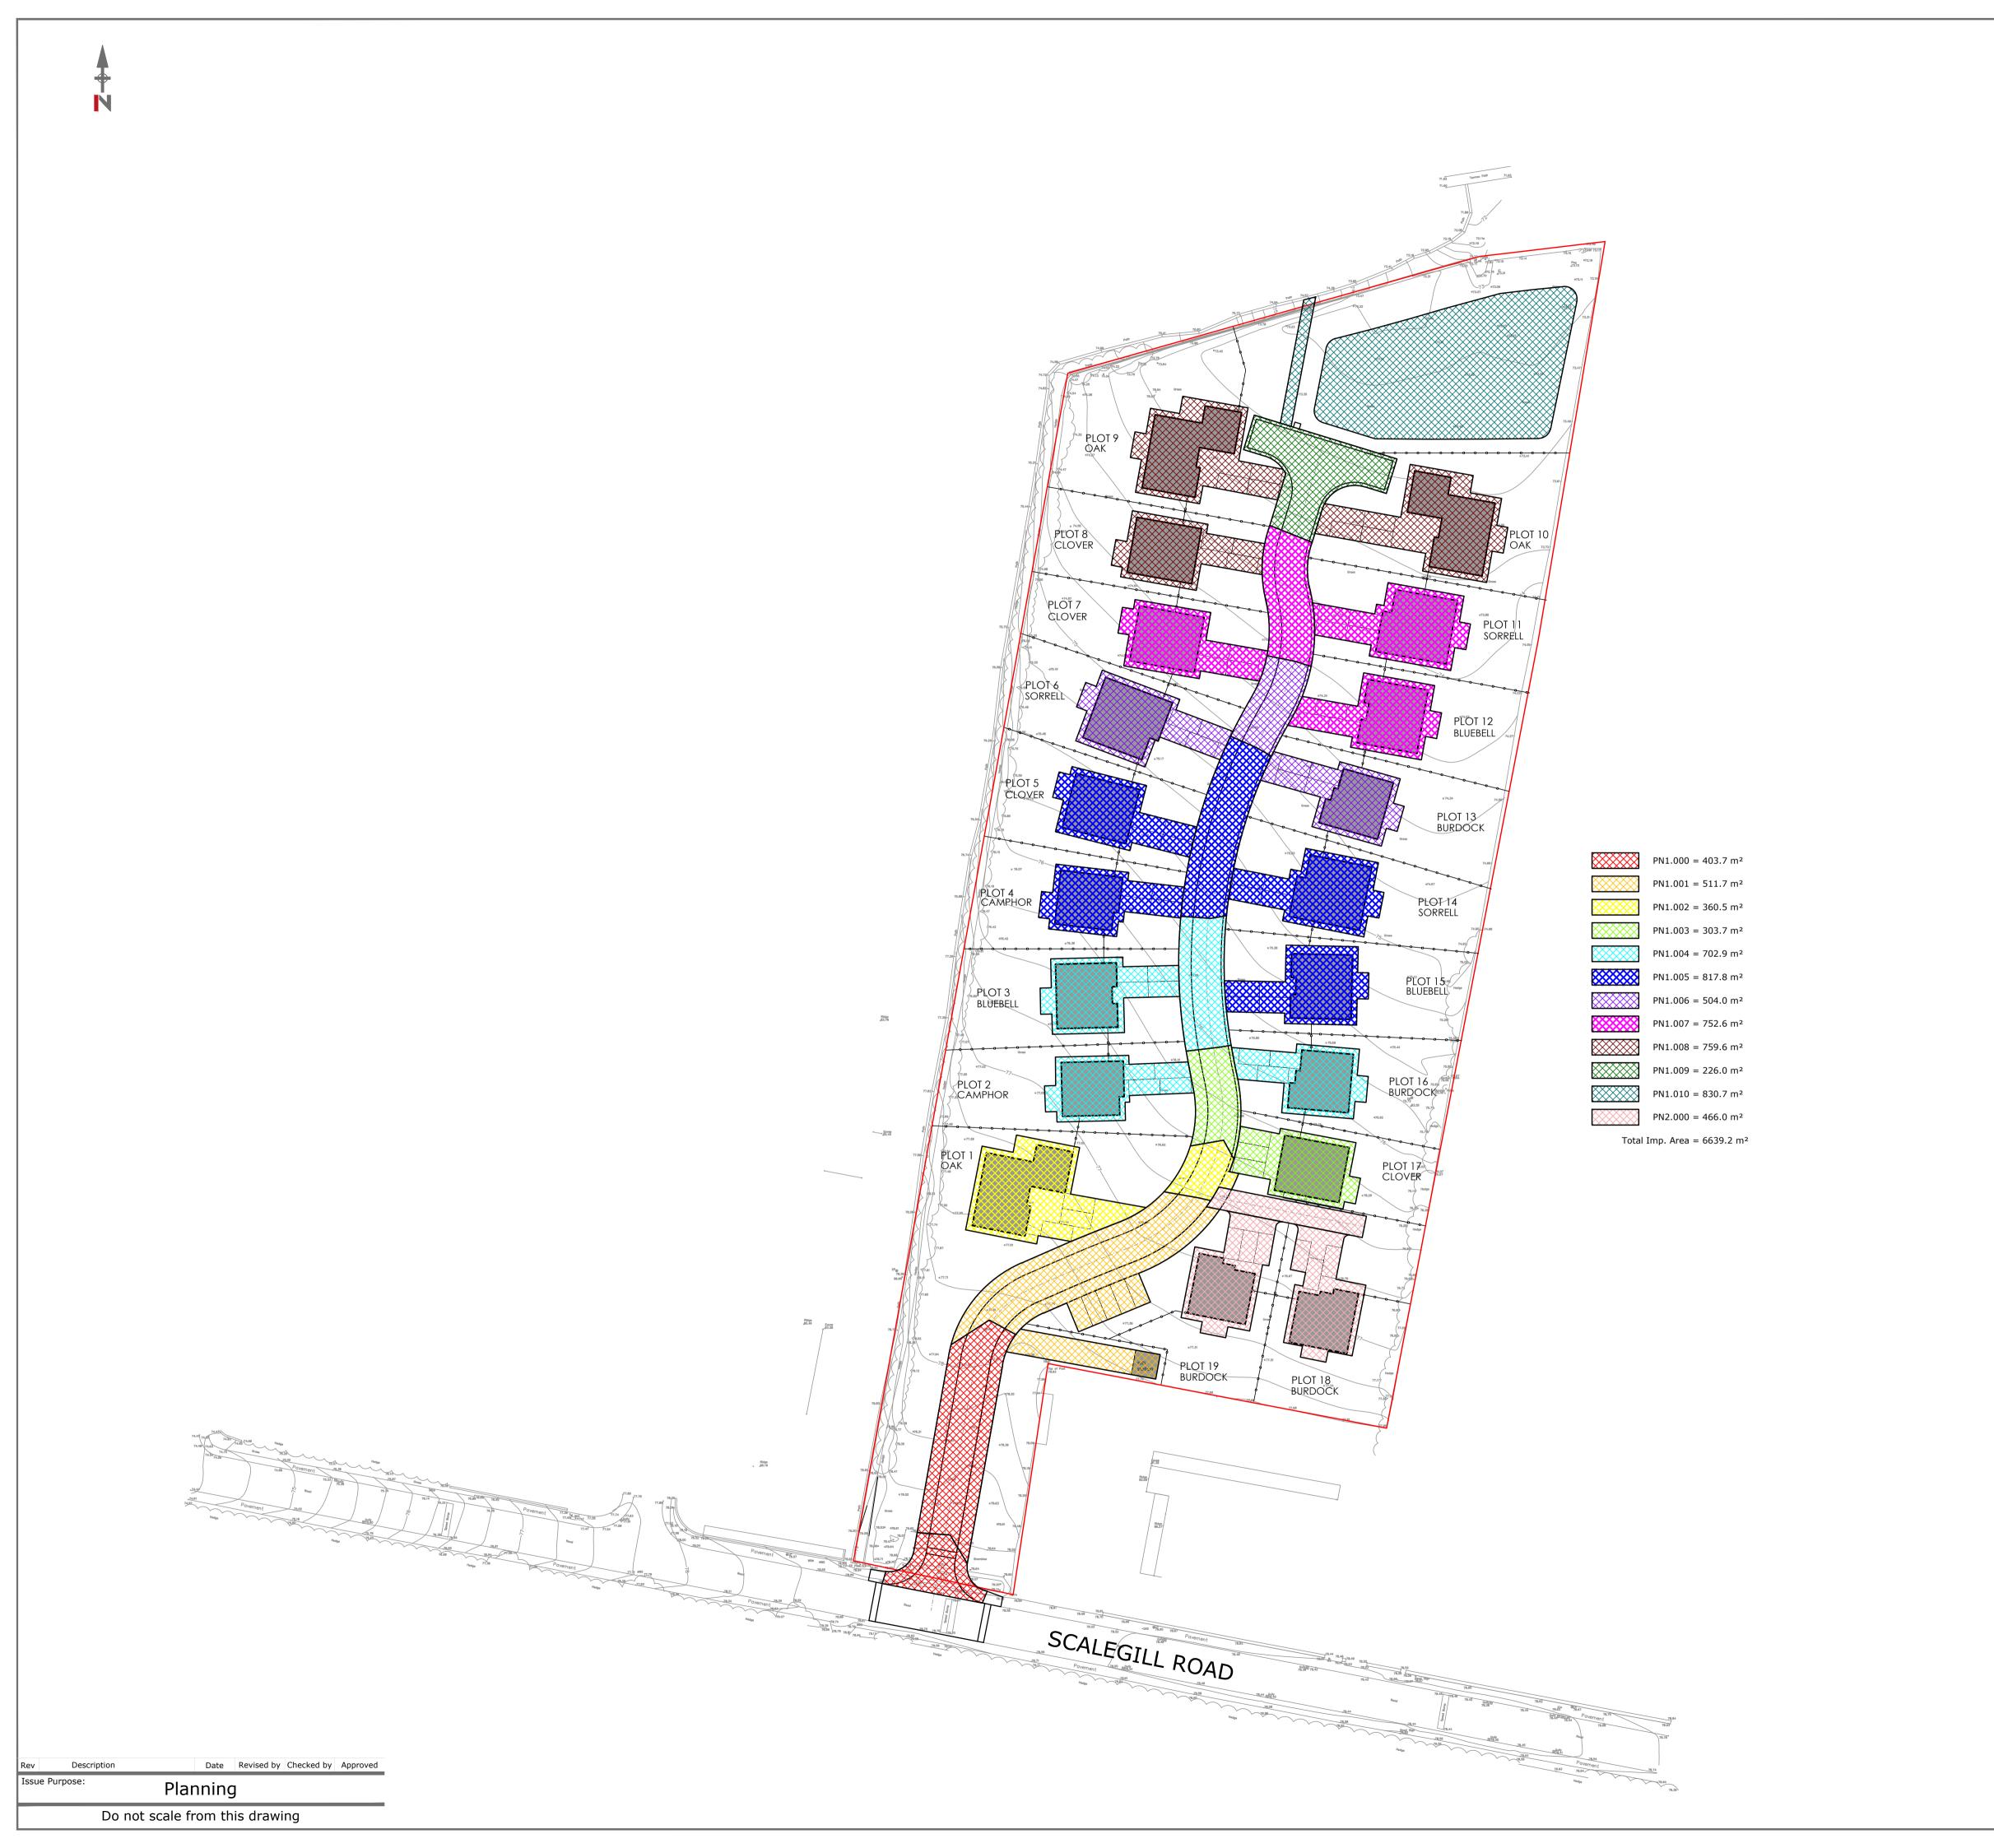
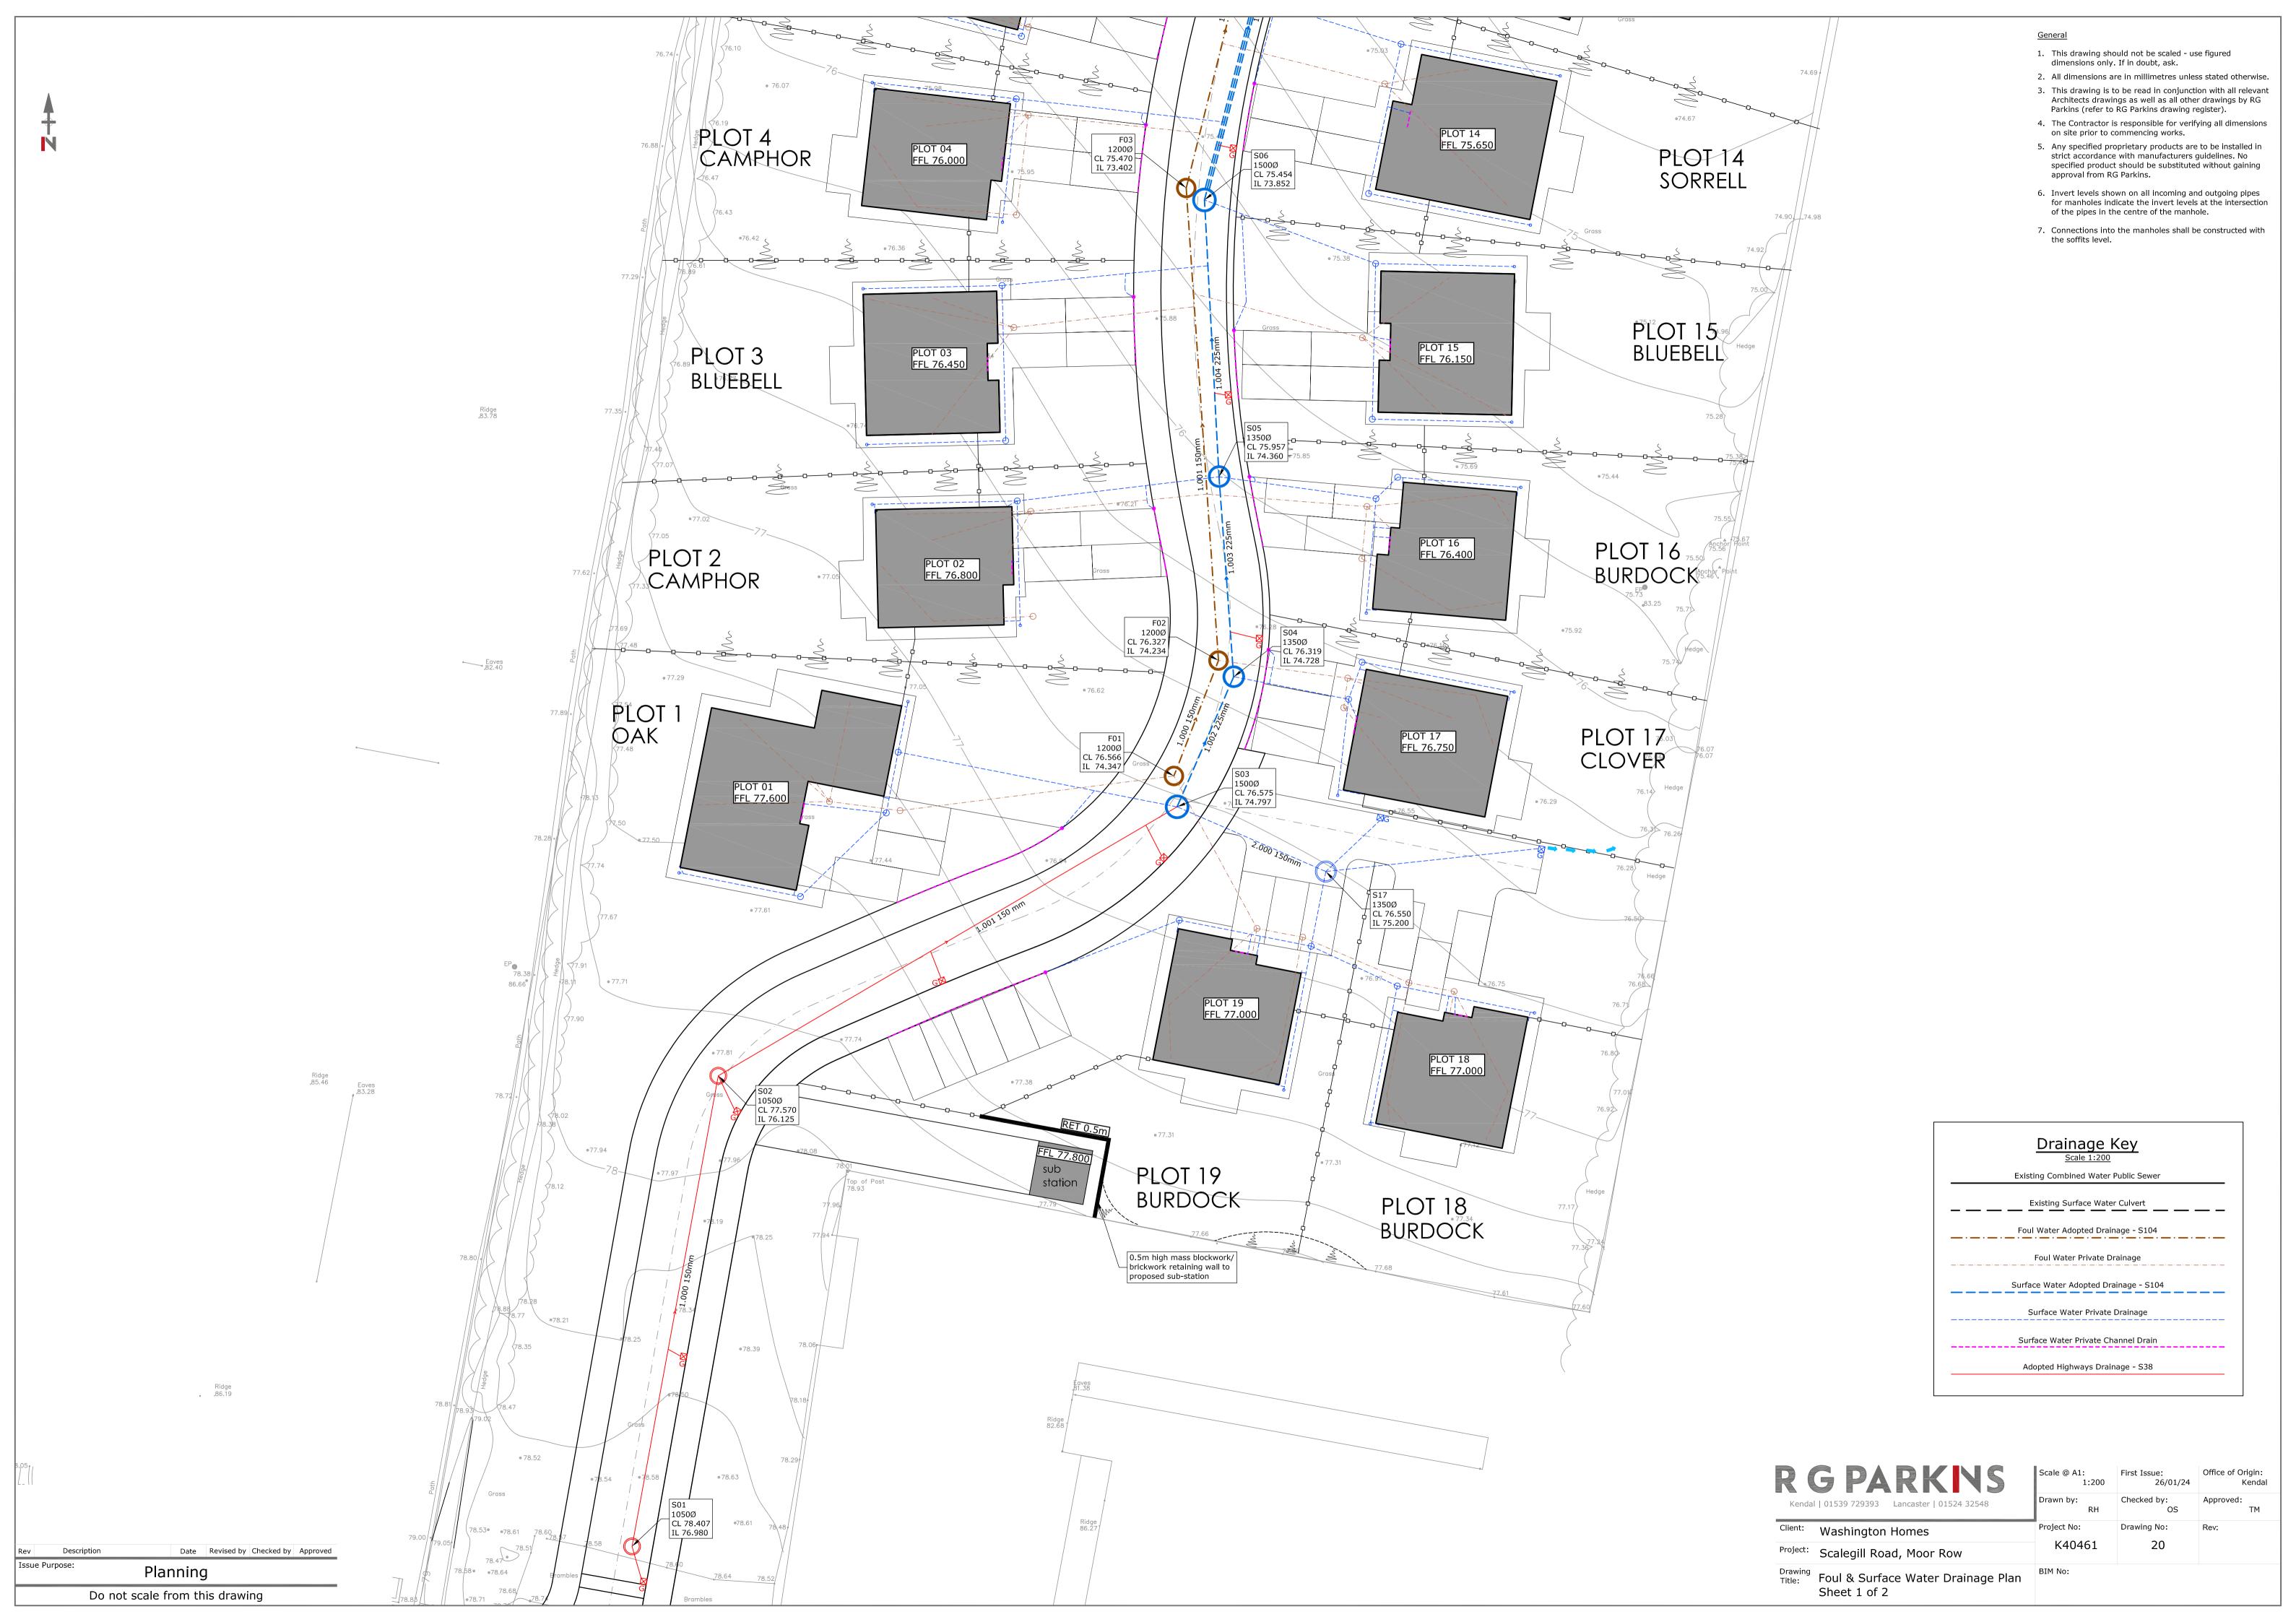
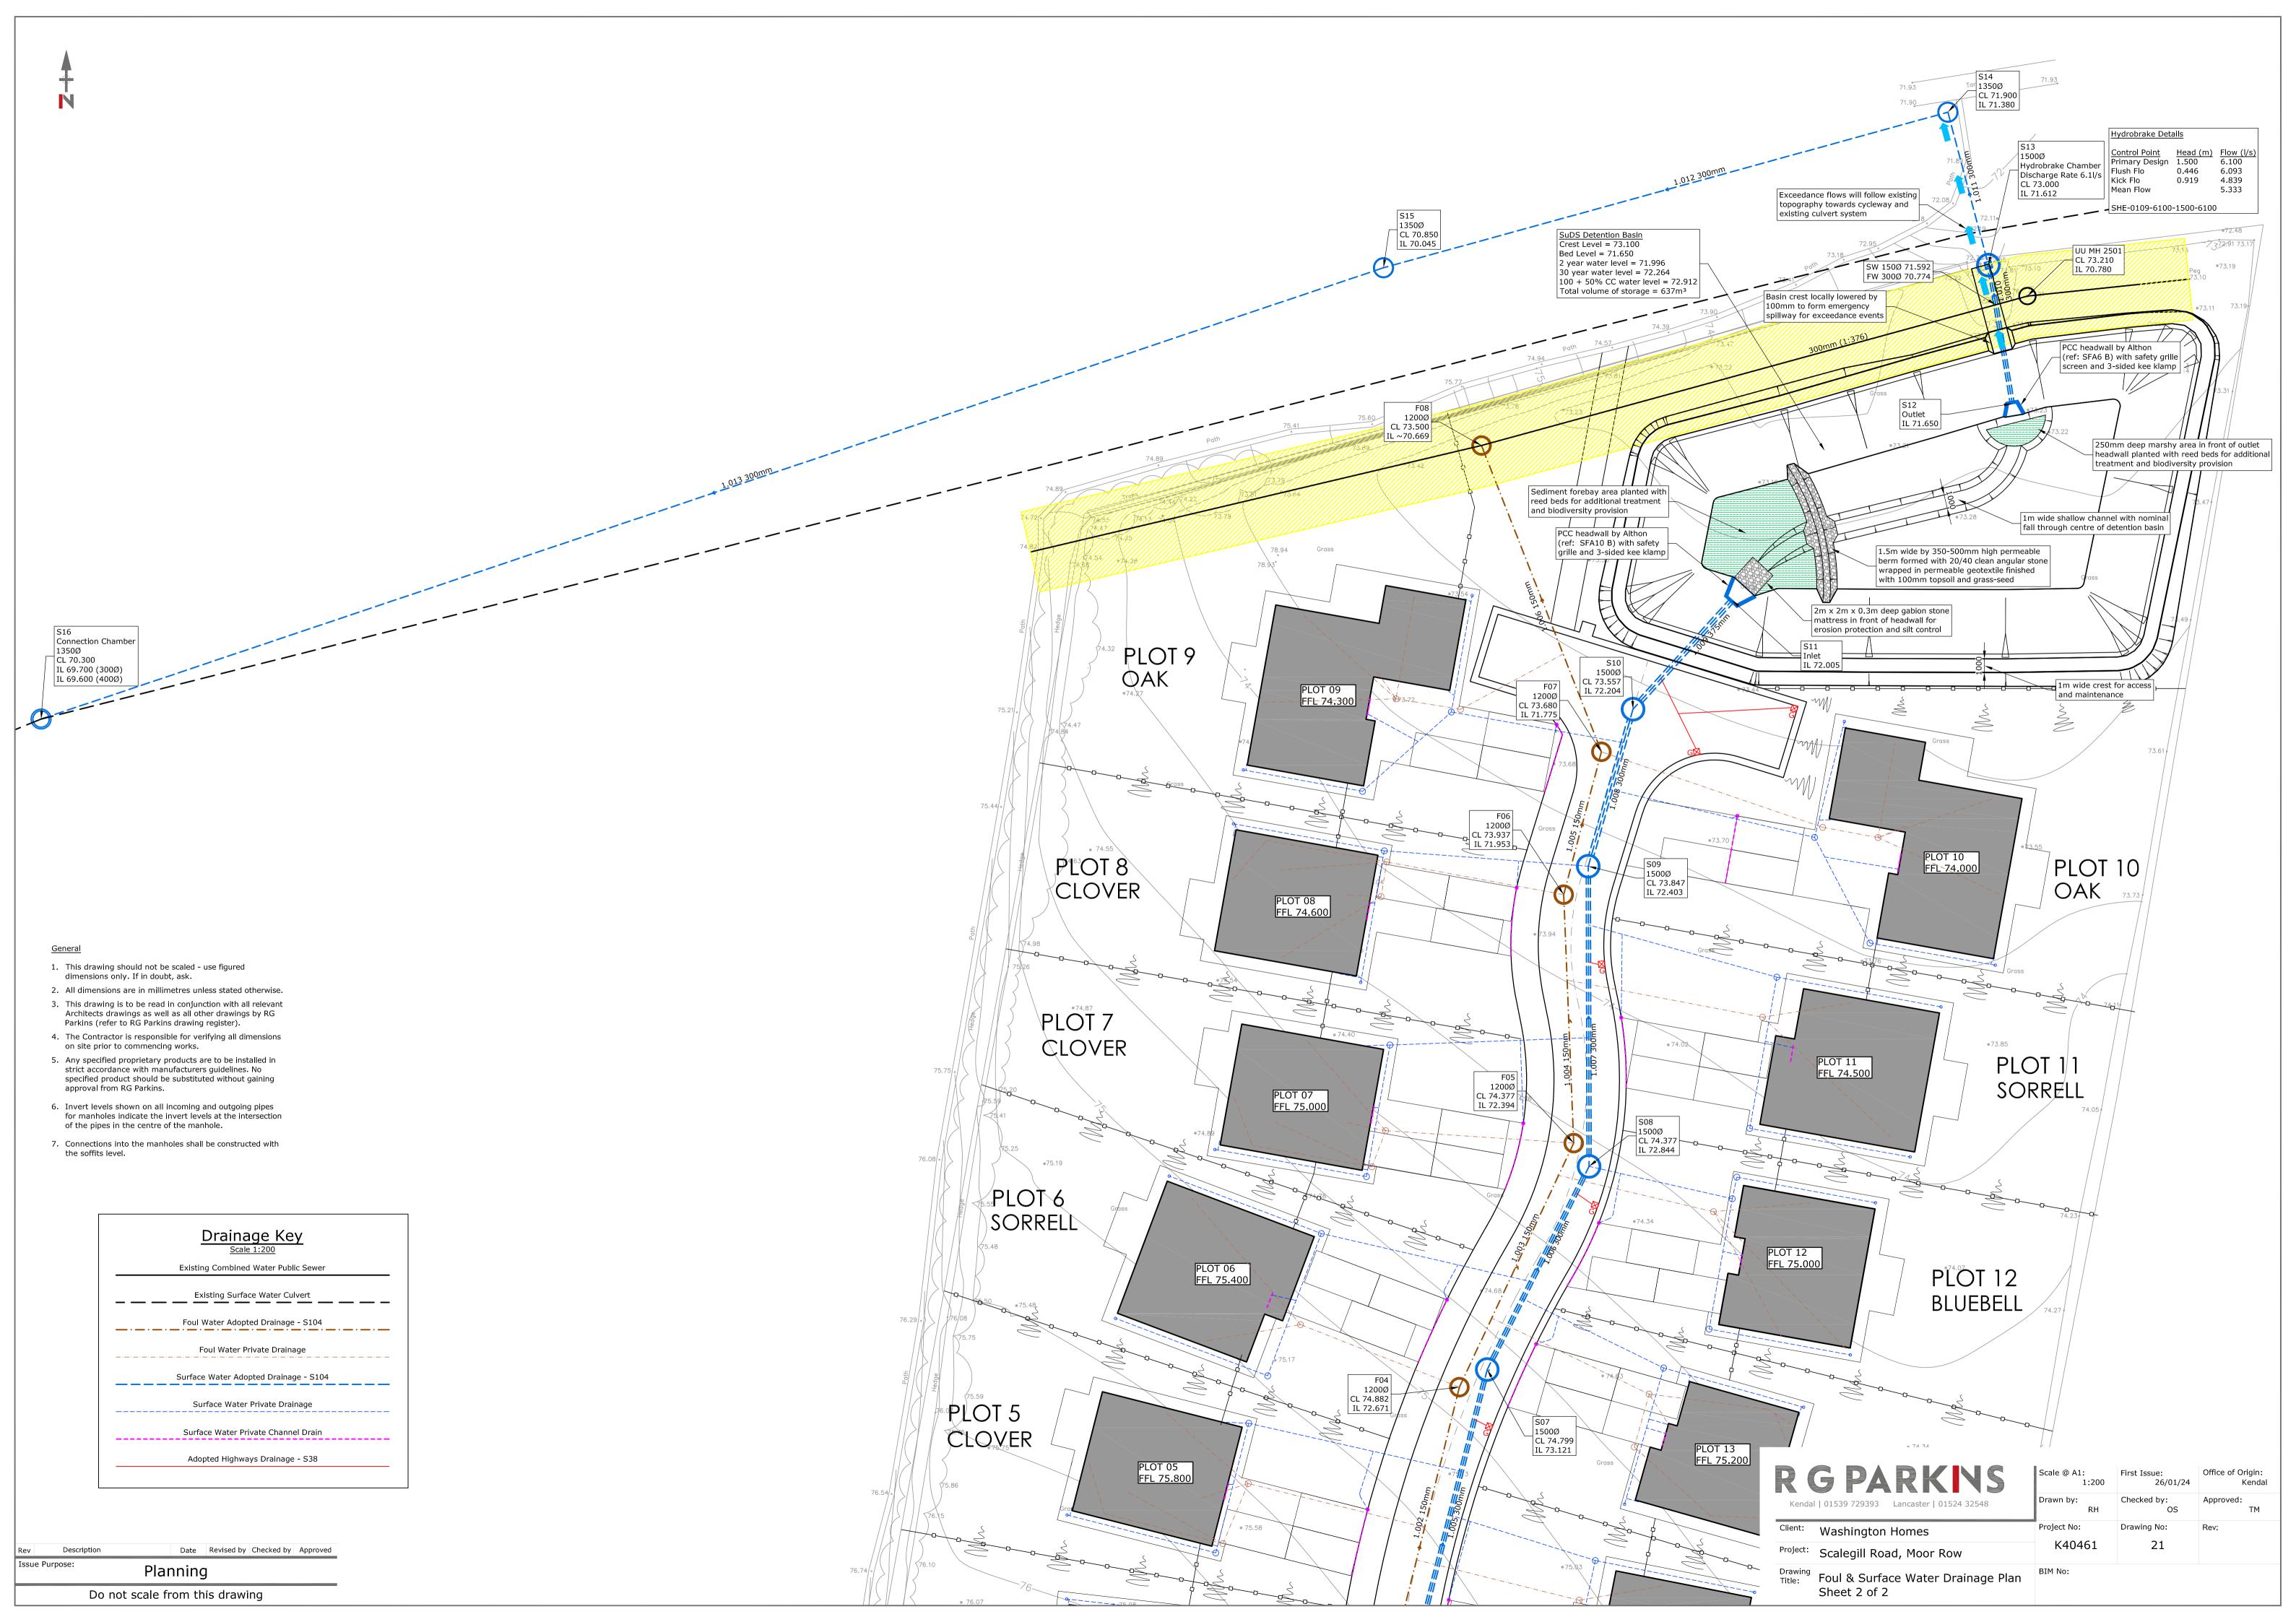
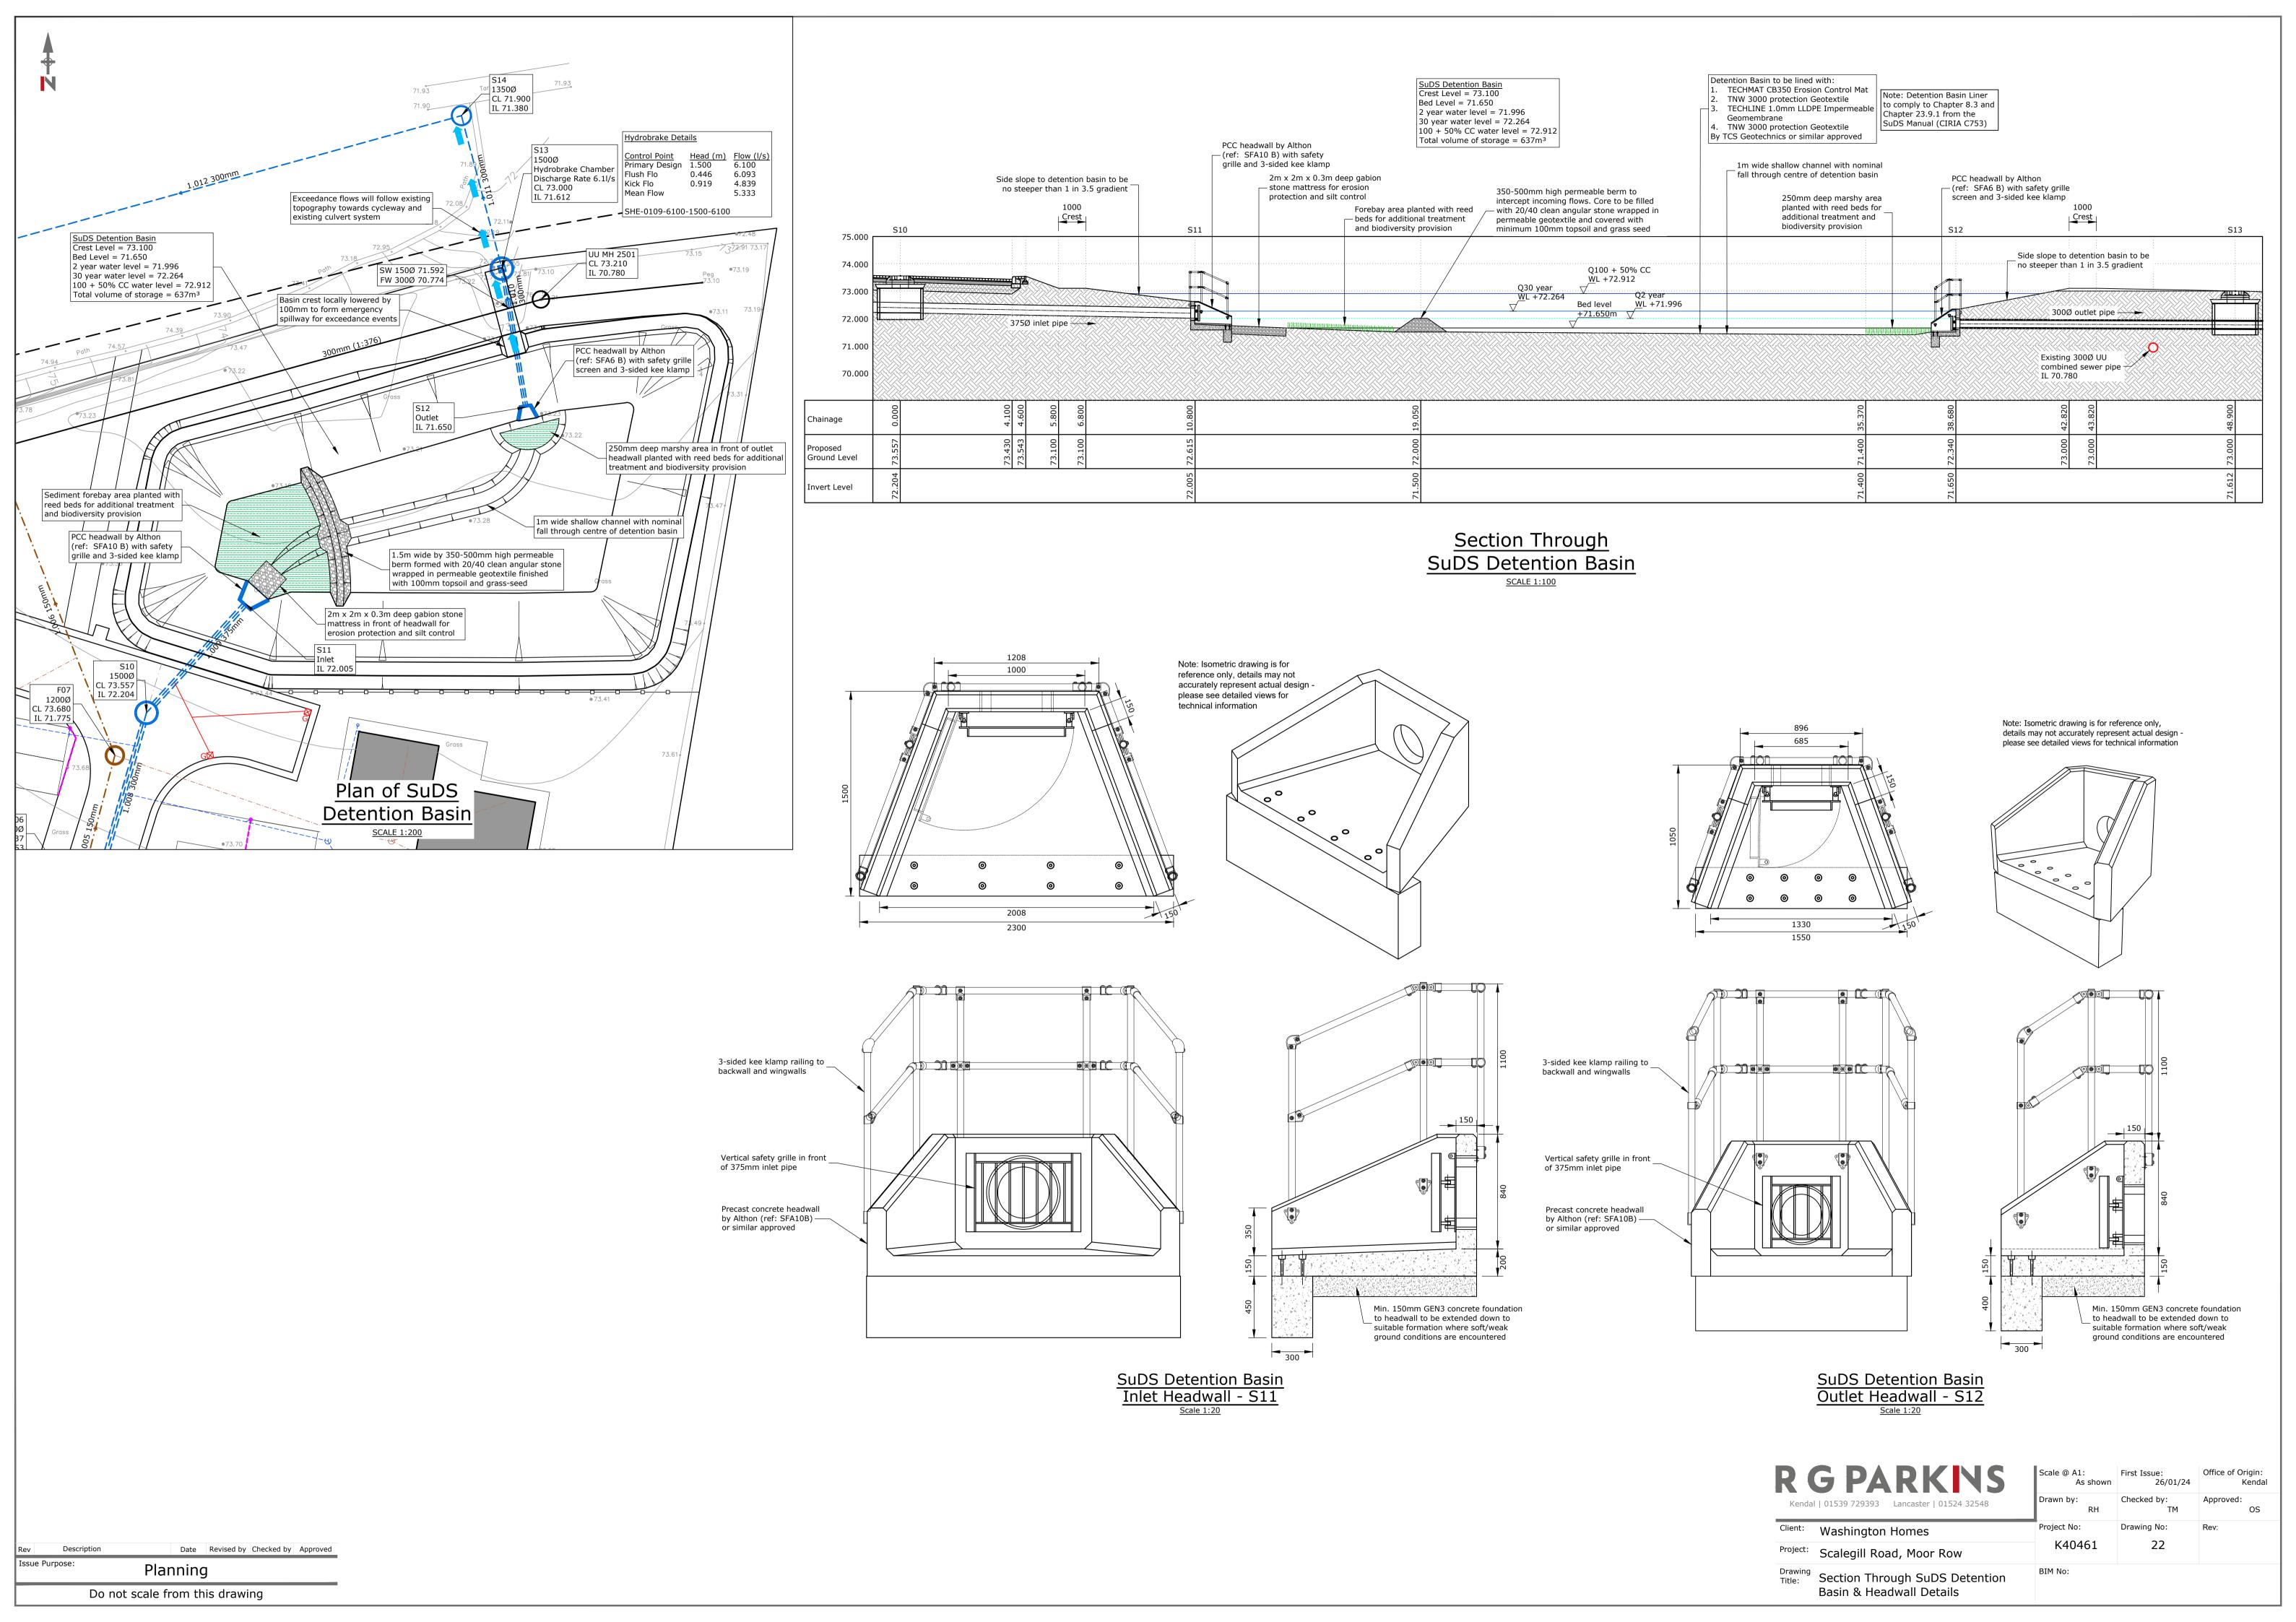
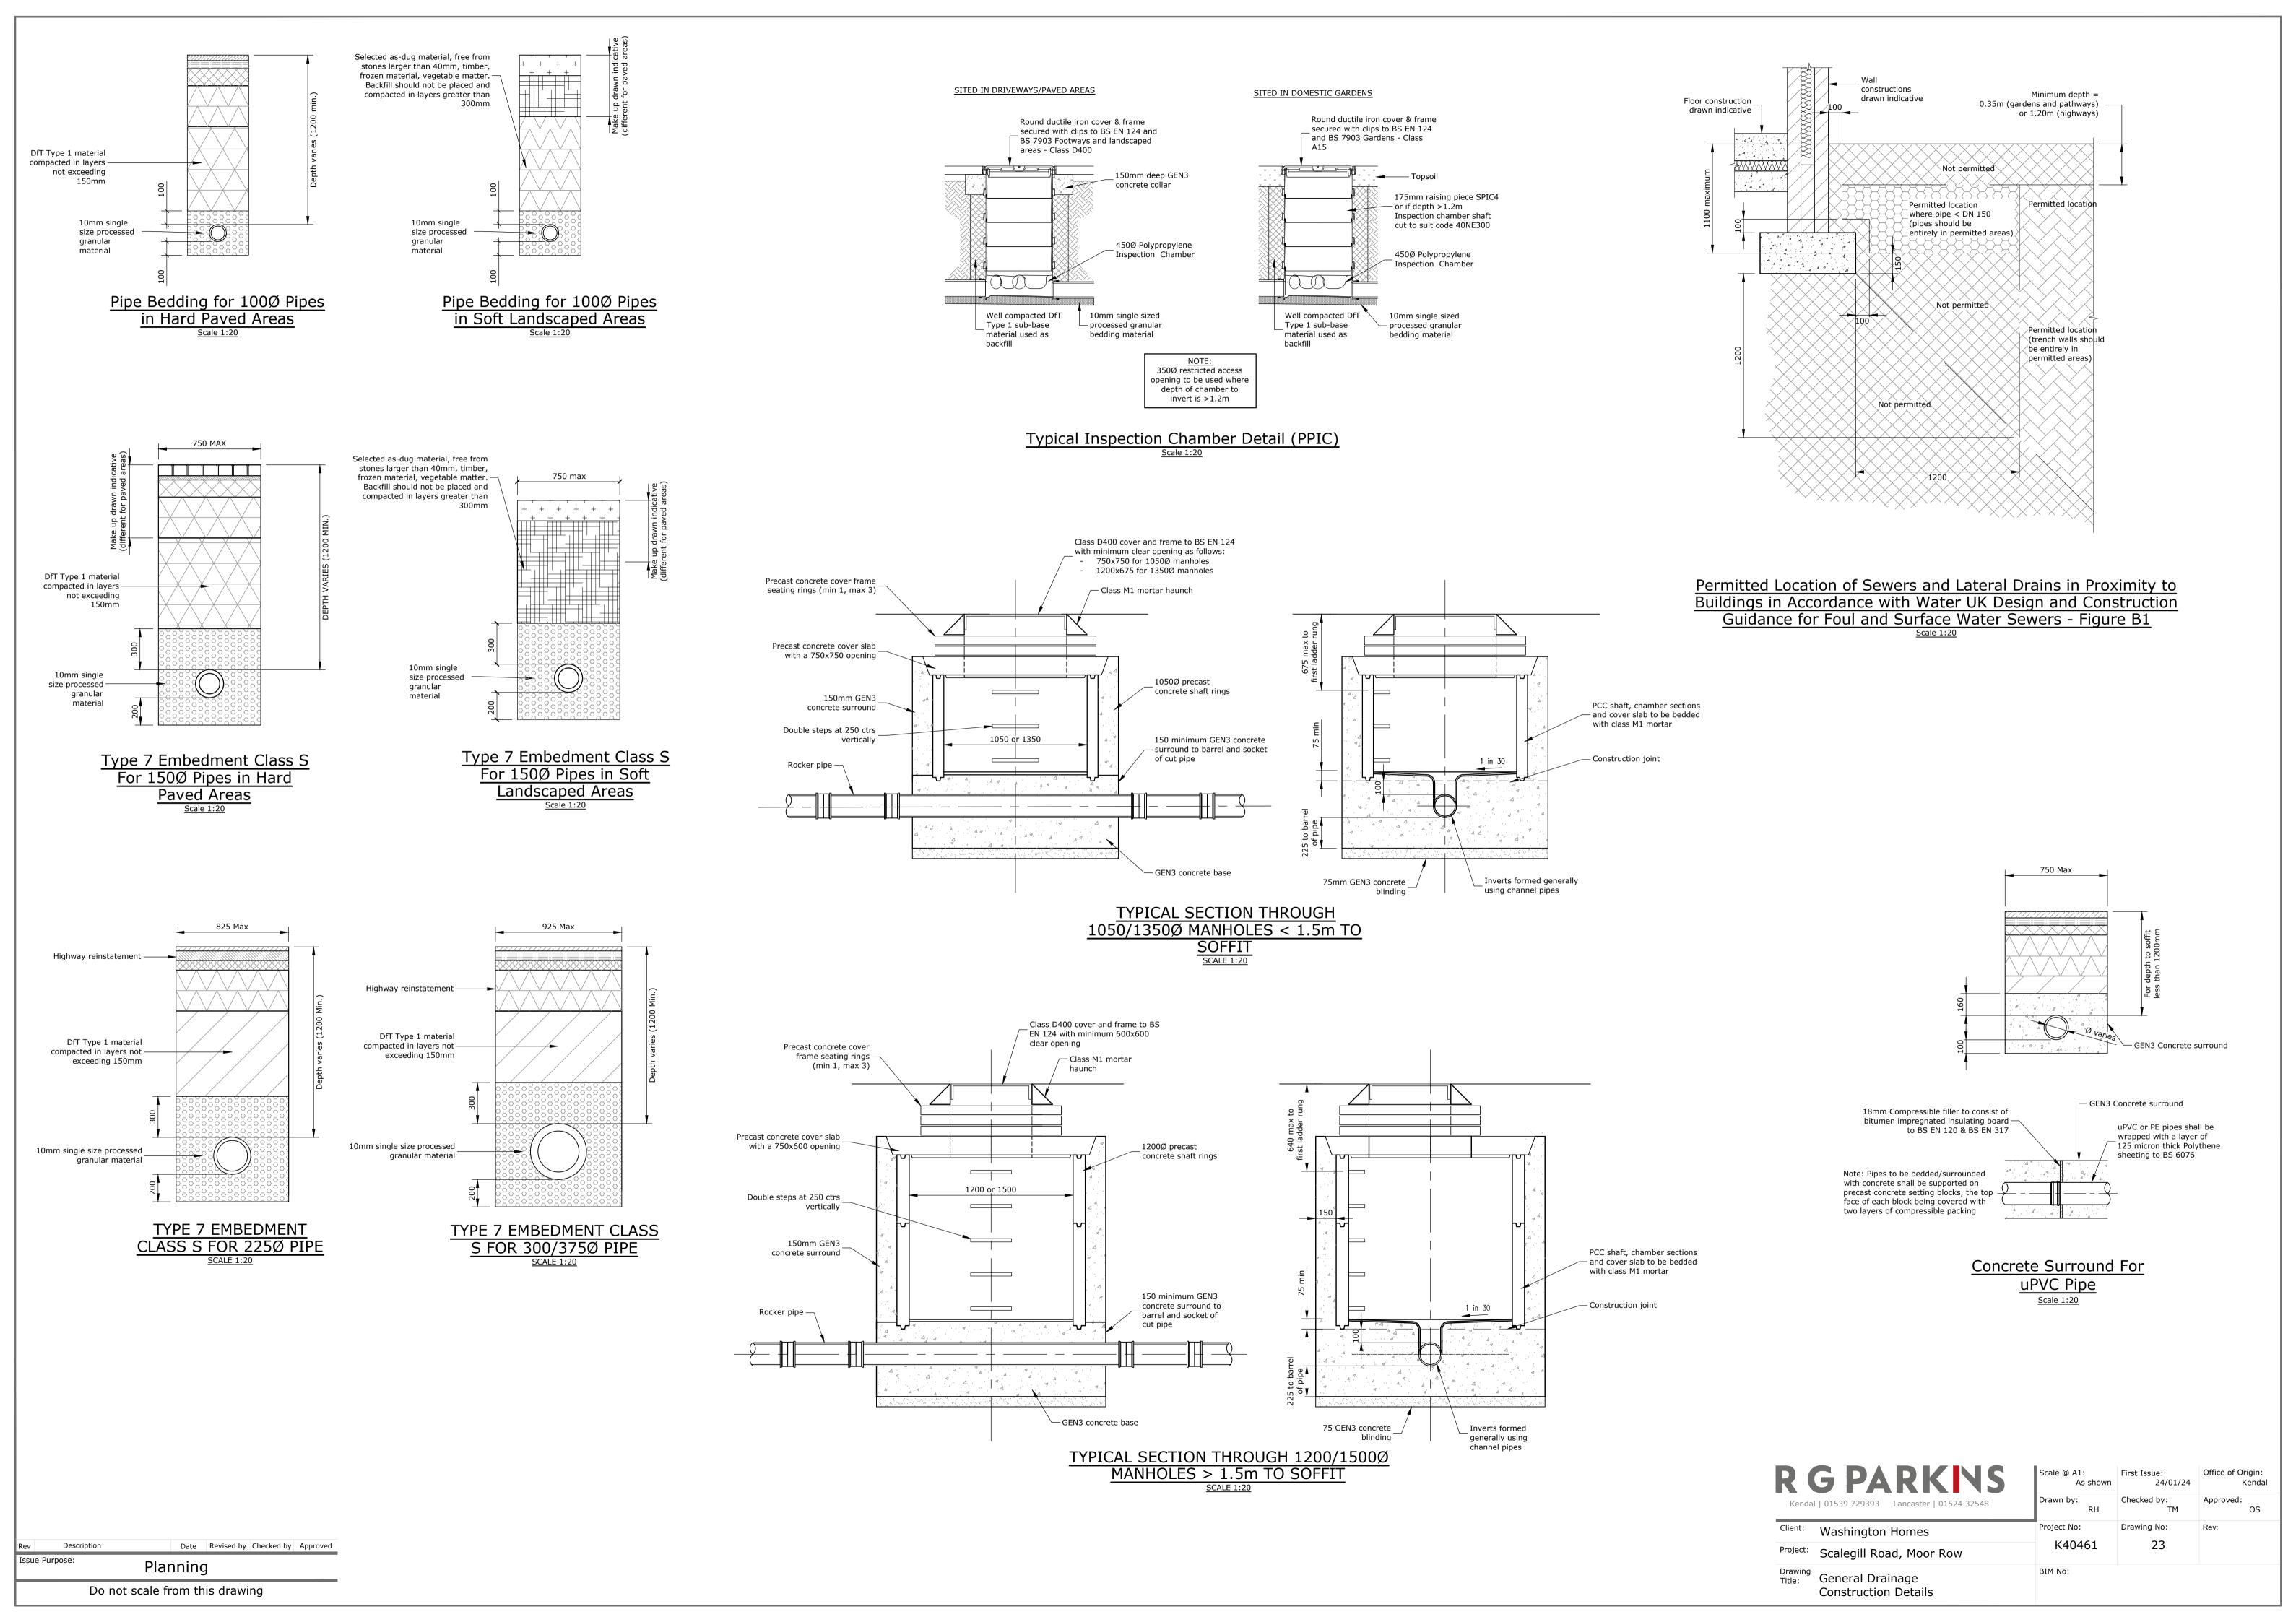
OUTLINE DRAINAGE LAYOUT

TYPICAL DRAINAGE DETAILS
