**GENESIS HOMES LTD
GENESIS HOUSE,
4 COWPER ROAD,
PENRITH,
CUMBRIA,
CA11 9BN**

**PRELIMINARY
ENVIRONMENTAL RISK ASSESSMENT
FOR
LAND ADJACENT TO KIRKLAND ROAD
ENNERDALE BRIDGE**

**Project No: EES17-099 v2
16th January 2018**

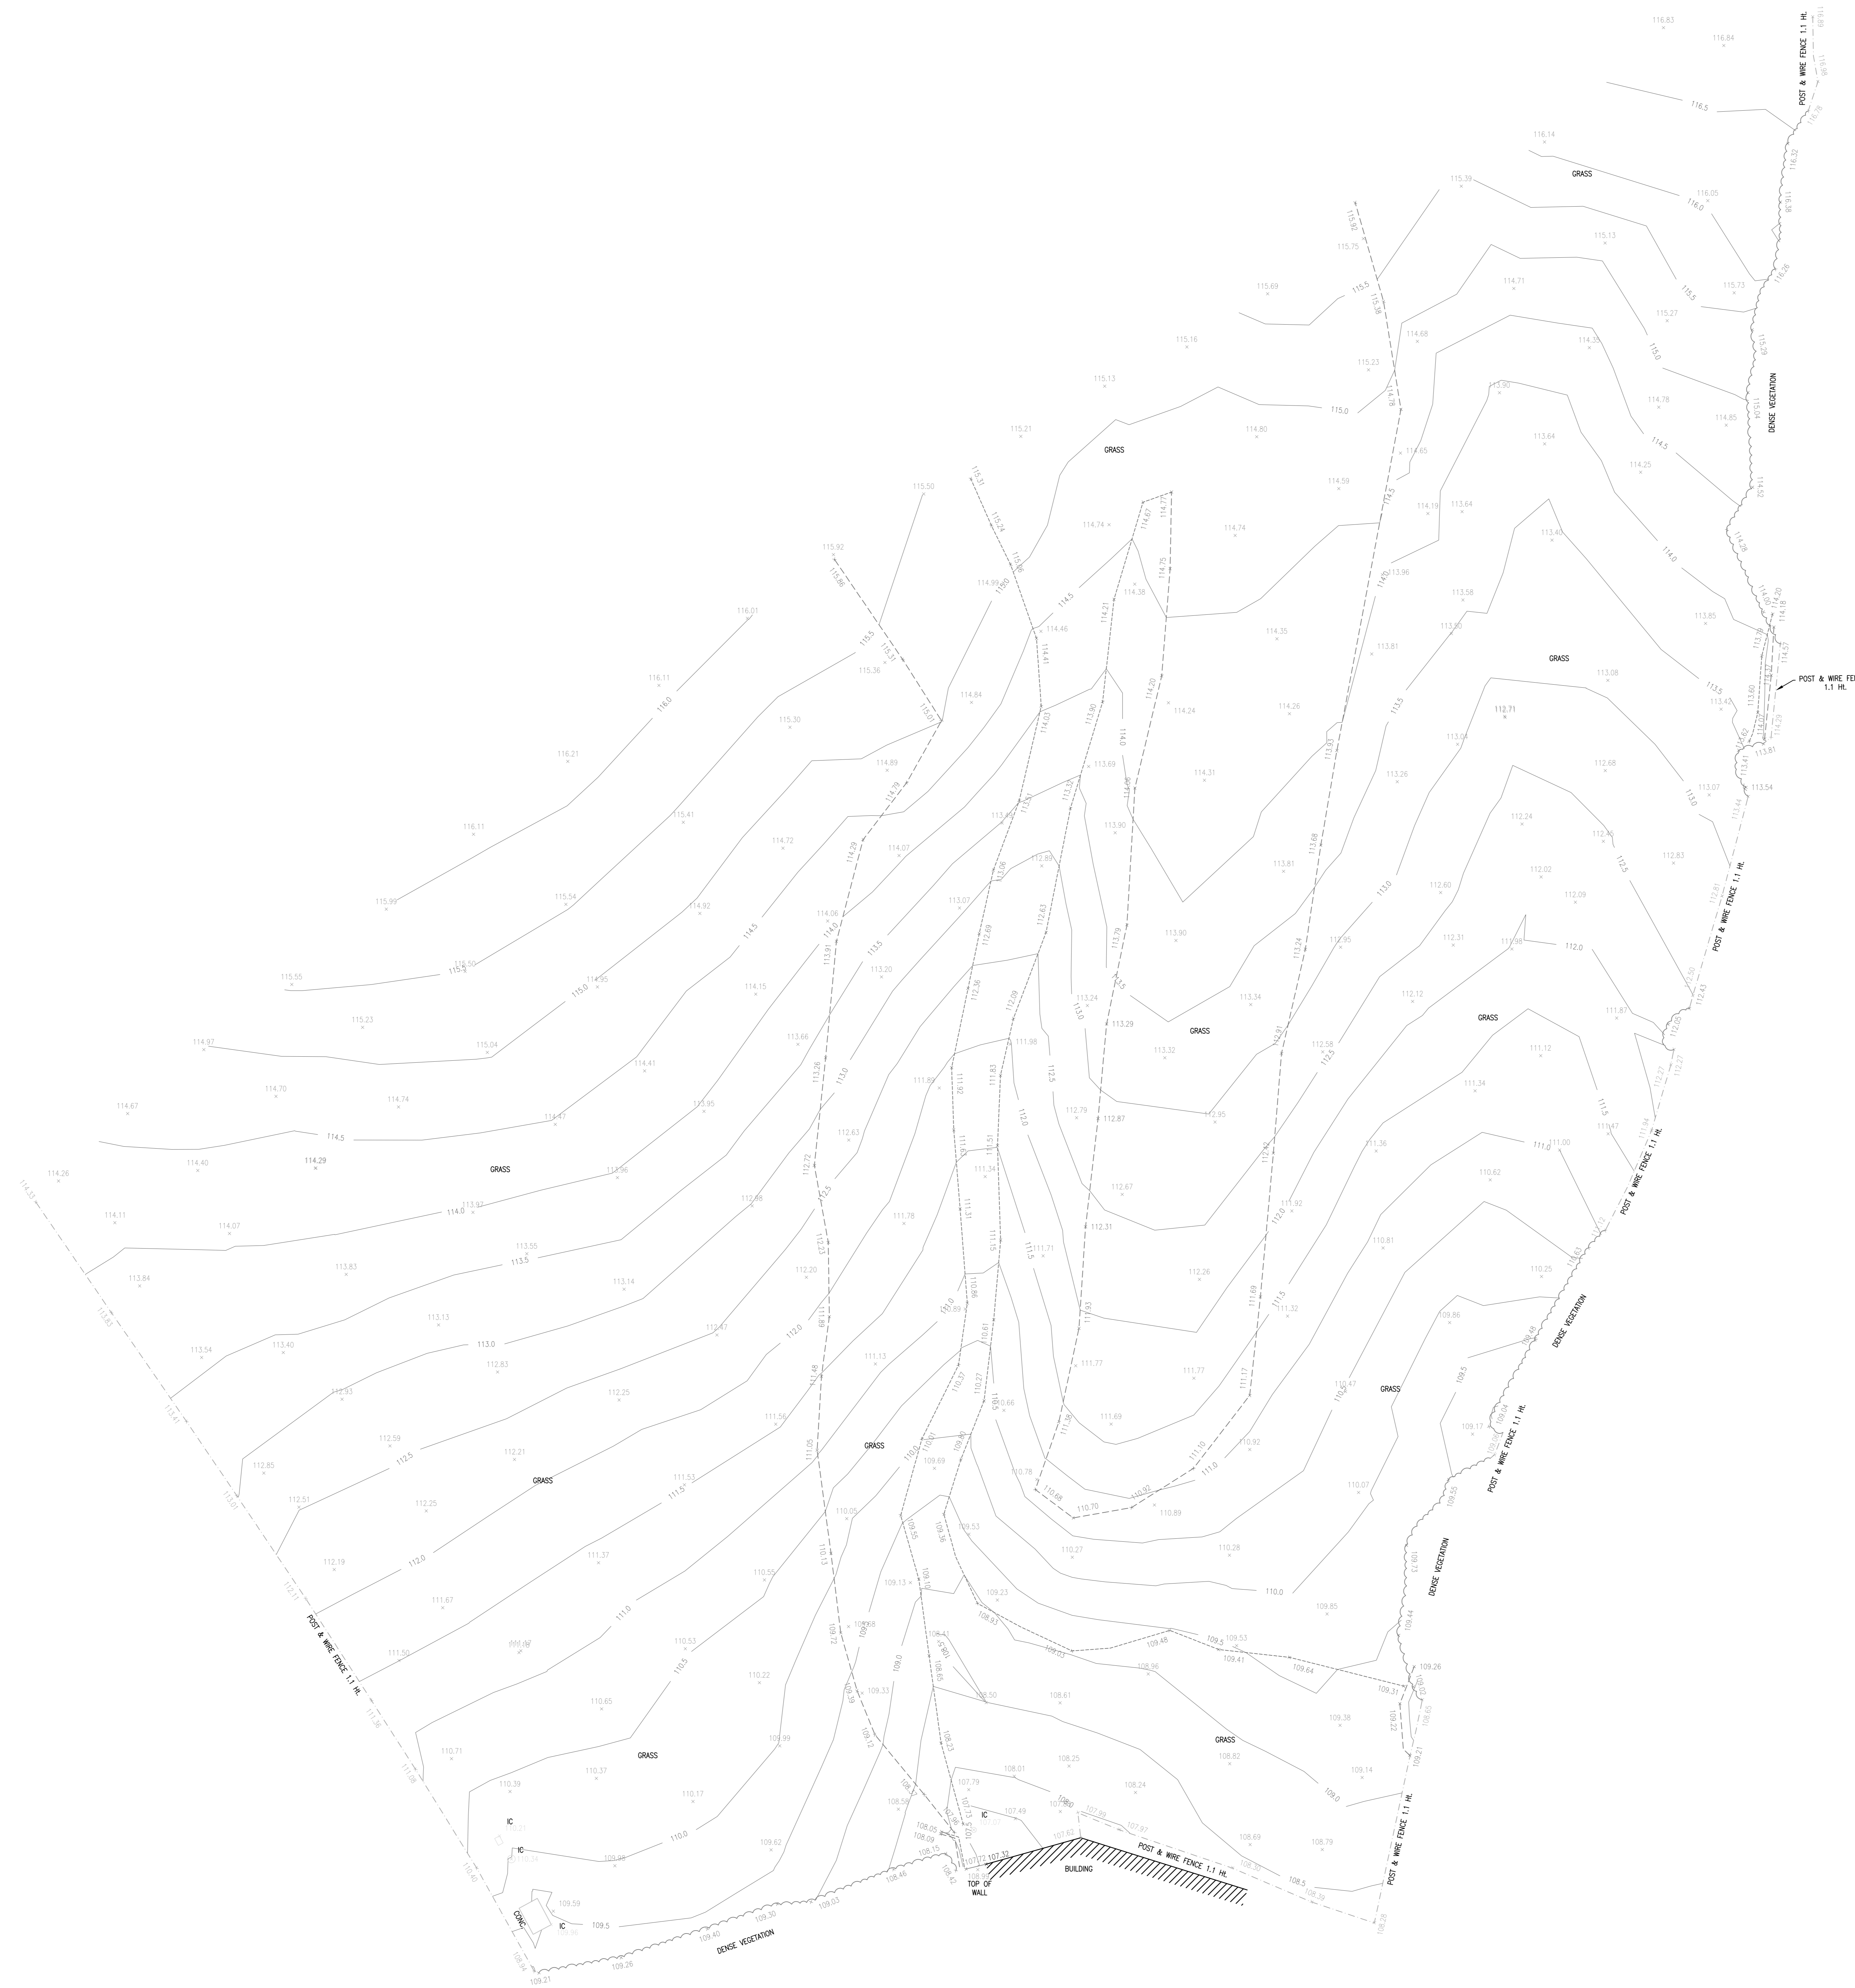
Drawing Title:
**ENNERDALE VIEW
TOPOGRAPHICAL SURVEY**

A topographical survey plan showing the application area with existing site layout and a further plan showing the proposed site layout are presented as Appendix 2.

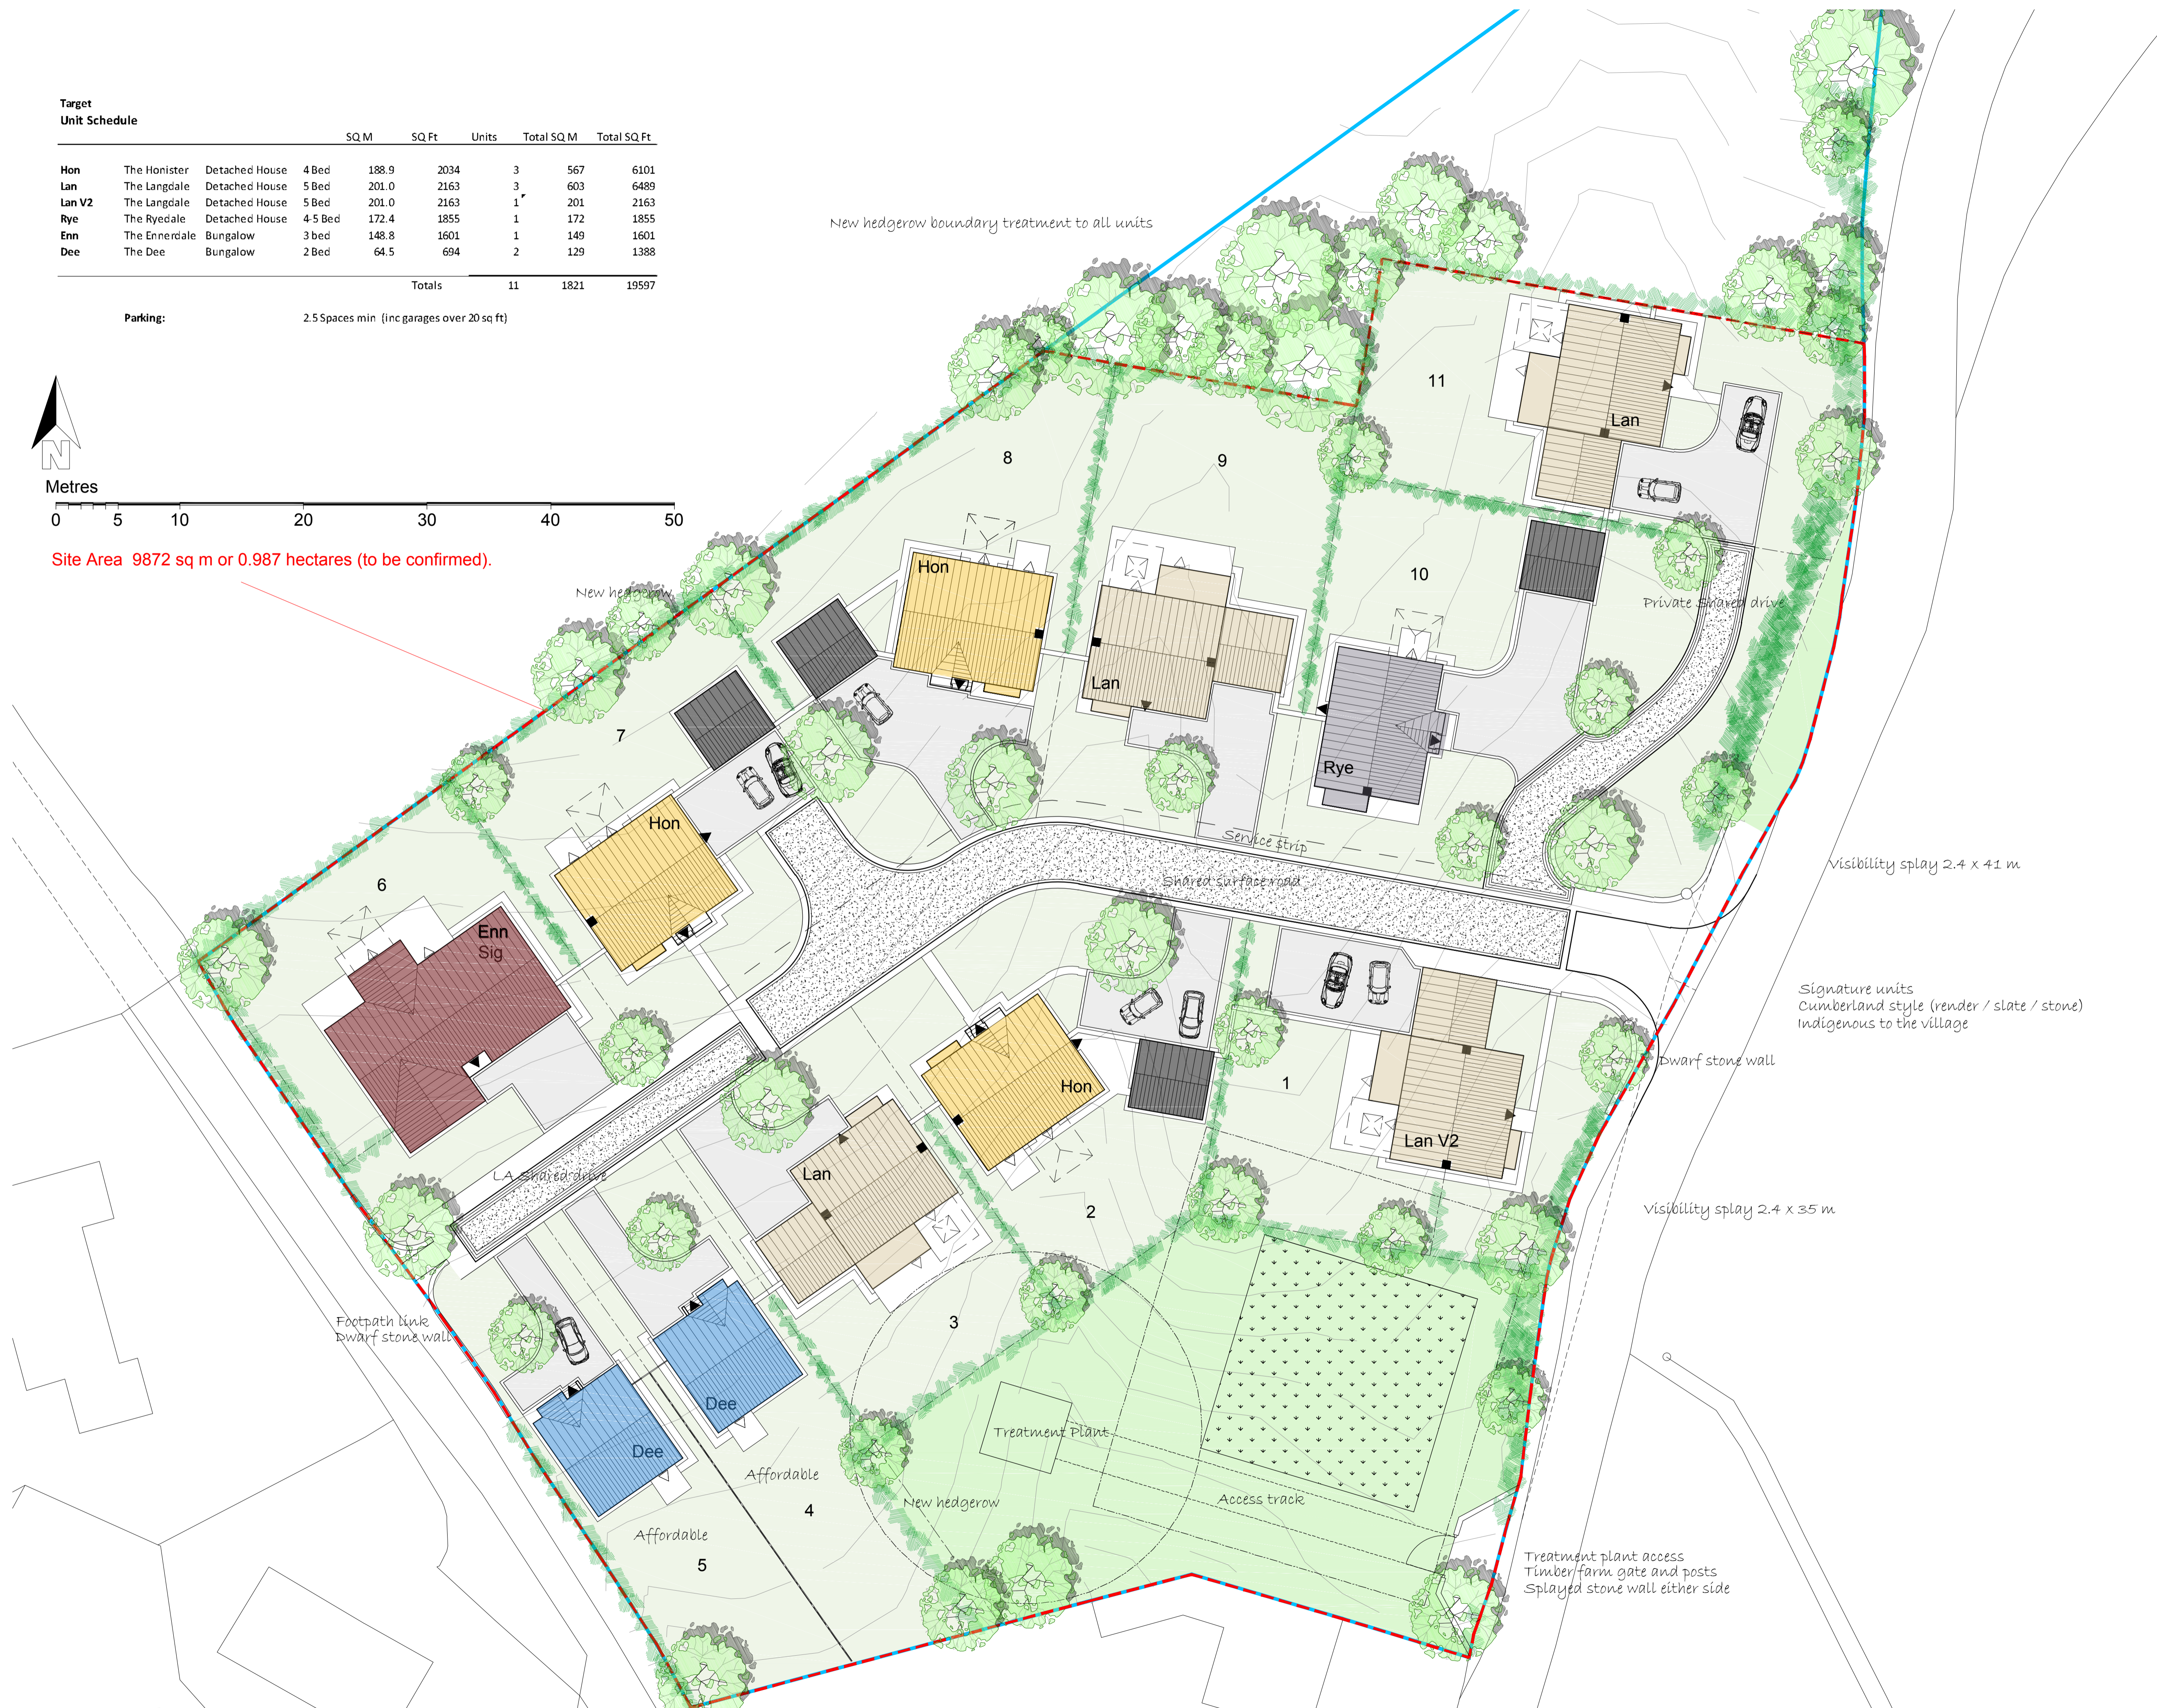
Site Area 9872 sq m or 0.987 hectares (to be confirmed).

visibility splay 2.4 x 41 m

Signature units
 Cumberland style (render / slate / stone)
 Indigenous to the village
