# **Bat and Barn Owl Survey**

## **Modern barn at Kilnmire Field, Lady Hall, Millom**

**28<sup>th</sup> May 2024**

**Report No. 0524/4**

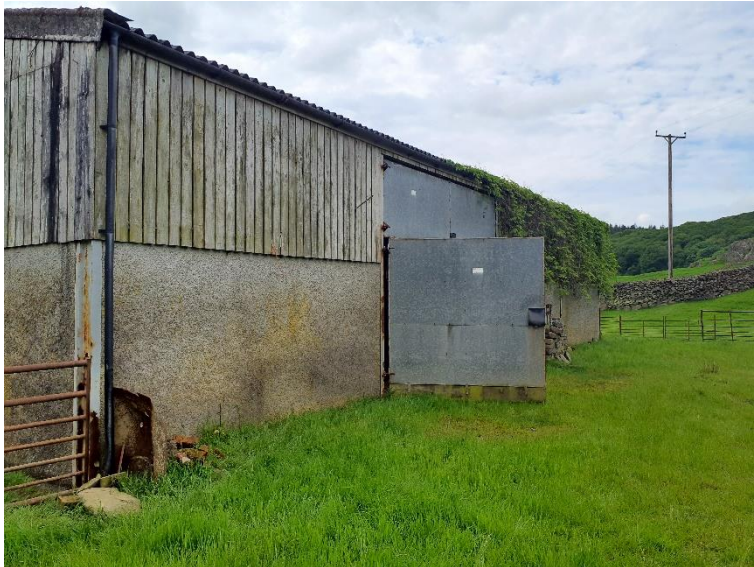
**Image 1.** Northern elevation showing large metal doors.

Small gaps above the doors could potentially allow access to the interior for small birds and for bats.

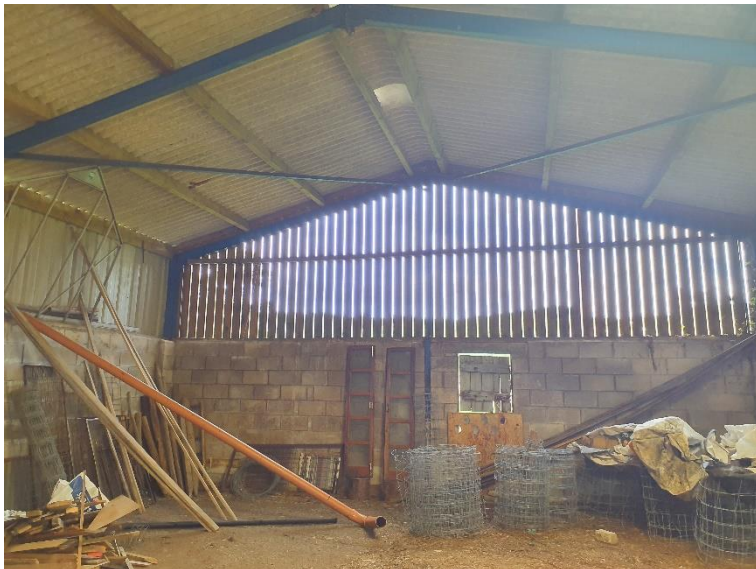
**Image 5.**  
Interior of the modern barn, western end.

Interior is light and airy, with no likely roost features for bats.
