**Isaburn, Kirkland**

**Preliminary Bat Roost Assessment Survey and Dusk  
Emergence Surveys for Bats**

**Project:** LE072 – Isaburn, Kirkland

**Report Date:** 15 July 2024

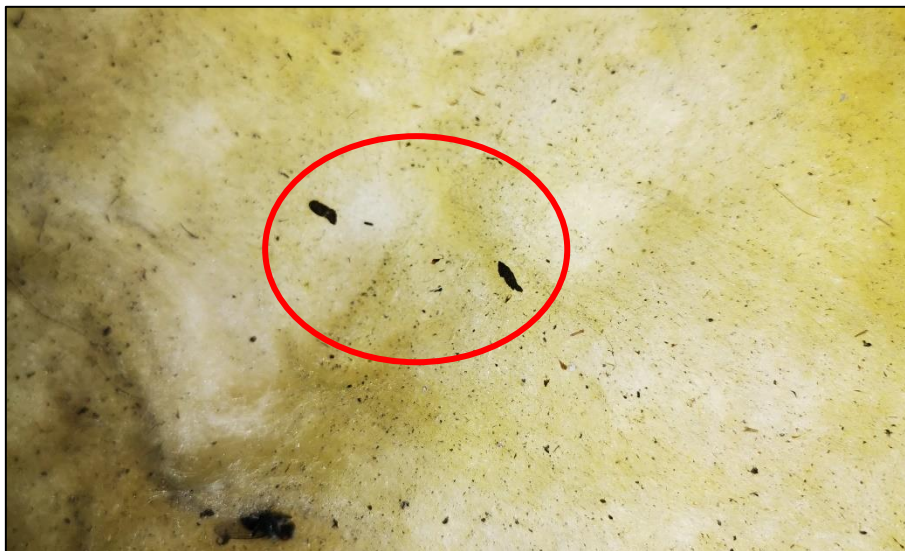
**Plate 1 – Old bat droppings on the rockwool insulation with the main loft**

During the Preliminary Bat Roost Assessment, a small number of old scattered bat droppings were identified within the main loft space of the building, with approximately four droppings counted during the survey (see Plate 1 and Figure 2 for the Site Plan with Evidence).

roof area. The droppings were relatively small, likely indicating the presence of pipistrelle species of bat *Pipistrellus sp.* The identified droppings appeared relatively old and crumbly, suggesting they were not from the recent bat active seasons.

As no evidence of current bat roosting activity was found within the roof of the building, it is considered that there are no active bat roosts currently present within the building and the old droppings identified within the loft resulted from an individual / opportunistic bat investigating the loft of the building in the past.

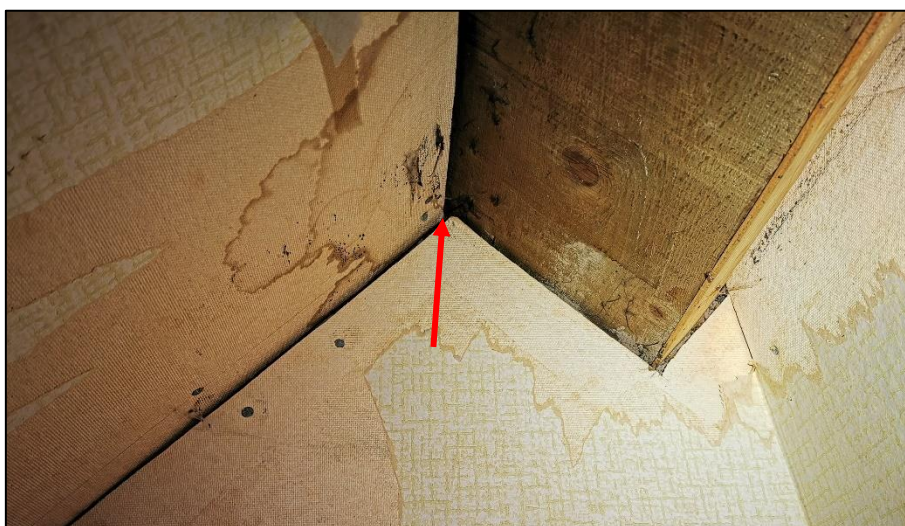
**Plate 2 – Bat dropping adjacent to the roof boarding within the cupboard**

Additionally, a single bat dropping was identified adjacent to the small gap between the roof boarding and the roof timber in the upper floor cupboard in the southwest section of the building (see Plate 2 and Figure 2).

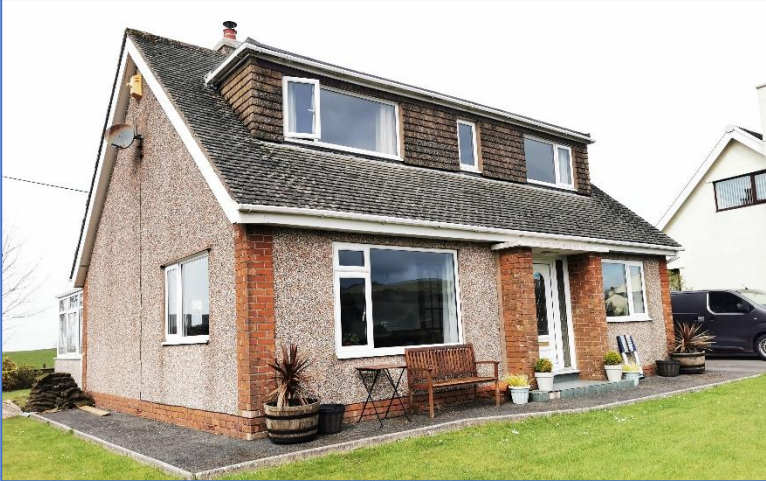
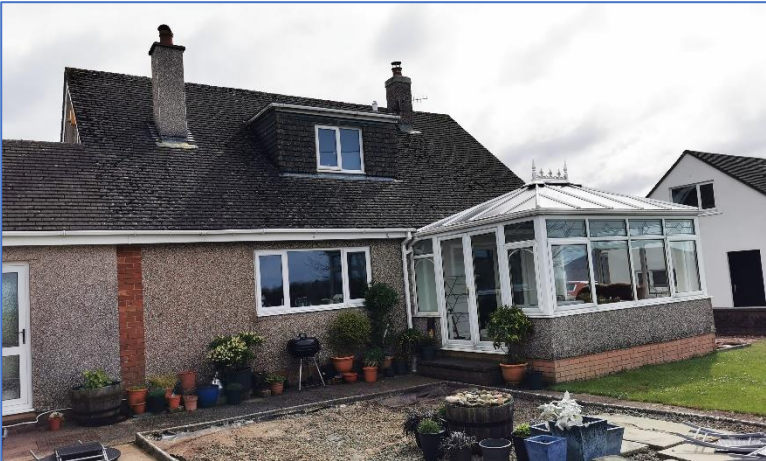
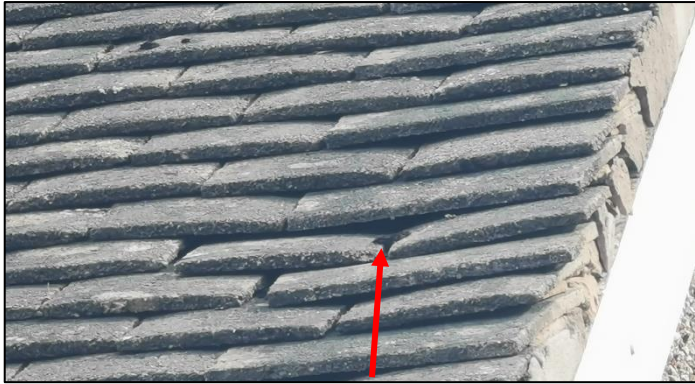
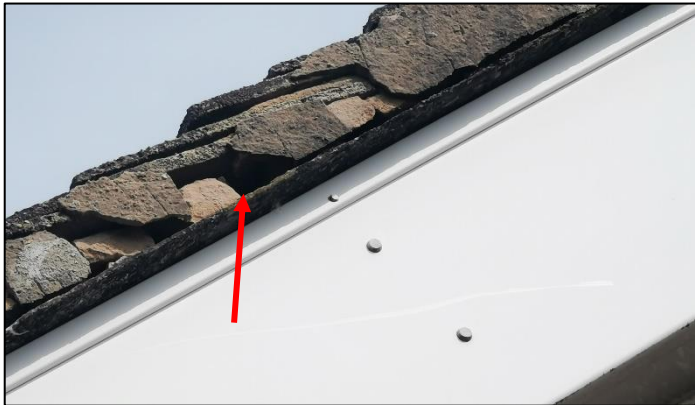
Description	Potential Roosting Features	Bat Roost Suitability
<p>The main building on the site was a two-story, brick-built residential dwelling, which was rendered on the exterior.</p>

<p>Gaps under lifted tiles at several location throughout the roof - roosting potential for crevice dwelling species between the roof covering and underlying bitumen felt.</p>

<p>Few gaps under edge roof tiles – southern gable</p>

<p>Moderate</p>

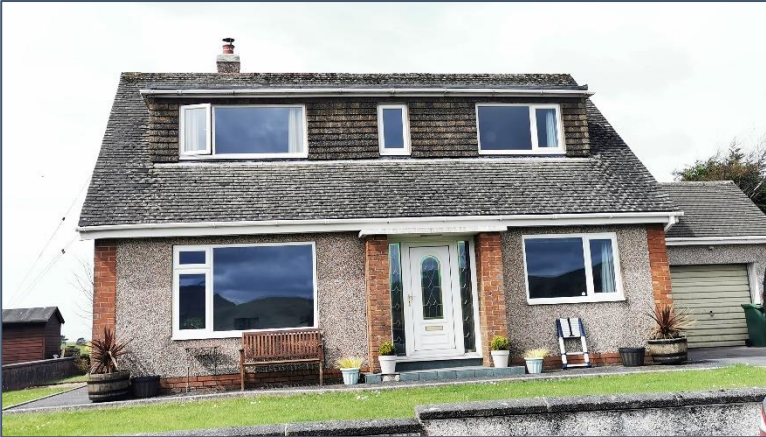
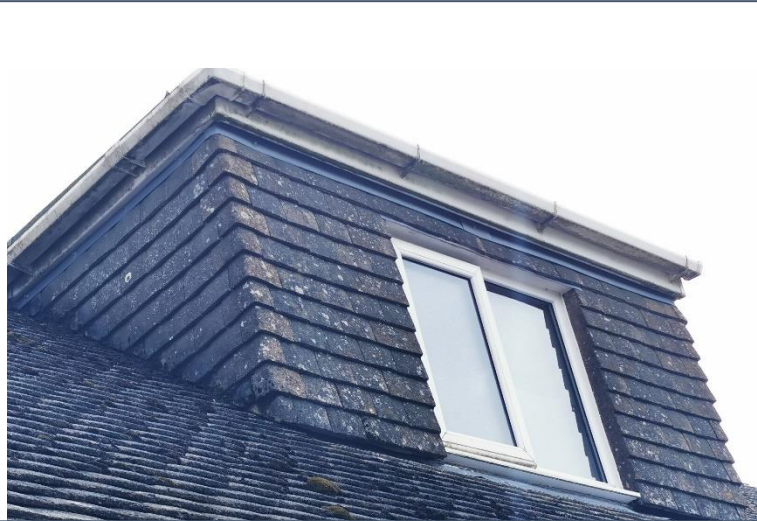
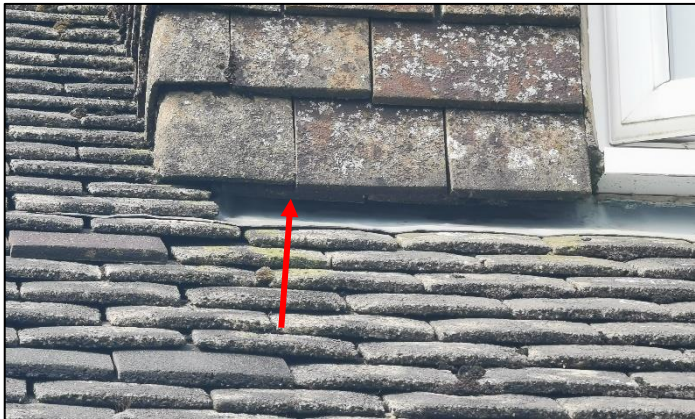
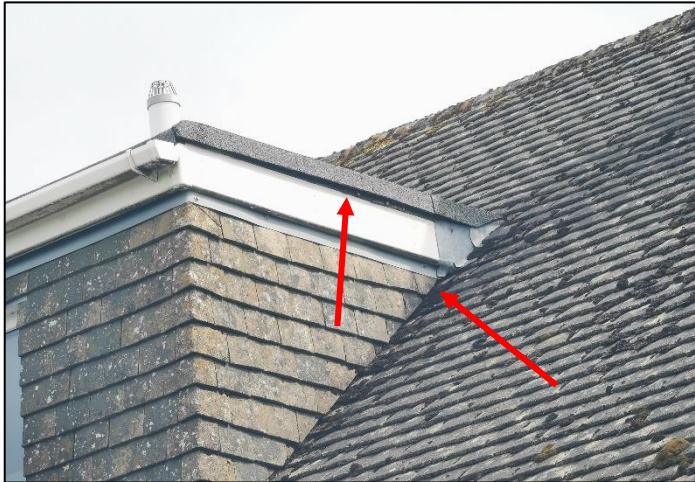
Description	Potential Roosting Features	Bat Roost Suitability
<p>The roof of the main house was finished with concrete tiles and lined underneath with bitumen felt. There were two dormers along the eastern and western elevations.</p>

<p>Gaps around dormers – where dormers join the main roof. Gaps behind the dormer roof overlap.</p>

<p>Moderate</p>

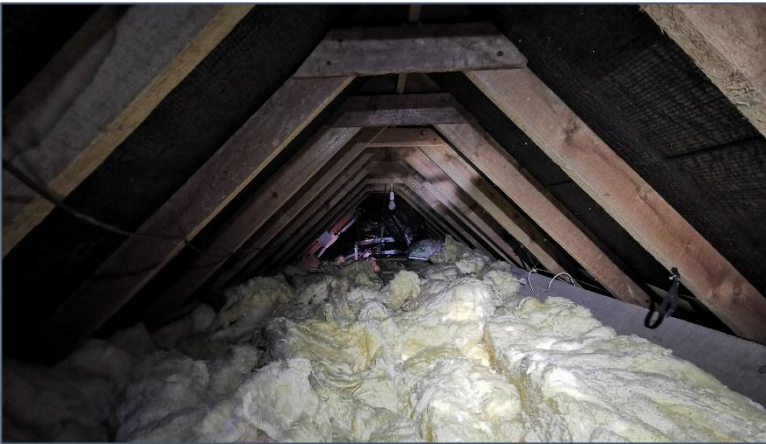
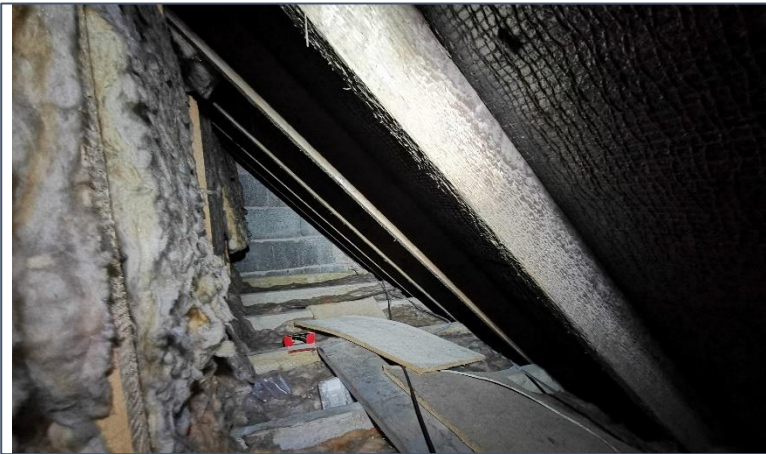
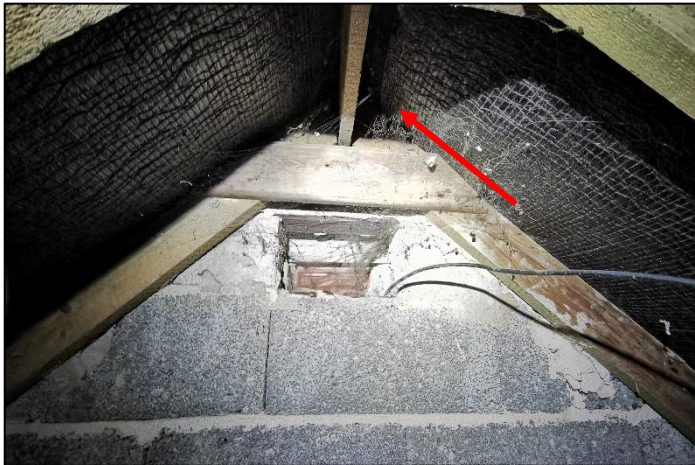
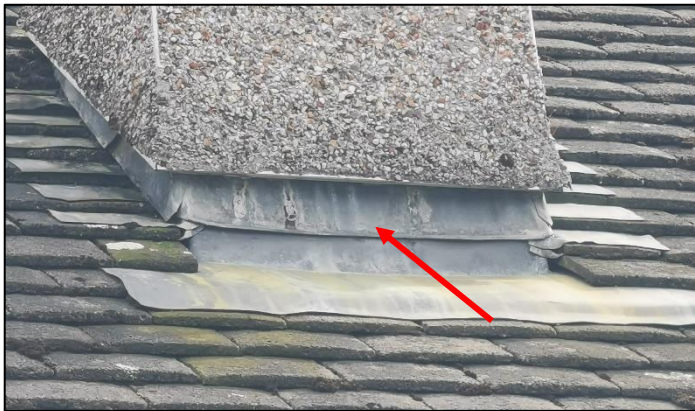
Description	Potential Roosting Features	Bat Roost Suitability
<p data-bbox="190 308 981 478">Internally, there was a small loft space (approximately 1m tall and 2m wide) that extended across the entire length of the roof underneath the ridge. Additionally, there were two boxed-in loft spaces below the dormer level along the west and east pitches of the roof.</p>

<p data-bbox="981 308 1695 343">Internal loft areas – void dwelling species.</p>

<p data-bbox="981 885 1695 917">Gaps around chimney flashing</p>

<p data-bbox="1695 829 1993 861">Moderate</p>
