# Arlecdon Farm, Arlecdon Preliminary Roost Assessment for Bats, Barn Owl Assessment and Bats Dusk Emergence Surveys

June 2025

**Project:** LE101 – Arlecdon Farm, Arlecdon

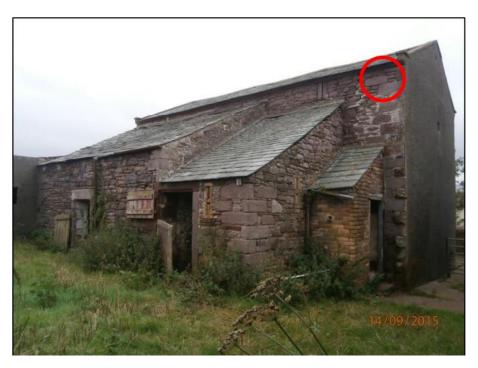
Plate 1 – Showing historical common pipistrelle stone crevice roost within building B2, identified during the previous bat survey conducted in 2015

As the identified day roosts R1 and R2, used by an individual common pipistrelle, are located within the external stone crevices of building B2, it is considered that these roosts can be retained during and after the works, and the proposed conversion can proceed outside of the Natural England EPS Mitigation Licence. While no current use was identified during the two dusk emergence surveys conducted in 2025, it is recommended that the external crevice in the western corner of building B2, which was used as a day roost by a single common pipistrelle in 2015 (RH), should also be retained.

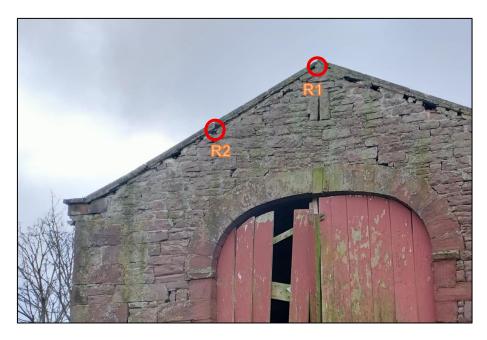
During the second dusk emergence survey, a single common pipistrelle bat was recorded entering the gap in the apex of the northeast gable wall of barn B2 at 21:40. The same bat re-emerged at 21:47. A second common pipistrelle bat was also observed emerging from the gap under the coping stone along the northeast gable wall of barn B2 at 21:48. Refer to Plate 2 and Figure 4 for the detailed locations of the identified soprano pipistrelle roosts.

Plate 2- showing common pipistrelle day roosts within the northeast gable of barn B2

- Roost R1 is located within the gap in the apex of the northeast gable wall of building B2. A single common pipistrelle was observed using this roost during the survey on 05/06/25. (see Plate 2 and Figure 4). This roost is considered to be a day roost used by an individual / low number of bats.
- Roost R2 is located within the gap under the coping stone along the northeast gable wall of building B2. A single common pipistrelle was observed using this roost during the survey on 05/06/25. (see Plate 2 and Figure 4). This roost is considered to be a day roost used by an individual / low number of bats.

Although the proposed conversion works are unlikely to damage, alter or modify the identified bat roosts, there is still a risk of disturbance to individual bats using the gaps in the external stonework within the surveyed building and adjacent properties. Therefore, the precautionary working methodology provided in this report must be adhered to in order to avoid significant disturbance to bats and to prevent committing an offence under the relevant wildlife legislation.

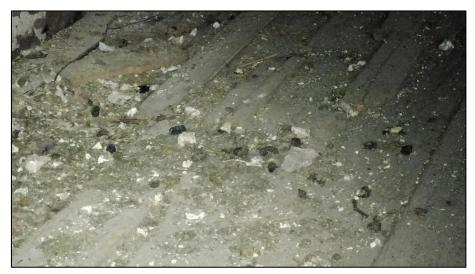
An accumulation of 40 pellets comprising a mixture of fresh (less than one month old) and older pellets was noted on the upper floor next to the internal northeast partition wall (see Plate 3). A cavity with streaks of whitewash on the stonework underneath was observed on top of the northeast partition wall (see Plate 4). The cavity was not subject to a detailed inspection due to the restricted access high up within the barn. Whitewash was also recorded on other beams within the barn.

Plate 3 – Accumulation of 40 mixed aged pellets on the floor next to the northeast partition wall

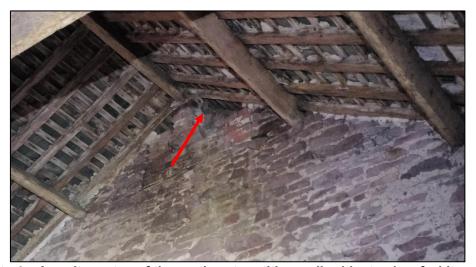
Plate 4 – A cavity on top of the northeast partition wall, with streaks of whitewash on the stonework underneath

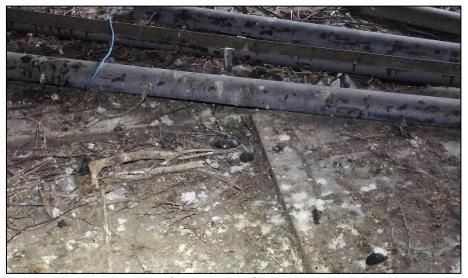
Scattered pellets of mixed ages (approximately 30 in total), as well as adult flight and body feathers, were noted throughout the barn floor (see Plate 5). An accumulation of 10 older barn owl pellets (6 to 12 months old) was also recorded on the floor in the northern corner of the barn (see Plate 6). See Figure 2 for the site plan with evidence.

Plate 5 - Barn owl pellets, feathers and faeces scattered through the barn

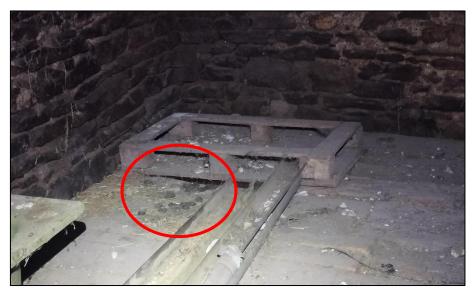
Plate 6 - Accumulation of older barn owl pellets in the northern corner of the barn

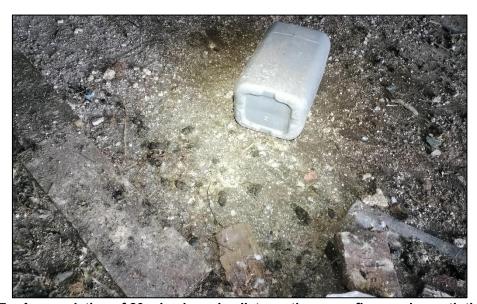
Scattered fresh (less than one month old) and older pellets were noted throughout the barn's upper floor, with approximately 40 pellets counted during the survey. This included an accumulation of 20 pellets underneath one of the barn's joists (see Plate 7), which was also marked with whitewash.

Plate 7 – Accumulation of 20 mixed aged pellets on the upper floor underneath the joist

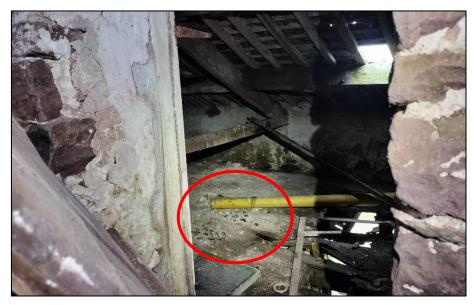
Approximately 20 mixed-aged pellets were also noted on the upper floor of the northwest lean-to of barn B2 (see Plate 8). See Figure 2 for the site plan with evidence.

Plate 8 – Accumulation of 20 mixed aged pellets on the upper floor within the lean-to of the barn

Building B2 was considered to provide sub-optimal nesting conditions for this species due to the lack of elevated, enclosed lofts or deep cavities preferred by barn owls. The upper floor of the lean-to in Barn B2 might provide potential nesting suitability; however, it was considered to be somewhat open, and no obvious previous nesting evidence was identified in this location.
