## Orchard Brow Barn, Haile, Egremont

Building Survey: Level II

Report 448

15<sup>th</sup> September 2023

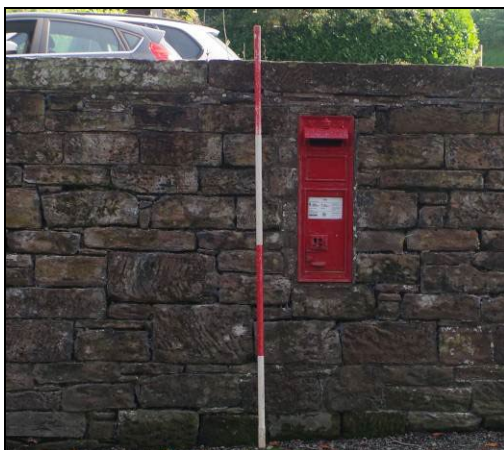
Figure 3. Victorian Royal Mail post-box

A boundary wall emanated south from the study building that yielded a wall-mounted Victorian post-box that was installed from 1857 to 1901 (figure 3). This post-box was not featured on the first edition Ordnance Survey map surveyed in 1861, but a box was featured nearby on the second edition Ordnance Survey map surveyed in 1898. By 1923 it was shifted to its present location.

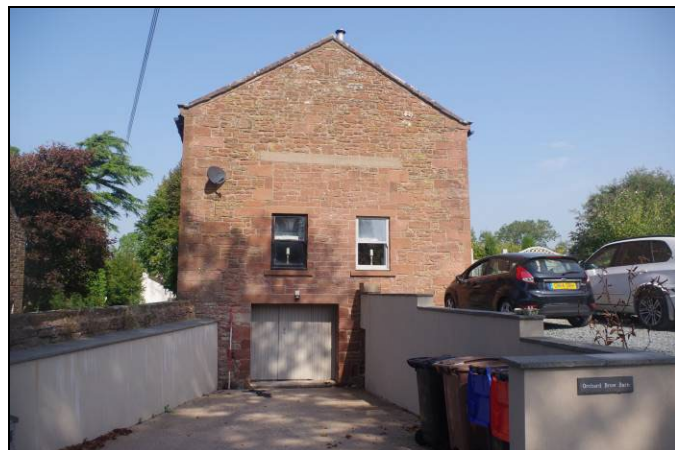
Figure 4. Approach to the original bank barn

The redeveloped part of the barn had removed the incline up to the main door that was characteristic of a bank barn. The incline was probably depicted to the right where access to the lower ground floor was not required (figure 4).

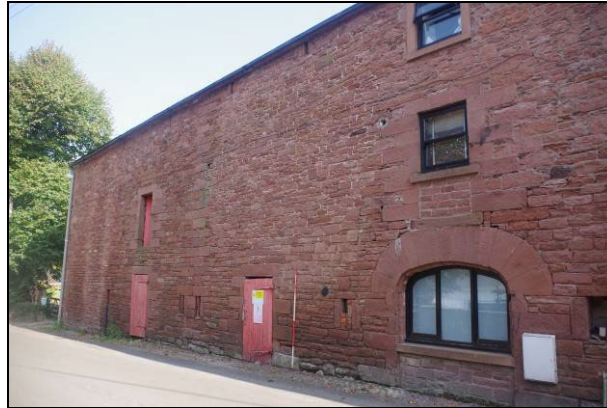
Figure 5. Entrance to a cart shed

The western elevation displayed a cart shed entrance on the ground floor now incorporated into the 1988 dwelling (figure 5).

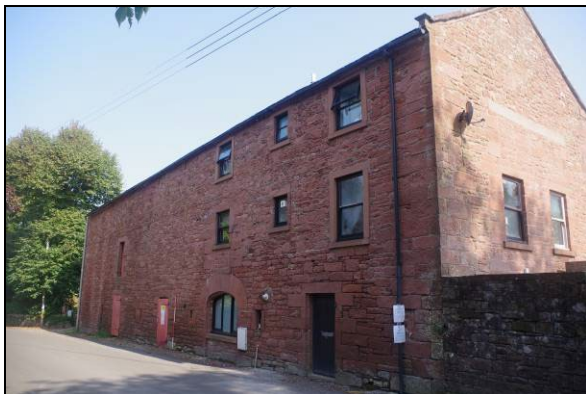
Figure 11. Western elevation with three floors

The study building was divided into two floors (formerly three), with three rooms being at ground floor level (figure 11). The study area was relatively flat with a slight rise from south to north on the street frontage.

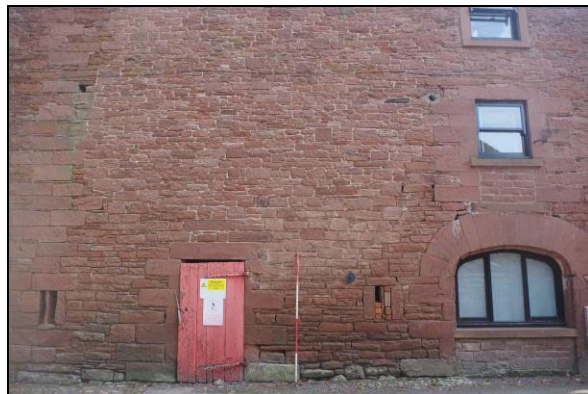
Figure 12. Interface between stone phases

A change in the stonework showing a series of red sandstone quoins that were partially keyed into the remaining stone fabric to a height of 3.20m indicated this addition (figure 12). The additional northern wing was constructed from larger red sandstone blocks compared to the slightly smaller red sandstone blocks that formed the original structure.

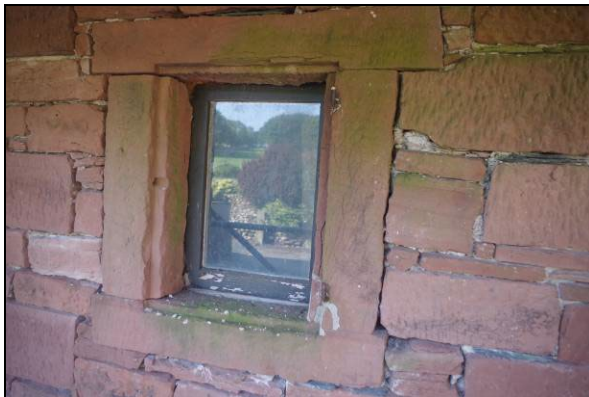
Figure 16. Window 2

Some of the stone fabric appears to represent possible sub-medieval elements notably Window 2 (figure 16) and stone corbels (figure 27). This action suggests re-use of stone probably from a close source. As the estate of Orchard Brow dated to the late 16<sup>th</sup> century at least, it is possible that this barn replaced an earlier structure.

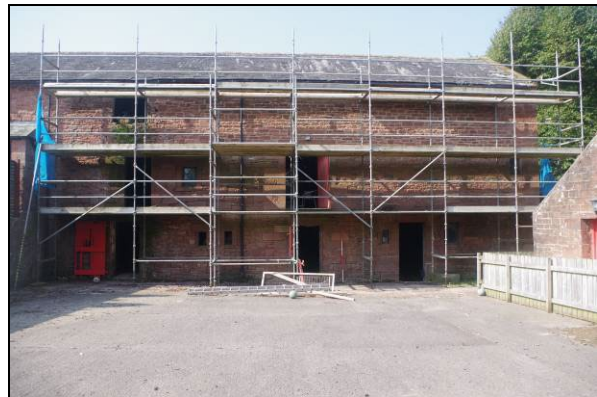
Figure 17. Eastern facade

The extended barn included the following architectural elements (figure 17):

- Window 4 was plain in design and measured 0.46m in width and 0.69m in height. This embellishment was probably a later amendment.
- Vent 10 measured 0.32m in width and 0.46m in height.

- Vent 11 measured 0.26m in width and 0.53m in width.
- Window 12 measured 0.59m in width and 0.86m in height. The surround was machine-cut and therefore a later amendment.

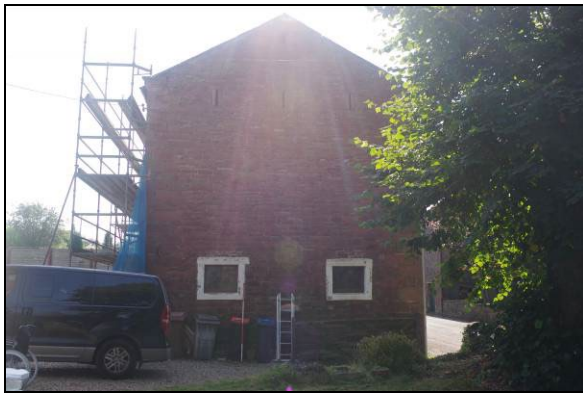
Figure 19. North elevation

The facade was finished in red sandstone blocks, the elevation framed by stone quoins (figure 19). Three vents were present on the first floor and an owl hole that was inaccessible, just beneath the ridge.

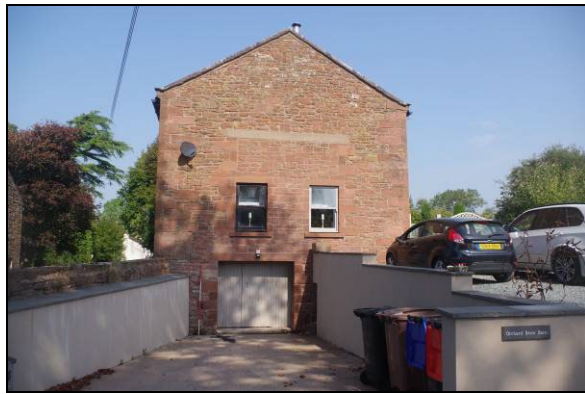
Figure 20. South elevation

The southern elevation was not subject to this study but denoted the former entrance to a bank barn. The former door was filled and two modern windows inserted with the lintel replaced in concrete (figure 20).

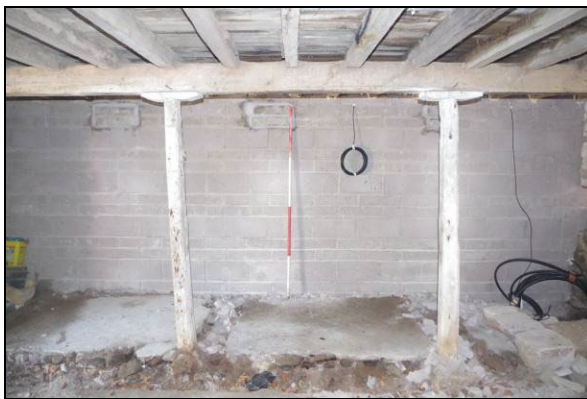
Figure 21. Bay 1, Room 1

Bay 1 (the southern bay) measured 5.67m in length, 1.75m in width and 2.08m in height and outlined as a series of stone kerbs with stone pads supporting two reused wooden columns measuring 0.13m x 0.12m and standing to a height of 1.90m (figure 21).

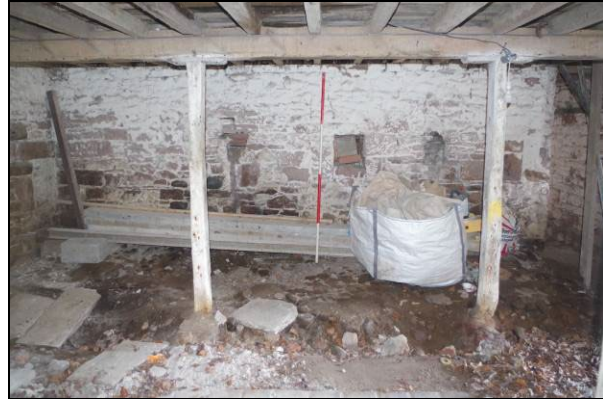
Figure 22. Bay 2, Room 1

Bay 2 (the northern bay) measured 5.58m in length, 1.90m in width and 2.02m in height and outlined as a series of stone kerbs with stone pads supporting two reused wooden columns measuring 0.13m x 0.12m and standing to a height of 1.90m (figure 22).

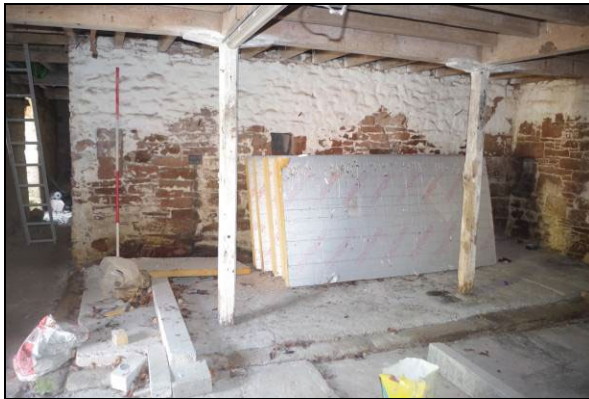
Figure 23. Bay 1, Room 2

Bay 1 (the southern bay) measured 5.39m in length, 2.26m in width and 2.19m in height and outlined as a series of stone kerbs with stone pads supporting two reused wooden columns measuring 0.13m x 0.12m (figure 23).

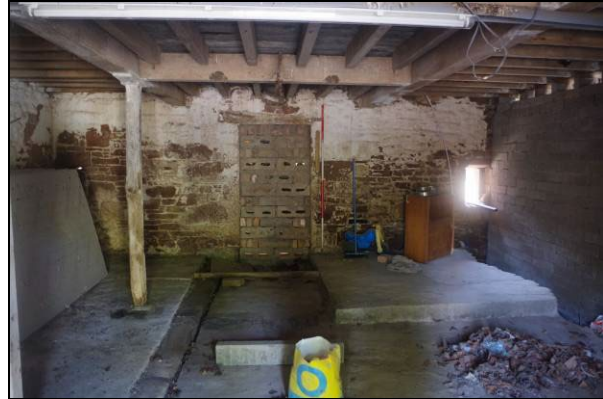
Figure 24. Defunct Bay 2, Room 2

Bay 2 (the northern bay) measured 5.39m in length, 1.96m in width and 2.02m in height (figure 24). Originally outlined as a fragmented series of stone kerbs, there was one stone pad but no columns (figure 25).

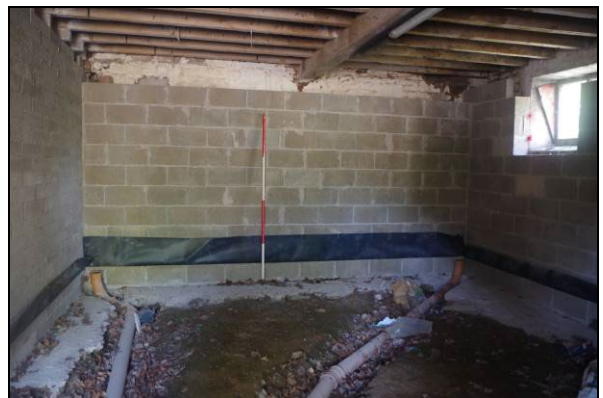
Figure 26. Room 3

Room 3 was located on the lower ground floor (figure 13) and was divided from Room 2 by a modern breeze block wall. The room represented a cow shed that measured 6.05m x 4.72m and was 2.49m in height. The floor had been removed to reveal a yellow clay surface. Breeze blocks that measured 0.19m in thickness had been applied almost up to the walls with a 0.02m gap (figure 26). Both windows measured 0.78m x 0.92m

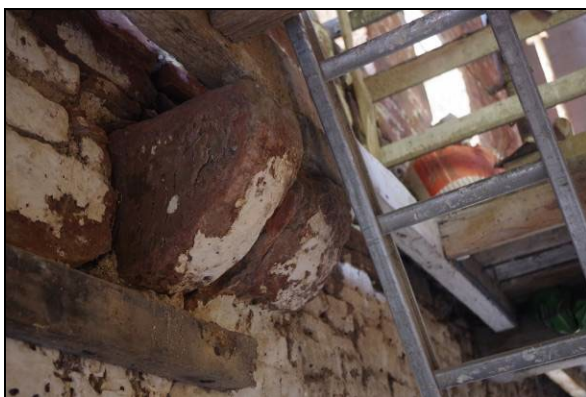
Figure 27. Stone corbel

Used almost certainly as a threshing barn and a hayloft, the floorboards were thick and did not appear machine-sawn and could fulfil an early 19<sup>th</sup> century date. Sandstone corbels appeared to support the floor (figure 27).

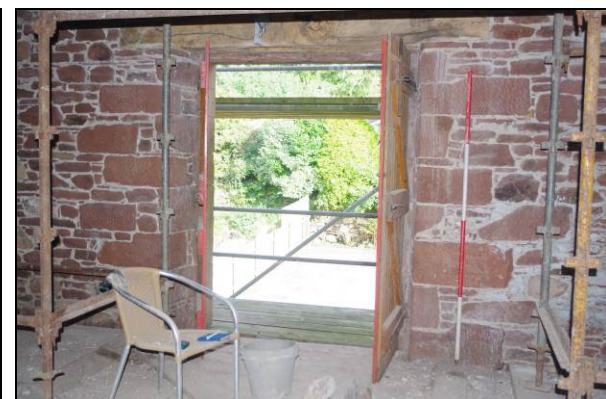
Figure 30. Double door forming egress

Door 3 (figure 15) appeared to form the main double door egress from the threshing barn for the finished grain or stored hay (figure 30). The back draught was provided by Door 7 (figure 14).
