Client: Day Cummins Ltd.

Site: Land at Low Road
Whitehaven, Cumbria

Tree Report for Proposed Residential Development

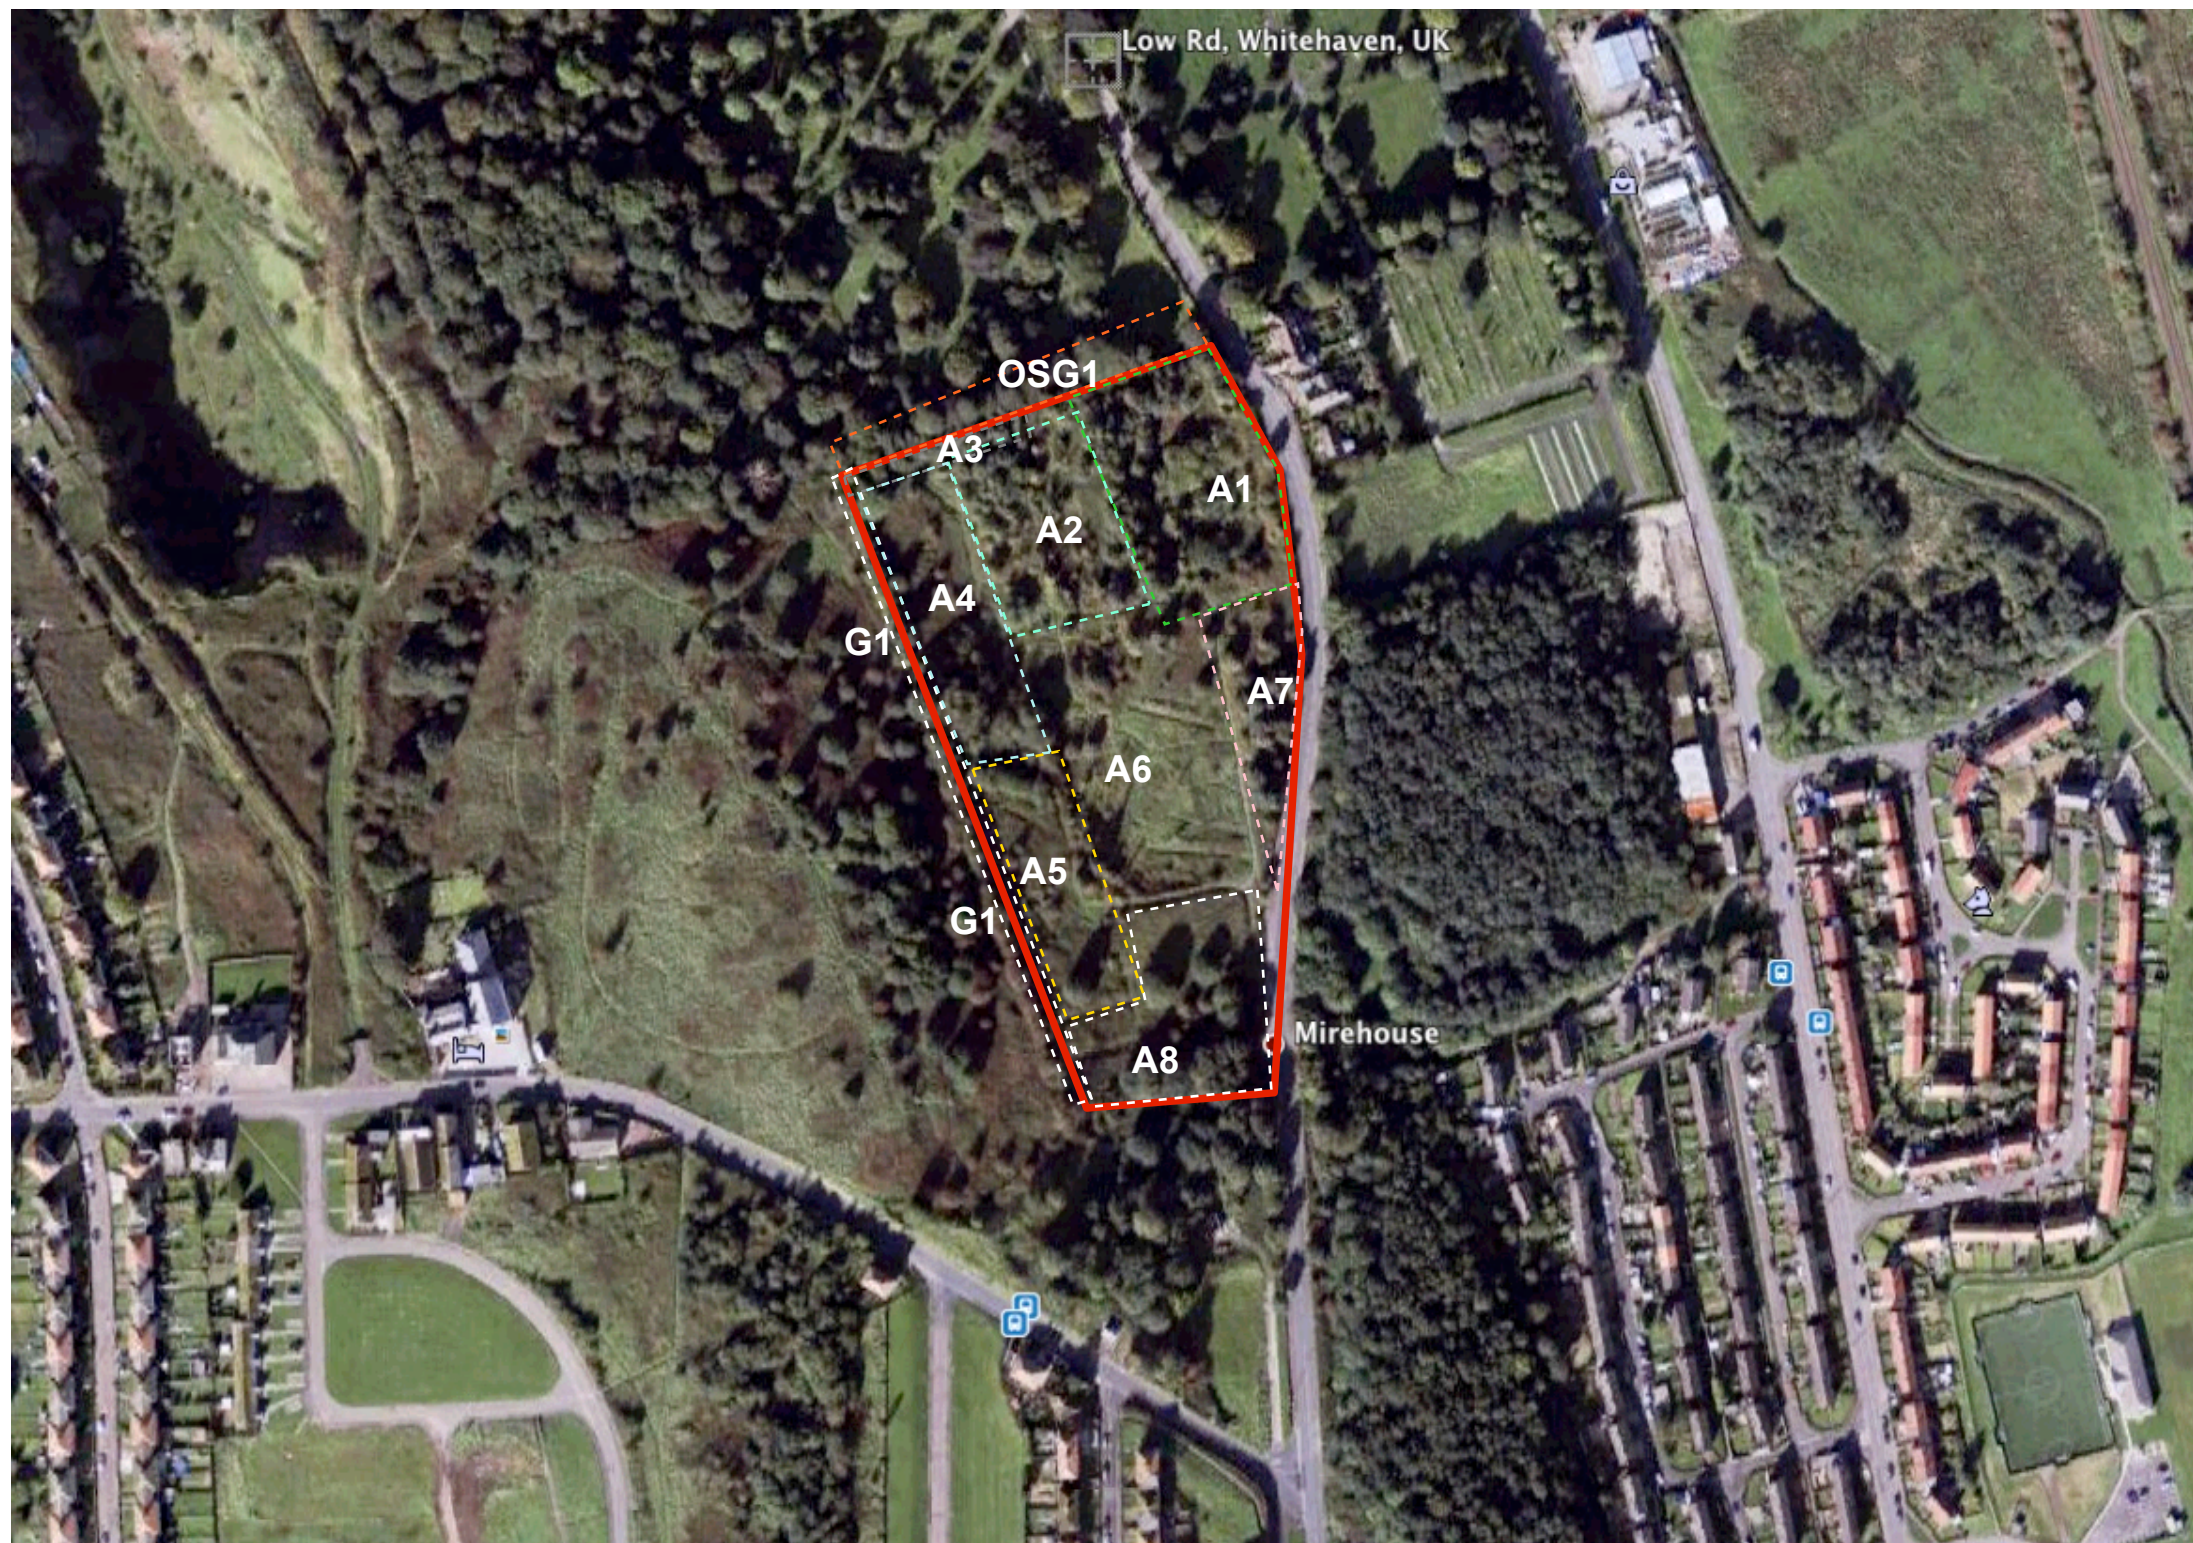
Tree Location Plan
Low Road, Whitehaven
Not to scale

Trees requiring removal to facilitate the proposed development or are unsuitable for retention are indicated in red on the Tree Location Plan and are further identified in the work recommendation section of the Tree Schedule.

Due to the nature of the site we have not indicated positions of Tree Protection Fences in Appendix 2 but if required they may be located at the distances indicated for the Root Protection Area (RPA) radii shown in Appendix 1.
