Heritage Statement

Proposed extension and refurbishment of 5 St George's Road, including demolition of existing outrigger extensions & former bank vault. Change of use from bank ground floor and residential 1st, 2nd floors to Mixed Use Arts & Enterprise Centre.

1st September 2023

Document: Reactivated Heritage Buildings - Heritage Statement
 Project No: M10392
 Issue: P03

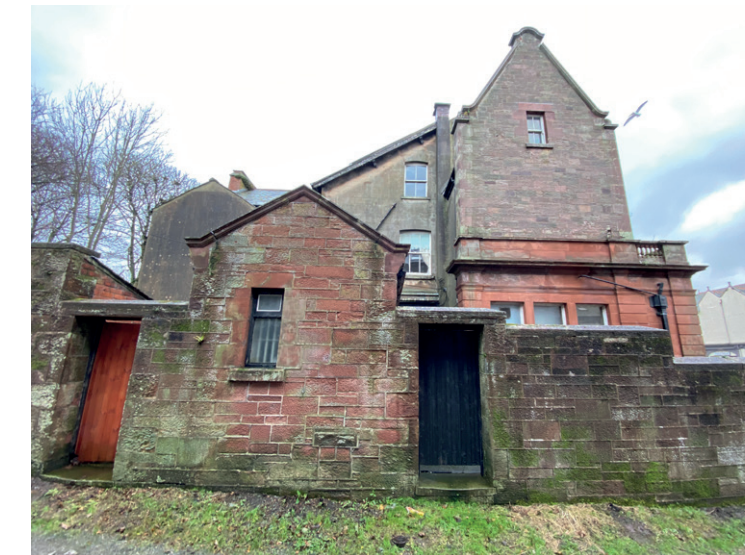
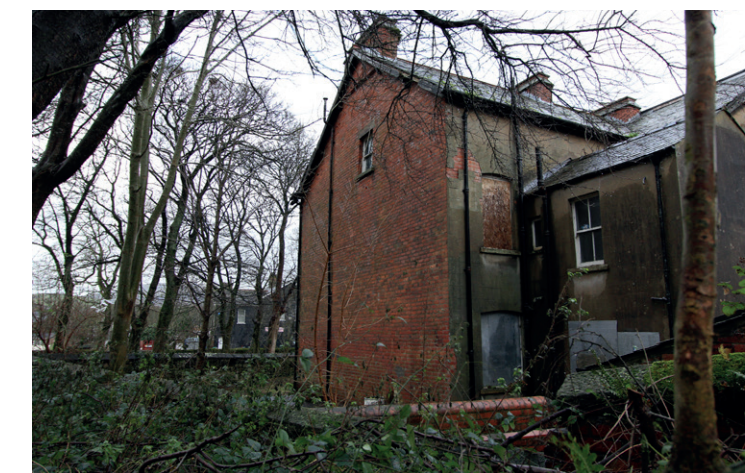
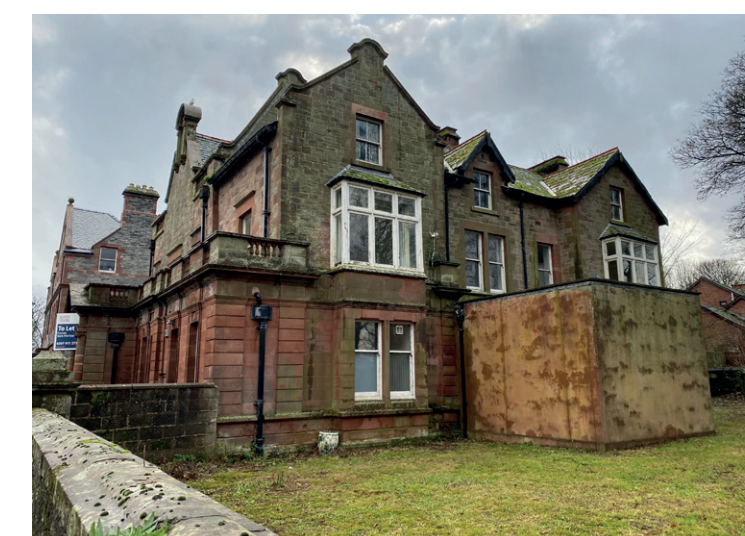
FIG 09 Elevations of existing building showing dilapidation.

The principal north-east elevation facing onto St. George's Road sets the scene with a ground red sandstone ground floor, with a matching low red sandstone balcony defining the line between ground and first floors. The original portico entrance creates symmetry to the facade aligning with the set-back gable wall of the first and second floors. All facades visible from St. George's Road are formed by gable walls with red-sandstone ashlar dressings when turning corners and around window apertures. The existing rear extensions formed of brick/render and these modern extensions detract from the character of the existing structure.

The north-west elevation of the former bank that forms part of the gateway view of the Market Square character area, is defined through the removal of historic features and the intrusion of a bank vault extension that sits central to the elevation.. This rendered concrete structure detracts from the overall impact of this asset and has a negative impact on the setting of the Conservation Area.

The boundaries to the site are in need of repair, and historic ironwork is missing or in a poor state of repair. Historic features are visible across the building, however signs of dilapidation are clear, due to the state of obsolescence this structure is in.

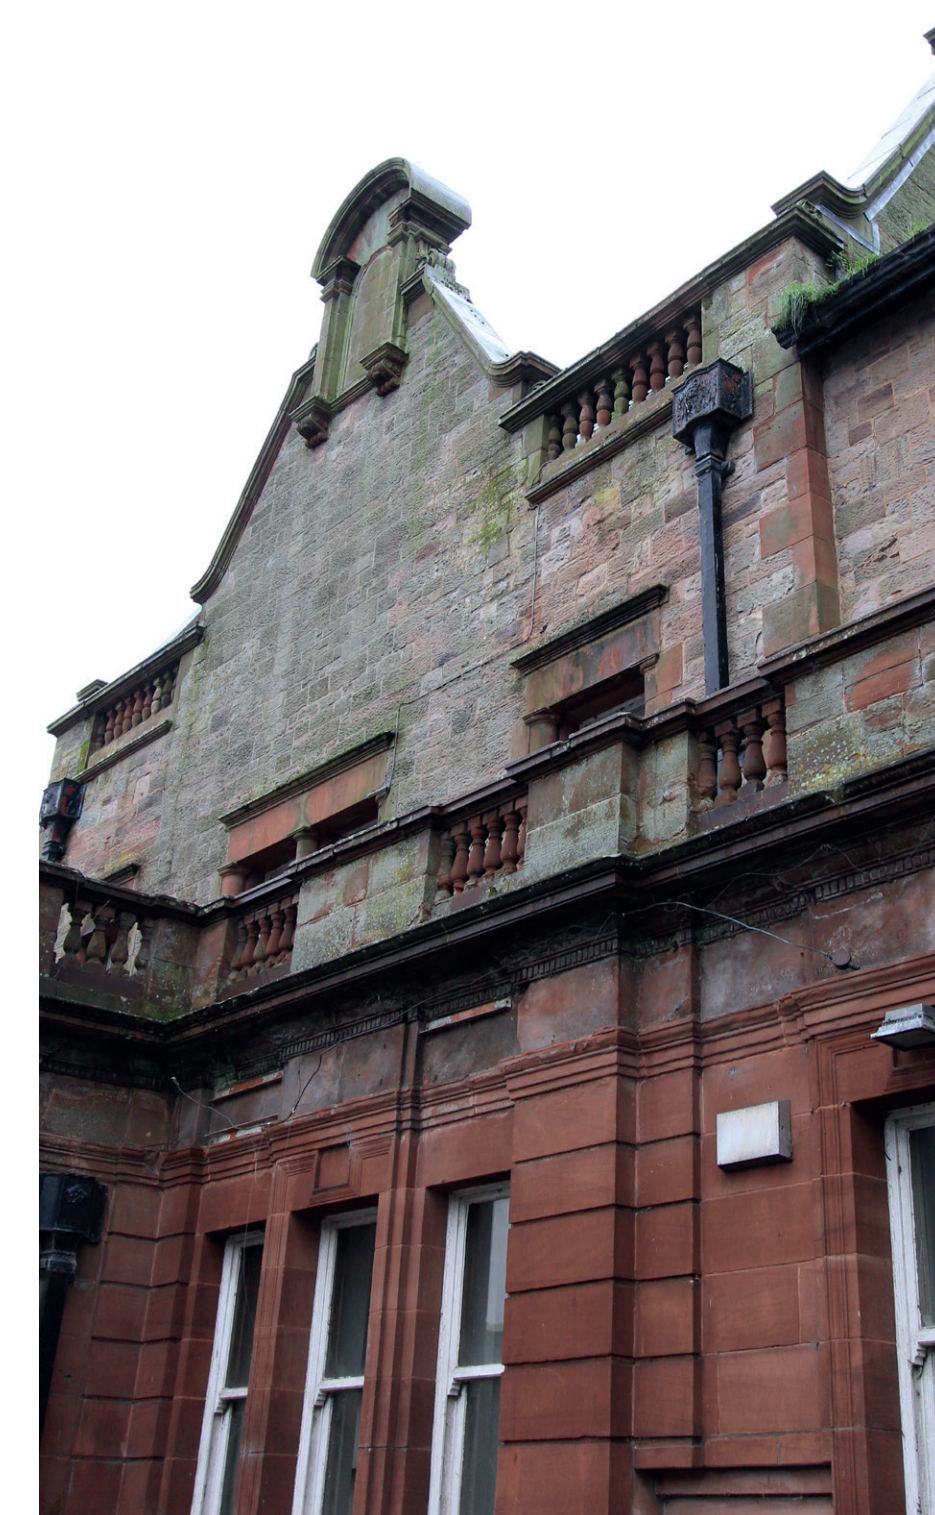
FIG 10 Detail view of Principal Elevation to George St. elevation.

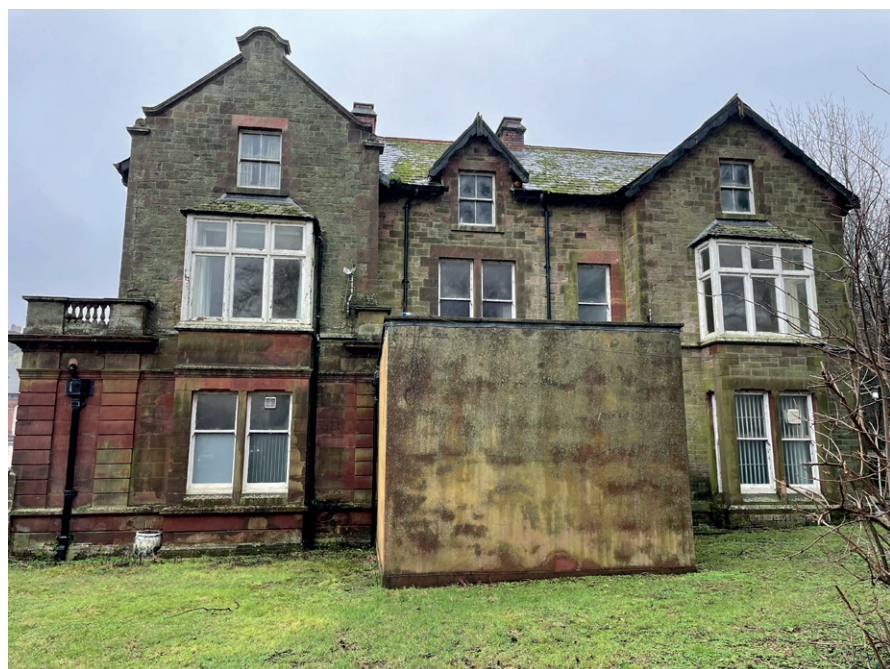
Elevation showing bankvault and it's impact on the existing elevations

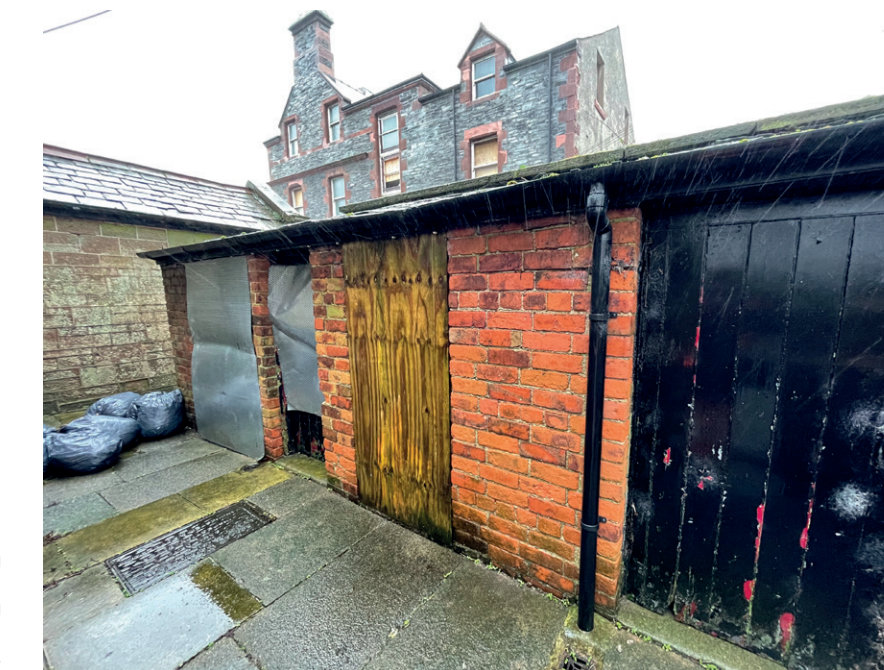
Existing outdoor building retained within garden space to form external work areas for activities such as pottery, and other heavy crafts.

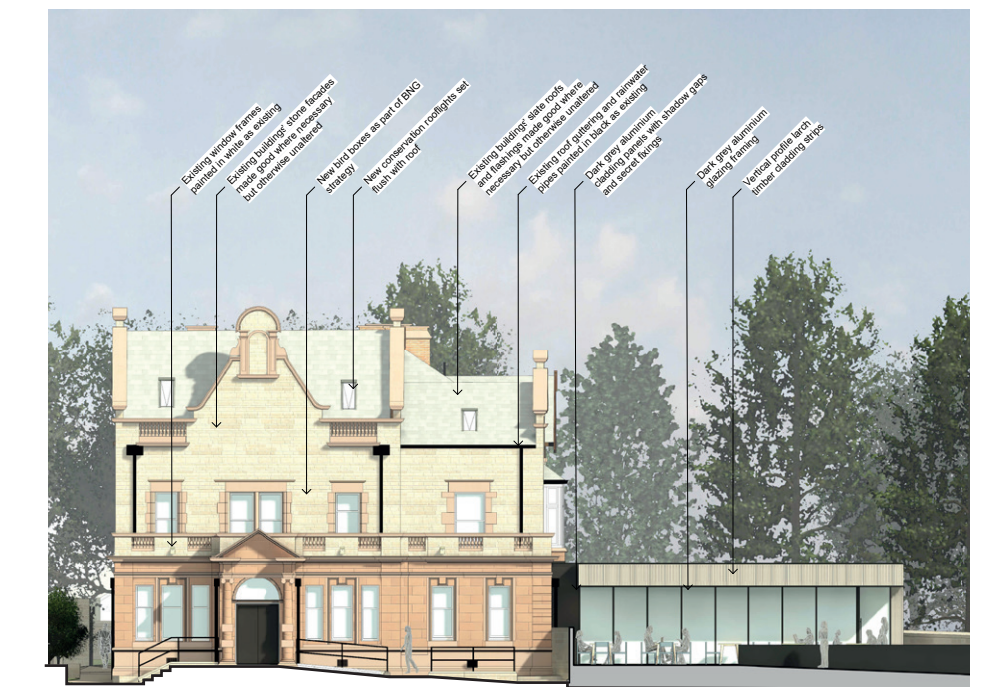
FIG 15 Principal North-East Elevation facing St. George's Road

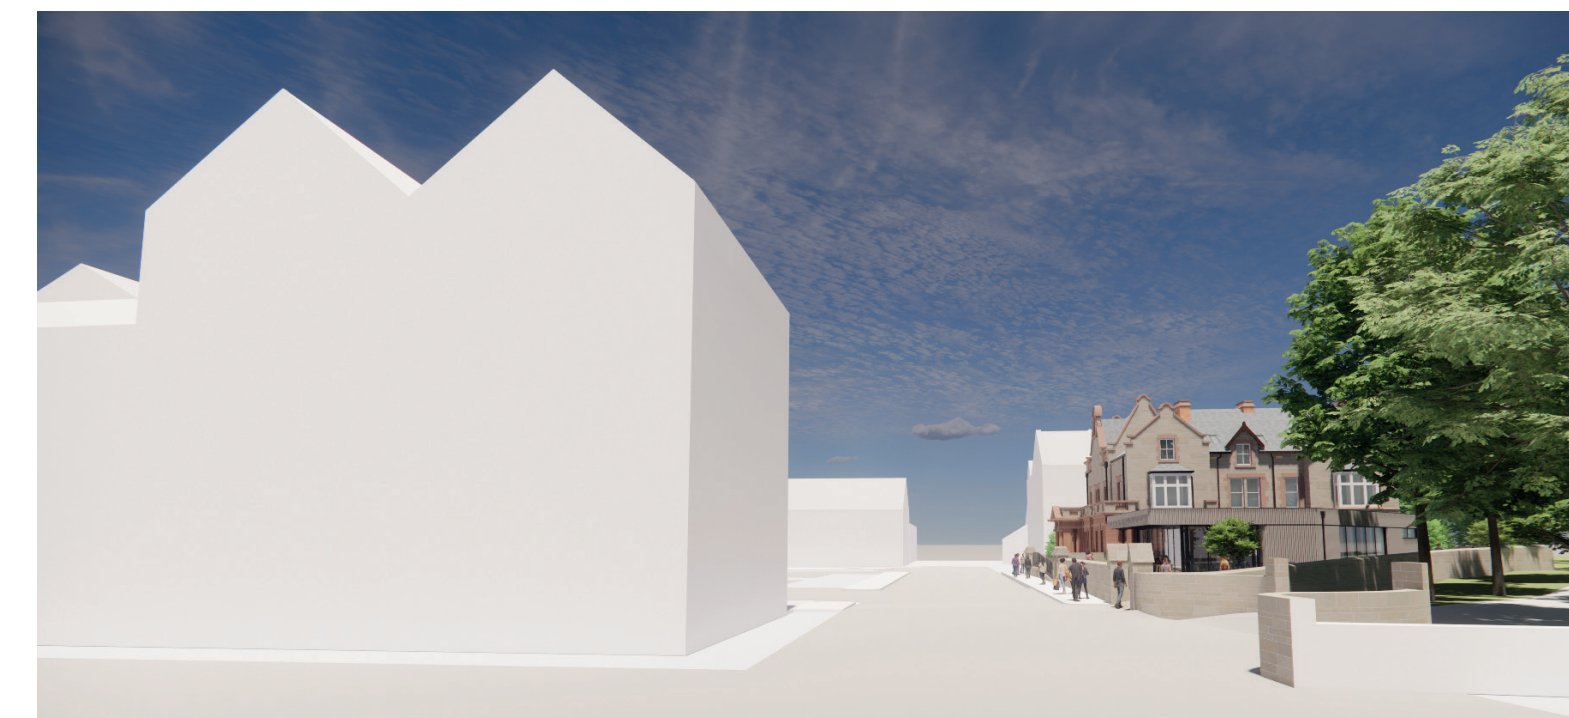
FIG 20 Proposed view of development along George St.

The proposed extension and development at 5 St. George's Road will see the redefinition of the elevation that forms part of the key view into Millom Town Square, as defined in the conservation area appraisal.

The view as you approach Millom town square from the railway station will be maintained and improved through the introduction of the single-storey cafe extension. The extension and removal of redundant bank vault will enhance the view and setting of the conservation area. The form of the extension is honest, and the reflects the shape of the site helping it to sit comfortably within the site.

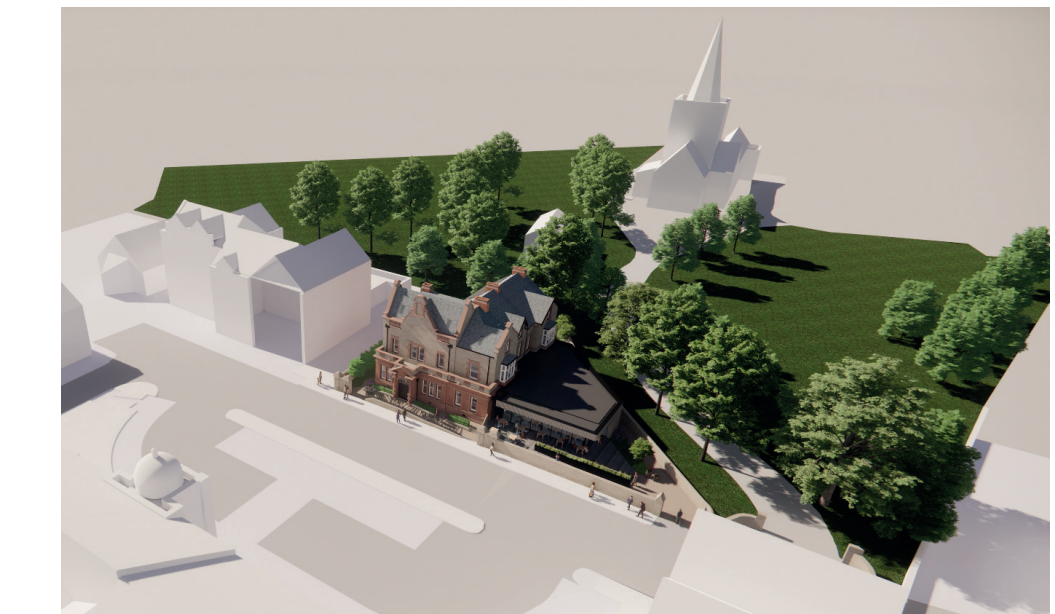
FIG 21 Proposed Development with Context.

North West Elevation, as seen within the grounds of the Church of St. George.

The single storey extension will see the use of visually lightweight materials to be purposefully differential to the visual weight and gravitas of the existing building.

As the materials on the existing are typical to the Millom Conservation Area, the vertical timber cladding provides a visually softer feel to the stonework and boundary walls, to help tie the new Arts and Enterprise Centre into the verticality of the adjacent mature trees.

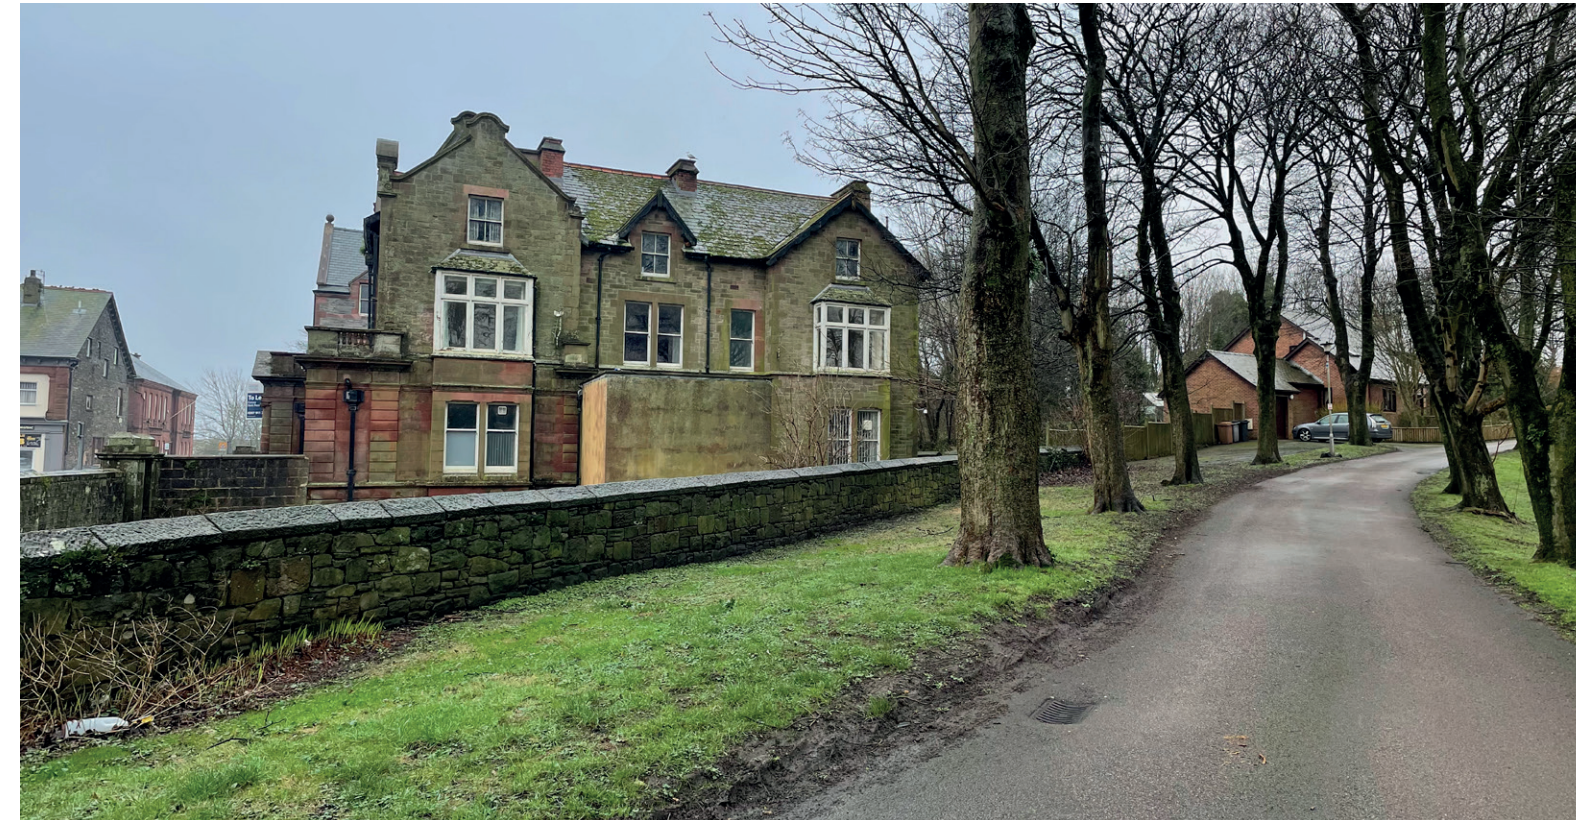
FIG 22 Existing Elevation view from within grounds of Church of St. George.

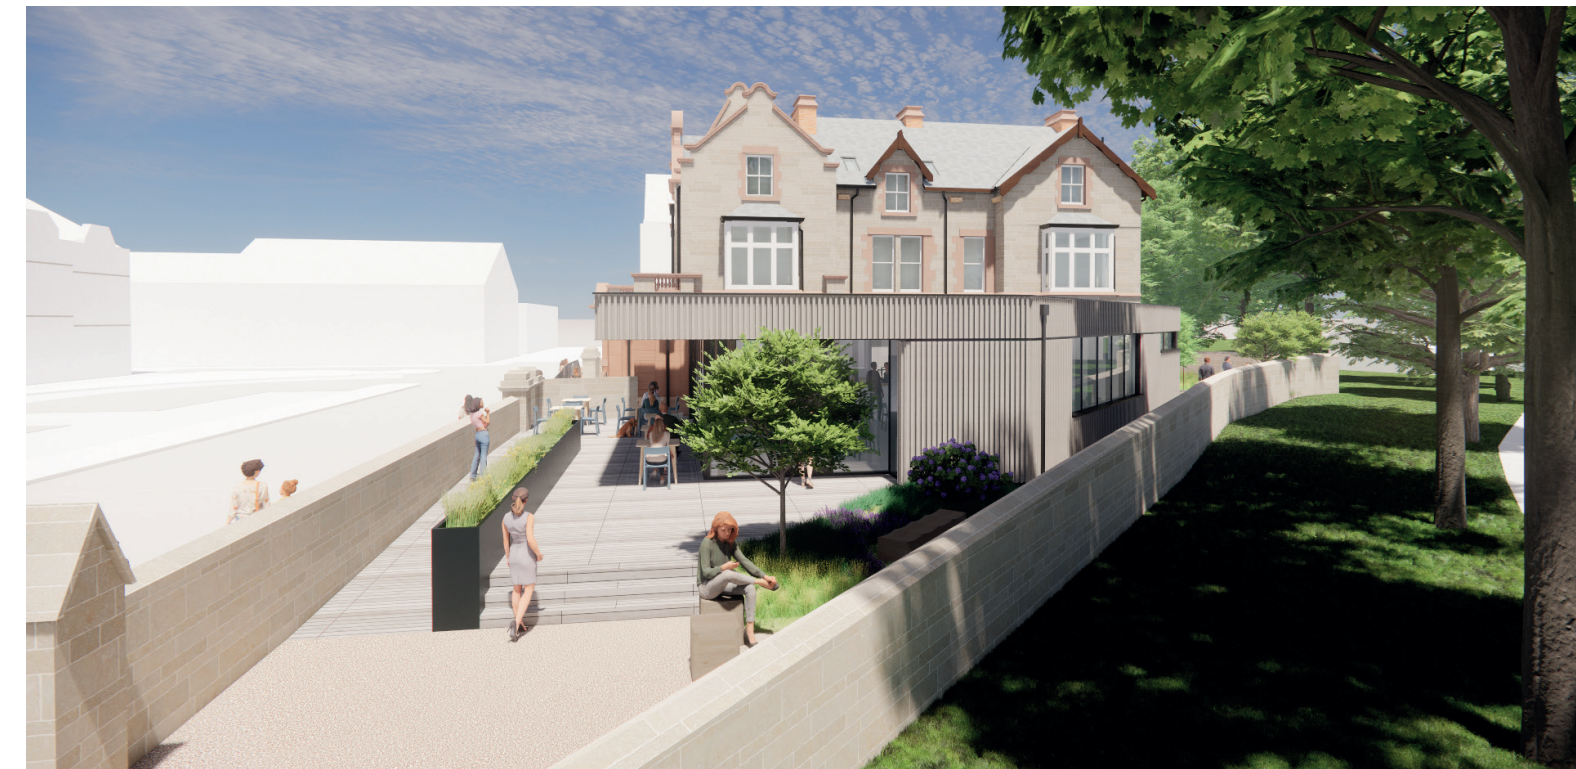
FIG 23 Proposed view of Millom Arts & Enterprise Hub

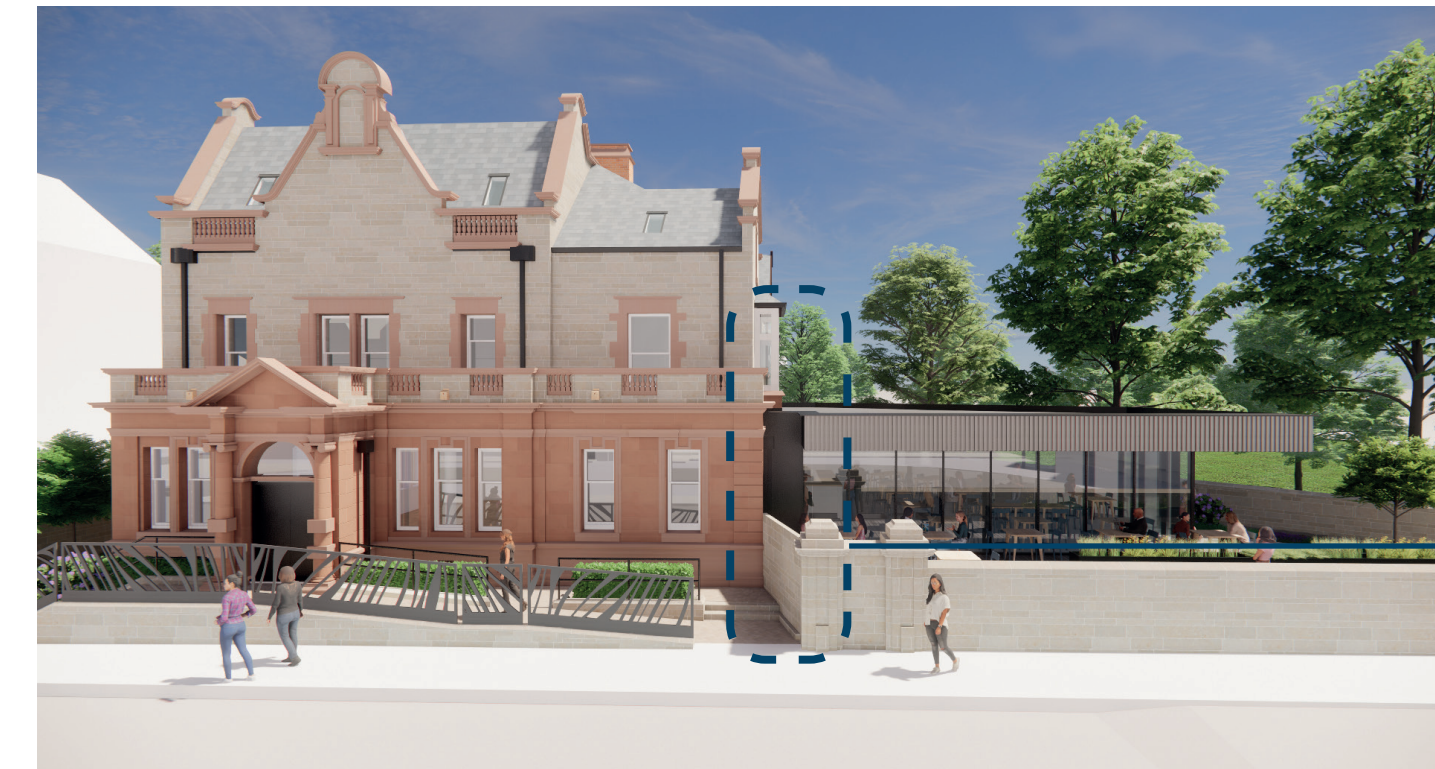
FIG 25 Proposed George St elevation

The new extension will read as subservient to the former bank building. The roof line responds to the feature banding that wraps around the elevation. In addition to this, a shadow gap will be used on the elevation to ensure there is a clear material separation between the existing and proposed.

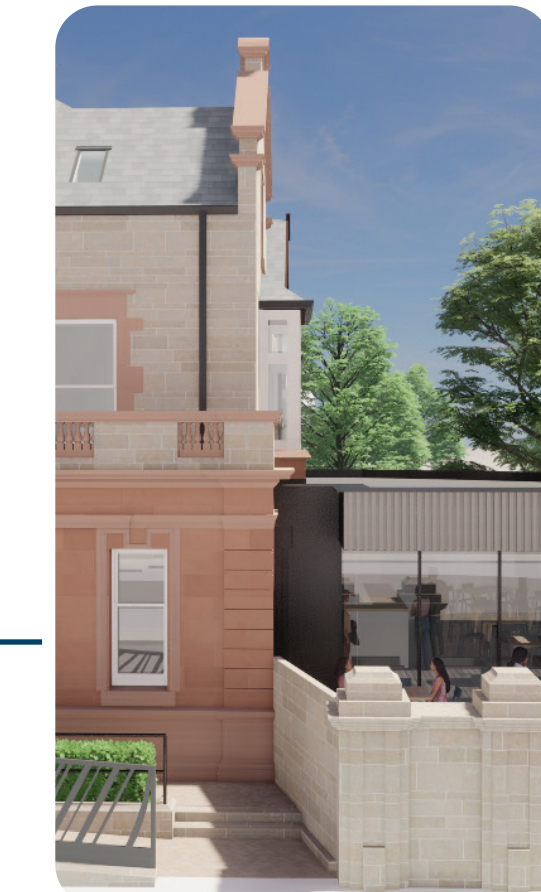
FIG 26 Vignette detail

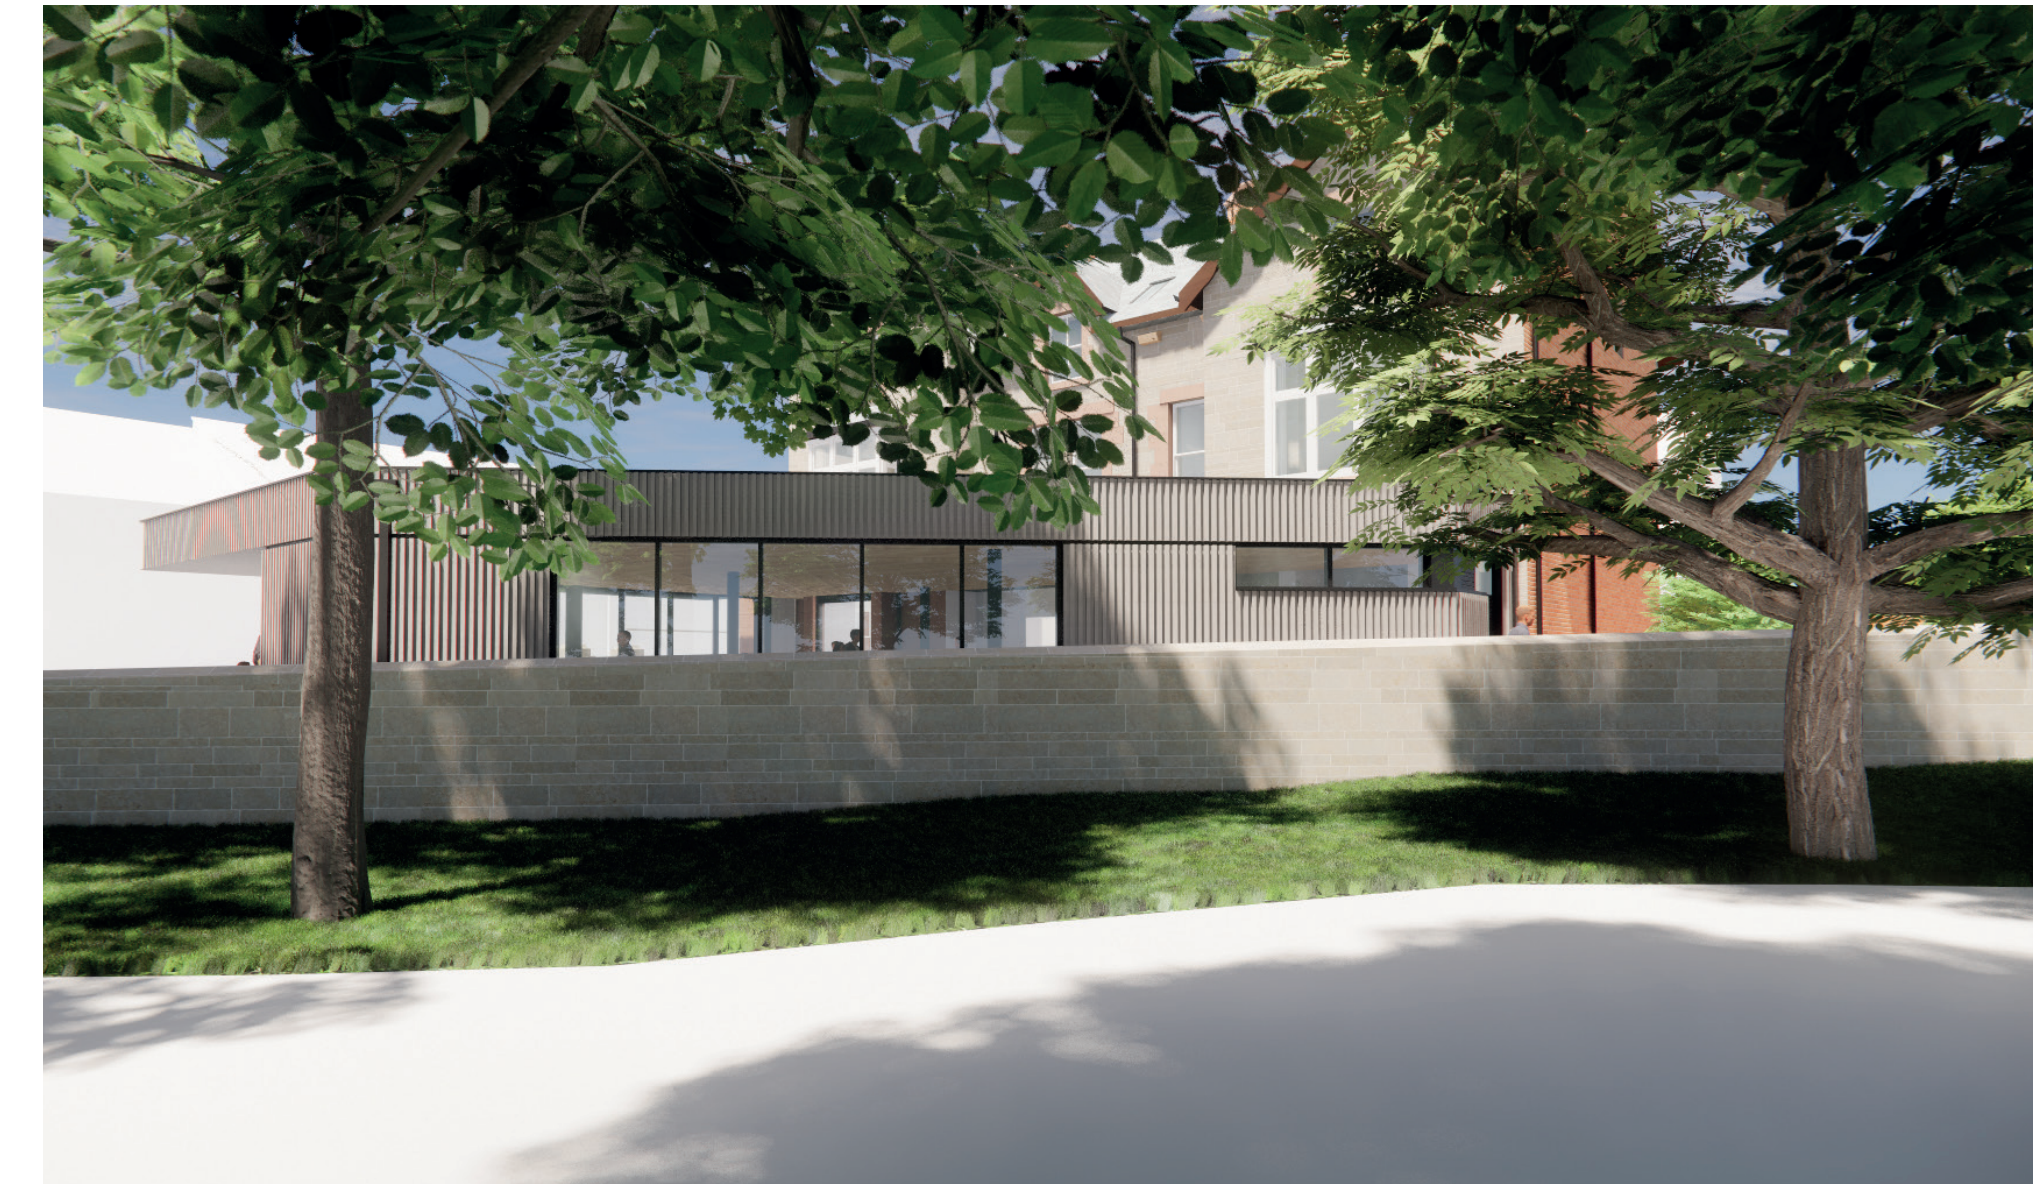
FIG 28 Proposed Elevation viewed from grounds of St George Church
