## **Sella Park, Calder Bridge**

### **Non-Licensed Method Statement in Respect of Bats**

Client: Sella Park Country House Hotel

April 2024

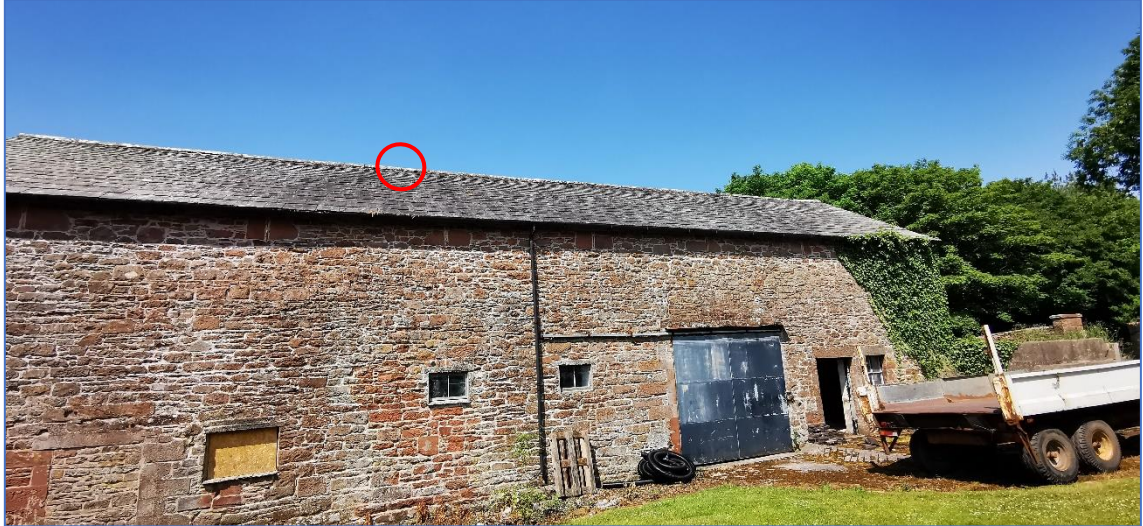
- **Roost R1** – Brandt’s bat day roost (used by an individual bat) located within a gap on top of the ridge beam / under the ridge tile in the central section of the barn (see Photo below and Appendix II).

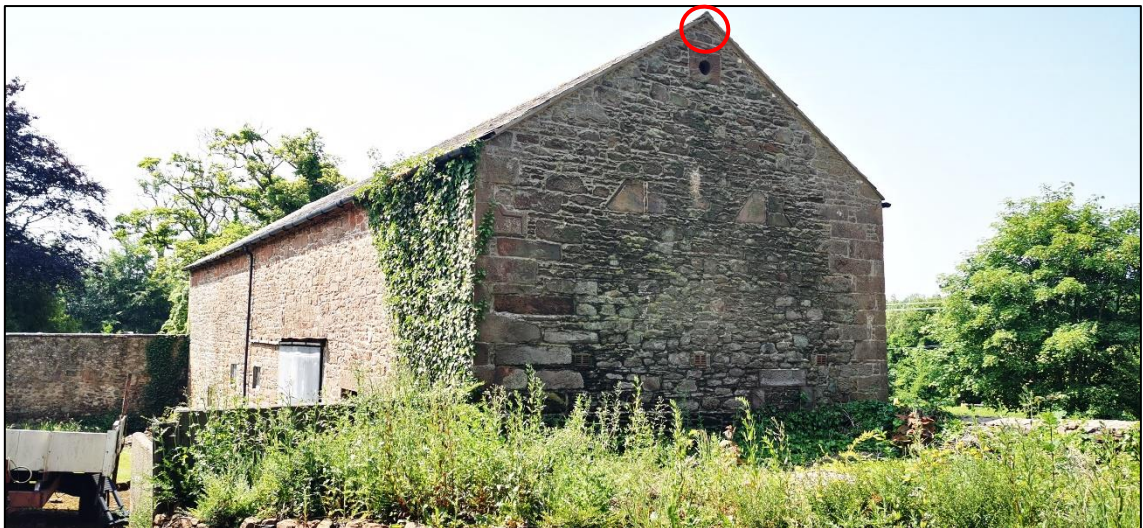
- **Roost R2** – soprano pipistrelle day roost (used by an individual bat) located under the apex ridge tile of the northern gable wall of the barn (see Photo below and Appendix II).

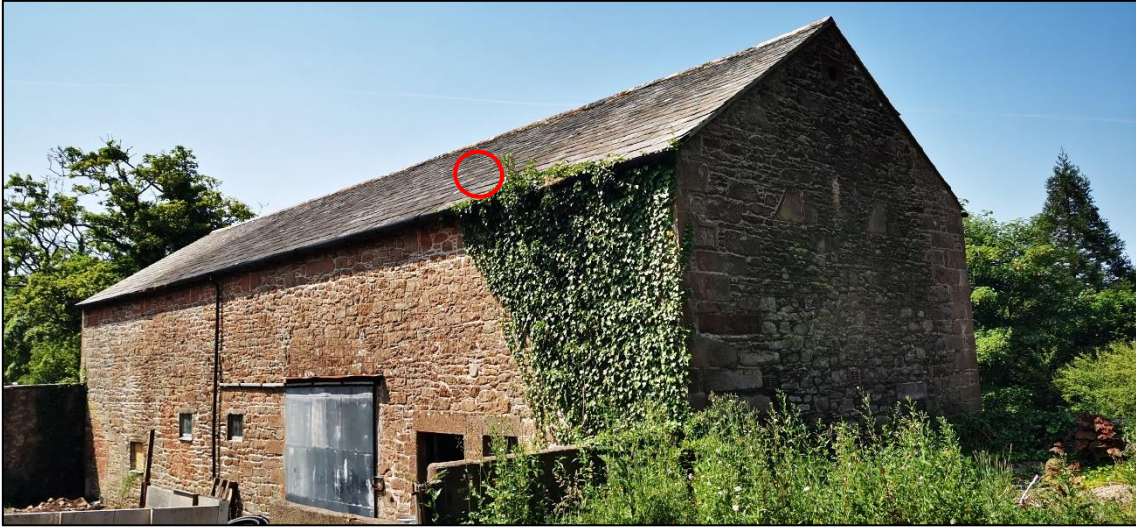
- **Roost R3** - Brandt’s bat day roost (used by up to three bats) located under the roof slates within the eastern pitch of the roof in the northern section of the barn. (see Photo below and Appendix II).

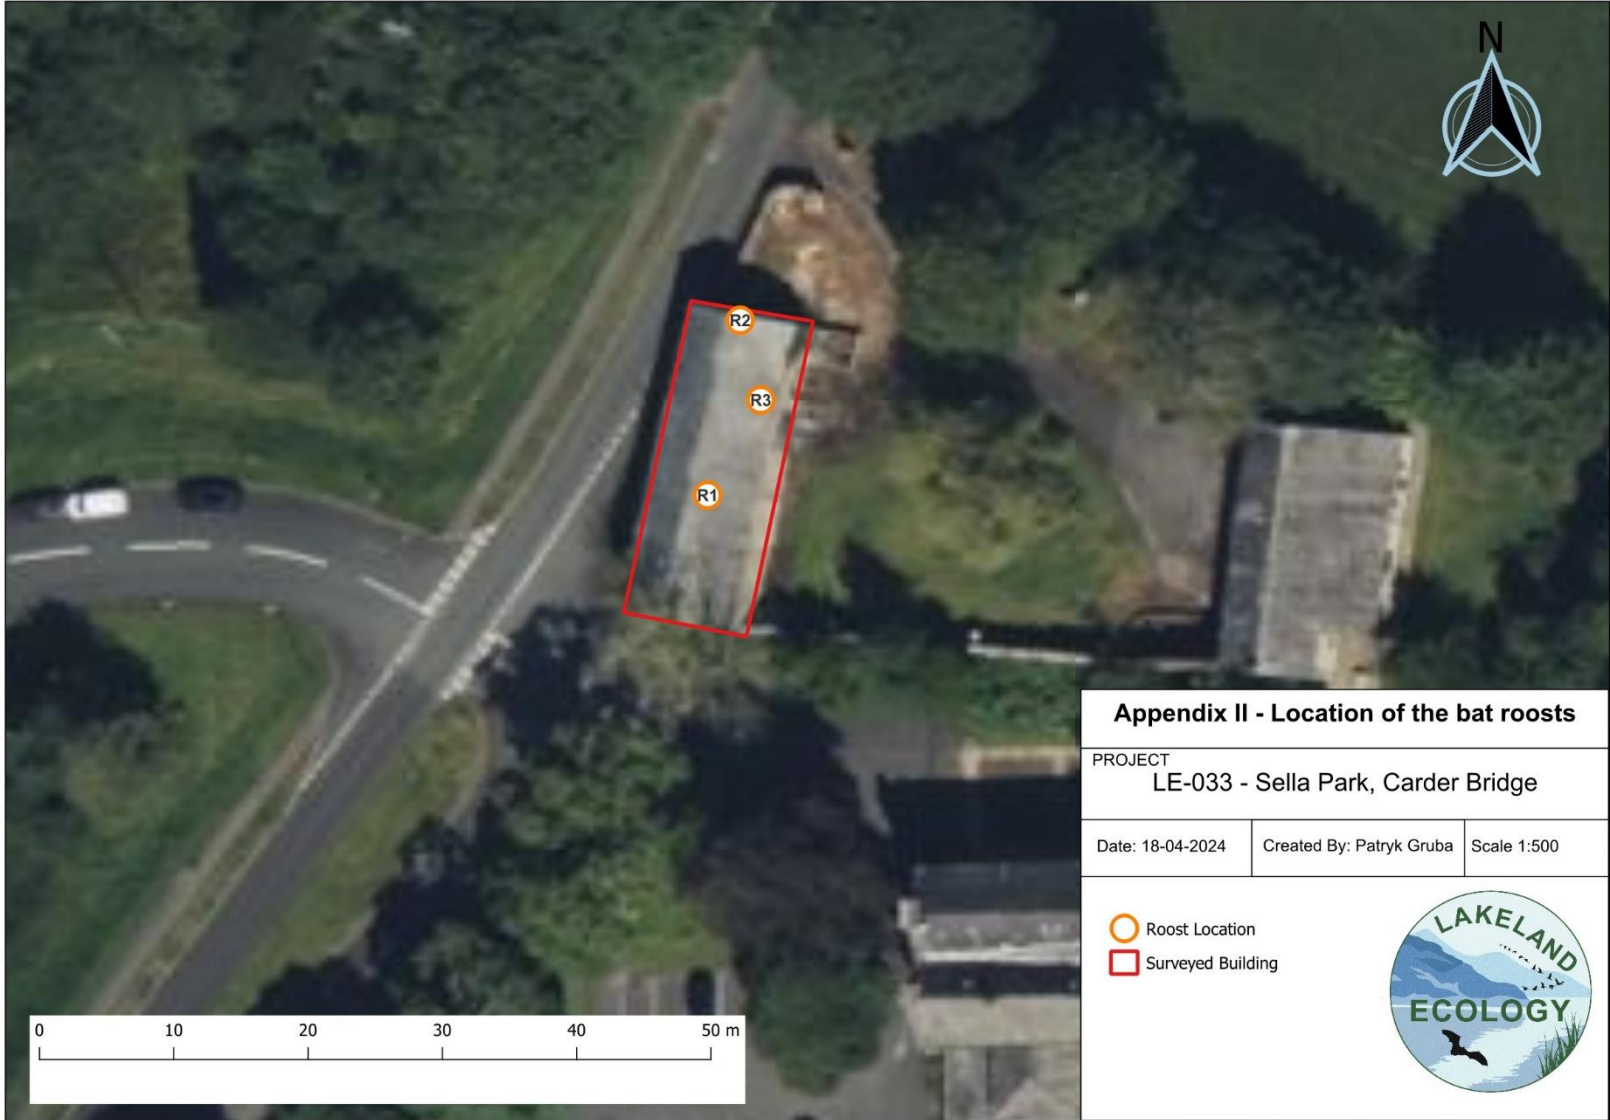
# APPENDIX II – LOCATION OF THE IDENTIFIED BAT ROOSTS

The following bat roosts were identified within the surveyed barn during the dusk emergence surveys conducted on site in Summer 2024:

- The identified roost must be retained, and no works must be undertaken in the sections of the roof where the bat roosts were identified (see Appendix II).
