# **Bat Survey**

## **Penhaven, Haverigg**

**10<sup>th</sup> January 2025**

**Report No. 0125/3**

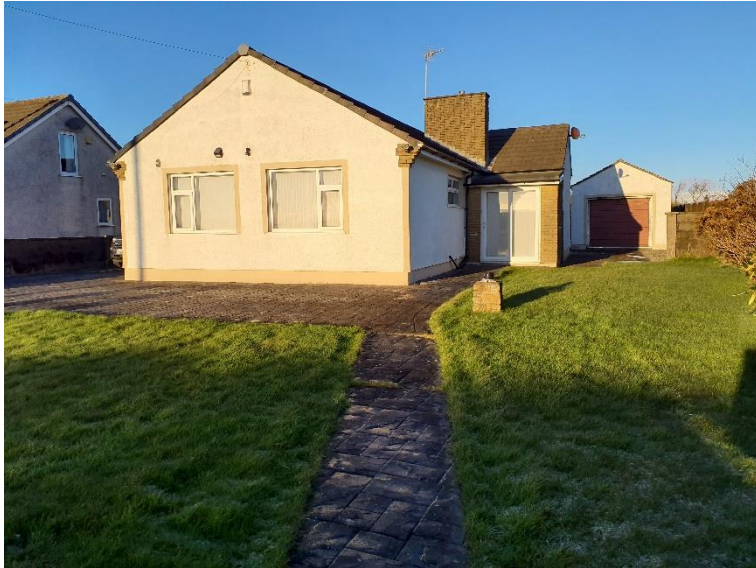
**Image 1.** Front (south) elevation of property.

Note the general good condition of render and roof. No gaps were seen under the eaves or around the roof area.

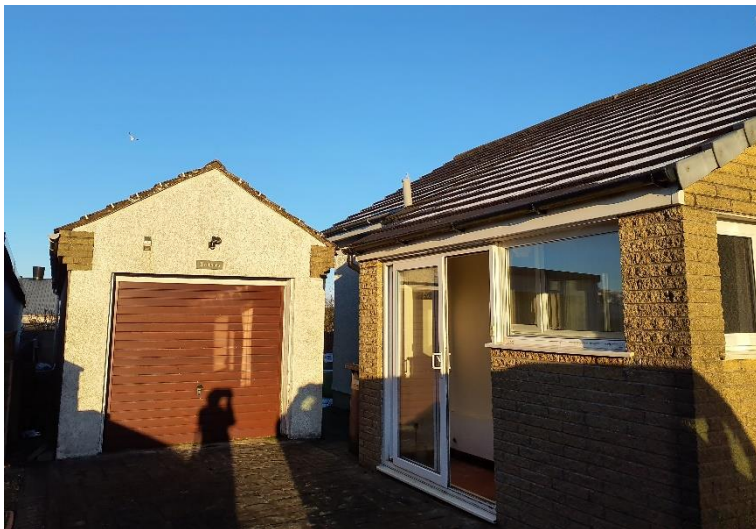
**Image 2.** West elevation of the property showing the garage and front door.

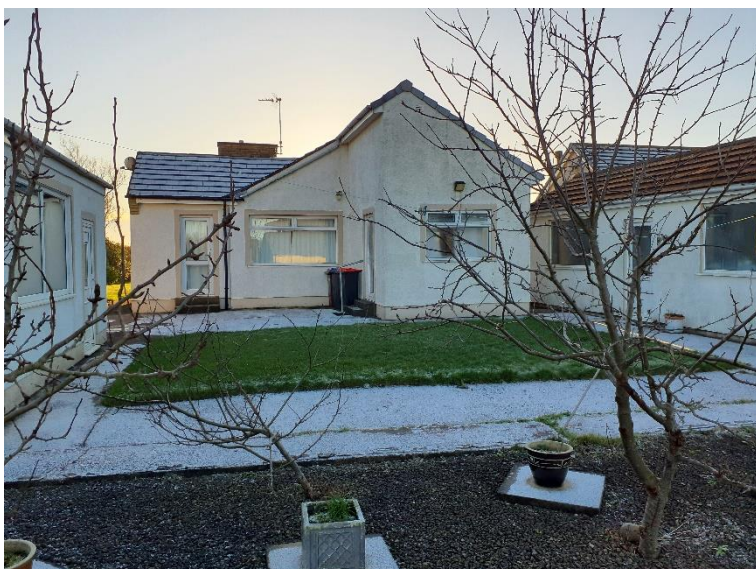
**Image 3.** Rear (north) elevation of the property, showing the two outbuildings.

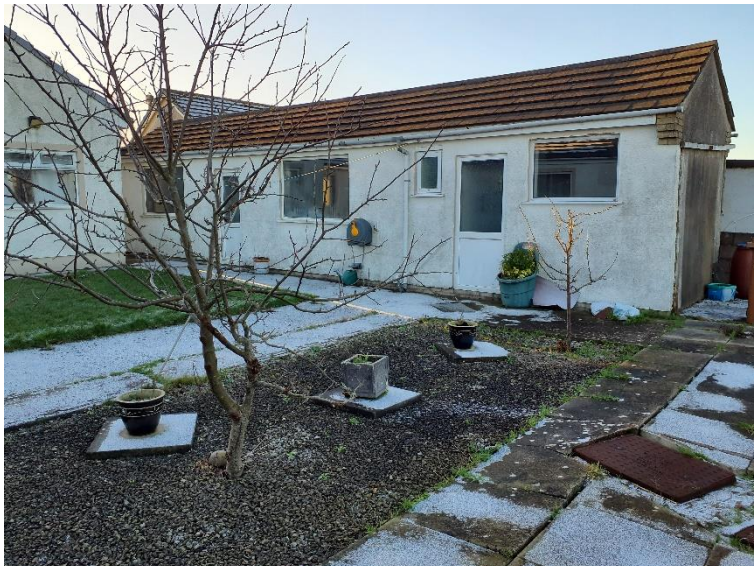
Both of the outbuildings have a similar construction with a pitched roof of concrete tiles and rendered external walls. Both have a garage door on the southern elevation, which is in poor repair on the eastern outbuilding. No significant gaps were found in or around the roof or eaves of either building. There were small gaps around the damaged doorway of the eastern outbuilding, but these were small and not extensive gaps.

**Image 5.**  
Garage/  
outbuilding at the  
western side of the  
property in the  
back garden. No  
gaps seen in or  
around the roof of  
this building.

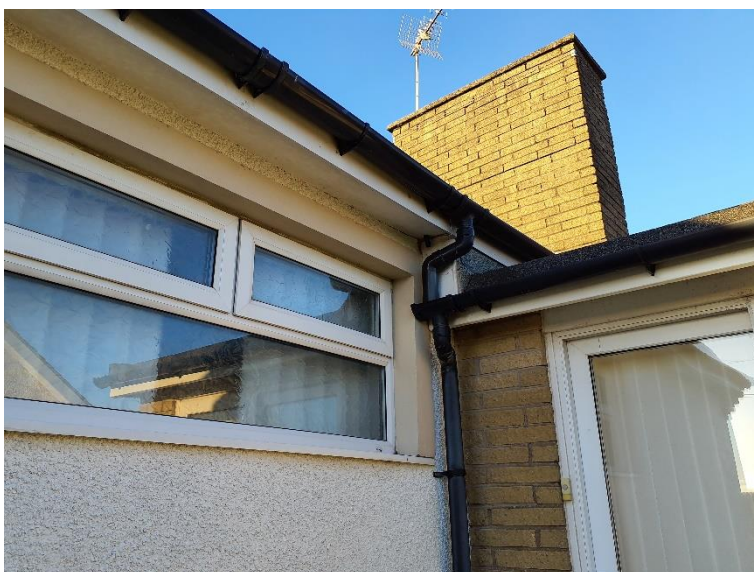
There were no gaps identified around the roof, walls or eaves. Window and door frames are well sealed with no gaps around the frames. The property has a brick chimney stack, which is well sealed with no gaps around the flashing.

**Image 6.**  
Side (eastern)  
elevation of house  
showing tight soffits  
and fascias with no  
gaps at the wall  
tops.

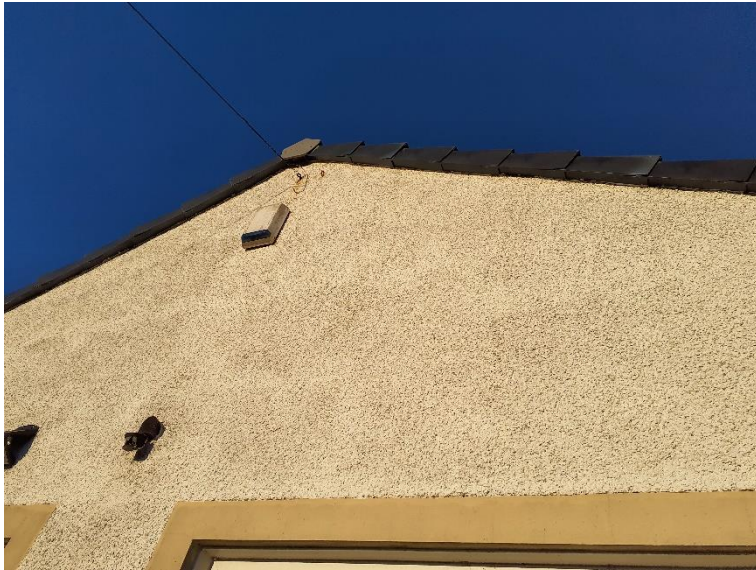
**Image 7.**  
Front of property  
showing gable end.  
No gaps present  
along the edge of  
the roof line.

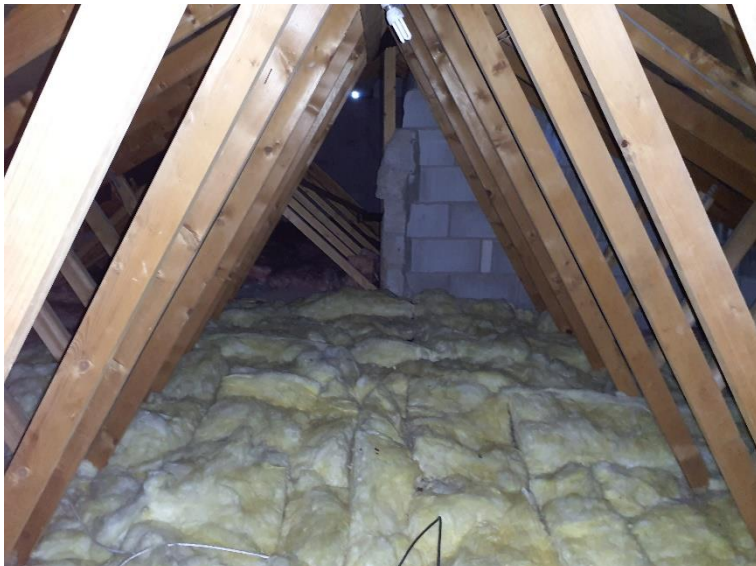
Internally there is one large roof void with a dense network of roof timbers inside. There is roofing felt under the tiles, which is generally in good condition, though is torn or sagging in some places. There is dense floor insulation in the loft. The loft area is dark and undisturbed.

**Image 8.**  
Interior of the roof  
space.

All dark and  
undisturbed, and no  
signs of mammal  
activity.
