PHASE 2: GROUND INVESTIGATION REPORT

PROPOSED RESIDENTIAL DEVELOPMENT

LAND AT IVY MILL, MAIN STREET

GLEESON REGENERATION LTD

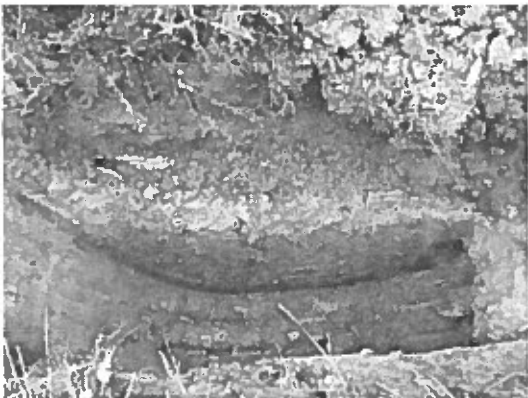
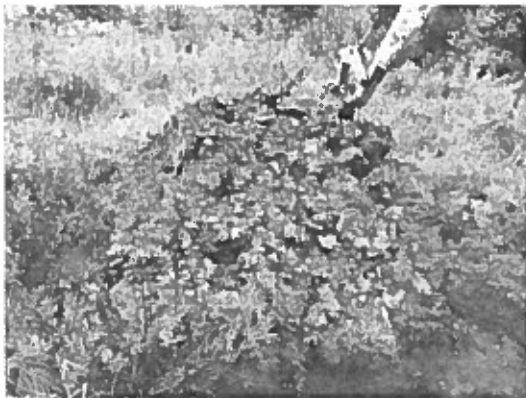
0.90 HSV: 40kN/m ² 0.90 B
1.00	2.00	Initially firm becoming stiff dark brown mottled grey slightly sandy slightly gravelly CLAY with occasional cobbles. Noted to be stiff at c.1.50m recovered as gravel size pieces.

1.75 B
		End of trial hole sides noted to be stable. Trial hole remained dry during and upon completion. Dimensions: L (2.50m) x W (0.90m) x D (2.00m)

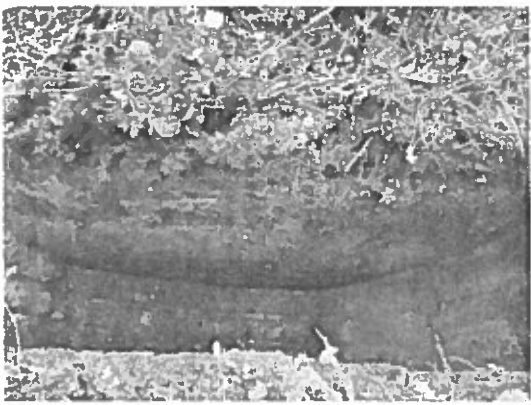
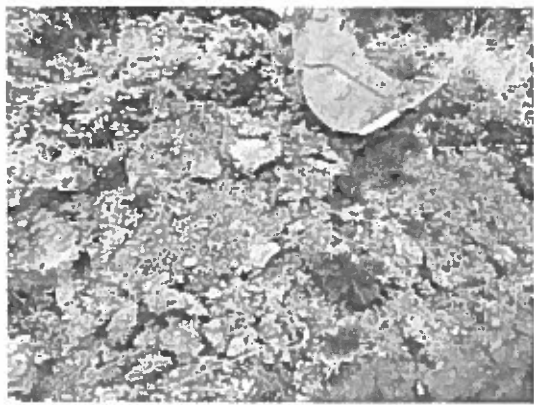
GEO2019-3886: Ivy Mill, Hensingham. TPB

0.10	0.50	MADE GROUND: Firm orange brown / grey slightly sandy CLAY. No anthropogenic debris noted.

2.25 B
		End of trial hole sides noted to be stable. Trial hole remained dry during and upon completion. Dimensions: L (3.00m) x W (0.60m) x D (2.25m)

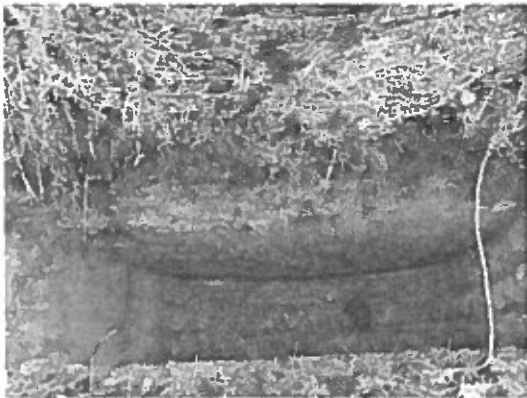
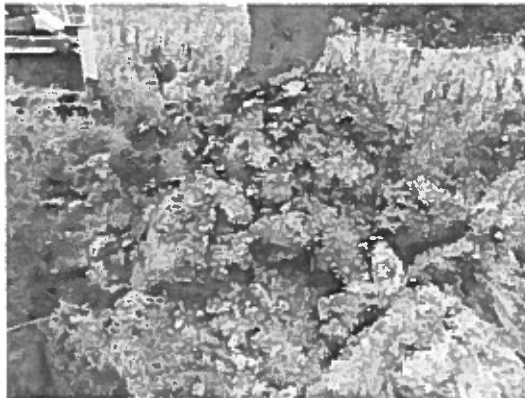
GEO2019-3886: Ivy Mill, Hensingham. TPC

1.80 B
		End of trial hole sides noted to be stable. Trial hole remained dry during and upon completion. Dimensions: L (2.60m) x W (0.60m) x D (2.15m)

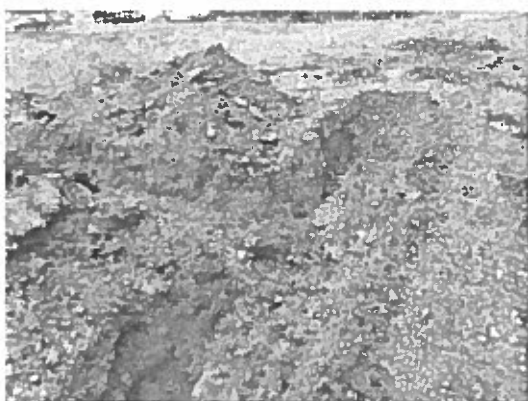
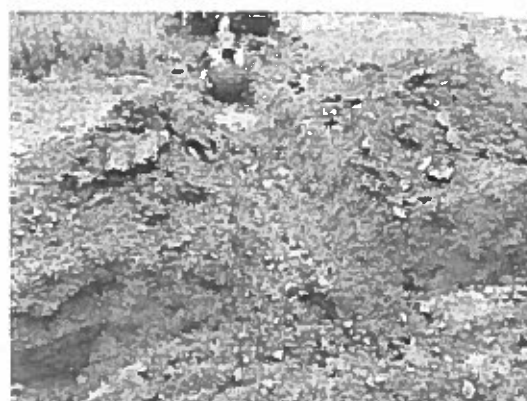
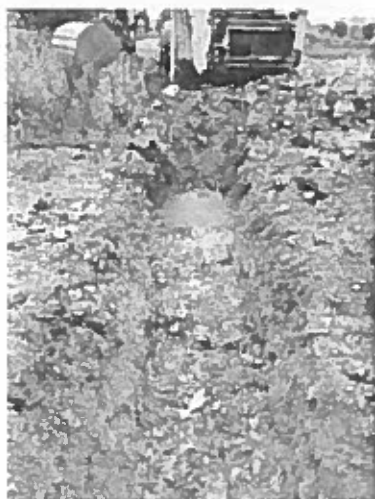
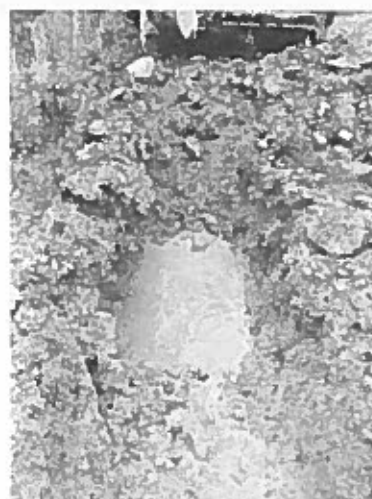
GEO2019-3886: Ivy Mill, Hensingham. TPD

- Within TPD, made ground was recorded to a depth of c.0.40m bgl and then identified a relatively thin layer of clay before encountering sandstone. The made ground (gravel) between c.0.23m to c.0.40m bgl was noted to exhibit slight olfactory evidence of hydrocarbons.

- The trial pit (TPD) was extended in length and direction with limited penetration into the sandstone albeit for the made ground (c.9m from the northern boundary) which fell away to c.1.10m bgl where no further excavation was possible. This area will need further works to fully determine the ground conditions at this location.

Depth From (m)	Depth To (m)	Strata Description	Legend	Testing / Samples
0.00	0.23	MADE GROUND: Grey and brown sandy fine to coarse GRAVEL of concrete, brick, sandstone, glass and plastic.		0.20 J
0.23	0.40	MADE GROUND: Grey fine to medium GRAVEL exhibiting slight olfactory evidence of hydrocarbons.		0.30 – 0.40 J
0.40	0.65	Stiff brown slightly gravelly CLAY.		
0.65	1.10	Possible sandstone encountered so extended the trial pit in to a "T" trench. At c.8m from the northern boundary, saturated GRAVEL (possibly demolition rubble) comprising concrete, brick, sandstone) to a depth of c.1.10m where no further excavation was possible.		0.60 W
		End of trial hole sides noted to be stable. The majority of the trial hole remained dry during and upon completion. Saturated gravels (demolition rubble) were noted at end of the trench. Dimensions: L (5.70m & 7.70m) x W (0.80m) x D (0.40m & 1.10m)

An anomaly was noted within TPD whereby made ground was recorded to c.0.40m bgl and then identified a relatively thin layer of clay before encountering sandstone. The made ground (gravel) between c.0.23m to c.0.40m bgl was noted to exhibit slight olfactory evidence of hydrocarbons. At this location, the trial pit was extended to create a "t" shaped excavation, primarily to determine the extent of the sandstone. Approximately c.9m from the northern boundary, the made ground was noted to fall away to a depth of c.1.10m bgl with no further excavation possible.

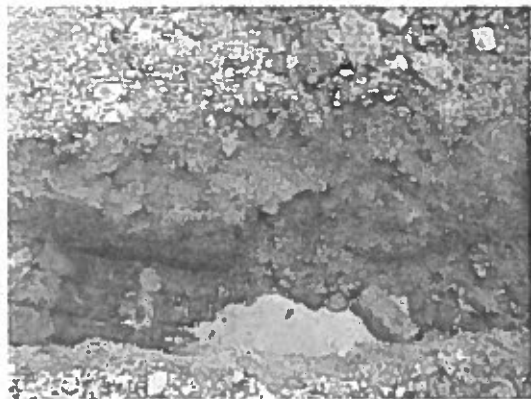
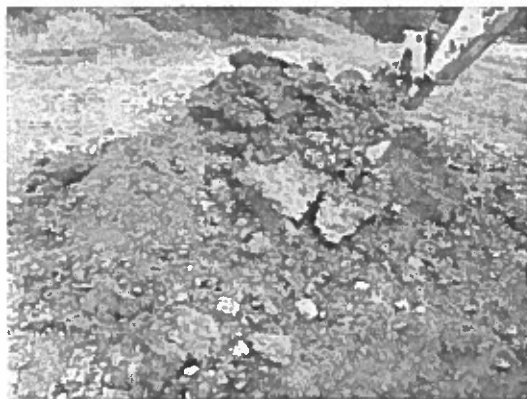
GEO2019-3886: Ivy Mill, Hensingham. TPG

1.50 B
		End of trial hole sides noted to be stable. A water ingress was noted at c.1.00m within the infilled former foundation run. Dimensions: L (4.20m) x W (0.65m) x D (1.50m)

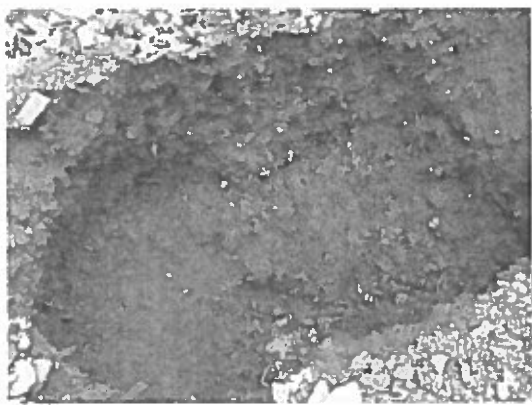
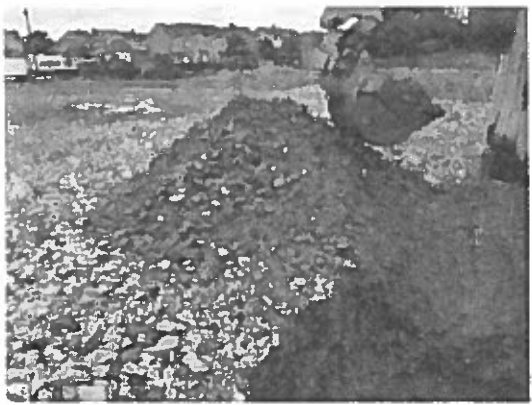
- On the stockpile, TP's F & G identified the crushed demolition rubble to depths of c.2.20m and c.2.40m bgl with possible concrete slabs noted at these depths, with no further excavation possible. On top of the "possible slab" encountered in TPF was a black gravel which exhibited olfactory evidence of hydrocarbons.

2.00 J
2.20		At c.2.20m, noted as being hard with no further excavation, possibly a concrete slab.

During and upon completion, trial hole sides noted to be unstable. A water ingress was noted at c.2.20m with a similar SWL upon completion. Dimensions: L (3.70m) x W (1.70m) x D (2.20m)

Although no relict foundations were identified, a possible slab was identified in TP's F & G below the demolition stockpile and therefore it may be the case that as well as the slab, former foundations may also be present on site.

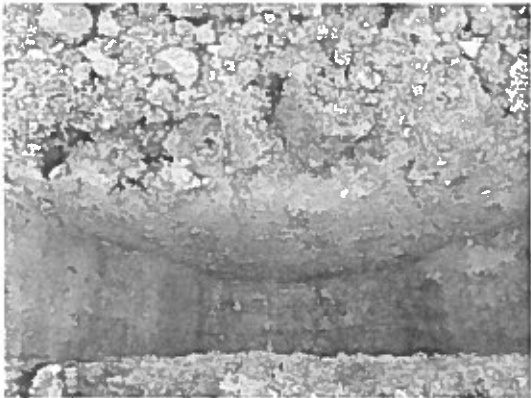
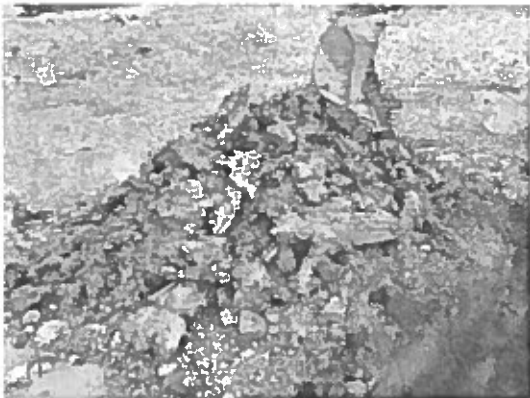
GEO2019-3886: Ivy Mill, Hensingham. TPH

Depth From (m)	Depth To (m)	Strata Description	Legend	Testing / Samples
0.00	0.30	MADE GROUND: Bare ground overlying soft brown / black gravelly SAND and sandy GRAVEL with angular cobbles. No visual or olfactory evidence noted.

1.50 HSV: 75kN/m ² 1.75 B
		End of trial hole sides noted to be stable. Trial hole remained dry during and upon completion. Dimensions: L (3.20m) x W (0.60m) x D (2.10m)

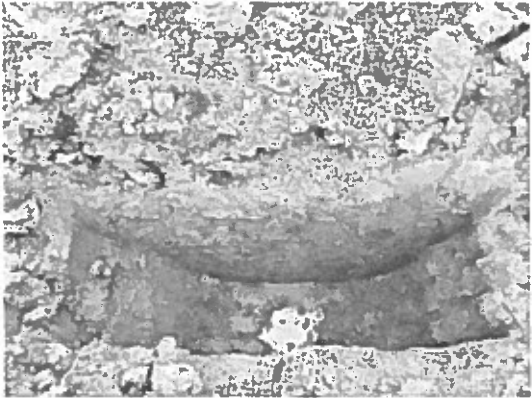
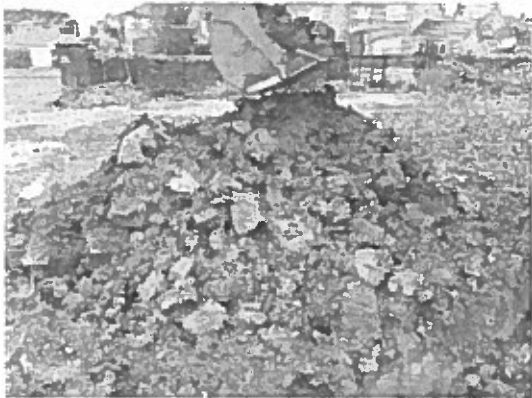
GEO2019-3886: Ivy Mill, Hensingham. TPJ

1.00 B 2.00 B
		End of trial hole sides noted to be stable. Water ingress noted at c.0.40m at interface of gravel and clay deposits. Trial hole remained dry during and upon completion. Dimensions: L (3.60m) x W (0.60m) x D (2.00m)

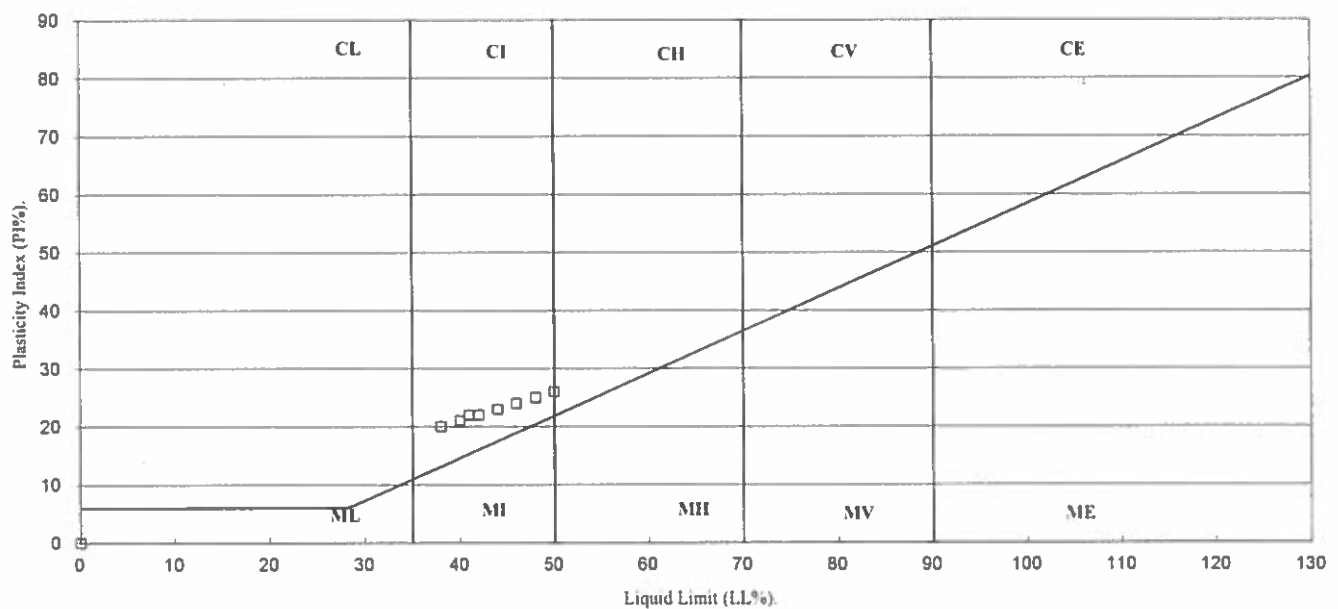
PLASTICITY CHART FOR CASAGRANDE CLASSIFICATION.

Typically, natural moisture contents of 14% and 31% were observed, with liquid limits of between 38% and 50% and plasticity indices of between 20% and 26% being recorded. The results indicate clays of intermediate plasticity and a low to medium volume change potential.
