Intrusive Site Investigation Report

| LOCATION | Proposed Development – Land at Dentholme, Cragg Road, Cleator Moor CA25 5PR |
| OUR REF. | G21044 |

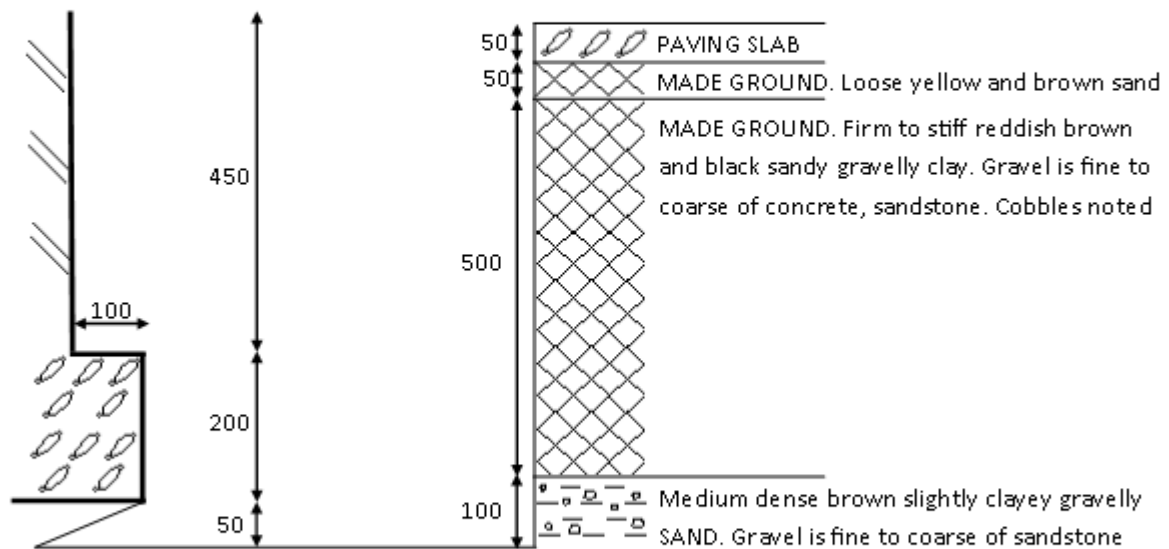
| OUR REF: G21044 | YOUR REF: | TRIAL PIT: A |

TPA encountered a concrete paving slab at surface of 0.05m thickness underlain by made ground of loose builders' sand to 0.10m. This was underlain by made ground of firm to stiff sandy gravelly clay with gravel of concrete and sandstone to 0.60m. Underlying this was natural medium dense clayey gravelly sand to termination at 0.70m.

Base of Foundation at 0.65m

Trial Pit terminated at 0.70m

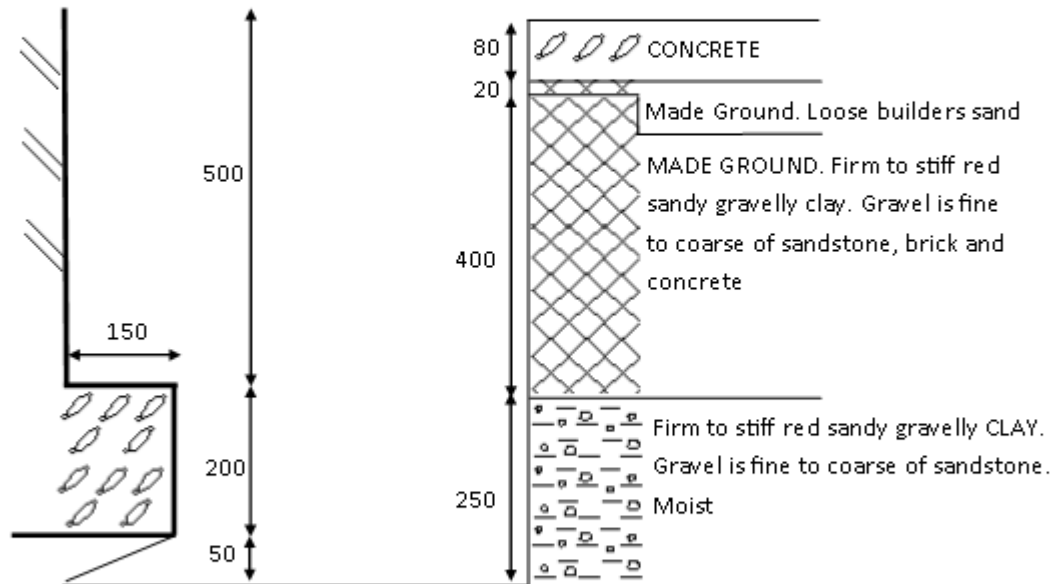
| OUR REF: G21044 | YOUR REF: | TRIAL PIT: B |

TPB encountered concrete at surface of 0.05m thickness followed by made ground of firm to stiff sandy gravelly clay with gravel of sandstone and concrete to 0.50m. This was underlain by natural firm sandy gravelly clay to termination at 0.75m.

Base of Foundation at 0.70m

Trial Pit terminated at 0.75m

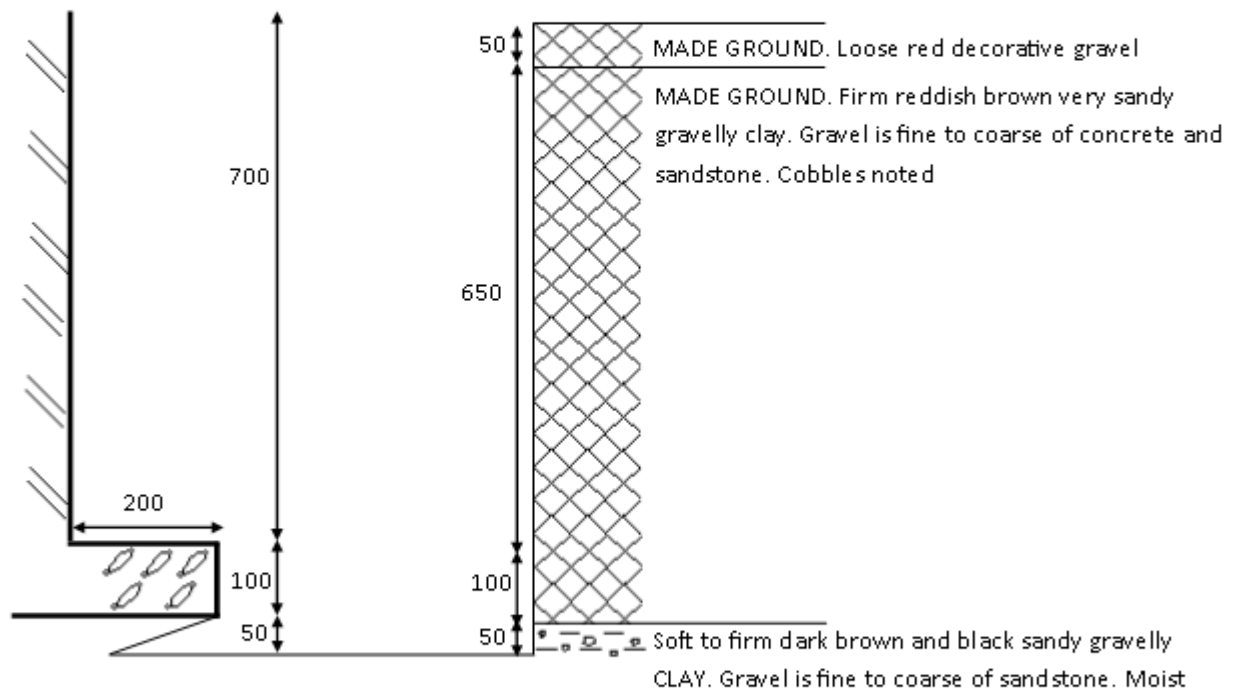
| OUR REF: G21044 | YOUR REF: | TRIAL PIT: C |

TPC encountered red decorative gravel of thickness 0.05m followed by made ground of firm very sandy gravelly clay with gravel of concrete and sandstone to 0.70m. This was underlain by natural soft to firm sandy gravelly clay to termination at 0.75m.

Base of Foundation at 0.80m

Trial Pit terminated at 0.85m

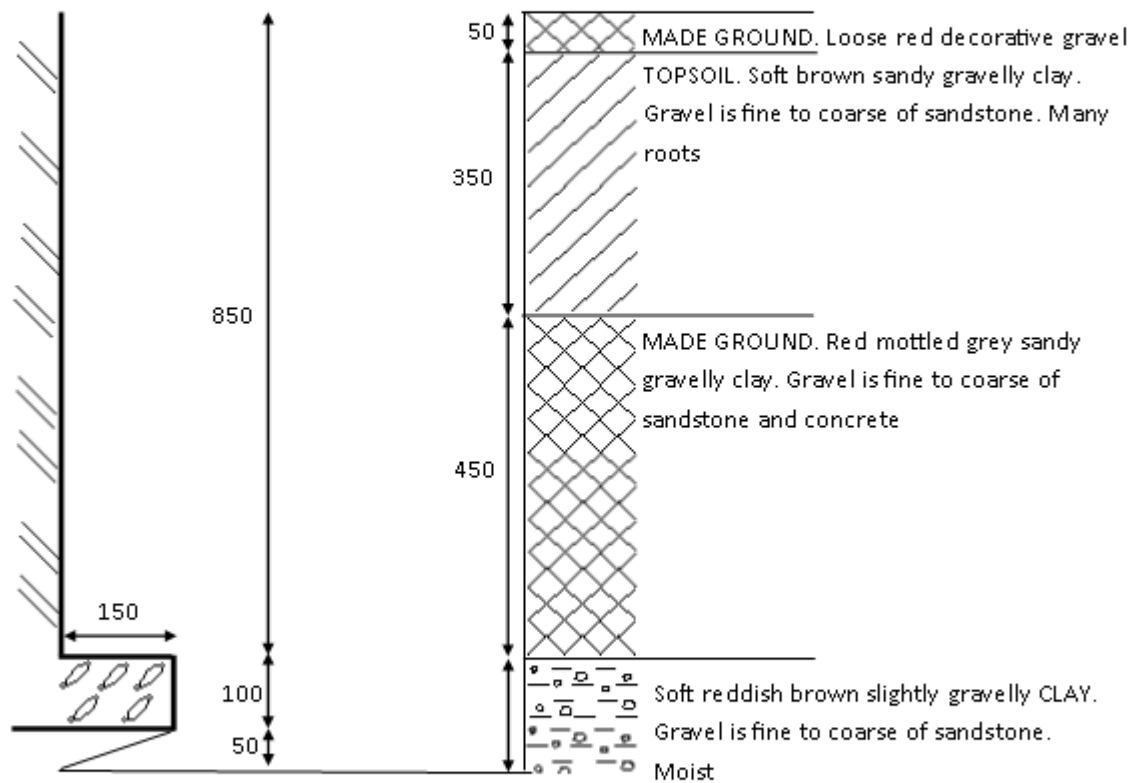
| OUR REF: G21044 | YOUR REF: | TRIAL PIT: D |

TPD encountered red decorative gravel of thickness 0.05m followed by topsoil of soft sandy gravelly clay to 0.40m. This was followed by made ground of soft sandy gravelly clay with gravel of sandstone to 0.85m underlain by natural soft slightly sandy gravelly clay to termination at 1.00m

Base of Foundation at 0.95m

Trial Pit terminated at 1.00m

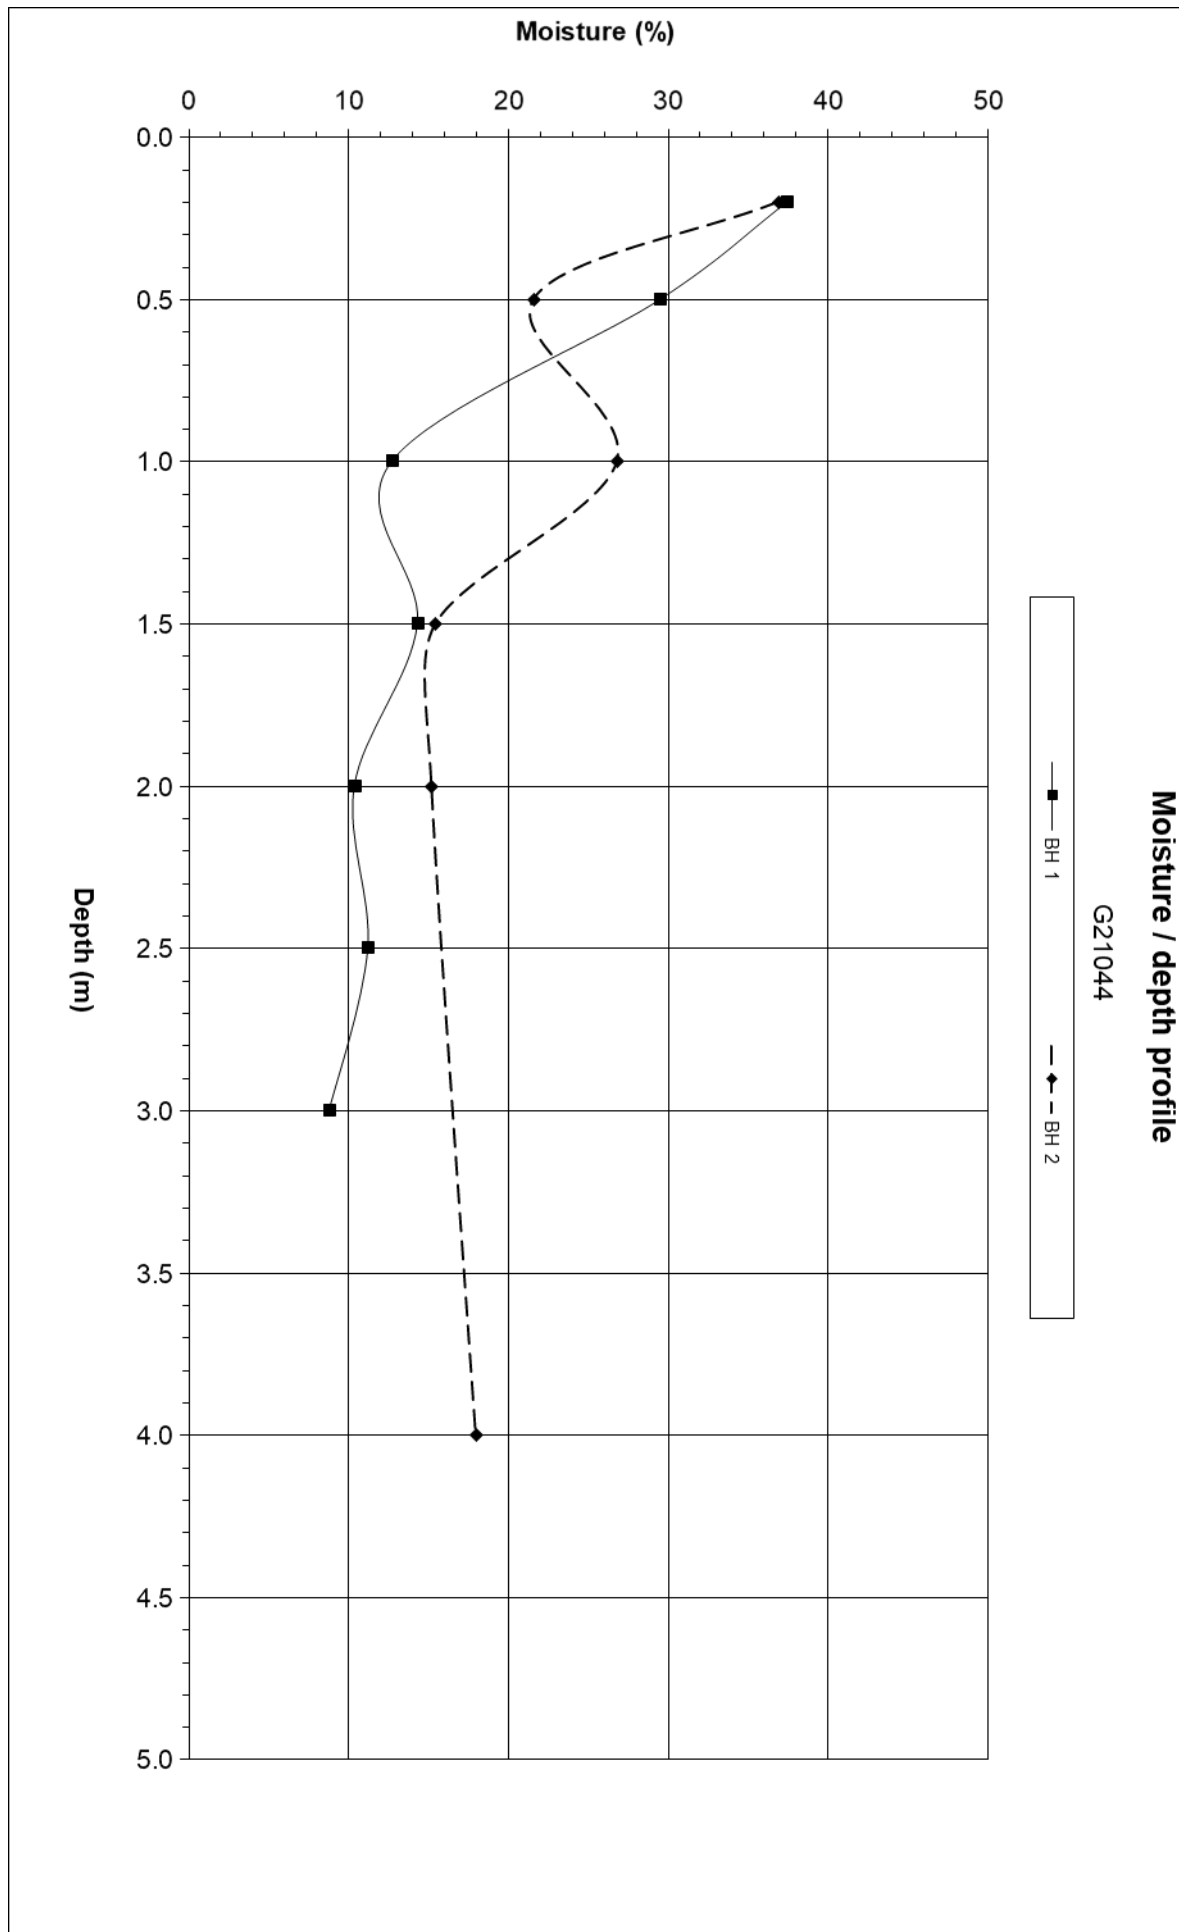
Moisture content profiles and moisture & plasticity test results (Table 1)

Geotechnical Testing has returned Plasticity Indices (PIs) of between 11.5% and 15.6% which classify the soils as Clay of Low (CL) plasticity according to BS 5930. These equate to NHBC Low Shrinkage Soils.

Although some vegetation is present at the site in the form of large hedges and smaller trees no roots were encountered in the excavations and no moisture depletion is therefore evident on the moisture profiles.

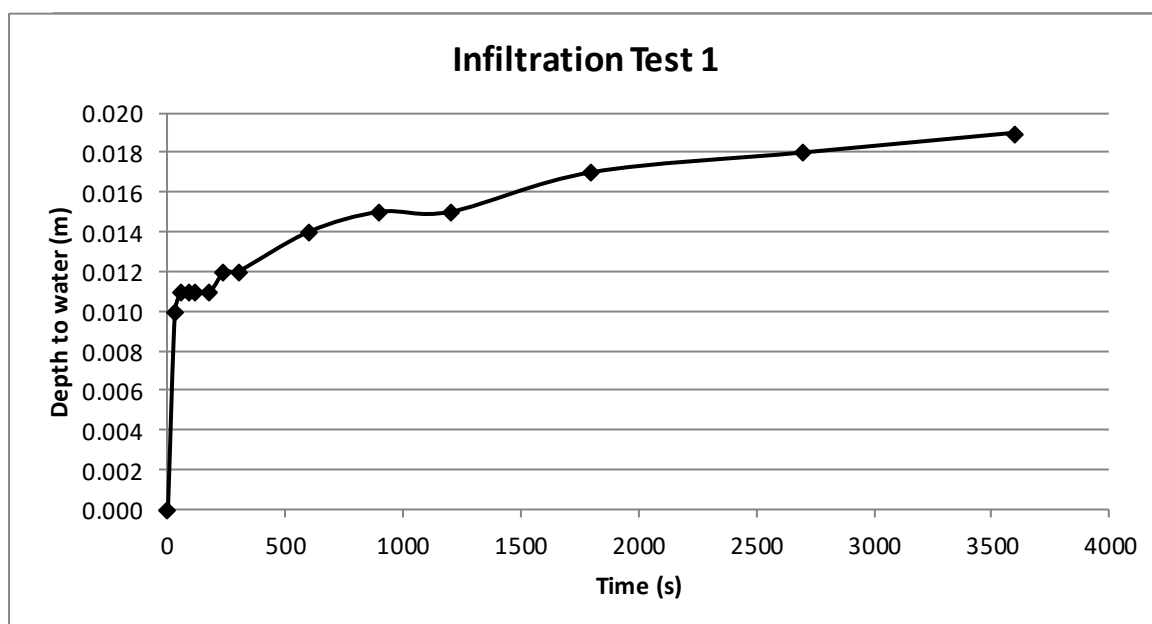
Infiltration test 1

The test was deemed to have failed due to the infiltration of only 19mm over an hour, with the bulk of the initial water intake in the first 5 minutes and most of this over the initial 30 seconds.

This would suggest that although the clay contained some sand and gravel it is almost entirely impermeable. Were soakaways to be utilised at the site these would lead to waterlogging of the ground eventually.

Permeability, k = 1.44E-08 ms⁻¹

Given the above it may be assumed that the strata at site would not provide an adequate infiltration medium for installation of soakaways and that an alternative means of disposal of surface water at the site be sought.
