**PHASE II SITE INVESTIGATION  
REPORT  
OF LAND AT  
DALZELL STREET,  
MOOR ROW,  
CUMBRIA**

**Prepared for:-  
Nigel Kay Homes Ltd  
Hollowdyke Farm  
Frizington  
Cumbria  
CA26 3QZ**

**September 2024  
Ref: GSI 2132 WG PII Report**

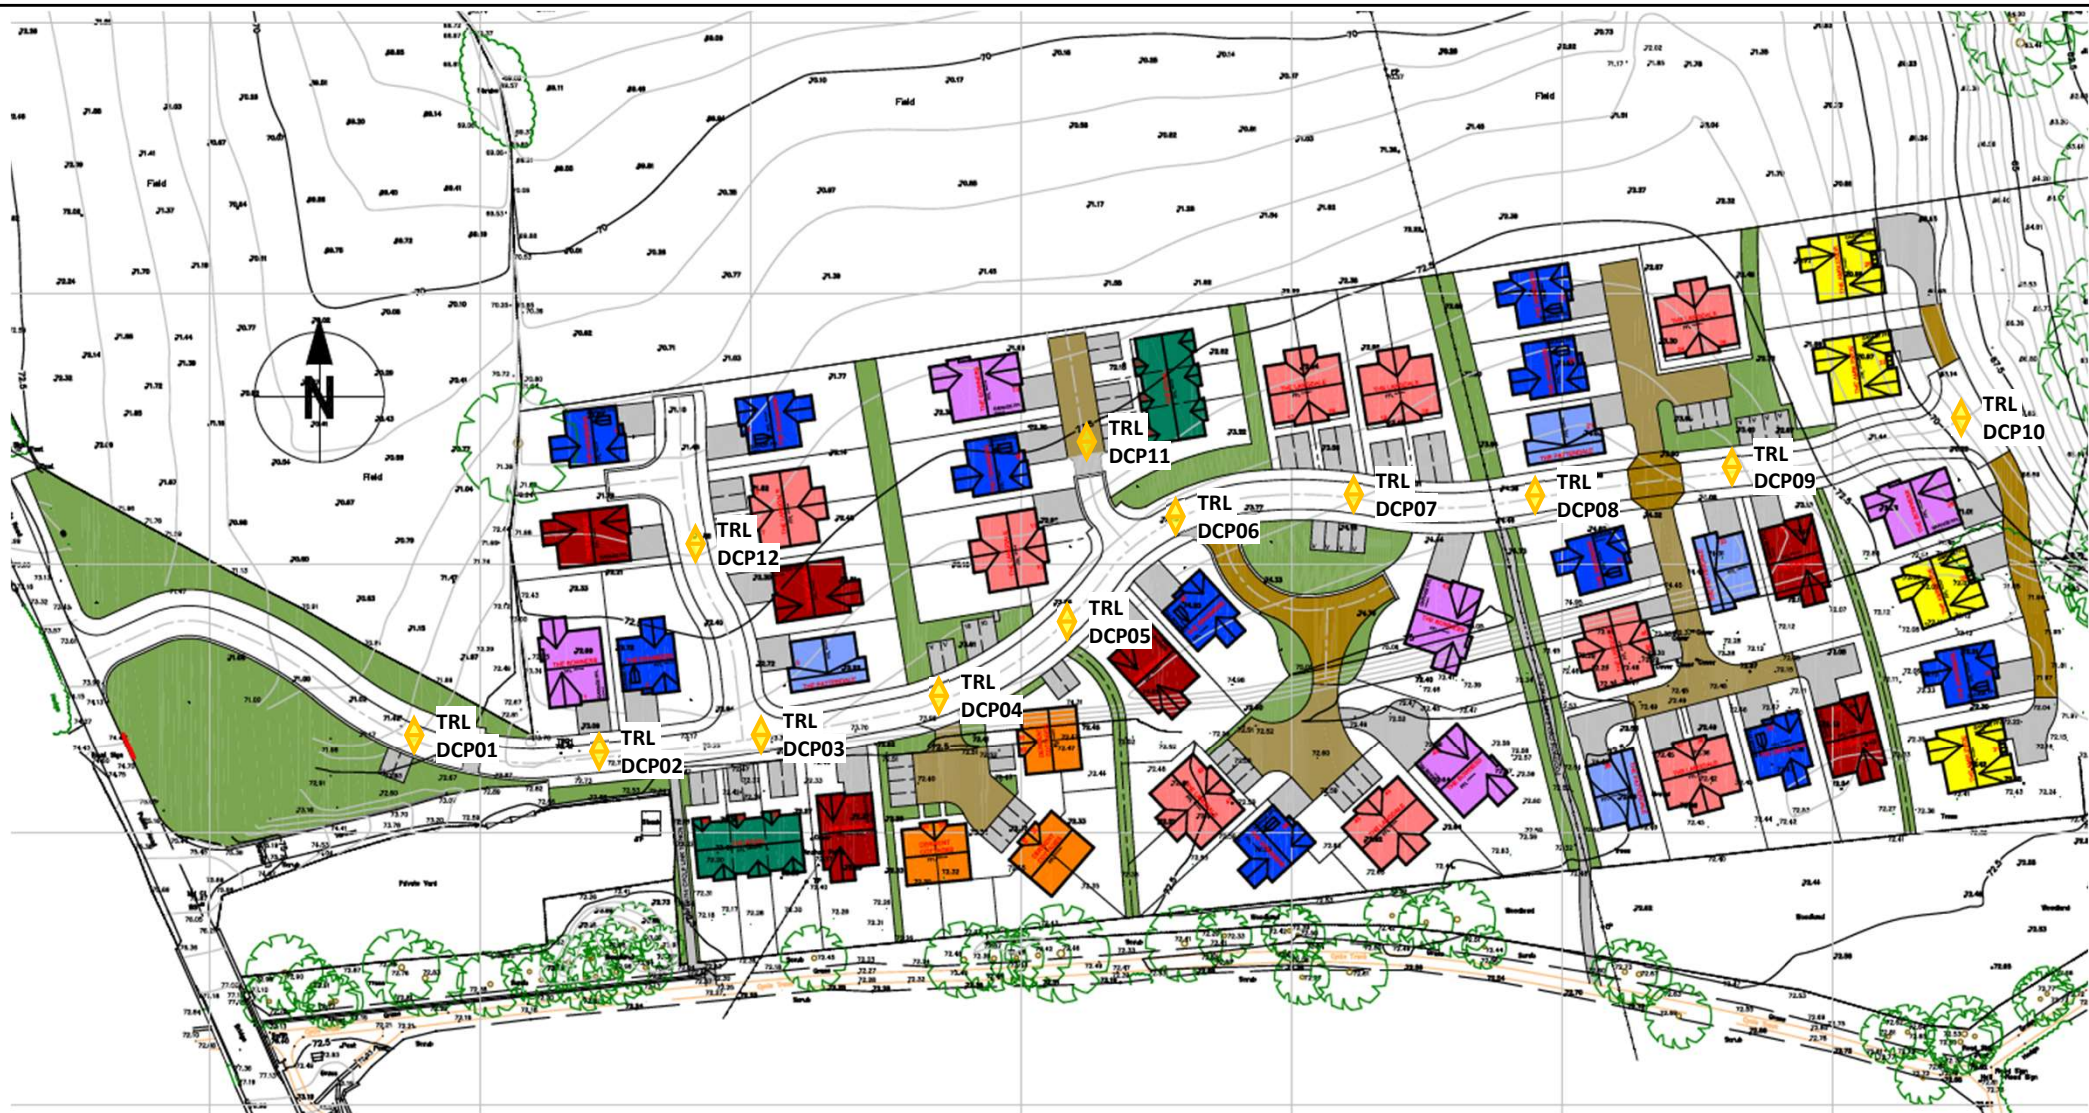
TRL DCP (CBR) Locations
