POW BECK, WHITEHAVEN.

BAT SURVEY.

Ref No: 211293.

Date: 22nd January 2021.

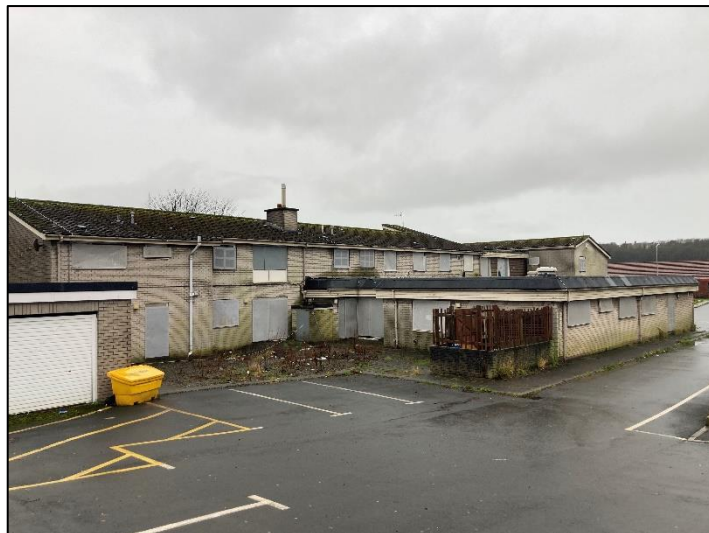
3.2.2. The photograph below shows the northern elevation of the buildings.

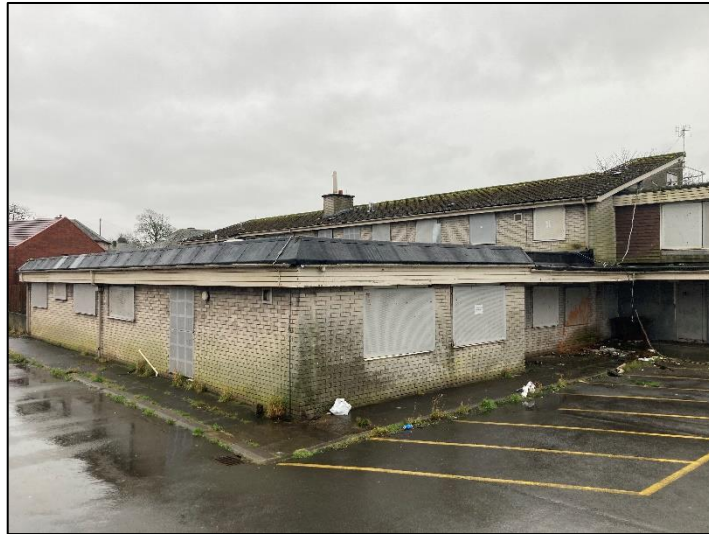
3.3.1.1. The surveyed building comprised two, two story sections with pitched roofs, which were connected by single storey flat roofed sections. The majority of the windows and doors were in situ and closed with metal shutters covering them externally. The building had brick cavity walls and two areas of hanging tiles on the northern and western walls. The building had four gable ends and wooden soffit and fascia boards around the eaves. These were all tight fitting and in a good condition. The brickwork was generally in a good condition with no visible cracks or crevices suitable for roosting bats.

3.3.1.2. The photograph adjacent shows the northern elevation of the building.

4.1.1. The building was assessed for the suitability for roosting bats. The brickwork was in a good condition with no visible cracks or crevices suitable for roosting bats. The roof was generally tight fitting with no gaps for roosting bats. No bat roosts or bat field signs were identified during the survey. Therefore, the building was assessed as having negligible potential and the proposed works will have **no impact** on roosting bats.

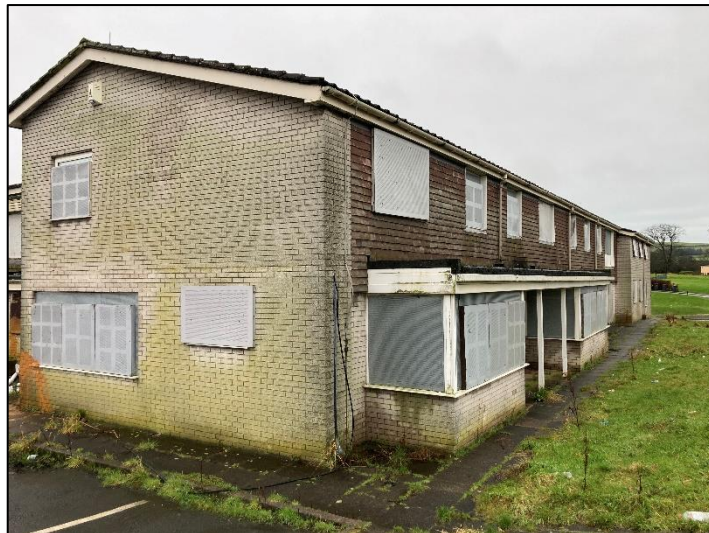
3.3.1.3. The photograph adjacent shows the western elevation of the building.

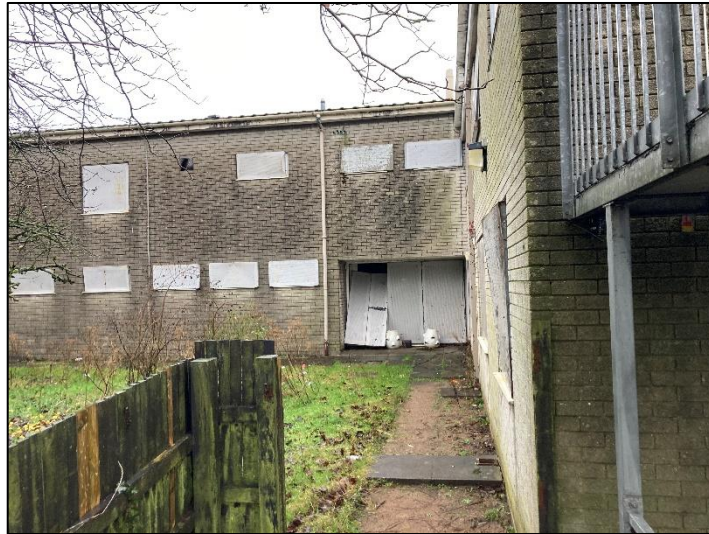
3.3.1.4. The photograph adjacent shows the southern elevation of the building.

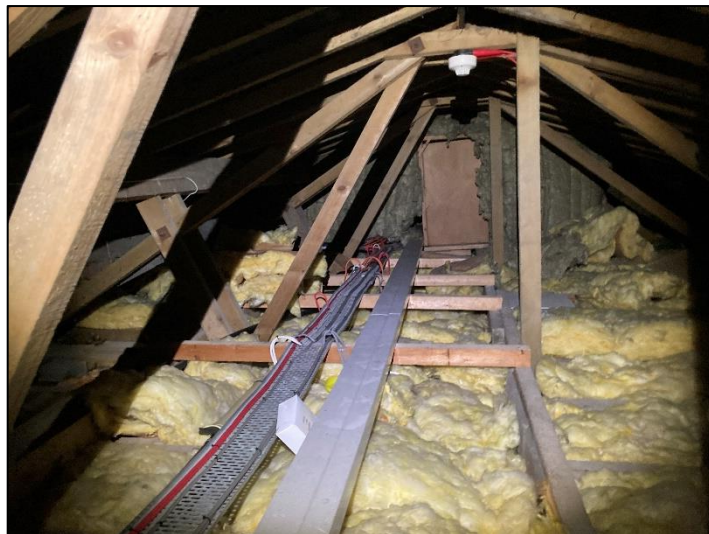
3.3.1.5. The two story sections of the building were covered with generally tight fitting interlocking tiles with a tight fitting hessian liner. Internally the roof was supported by a timber 'A frame', which was in a good condition with no gaps or cracks suitable for roosting bats.

3.3.1.6. The photograph below shows the internal elevation of the roof.

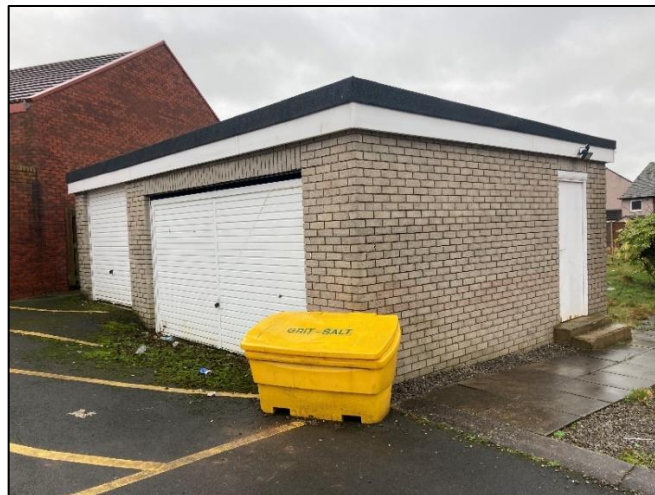
3.3.2.1. The surveyed building was a single storey flat roofed garage. Access could not be gained internally. However, a visual inspection could be carried out through an area of missing timber above the garage door and the building was assessed as unsuitable for roosting bats. All the doors were in situ and generally tight fitting. The building had solid brick walls and wooden fascia boards. These were all tight fitting and in a good condition. The brickwork was generally in a good condition with no visible cracks or crevices suitable for roosting bats.

3.3.2.2. The flat roofed sections comprised a wooden frame, which was covered with a tight fitting bitumen felt. The felt covering was in a good condition with no gaps or cracks suitable for roosting bats.

4.2.1. The building was assessed for the suitability for roosting bats. The brickwork was in a good condition with no visible cracks or crevices suitable for roosting bats. The roof was generally tight fitting with no gaps for roosting bats. No bat roosts or bat field signs were identified during the survey. Therefore, the building was assessed as having negligible potential and the proposed works will have **no impact** on roosting bats.
