## Preliminary Roost Assessment

Elf Hall, Roanlands Brow, Millom, Cumberland, LA18 5HR

This report is prepared to inform a planning application with Cumberland Council (Copeland Area). The proposal is described as:  
Demolition of existing structures and construction of replacement dwelling.

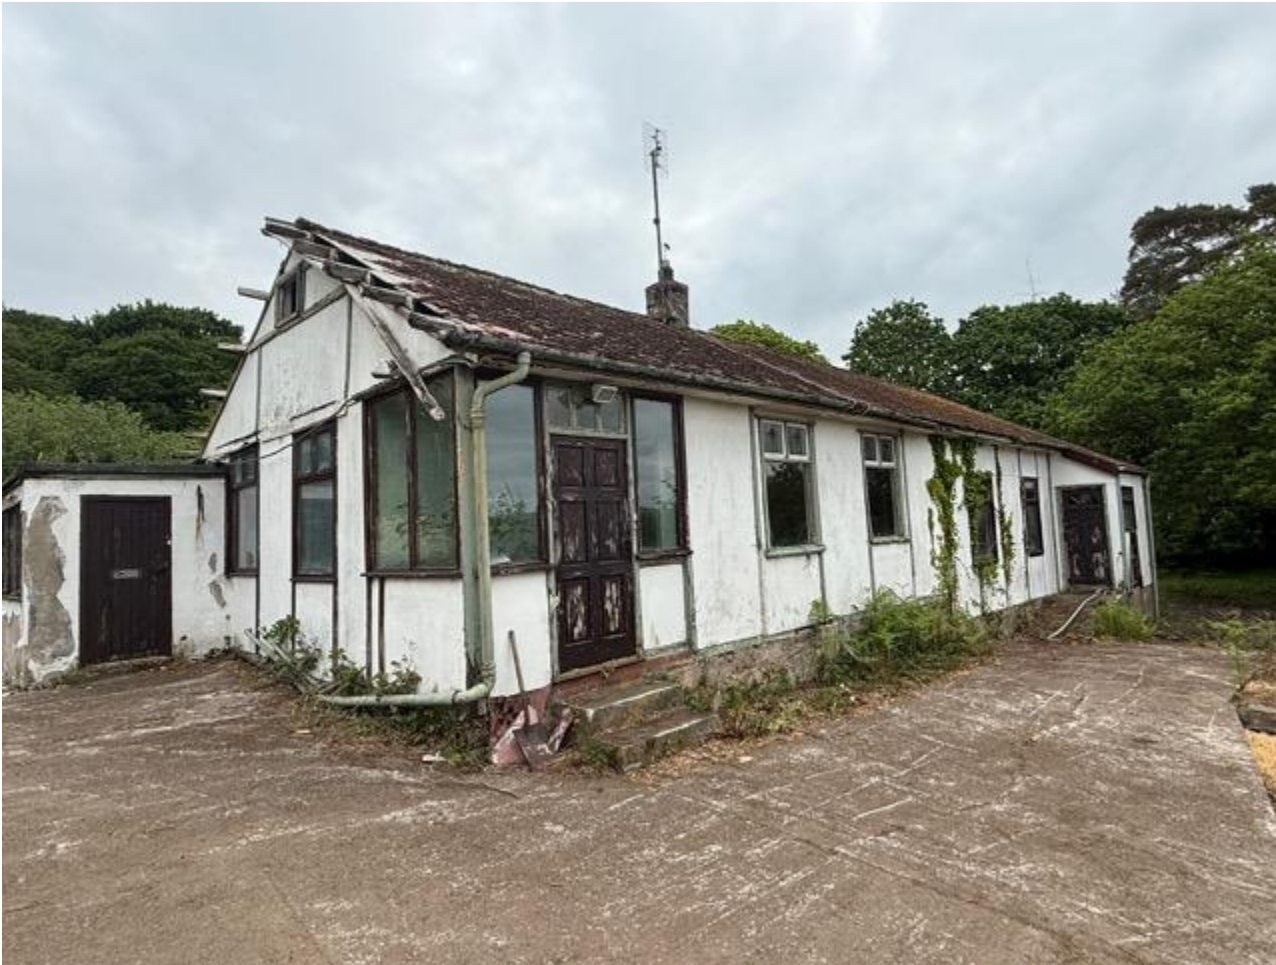
Photo 1: Southern and western elevation of B1.

Given the presence of some features on B1, along with the high foraging and commuting value of the wider landscape, B1 is determined to be of **moderate value** to roosting bats. Suitability is reduced from high, given the high lighting levels present within the internal roof void.

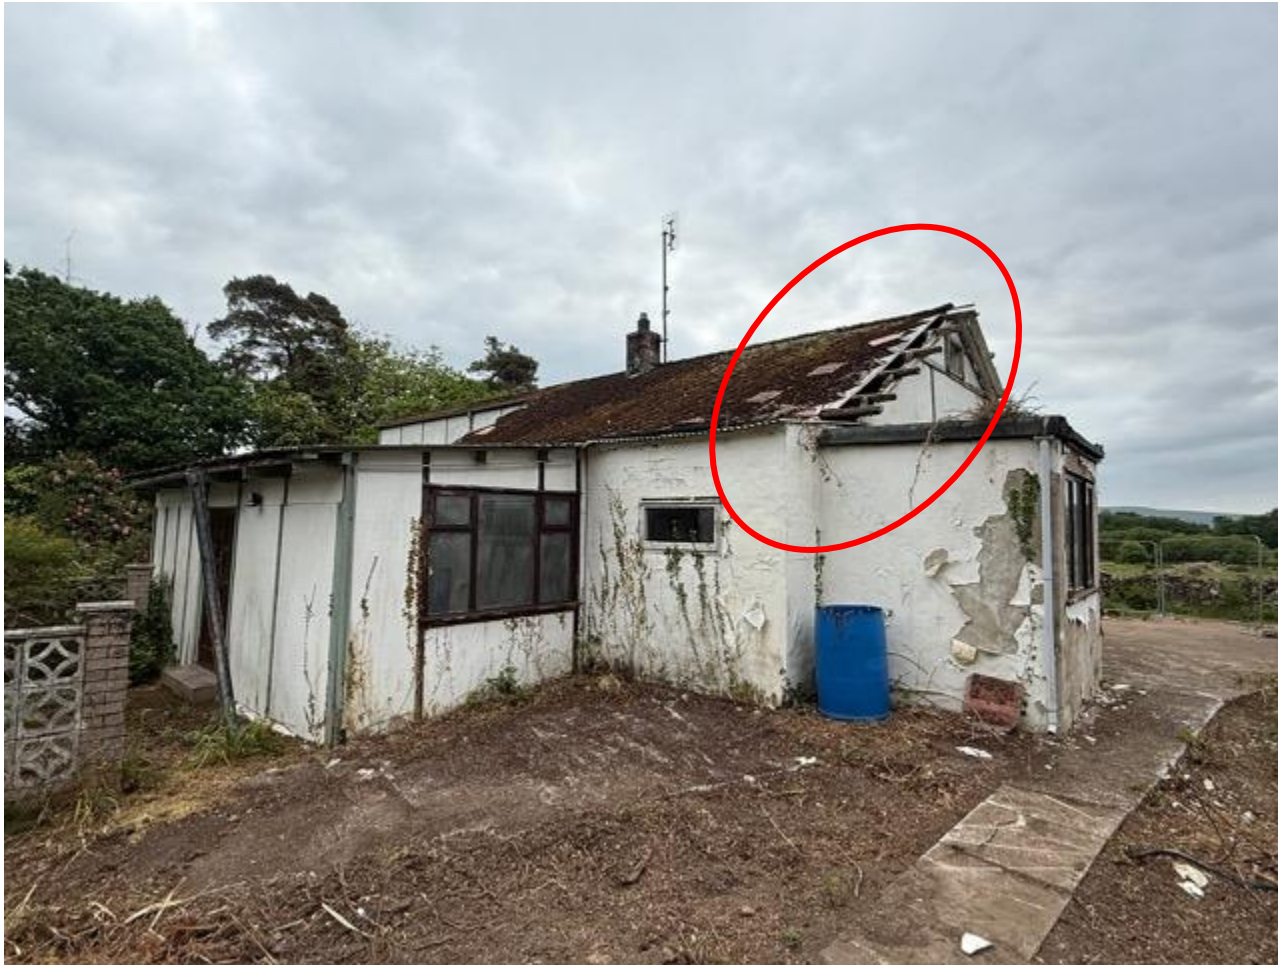
Photo 2: Northern and western elevation of B1.

Example of missing roof tiles present on eastern and western elevations are circled in red.

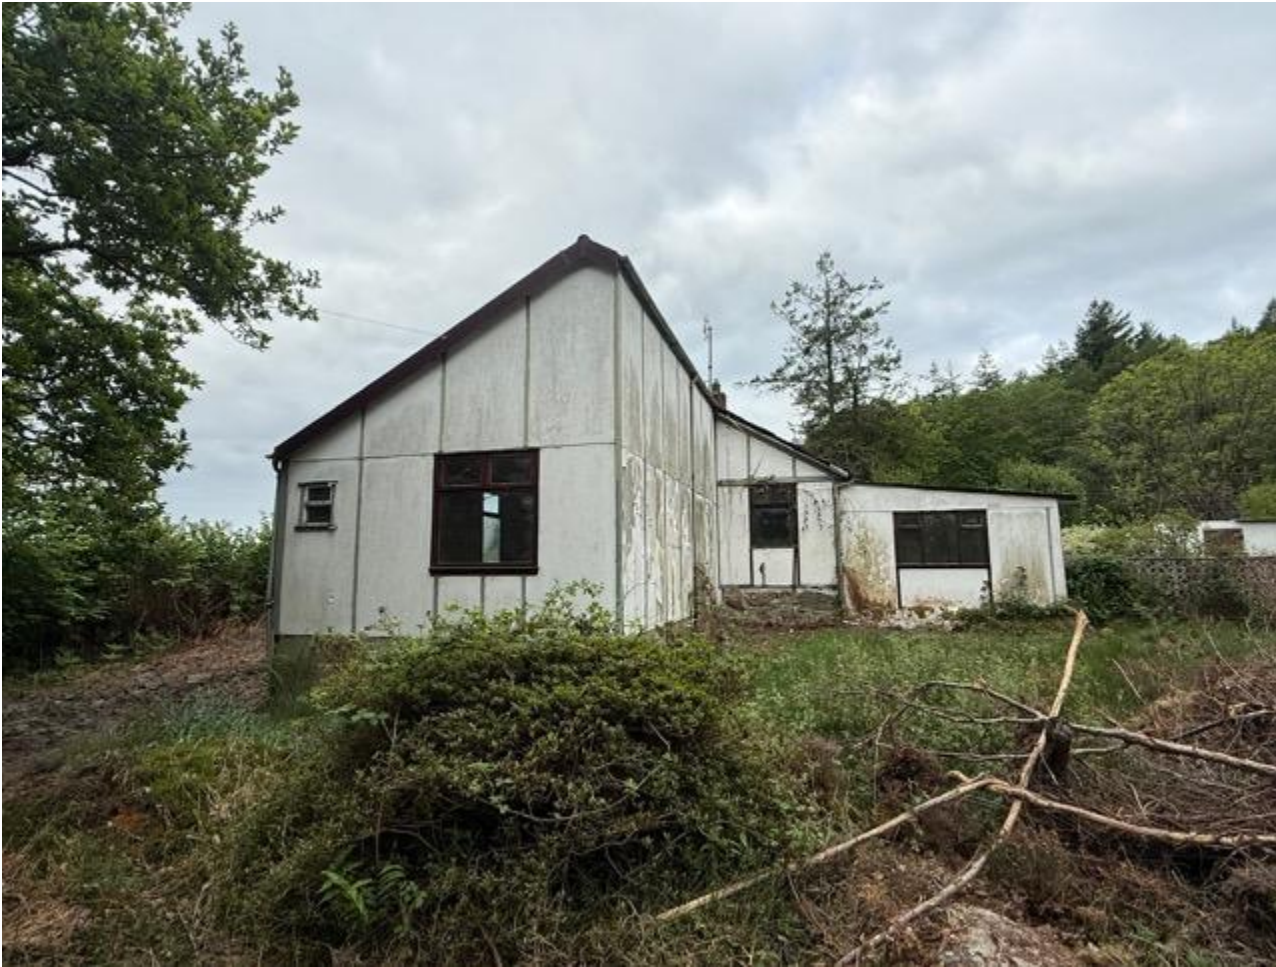
Photo 3: Eastern elevation of B1.

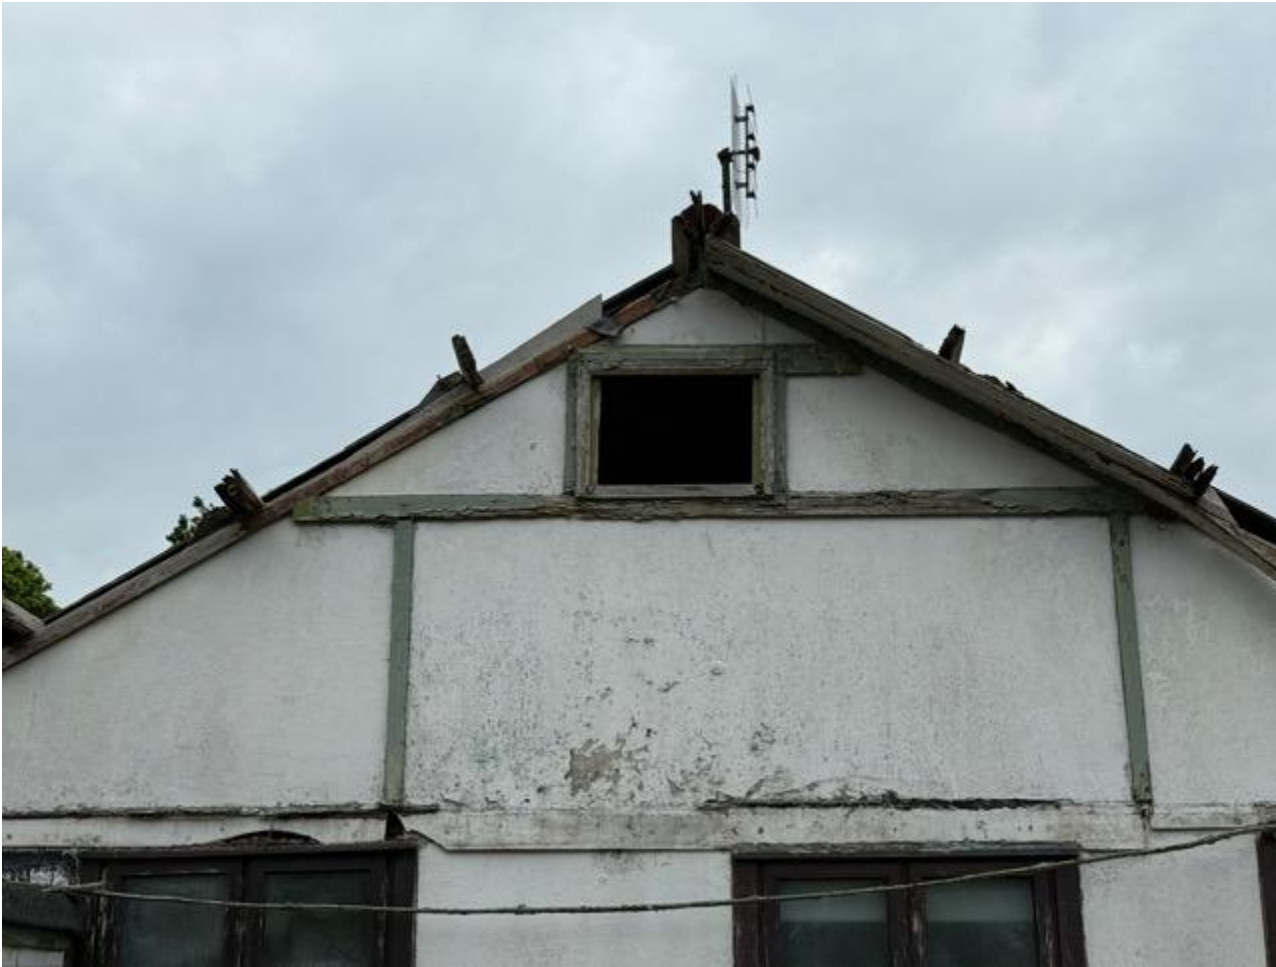
During the internal assessment, given the presence of the significant areas of missing roof tiles, and open hatch present on the western elevation, the void present was determined to have high lighting levels present within, which could potentially deter roosting bats. However, the internal roof space contained a number of internal crevices, present within the timber frame, which bats could utilise for roosting, as they were located within darker sections of the void, away from the gable ends.

Photo 4: Opening present to roof void present on western elevation of B1.

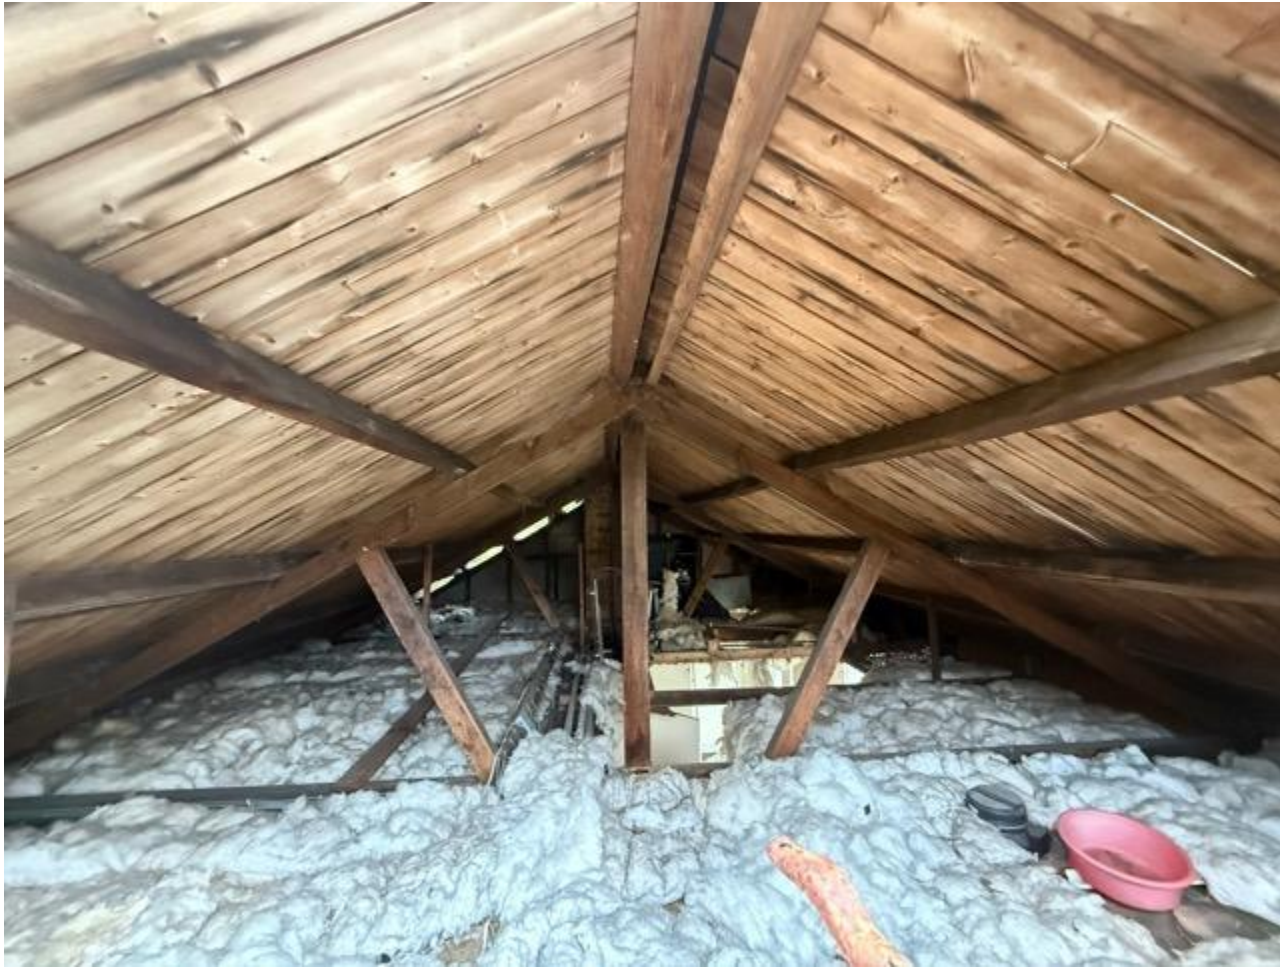
No evidence of roosting bats was observed during the survey on B1.

Photo 5: Internal area of B1.

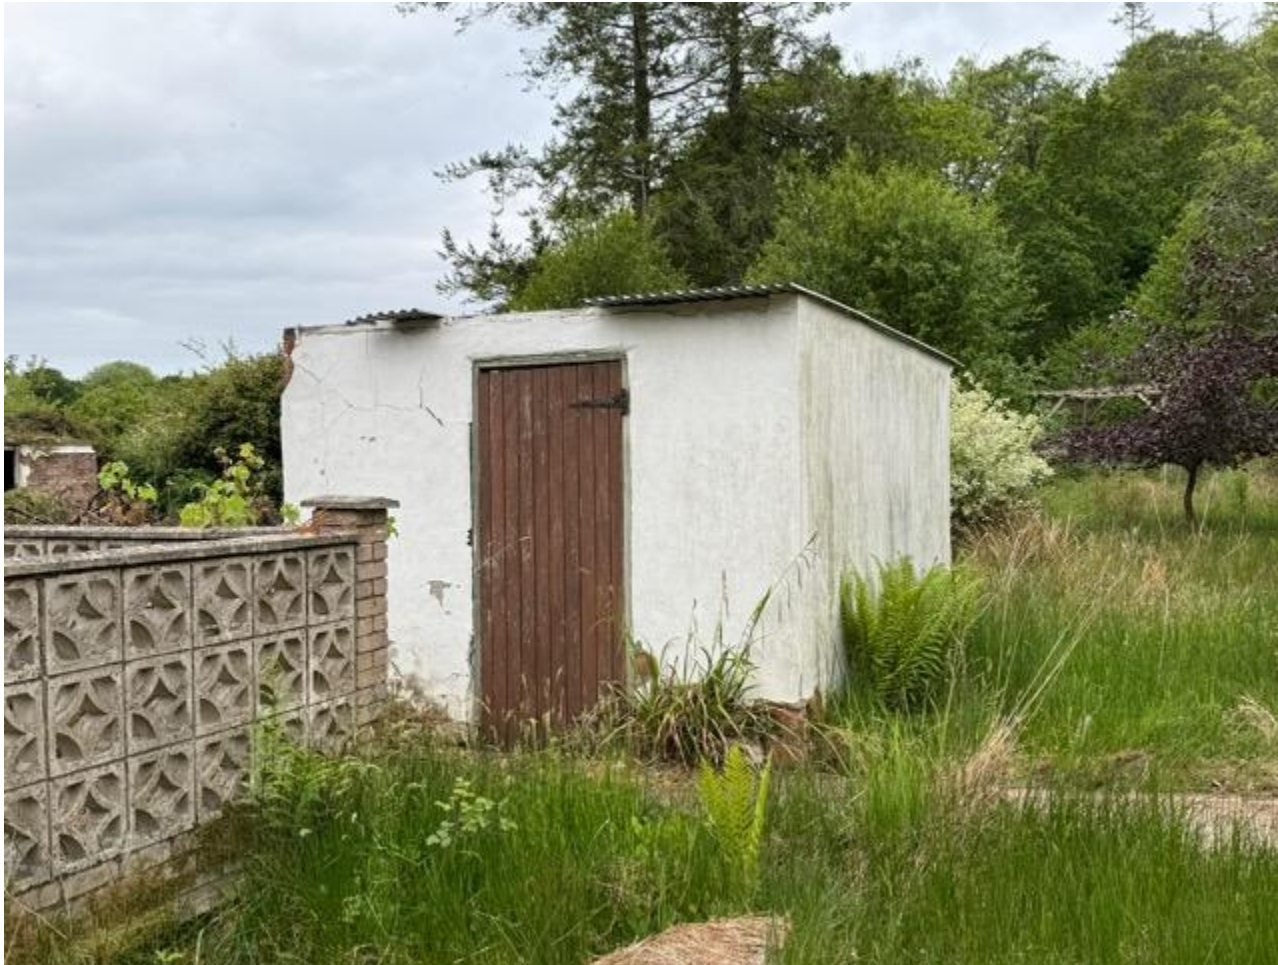
Building B2 is a small outbuilding structure present in the central section of the site. It comprises a concrete built-rendered structure, with a flat roof, covered in corrugated sheeting, which has partly collapsed. There is no void present within the structure and there are no external features which could be utilised by roosting bats. As such, B2 is determined to be of **negligible value** to roosting bats.

Photo 6: Building B2.

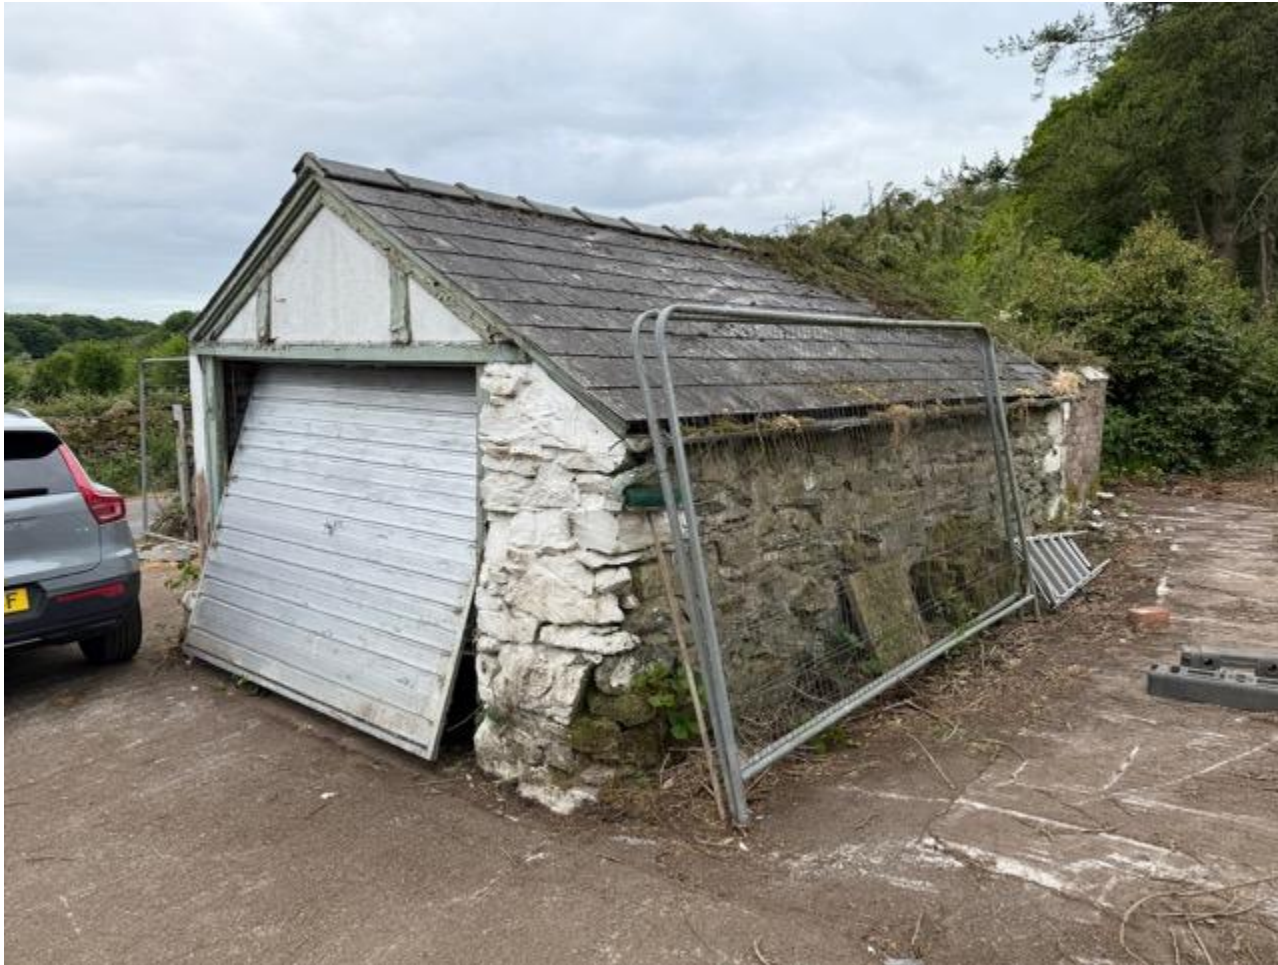
Building B3 is a garage structure located within the southern section of the site. It comprises a stone-built structure, with a pitched roof, covered in slate roof tiles. There is no void present within the building. The building is generally in good condition and contains no suitable external features present within the roof

<p>structure or stone-work that could provide suitability for roosting bats. As such, B3 is determined to be of <b>negligible value</b> to roosting bats.</p>
<p><i>Foreseen Impacts</i></p>	<p>As the proposals include the demolition of B1, any bat roosts within them will be destroyed. This could also result in death or injury of bats.</p> <p>Bats are very unlikely to be roosting within buildings B2 and B3 and as such, there are not anticipated to be any impacts on bats in this location as a result of the proposed development.</p>
<p><i>Recommendations</i></p>	<p>B1 has <b>moderate habitat value</b> to roosting bats.</p> <p><b>Two bat emergence/re-entry surveys</b> are required on B1 during the active bat season (May – September) to confirm presence/likely-absence of bats roosting in or on the building.</p> <p>These survey visits should be completed during the optimal survey period mid-May to August inclusive. The survey visits should be at least three weeks apart.</p> <p>Sub-optimal: early May and September. Would require greater justification of timing e.g., weather conditions, known local bat activity.</p> <p>One of the surveys could be a dawn re-entry survey, or all three can be at dusk if supported by night vision aids (NVA).</p>

Photo 7: Building B3.

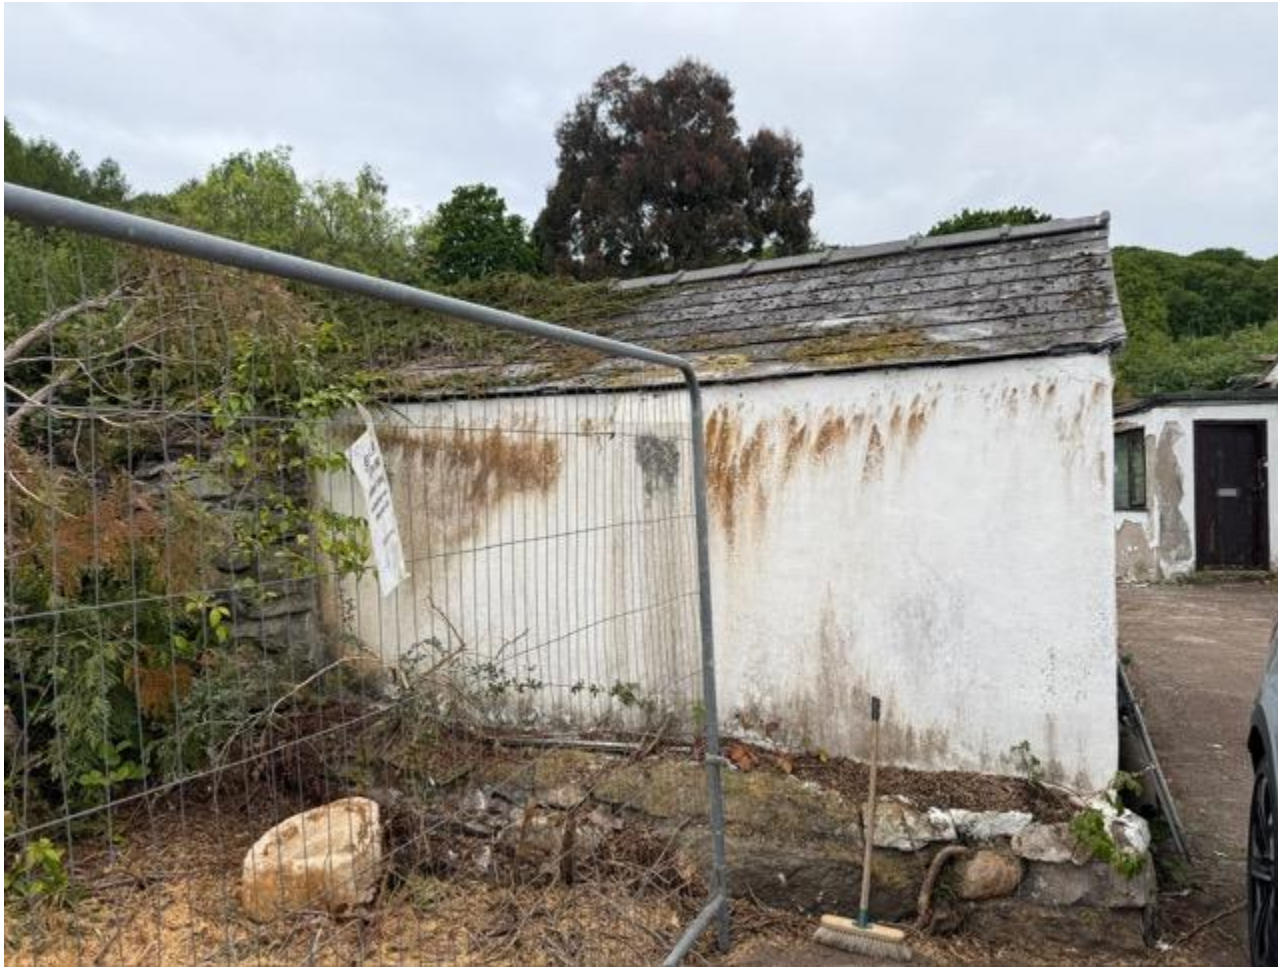
Photo 8: Southern elevation of B3.
