Preliminary Ecological Appraisal

Millom RUFC, Haverigg

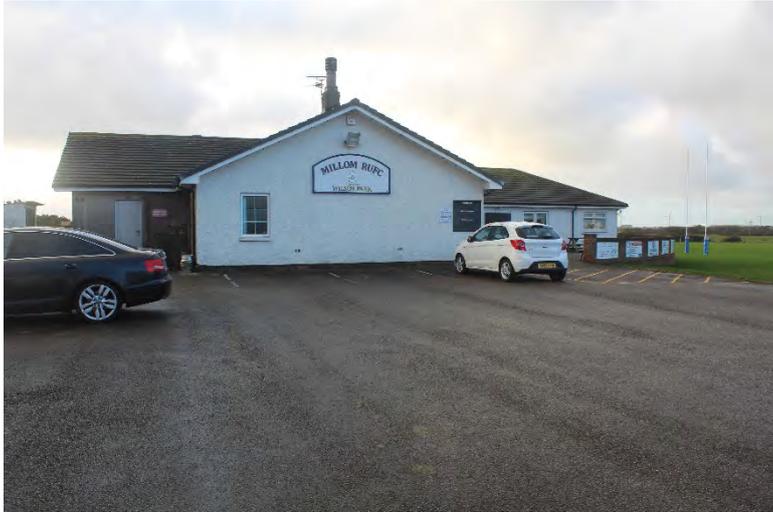
Existing clubhouse and
hardstanding carpark

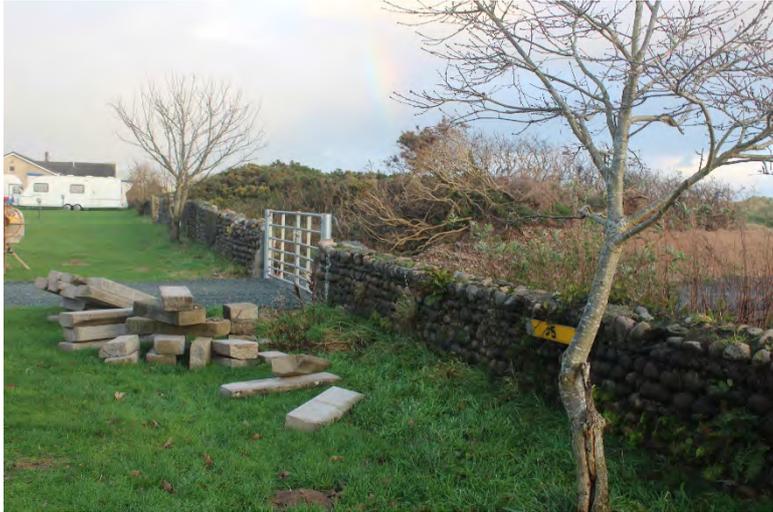
Scattered trees along wall on southern boundary

7.1.1 The roots of trees on the site boundaries should be adequately protected during work in accordance with industry standards. All trees should as far as possible be retained in the scheme. Where a tree must be removed, it should be replaced with trees/shrubs that can tolerate the exposed coastal conditions at the site, for example Hawthorn (*Crataegus monogyna*).

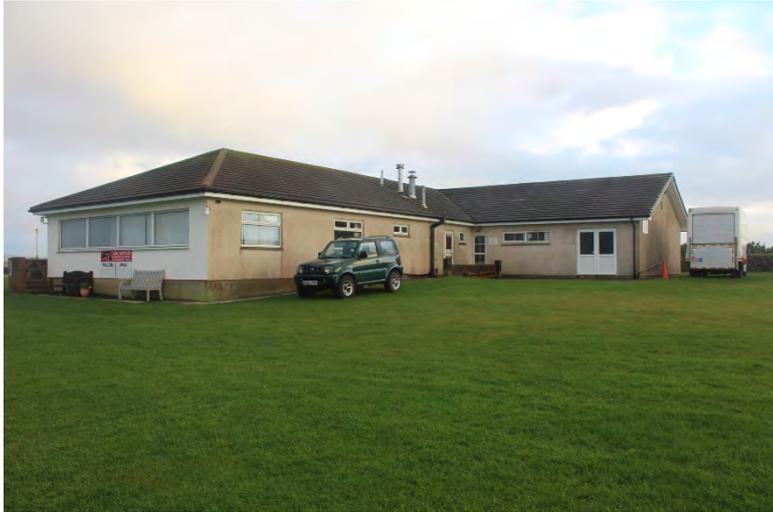
The clubhouse (TN1) is in good condition, in a relatively exposed location

- 6.5.6 The buildings at the site were inspected for their potential for use by bats. The clubhouse (TN1) was found to be in excellent condition, with rendered walls and boxed soffits sealed. The roof tiles, ridge tiles and verge caps were in place, tightly fitted.

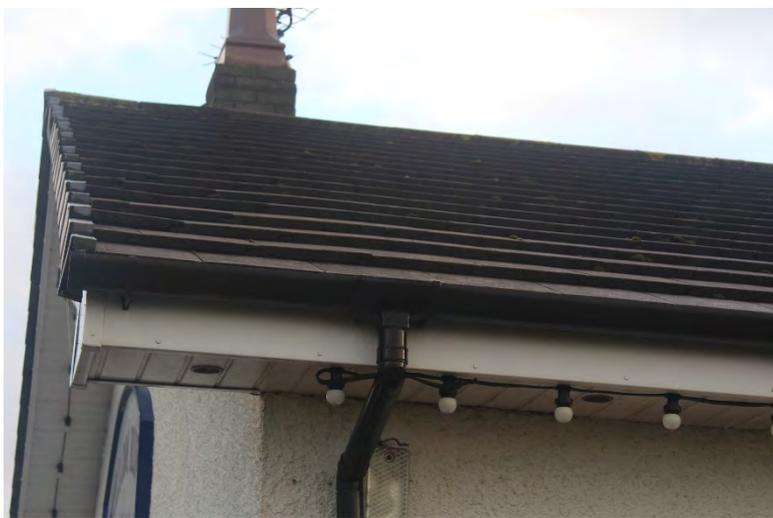
The roof tiles and roof verges are all in place and closely fitted

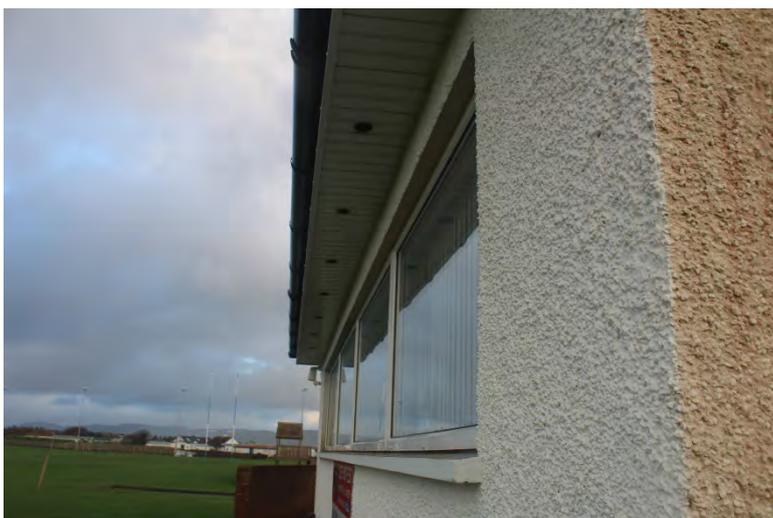
Soffits are sealed

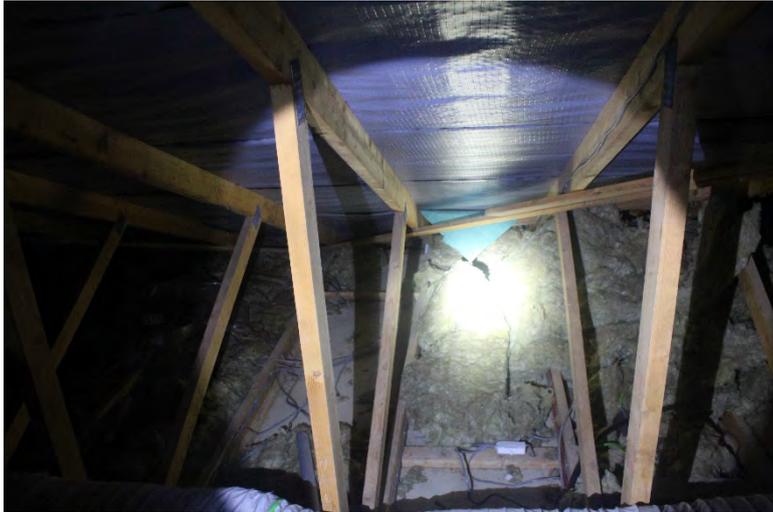
The roof voids in the clubhouse have timbers in good condition, and are relatively cluttered with struts. The roof lining is intact and the eaves lines are sealed. No signs of bats were found.

6.5.7 The roof voids in the clubhouse had timbers and roof lining in good condition, and the spaces seemed well sealed, with insulation present. The voids were cluttered with struts. There was no evidence of use by bats found associated with the building. Overall, this building has negligible potential for use by bats, our categorisation would be 1. Further details of our categorisation can be found in Table 3.

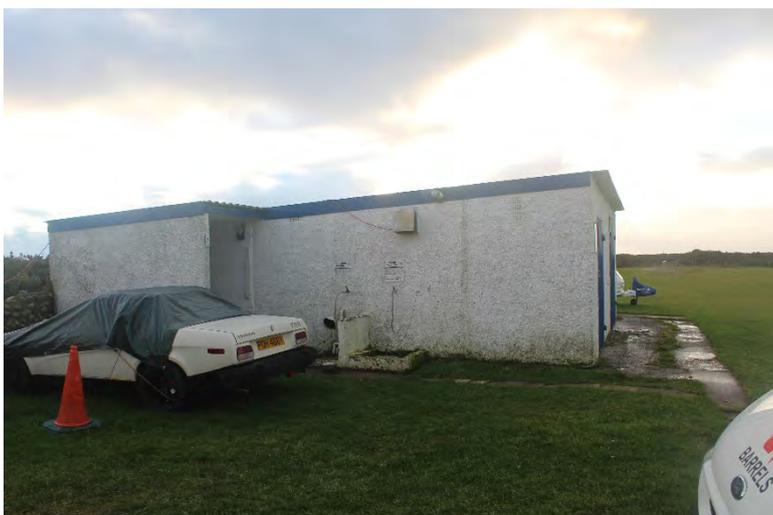
Outbuilding (TN2) to west of clubhouse, to be lost as part of proposal. The building is well sealed with no indications of use by bats.
