**Preliminary Roost assessment**  
**Former Park Head Inn**  
**Tuesday, 26 August 2025**  
**Version 1**

Former Park Head Inn  
Thornhill  
Egremont  
Cumbria  
CA22 2RP

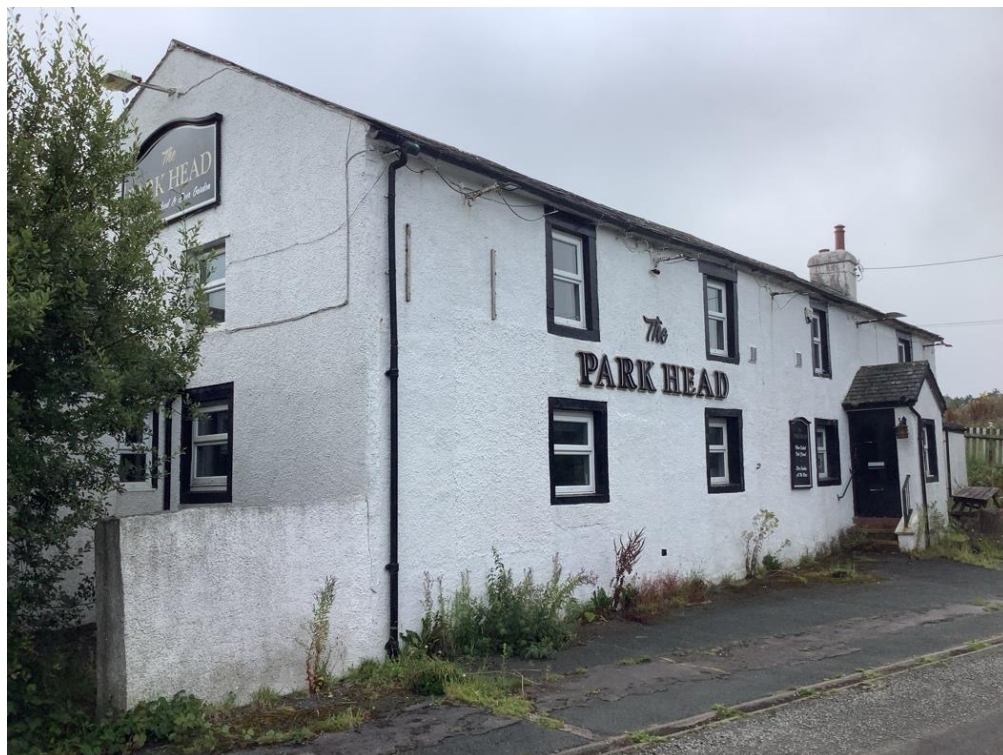
##### Front of site

The site is stone-built and fully rendered. The guttering is fixed directly into the rendered walls. The window and door fittings were tight-fitting uPVC. It has a slate roof with daubing at the southern end of the site and a slate roof with roofing felt below at the northern end. There is a small loft area throughout

There were raised slates on the roof. No signs were found at the southern end which had daubing beneath the slates, but at the northern end there was roofing felt, leaving a gap that could not be inspected and therefore a presence/ likely absence survey was warranted to ensure no bats were using this area.
