**REMEDIATION STRATEGY
FOR LAND AT
DALZELL STREET
MOOR ROW**

**Nigel Kay Homes Ltd
Hollowdyke Farm
Frizington
Cumbria
CA26 3QZ**

**September 2024
Ref: GSI 2132 LD RS Report V1**

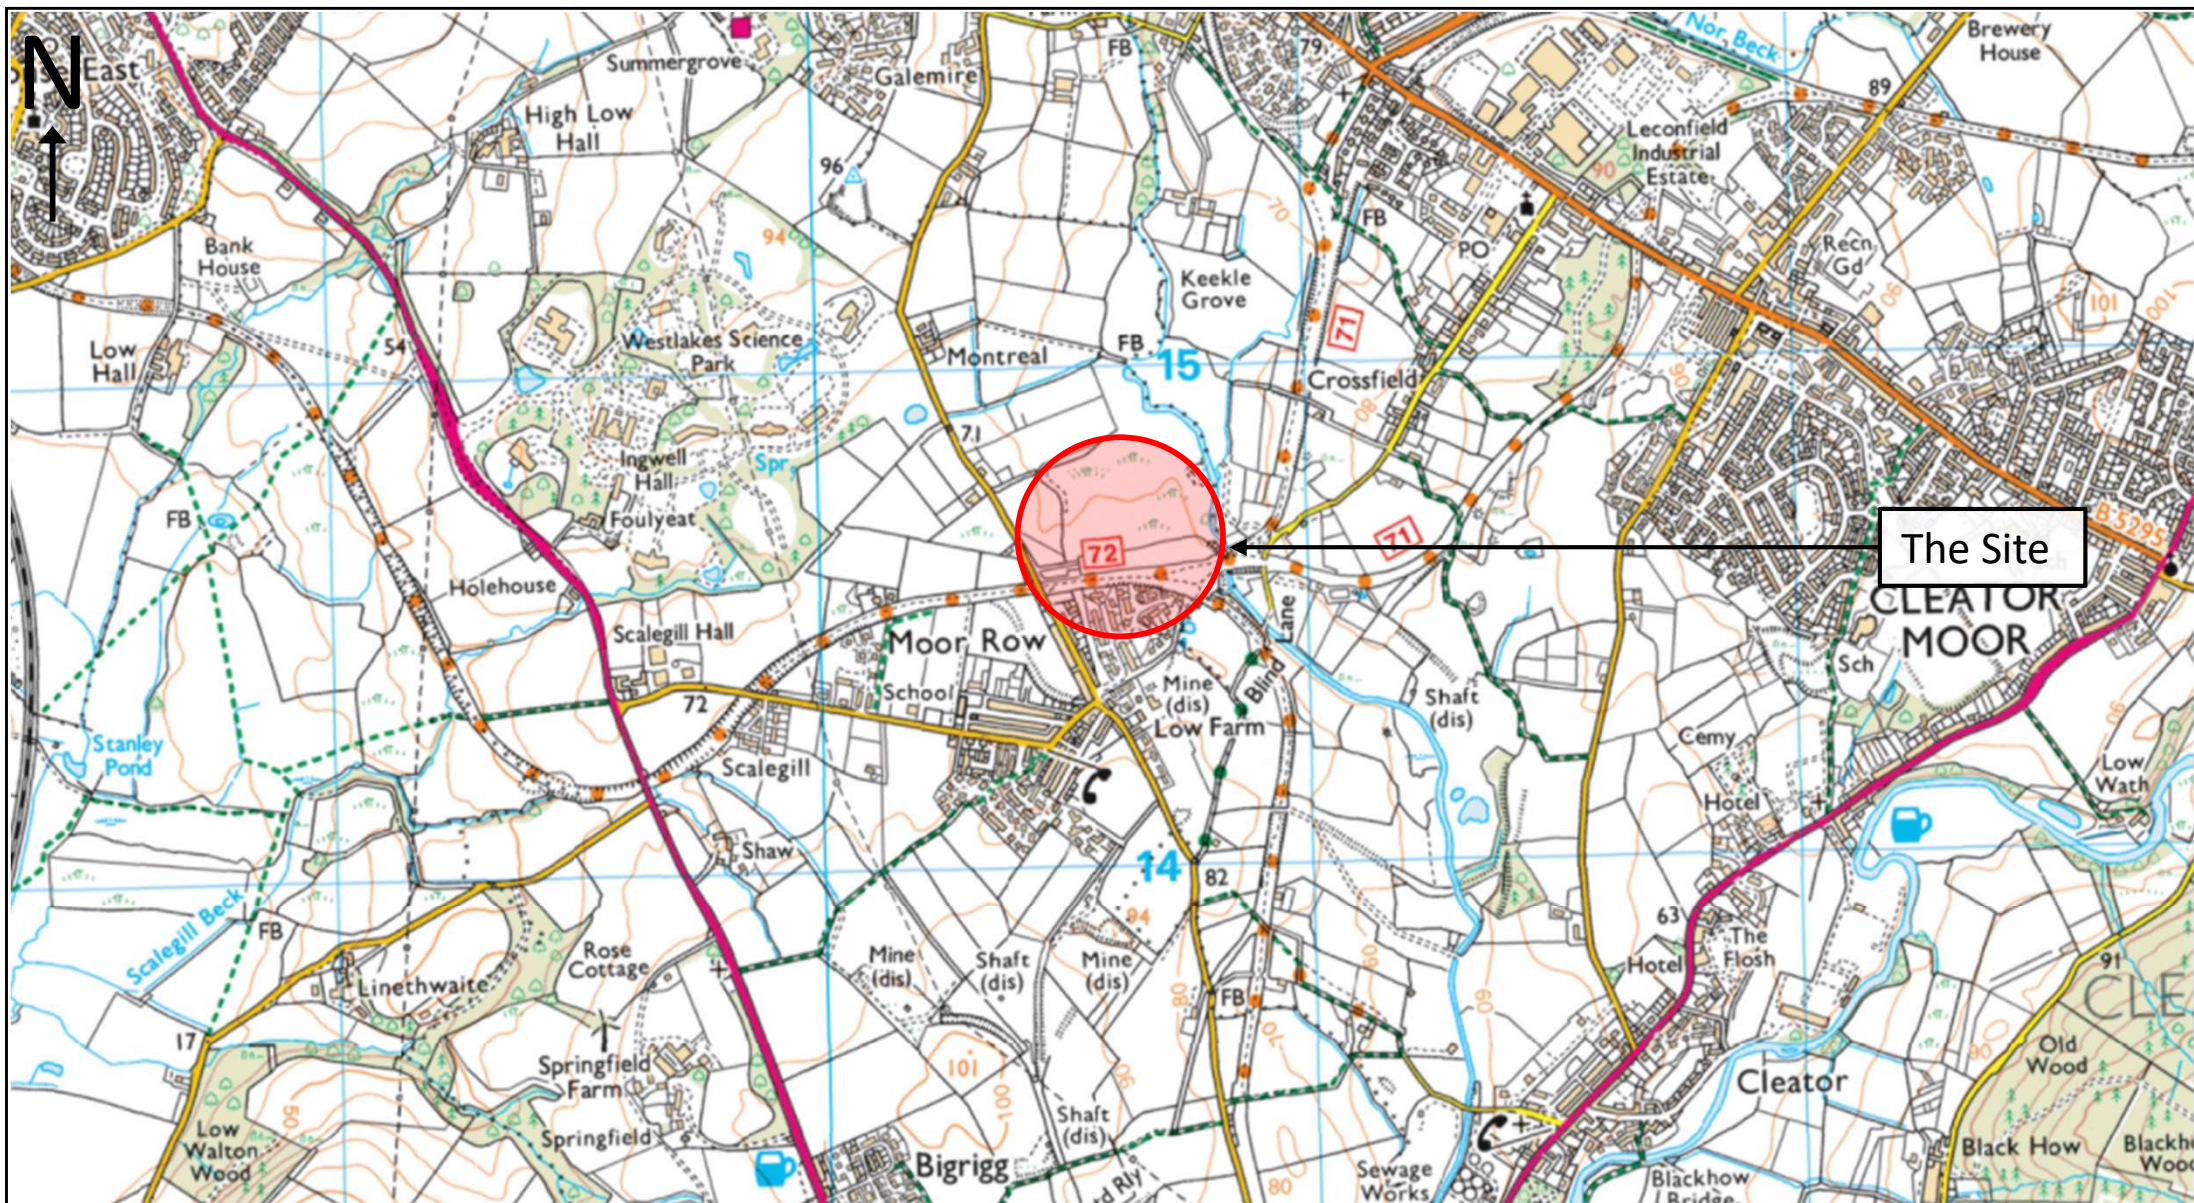
2.1.2 A site location plan is presented as Drawing No. GSI 2132/01 in Appendix A.

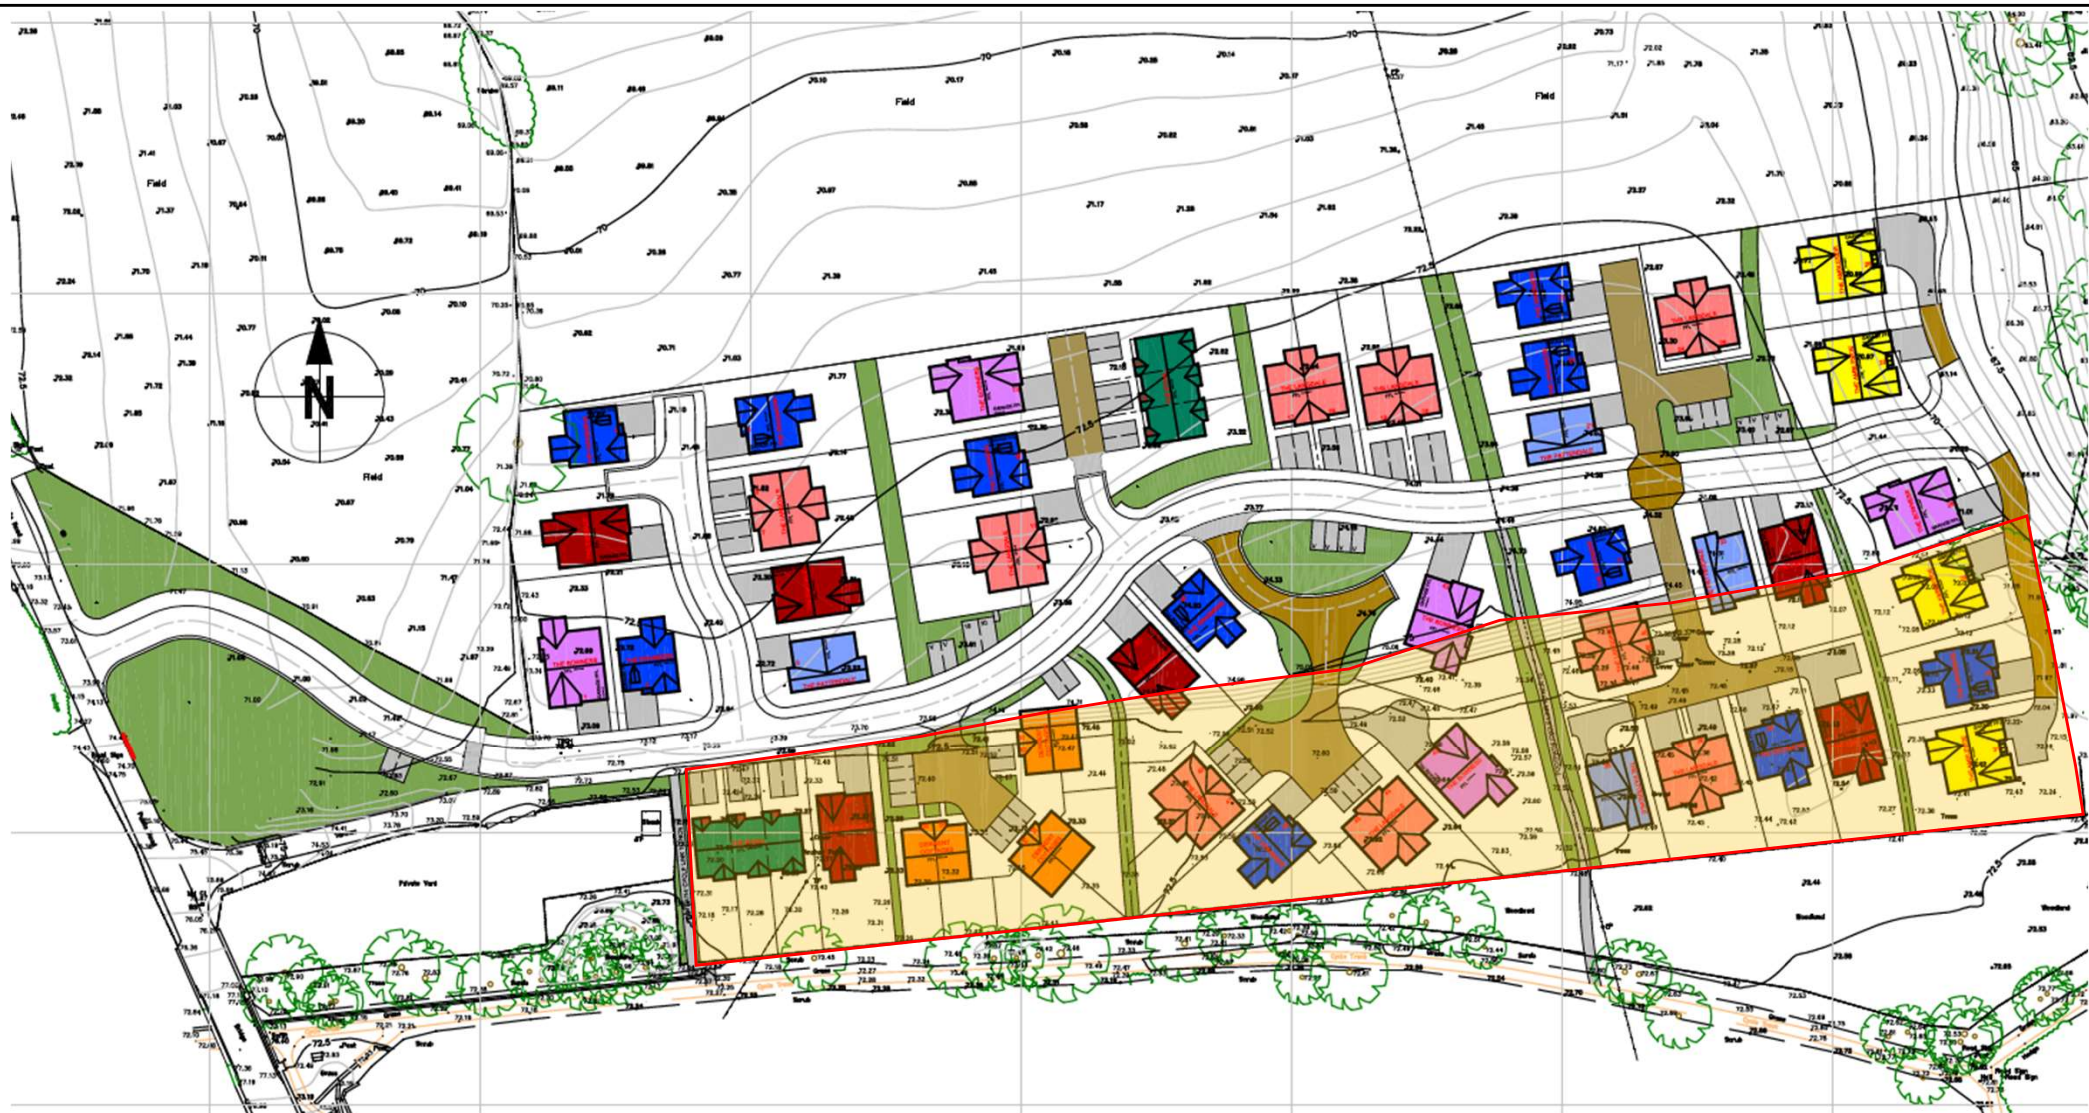
Remediation extents for cover systems in areas of soft landscaping

- Concentrations above guideline values of Arsenic, Lead, Benzo(a)anthracene, Benzo(a)pyrene, benzo(b)fluoranthene, dibenzo(ah)anthracene were recorded with in the granular made ground, alongside quantified asbestos within the Brownfield portion of site only, as defined on drawing GSI2132/03 and GSI2132/04 (Appendix A).

- 5.4.4 Remedial measures are required with respect to any intended landscaped areas associated with the new construction. It is considered removal of a minimum of 600mm of Made Ground (or until natural strata where the Made Ground is <600mm thick) would reduce the risk to human health, by importing and providing a clean cover system in accordance with BRE Cover Systems for Land Regeneration which would reduce the risk to human health.
