**PROPOSED DEVELOPMENT: KIRKLAND ROAD, ENNERDALE BRIDGE  
STAGE 1 ROAD SAFETY AUDIT AND DESIGNER'S RESPONSE**

**Land Adjacent to Kirkland Road, Ennerdale Bridge  
Proposed Footway across Croasdale Bridge**

**Stage 1 Road Safety Audit**

Report No. A103748-1/RSA1

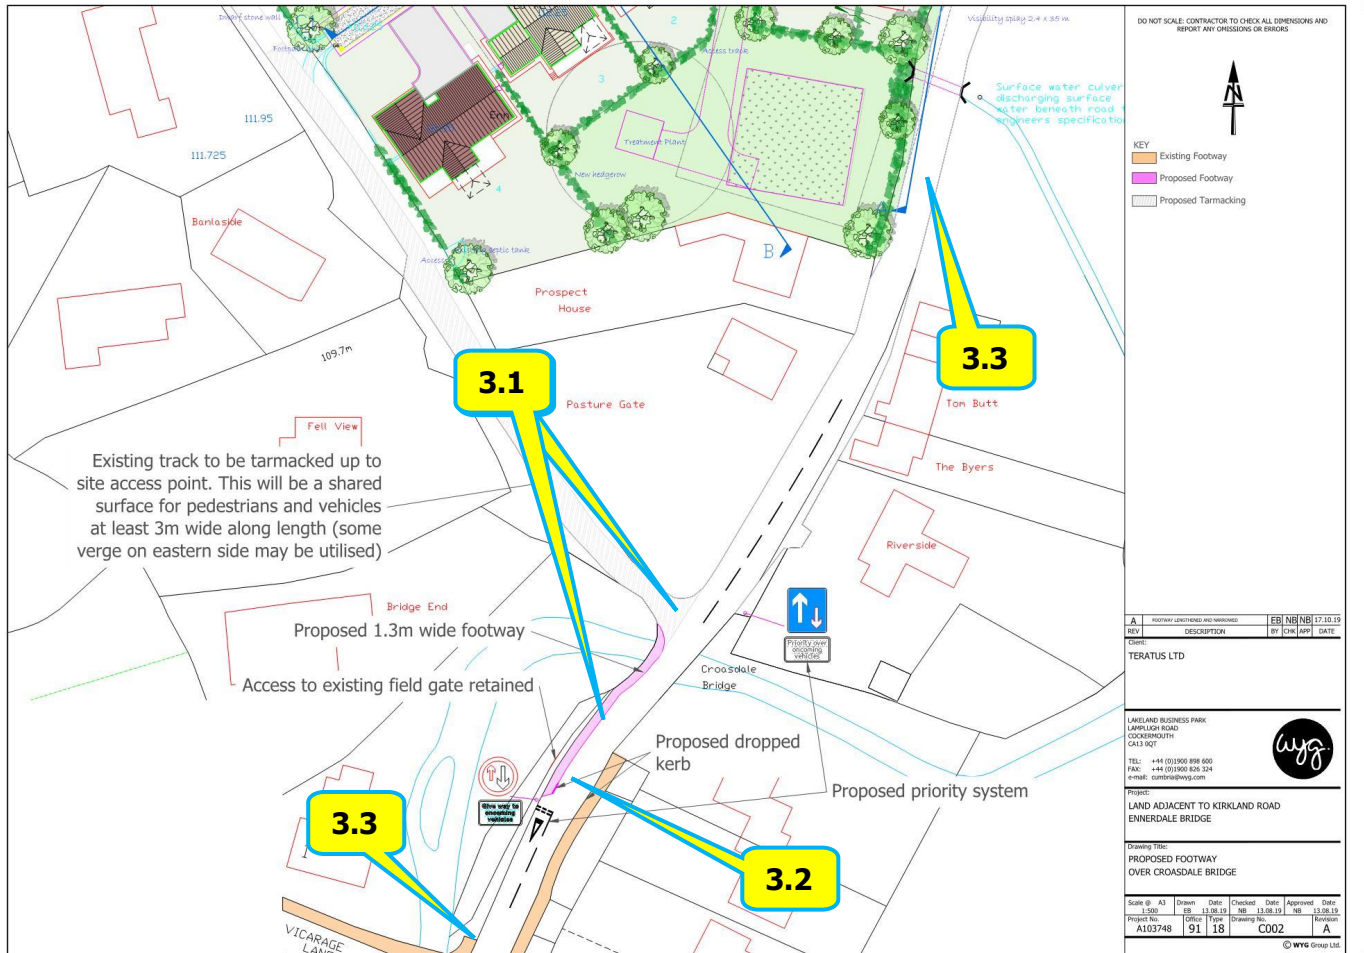
## 6. LOCATION PLAN OF ITEMS RAISED BY THIS AUDIT

Location: Kirkland Road and the track adjacent to the development.

Summary: The absence of footway lighting could result in pedestrians tripping or slipping and being struck by vehicles.

No details of lighting have been shown on the drawing submitted for audit, and the issue was raised in the 2018 Road Safety Audit. There will be an increase in pedestrian use of Kirkland Road and the track once the development and new section of footway are in place. If lighting is not provided there will be an increased risk of pedestrian trips and slips and of collisions with vehicles.

Location: The new footway on Kirkland Road.

Summary: The absence of bollards and road markings could lead to a number of collision types.

There are no bollards or other identifying features shown at the southern end of the new footway. In addition, there are no road markings shown to guide motorists past the footway towards the offside of the bridge. In their absence, there could be an increased risk of motorists colliding with the footway and the attendant risks of losing control and of collisions with pedestrians.

Location: The Kirkland Road approaches to the bridge.

Summary: The absence of signs warning road users of the changes to the road layout could increase the risk of a number of collision types.

There are no temporary signs specified to warn road users of the new priority system. In their absence, users might be unaware of the changes and brake or manoeuvre suddenly with the attendant risk of losing control, or of tail end or head on collisions.

It is recommended that an appropriate system of lighting is installed northwards from the existing system in the village to the south, to include the new footway and the track. If this recommendation is accepted, and a system of lighting is introduced, then the sign and supplementary plate indicating the give way at the priority system should be directly illuminated if they lie within 50m of any lamp within that system.

It is recommended that bollards with reflectorised bands or other warning features are installed at the southern end of the footway. In addition, it is recommended that edge of carriageway markings are laid to guide motorists past the footway.

It is recommended that once the scheme is in place, signs to Diagram 7014 are erected on the approaches to the priority system, worded appropriately.
