PHASE 2: GROUND INVESTIGATION REPORT

PROPOSED RESIDENTIAL DEVELOPMENT

BRITISH LEGION SITE, CHURCH ROAD

DISTINGTON, CUMBRIA

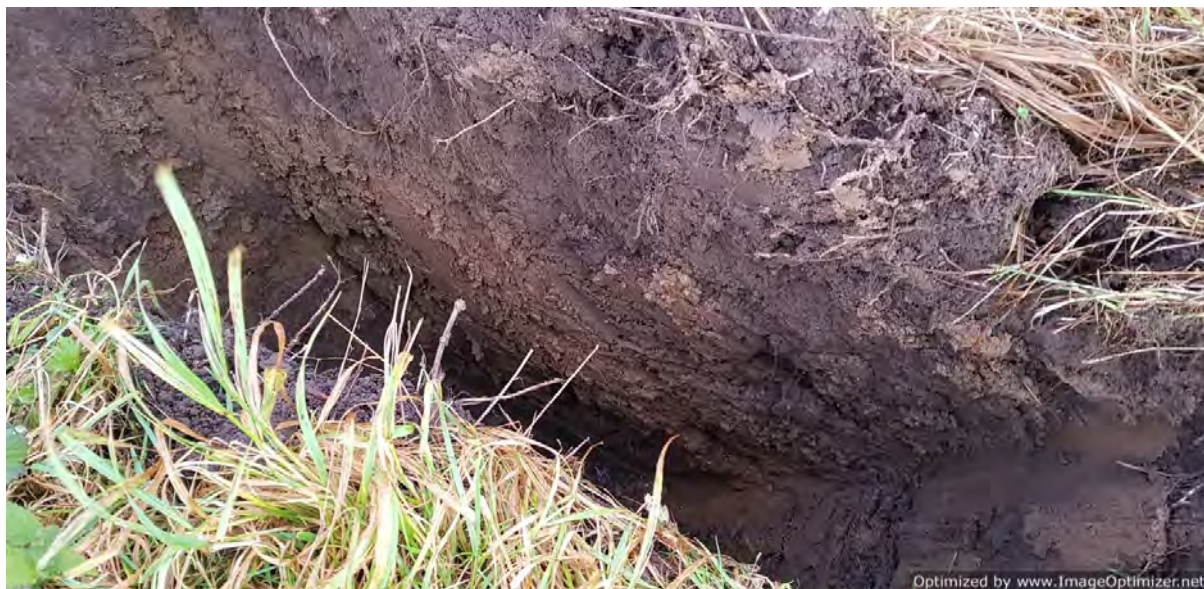
GEO2019-4032: Land off Church Road, Distington, Cumbria – TP02

Soil Infiltration Test	
Pit Dimensions: 0.30 x 1.80m	
Duration (mins)	Water Level (m bgl)
0	0.40
20	0.41
80	0.39
120	0.38

In order to facilitate the soak-away design, soil infiltration tests were completed in trial pits TP01 to TP03. The tests involved excavating a trial pit to the appropriate depth (c.1.50m to c.1.70m bgl) and partially filling with water. The water level was monitored at regular intervals.

During the test, the water level either remained static or rose within the pit, possibly due to the shallow groundwater ingress. The tests were terminated after a maximum duration of 240 minutes (4 hours). Based on the results of the tests, the ground conditions are not considered suitable for soak-away drainage.

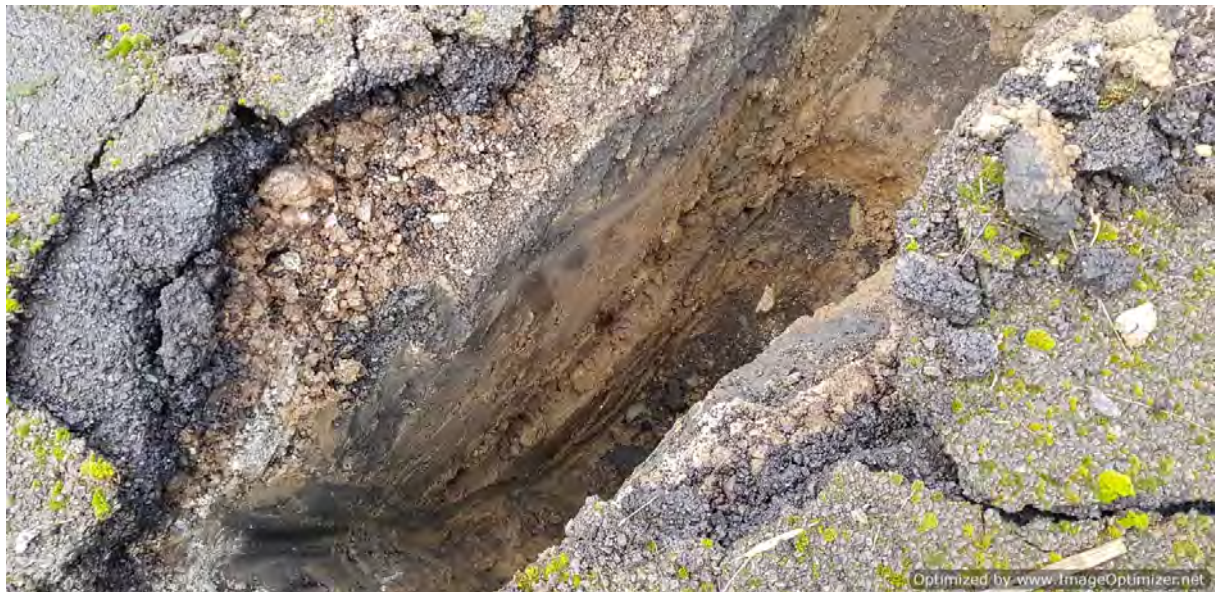
GEO2019-4032: Land off Church Road, Distington, Cumbria – TP04

Soil Infiltration Test	
Pit Dimensions: 0.35 x 1.80m	
Duration (mins)	Water Level (m bgl)
0	0.45
40	0.45
75	0.45
120	0.45
240	0.45

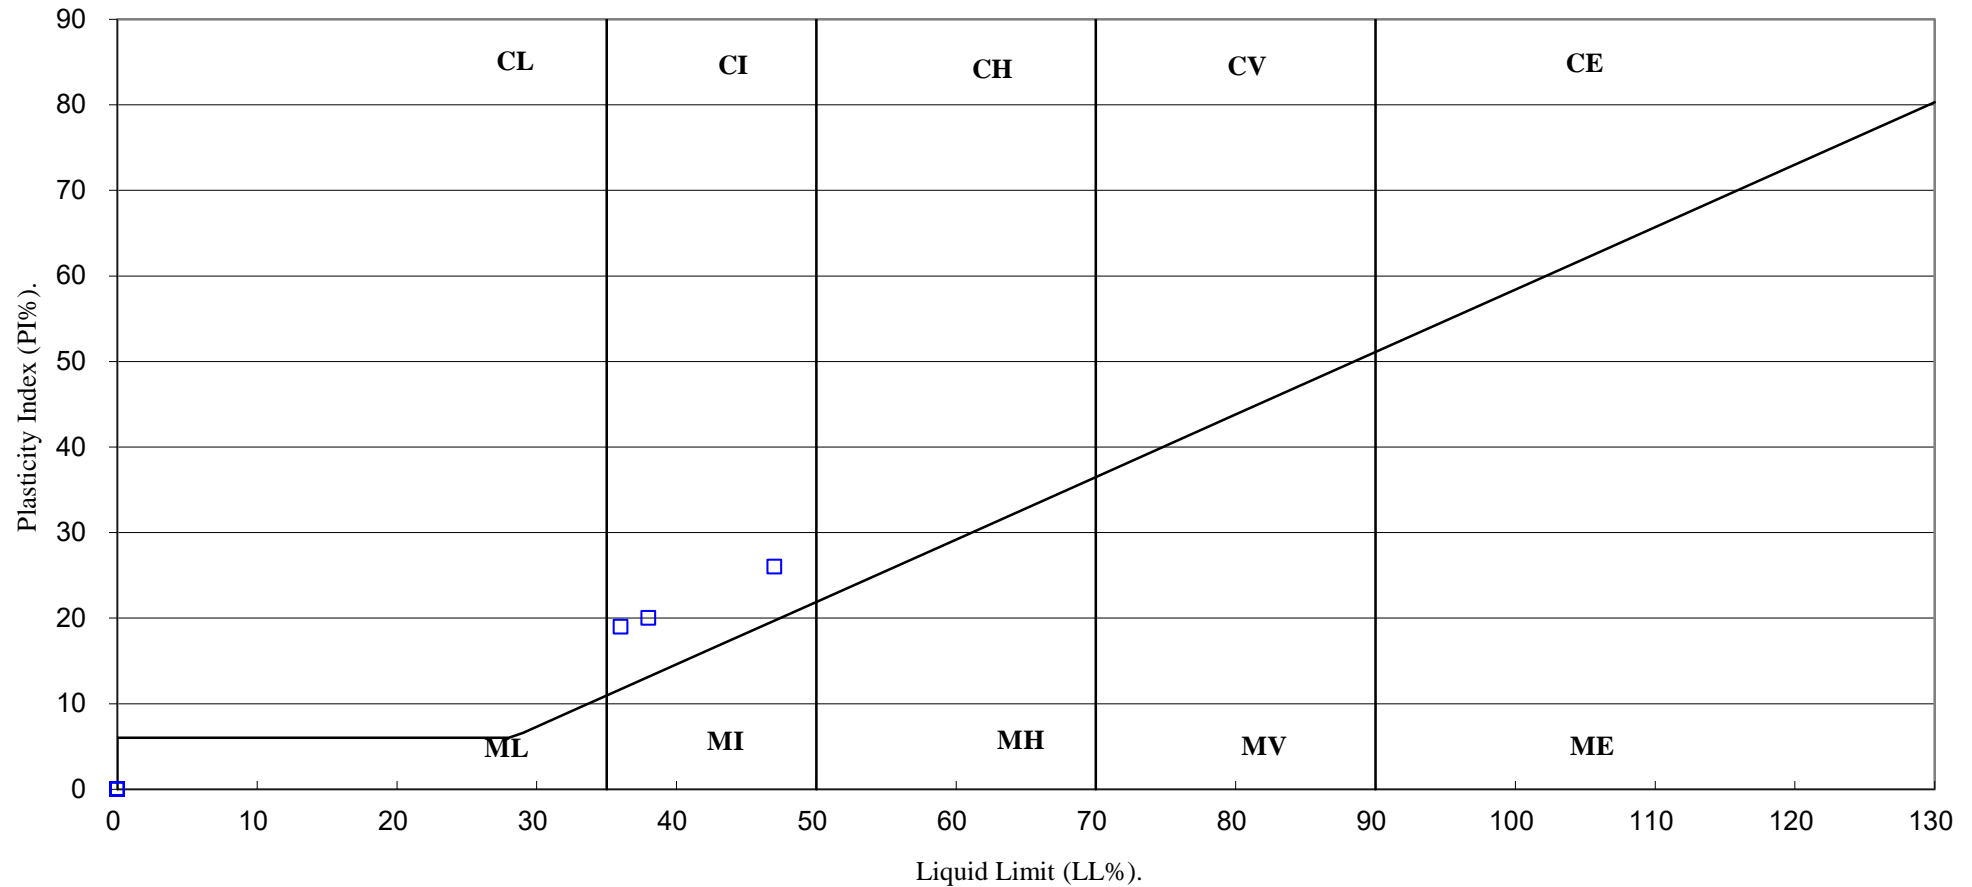
PLASTICITY CHART FOR CASAGRANDE CLASSIFICATION.

Natural moisture contents of 14% and 22% were observed with liquid limits between 36% and 47% and plasticity indices of between 19% and 26% being recorded. The results indicate clays of intermediate plasticity and a medium volume change potential.

3 No. samples of the natural clay deposits recovered from the exploratory holes at depths of between c.1.00m and c.1.50m bgl were scheduled for classification tests to determine their moisture content, liquid and plastic limits. The results of the testing are contained in the PSL report (ref: PSL19/7765) presented in Appendix III and summarised below.
