Project No: GEO2023-5701

Project Title: Uldale View, Egremont – Soil Infiltration Test Report

Geo Environmental Engineering Ltd (GEO) were commissioned by the Client, Gleeson Regeneration Ltd to carry out soil infiltration tests to aid the drainage design for the proposed residential development at Uldale View in Egremont, Cumbria.

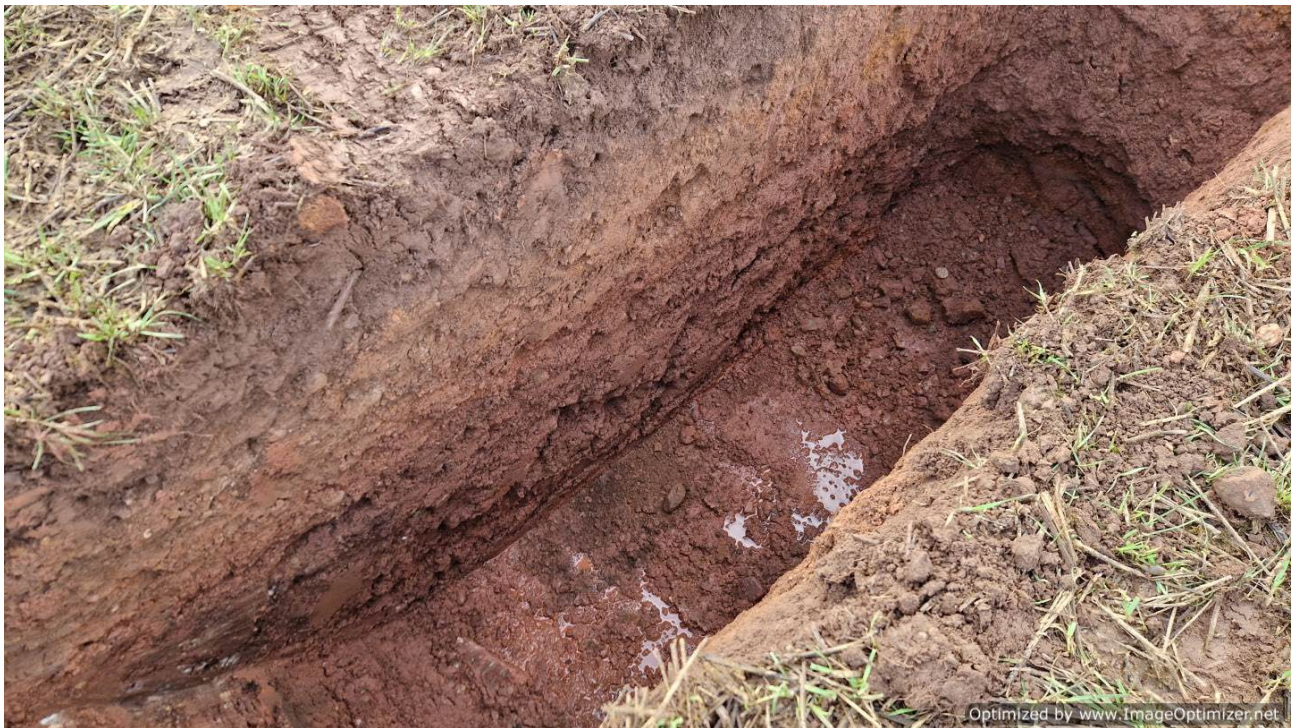
GEO2023-5701: Uldale View, Egremont – TP-A

Depth From (m)	Depth To (m)	Strata Description	Legend	Testing / Samples
0.00	0.30	TOPSOIL: Dark grey brown silty sandy gravelly LOAM.

0.30	0.65	Orangey brown silty very sandy fine to coarse GRAVEL with occasional cobbles and lenses of gravelly sand.

0.65	1.50	Dark red brown silty very sandy GRAVEL and COBBLES.

End of trial hole at 1.50m bgl – Soil Infiltration Test Completed. Slight groundwater ingress at c.1.45m bgl. Trial hole backfilled with arisings on completion.		
Engineer: J.Brock Site Works Date: 06/02/2023 Plant: Tracked 360 Excavator Dimensions: 2.60m x 0.65m			Log Notes: HSV = Hand Shear Vane (kN/m ²) LP = Limited Penetration (HSV/CBR) B = Bulk Bag, J = Amber Glass Jar, T = Plastic Tub

Soil Infiltration Test Results – TP-A	
Duration (mins)	Water Level (m bgl)
0	0.49
16	0.54
69	0.62
128	0.69
225	0.76
327	0.81

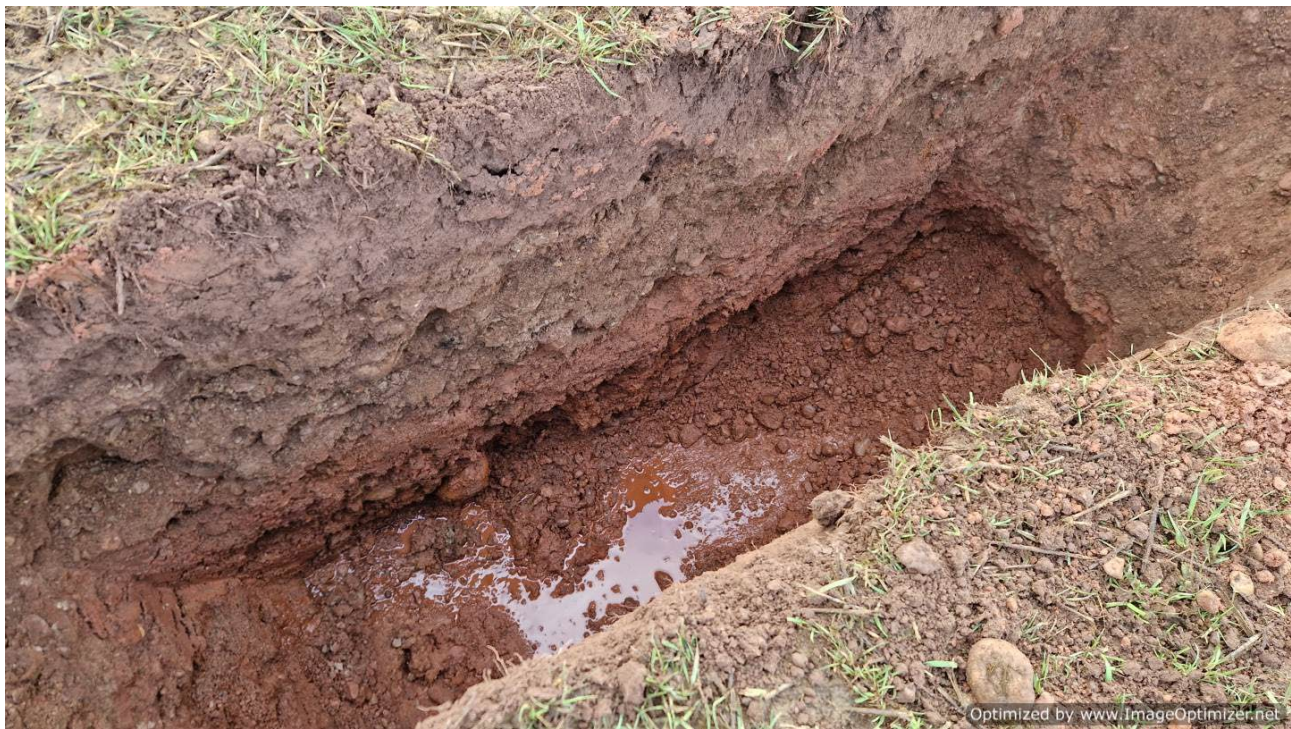
GEO2023-5701: Uldale View, Egremont – TP-B

Depth From (m)	Depth To (m)	Strata Description	Legend	Testing / Samples
0.00	0.28	TOPSOIL: Dark grey brown silty sandy gravelly LOAM.

0.28	1.60	Brown slightly silty very sandy GRAVEL with occasional sub-rounded cobbles.

End of trial hole at 1.60m bgl – Soil Infiltration Test Completed. Moderate groundwater ingress at c.1.45m bgl. Trial hole backfilled with arisings on completion.		
Engineer: J.Brock Site Works Date: 06/02/2023 Plant: Tracked 360 Excavator Dimensions: 2.50m x 0.65m			Log Notes: HSV = Hand Shear Vane (kN/m ²) LP = Limited Penetration (HSV/CBR) B = Bulk Bag, J = Amber Glass Jar, T = Plastic Tub

Soil Infiltration Test Results – TP-B	
Duration (mins)	Water Level (m bgl)
0	0.56
56	0.71
115	0.78
213	0.86
314	0.93

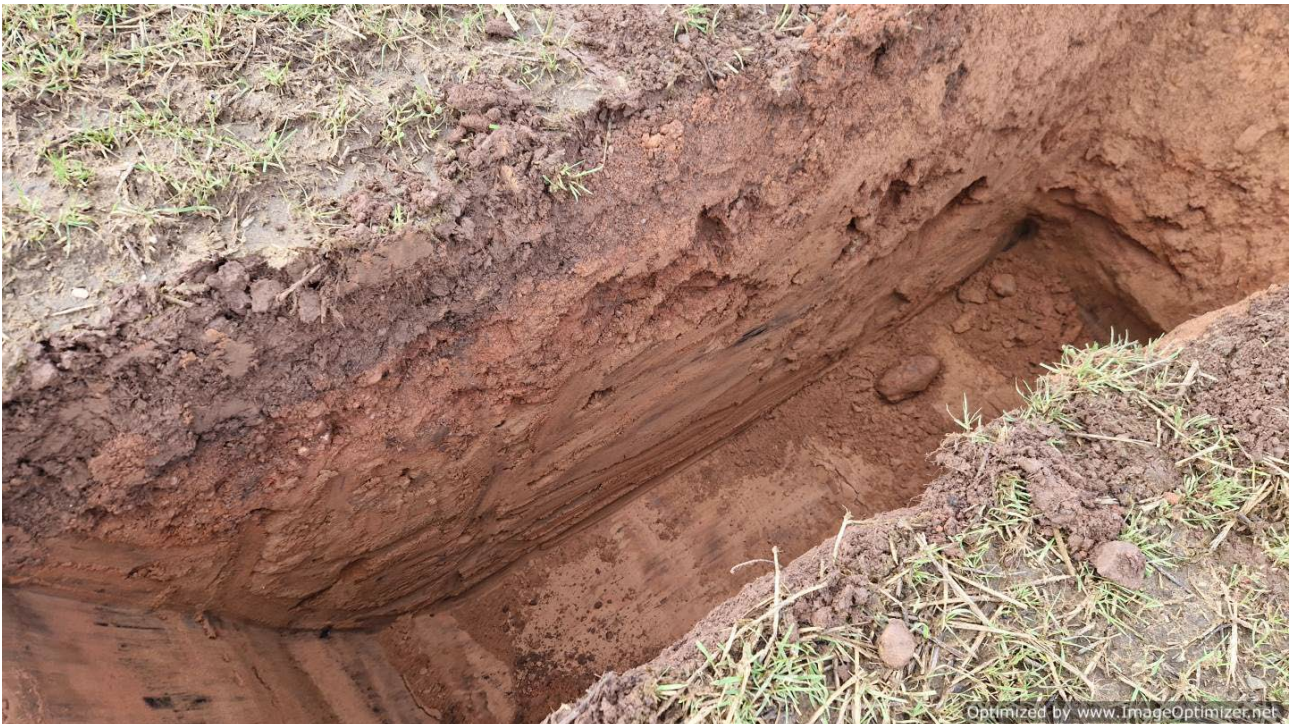
GEO2023-5701: Uldale View, Egremont – TP-C1

Depth From (m)	Depth To (m)	Strata Description	Legend	Testing / Samples
0.00	0.33	TOPSOIL: Dark grey brown silty sandy gravelly LOAM.

0.33	1.45	Dark red brown silty very gravelly SAND with occasional cobbles and lenses of sandy gravel.

End of trial hole at 1.60m bgl – soil infiltration test completed. Trial pit dry on completion. Trial hole backfilled with arisings on completion.		
Engineer: J.Brock Site Works Date: 06/02/2023 Plant: Tracked 360 Excavator Dimensions: 2.50m x 0.65m			Log Notes: HSV = Hand Shear Vane (kN/m ²) LP = Limited Penetration (HSV/CBR) B = Bulk Bag, J = Amber Glass Jar, T = Plastic Tub

Soil Infiltration Test Results – TP-C1	
Duration (mins)	Water Level (m bgl)
0	0.50
22	0.66
81	0.80
179	0.96
281	1.09

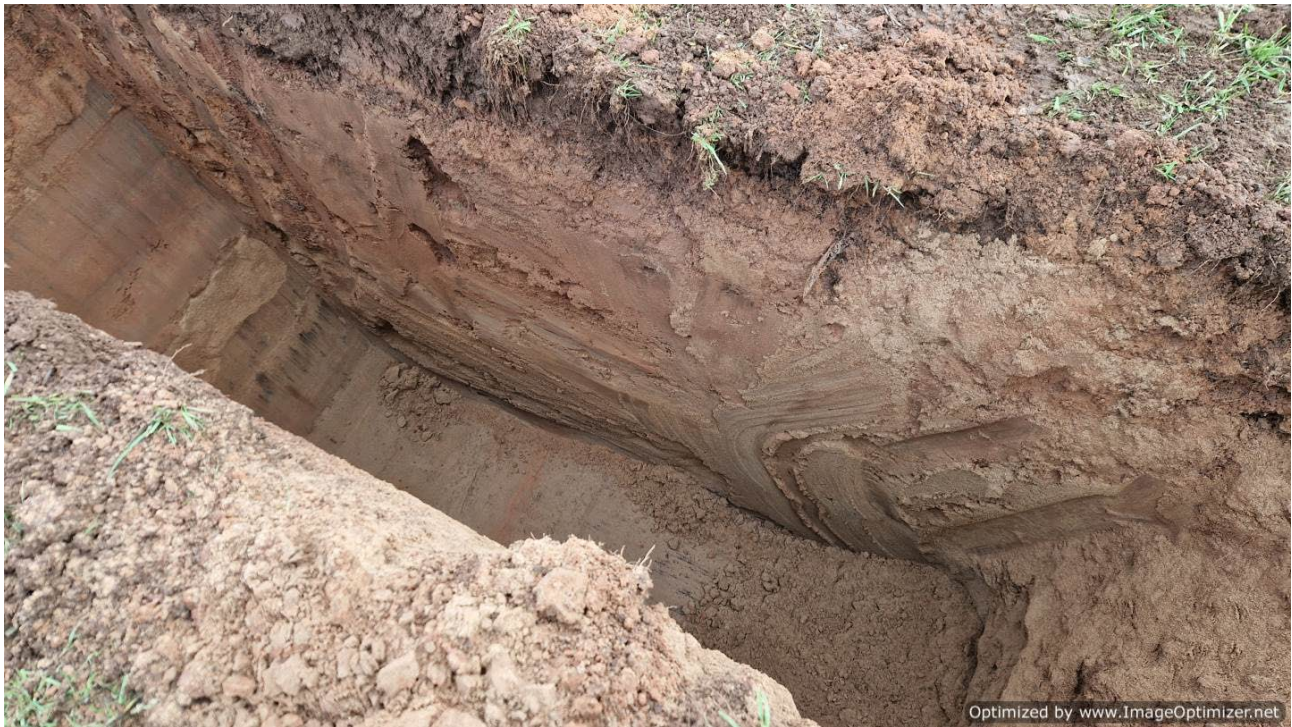
GEO2023-5701: Uldale View, Egremont – TP-D

Depth From (m)	Depth To (m)	Strata Description	Legend	Testing / Samples
0.00	0.31	TOPSOIL: Dark grey brown silty sandy gravelly LOAM.

0.31	1.60	Brown slightly silty fine to medium SAND. Becoming medium sand with depth.

End of trial hole at 1.60m bgl – soil infiltration test completed. Trial pit dry on completion. Trial hole backfilled with arisings on completion.		
Engineer: J.Brock Site Works Date: 06/02/2023 Plant: Tracked 360 Excavator Dimensions: 2.40m x 0.65m			Log Notes: HSV = Hand Shear Vane (kN/m ²) LP = Limited Penetration (HSV/CBR) B = Bulk Bag, J = Amber Glass Jar, T = Plastic Tub

Soil Infiltration Test Results – TP-D	
Duration (mins)	Water Level (m bgl)
0	0.64
10	0.76
68	0.98
166	1.16
267	1.26

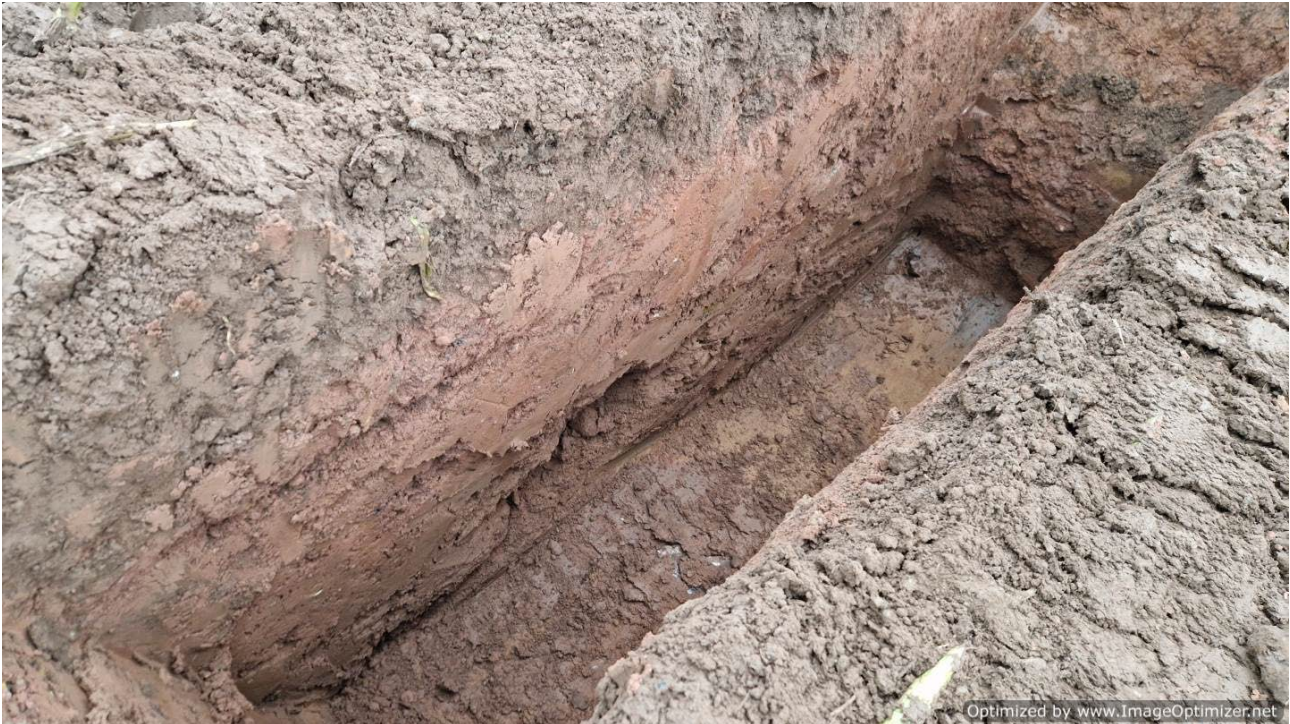
GEO2023-5701: Uldale View, Egremont – TP-E

Depth From (m)	Depth To (m)	Strata Description	Legend	Testing / Samples
0.00	0.28	TOPSOIL: Dark grey brown silty sandy gravelly LOAM.

0.28	1.30	Firm to stiff dark brown slightly sandy gravelly CLAY with occasional cobbles.

1.30	2.00	Brown slightly silty fine to medium SAND with occasional cobbles and boulders. Occasional lenses of sandy gravelly clay and sandy sub-rounded gravel.

End of trial hole at 2.00m bgl – soil infiltration test completed. Trial pit dry on completion. Trial hole backfilled with arisings on completion.		
Engineer: J.Brock Site Works Date: 07/02/2023 Plant: Tracked 360 Excavator Dimensions: 2.60m x 0.65m			Log Notes: HSV = Hand Shear Vane (kN/m ²) LP = Limited Penetration (HSV/CBR) B = Bulk Bag, J = Amber Glass Jar, T = Plastic Tub

Soil Infiltration Test Results – TP-E	
Duration (mins)	Water Level (m bgl)
0	0.81
76	0.98
150	1.15
230	1.34
305	1.51

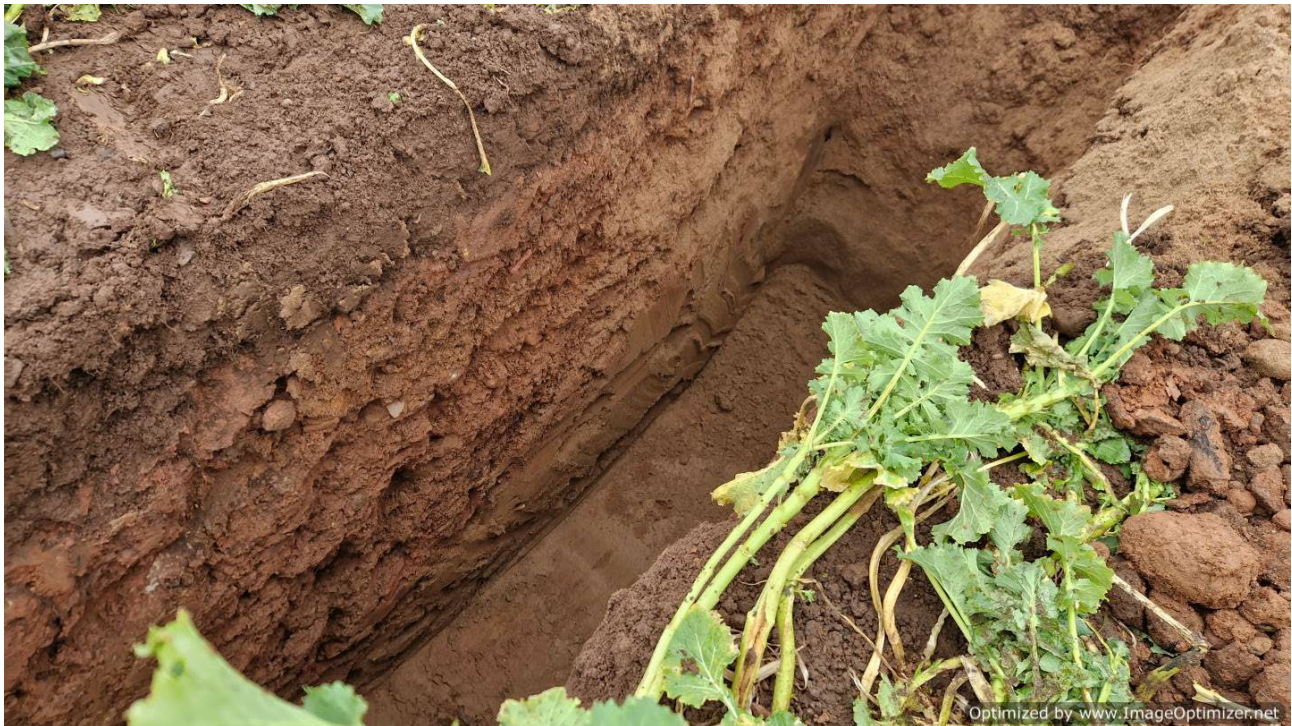
GEO2023-5701: Uldale View, Egremont – TP-F

Depth From (m)	Depth To (m)	Strata Description	Legend	Testing / Samples
0.00	0.28	TOPSOIL: Dark grey brown silty sandy gravelly LOAM.

0.28	1.30	Dark brown very silty fine to coarse angular to sub-rounded GRAVEL with occasional cobbles and boulders. Occasional lenses of very gravelly clay.

1.30	2.00	Brown slightly silty very gravelly SAND.

End of trial hole at 2.00m bgl – soil infiltration test completed. Trial pit dry on completion. Trial hole backfilled with arisings on completion.		
Engineer: J.Brock Site Works Date: 07/02/2023 Plant: Tracked 360 Excavator Dimensions: 2.60m x 0.65m			Log Notes: HSV = Hand Shear Vane (kN/m ²) LP = Limited Penetration (HSV/CBR) B = Bulk Bag, J = Amber Glass Jar, T = Plastic Tub

Soil Infiltration Test Results – TP-F	
Duration (mins)	Water Level (m bgl)
0	0.74
69	1.01
242	1.29
320	1.47
