Project No: GEO2022-5651

Project Title: Land at Pallaflat Farm, Bigrigg, Cumbria – Soil Infiltration Test Report

Geo Environmental Engineering Ltd (GEO) were commissioned by Mr Pete Woolaghan to carry out soil infiltration tests for the proposed residential workshop/store within the grounds of their residential dwelling at Pallaflat Farm, Bigrigg, Cumbria as indicated on the site location plan.

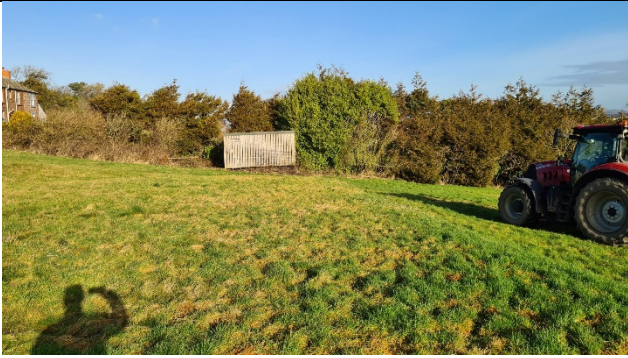
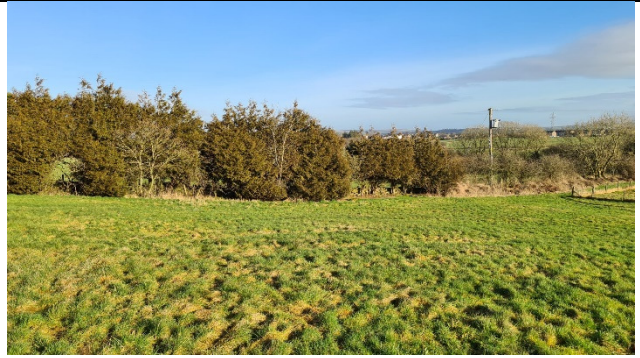
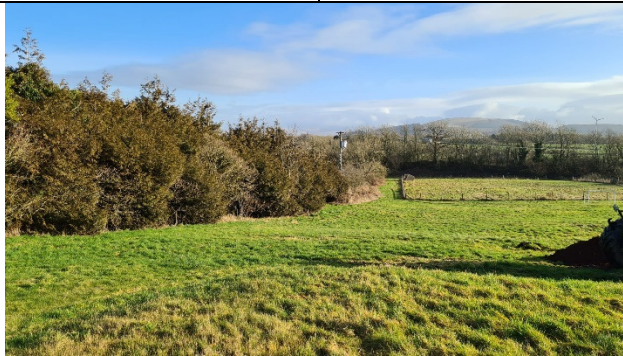
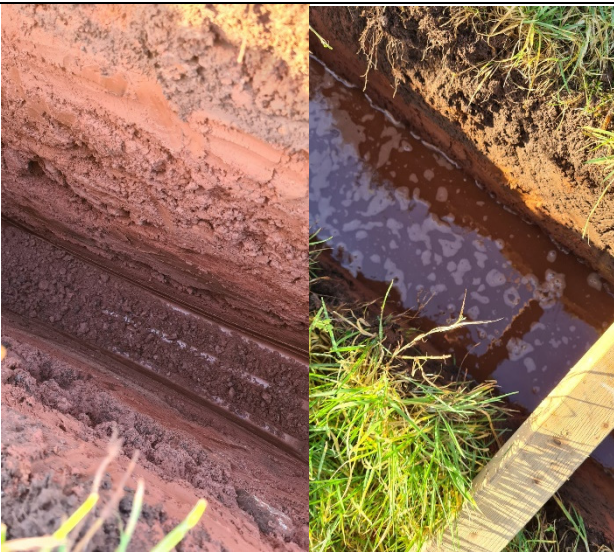
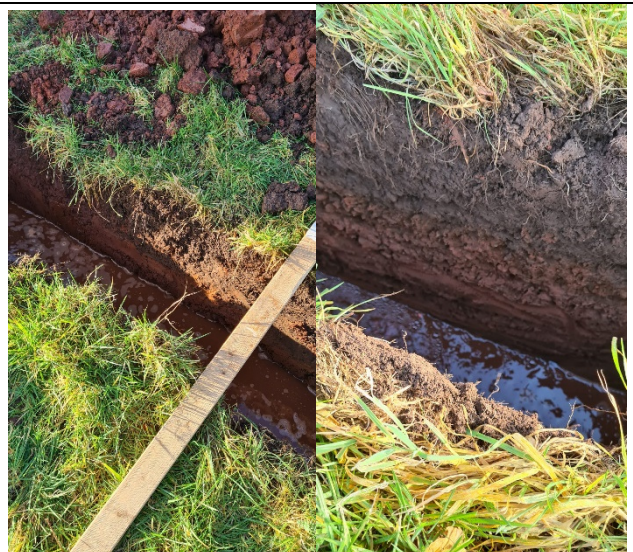
GEO2022-5651: Land at Pallaflat Farm – Site Photographs

Looking West
